RECOMMENDATION REPORT

CASE NO.: CHC-2015-3306-MAEX

PROJECT: 1830 N. Taft Avenue
Historic-Cultural Monument (HCM) No. 1070

The Polynesian
1830 N. Taft Avenue - Hollywood
Historic Structure Report

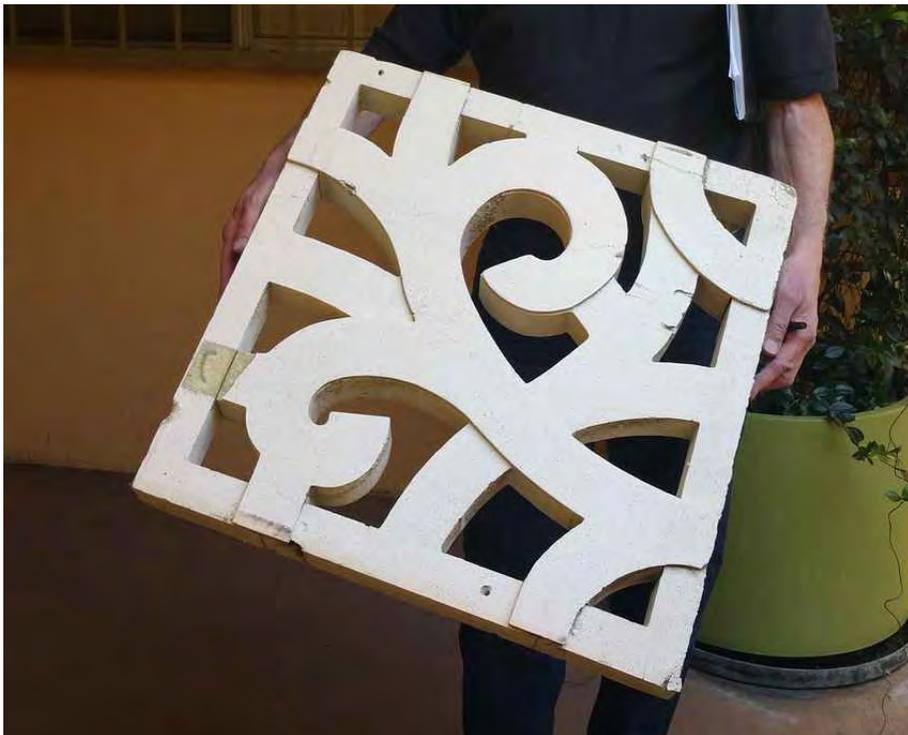
Fig. 2-7 Architectural screen panel blown down in a recent windstorm

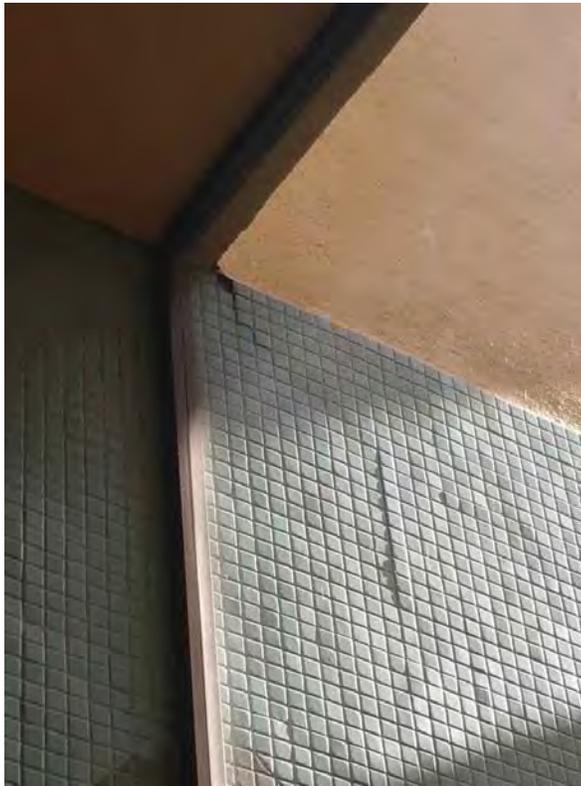
Fig. 2-9 Mosaic tile mural with crack

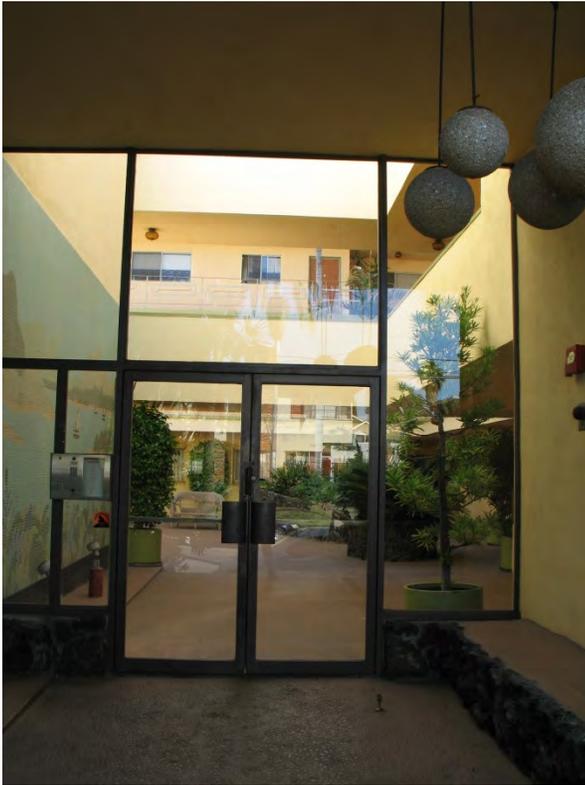
Fig. 2-9A Aluminum storefront style entry door

The aluminum entry doors from the street into the courtyard (Fig 2-9A) appear to be original or near original. The owner believes they were added for security in the 1960's

and that the entrance was formerly wide open. It is not entirely clear from looking at the details and there is no documentation of the original entrance. The lava rock sill and window frame into the Mosaic artwork in odd and not entirely resolved way and the window frame itself is probably fastened straight through the mosaic artwork tile (Fig 2-8). The owner has no desire to eliminate the secured entry function, however, is interested in a possibly replacing the storefront. It's possible that more damage would be done in removing the storefront system, especially to the mosaic artwork, so the preservation recommendation is inclined to suggest preserving the entire aluminum storefront system and repairing in place.

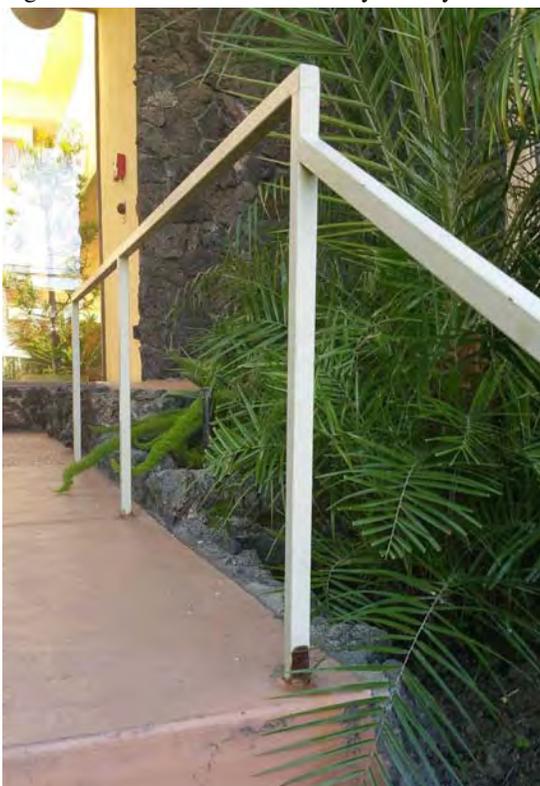
Fig. 2-11 Railing at courtyard entry with rust at base

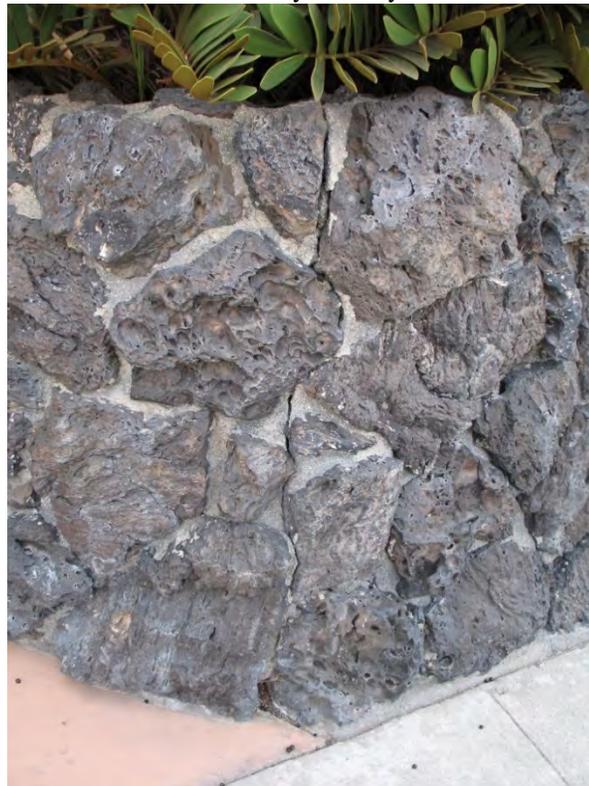
Fig. 2-12 Street entry Lava stone planter with crack

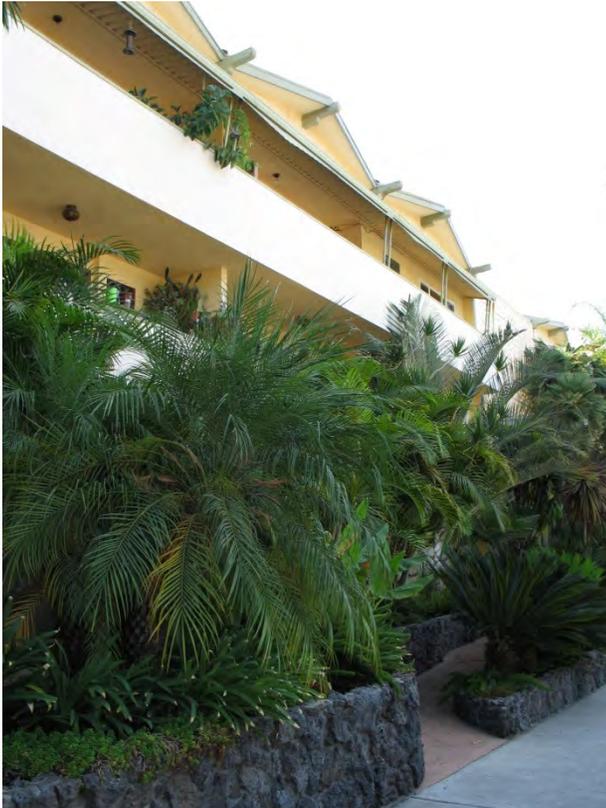
Fig. 2-13 Street view with over planting

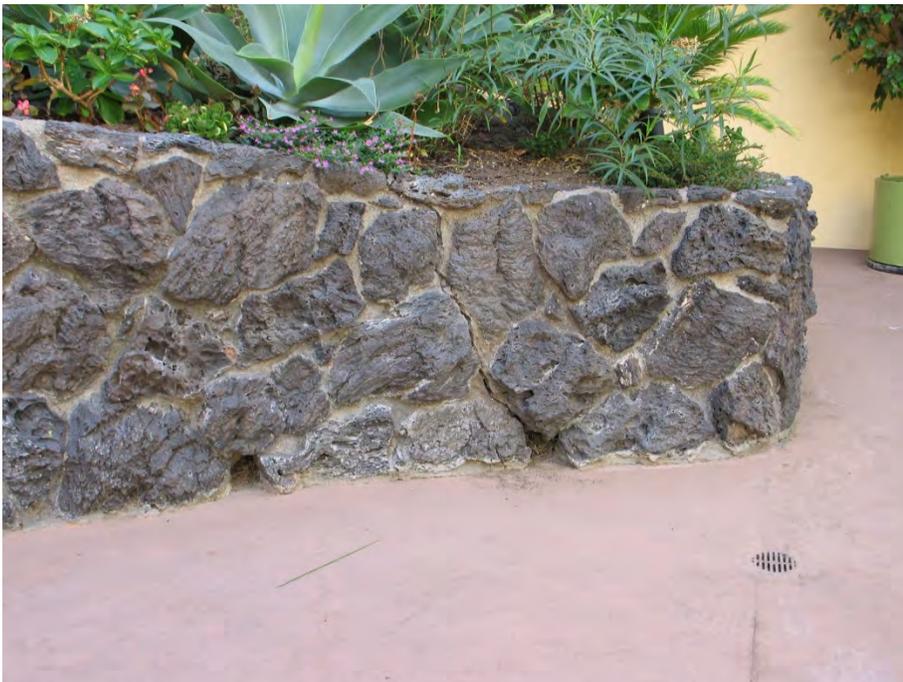
Fig. 2-18 Crack in lava stone planter

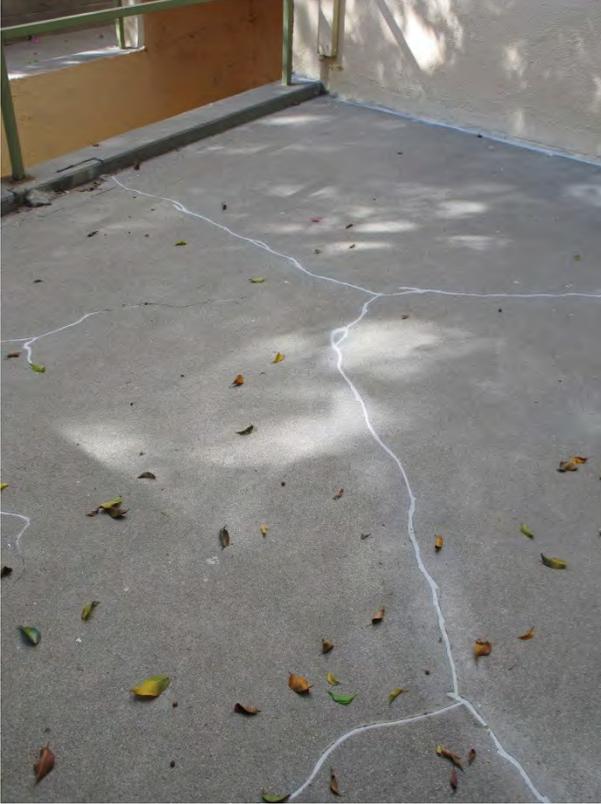
Fig. 2-20 Rear podium deck cracking

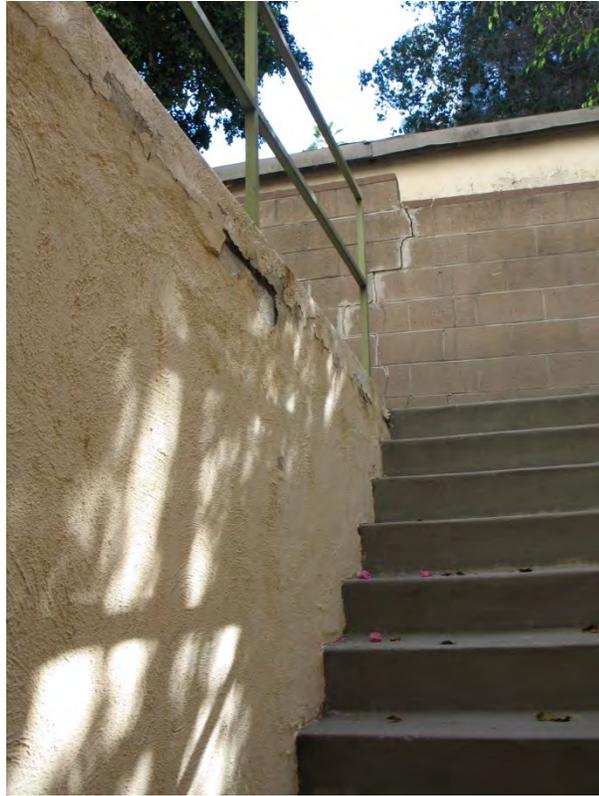
Fig. 2-21 Rear podium deck – cracking

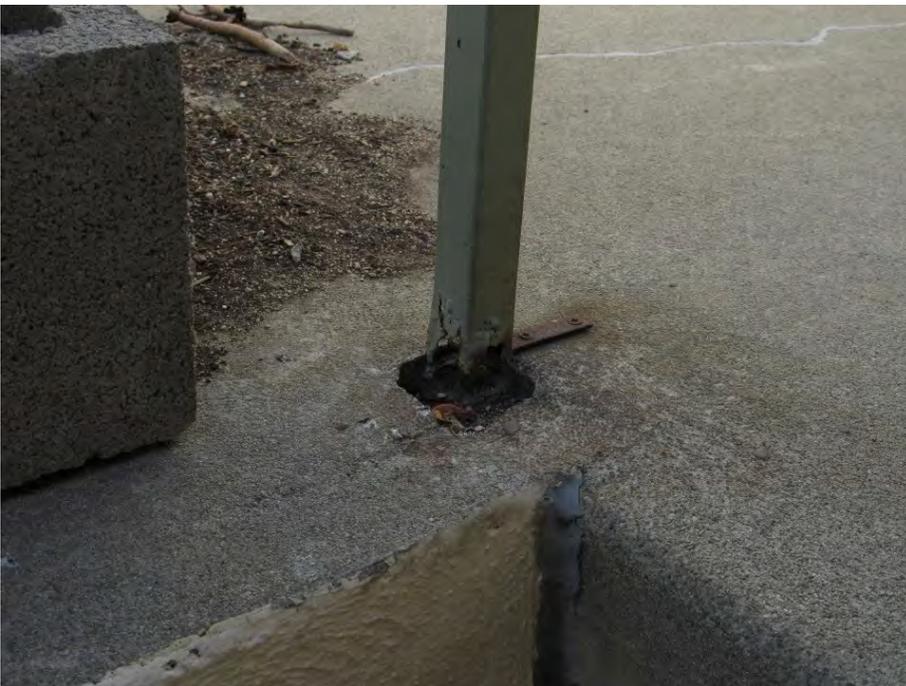
Fig. 2-22 Railing with extensive corrosion

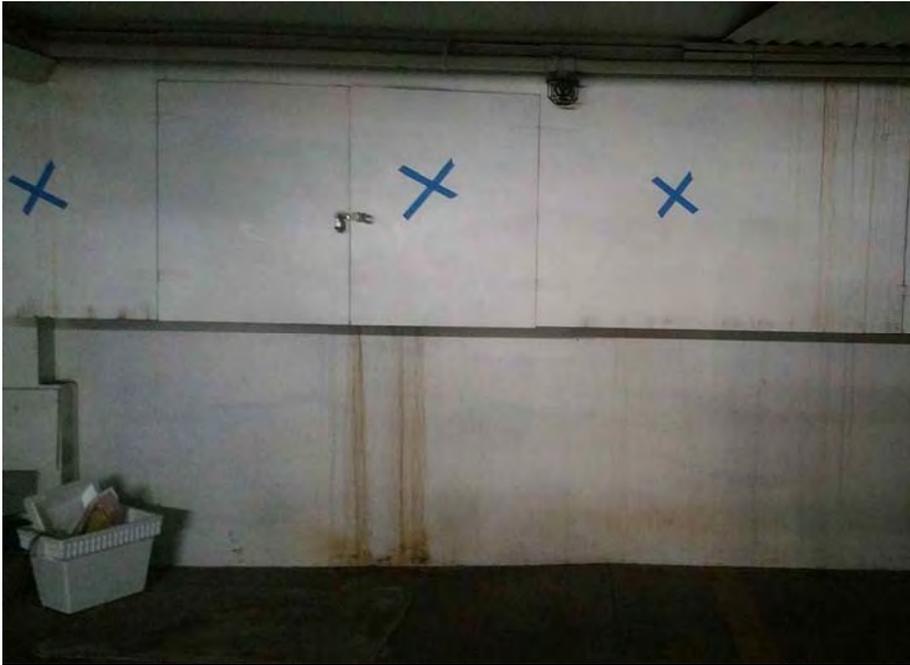
Fig. 2-23 Rear wall of garage showing water damage from rear podium cracks

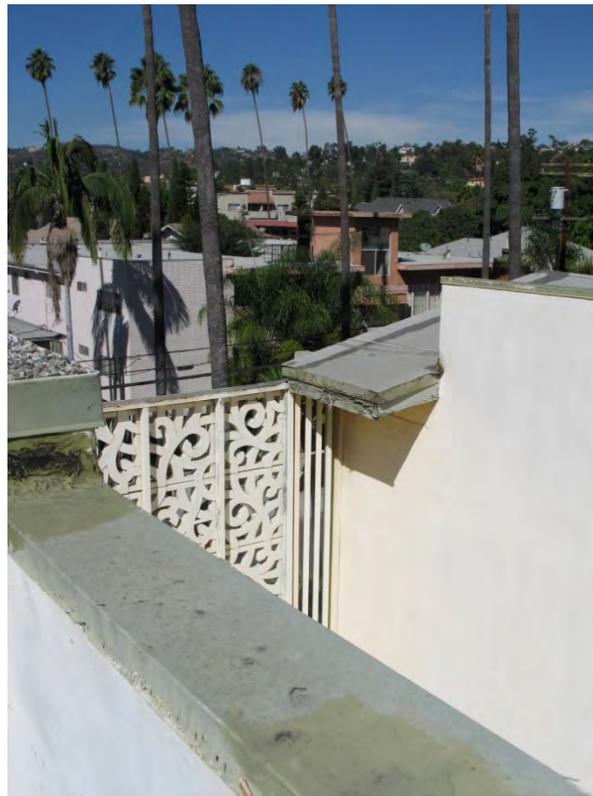
Fig. 2-28 Painted fascia board – rotting

The fascia boards on the street elevation should be inspected, repaired and repainted (Fig. 2-28 & 29).

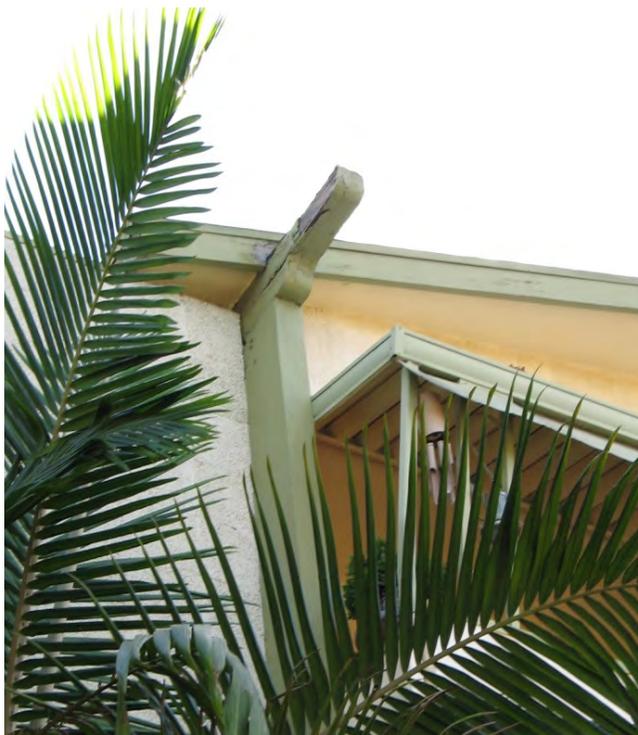
Fig. 2-29 Painted fascia and outrigger - rotting

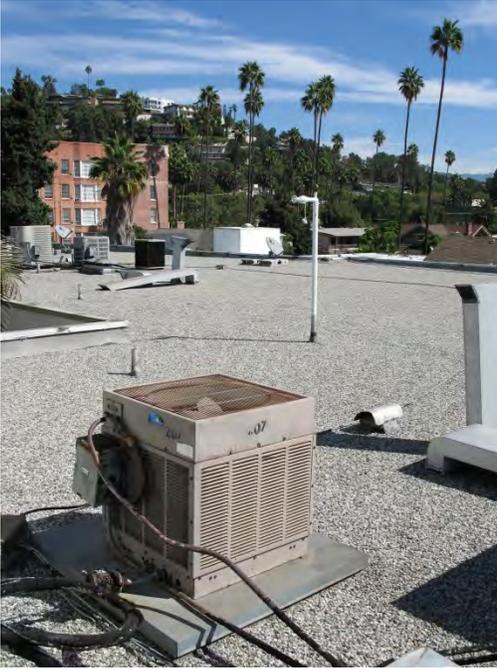
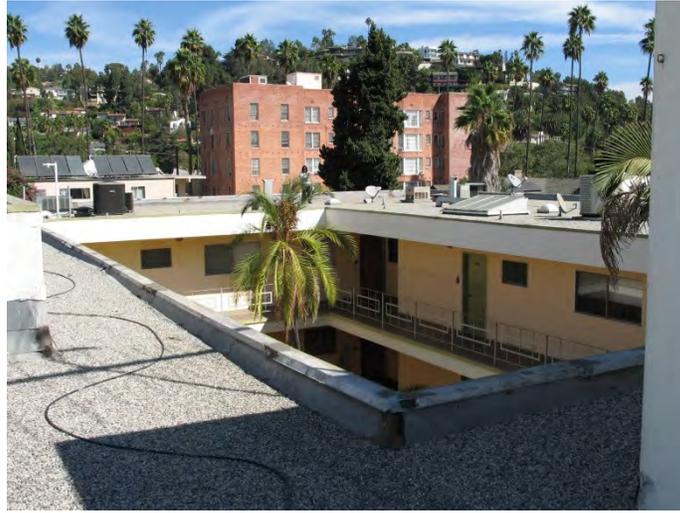
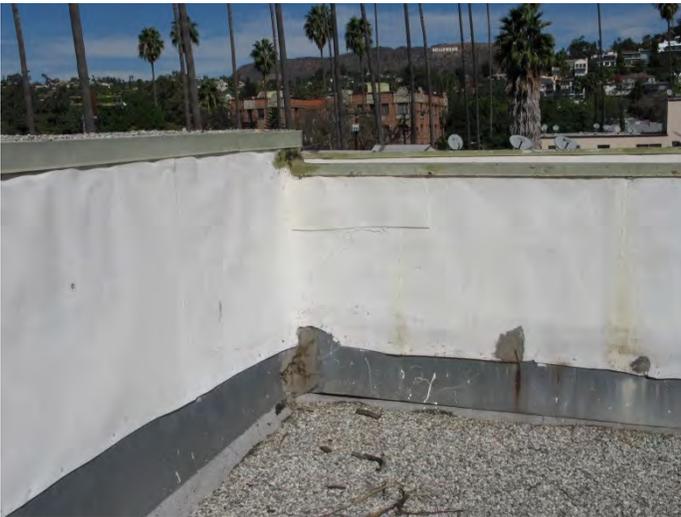
Fig. 2-30 Ballasted flat roofing

Fig. 2-31 Ballasted flat roofing

Fig. 2-32 Ballasted flat roofing and parapet (facing street)

mechanical equipment should be appropriately fastened to prevent toppling in an earthquake. (Fig. 2-30 thru32).

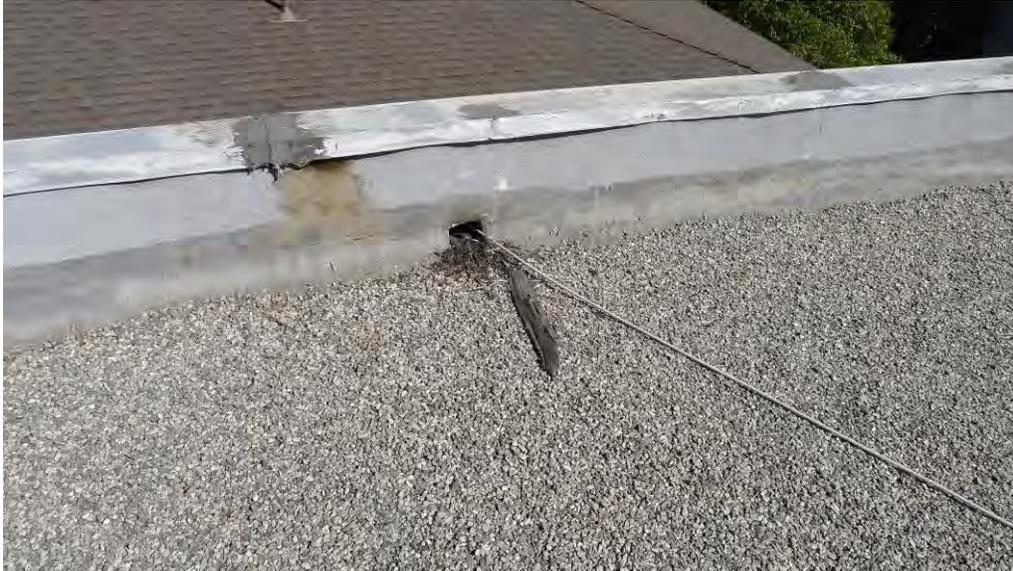
Figure 3: Roof scupper with cable and debris

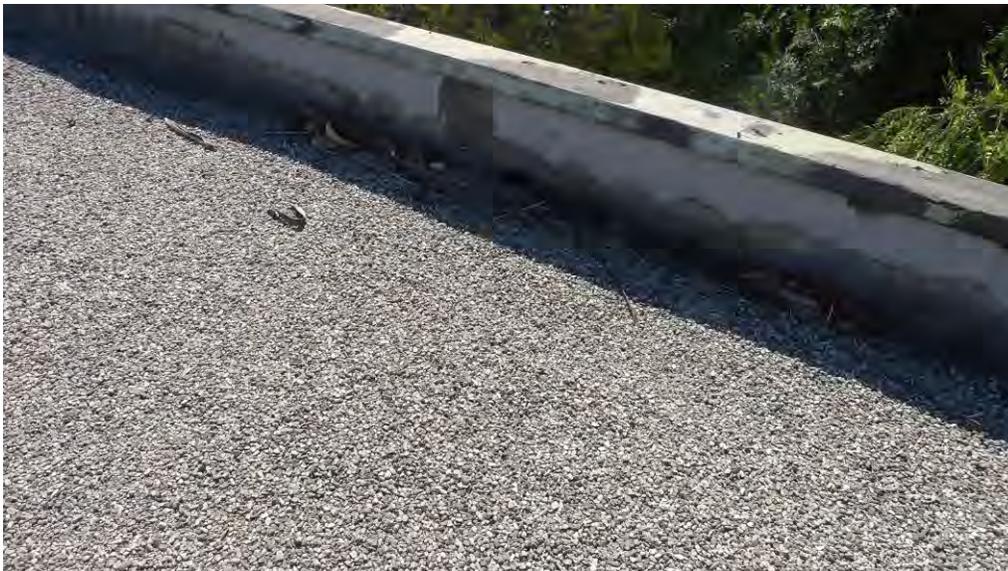
Figure 4: Debris at scuppers at multiple locations

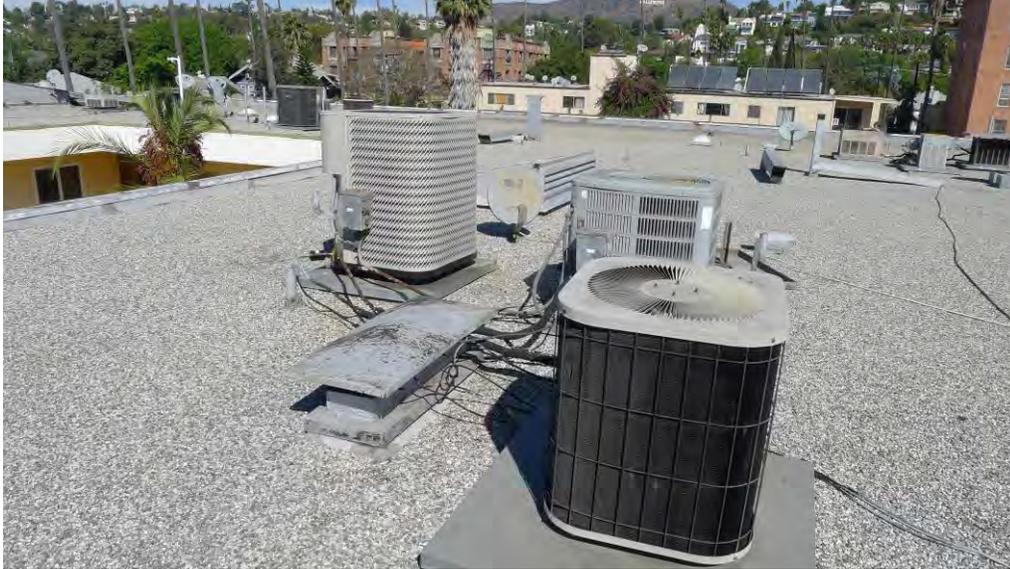
Figure 5: Units with no visible anchorage

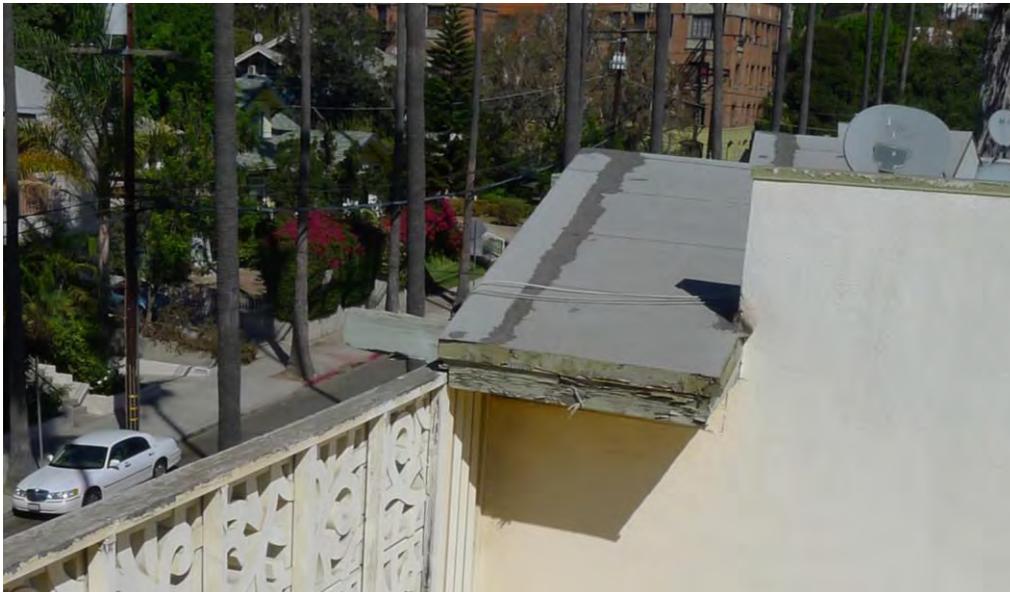
Figure 6: Deterioration of exposed roof beam

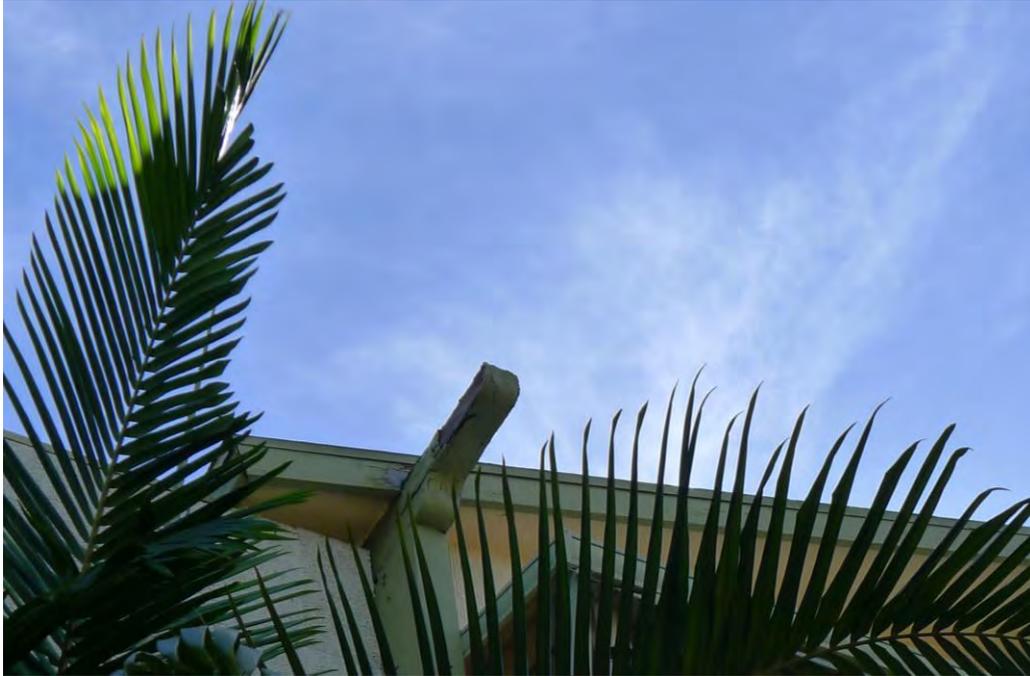
Figure 7: Paint peeling from cantilever overhang

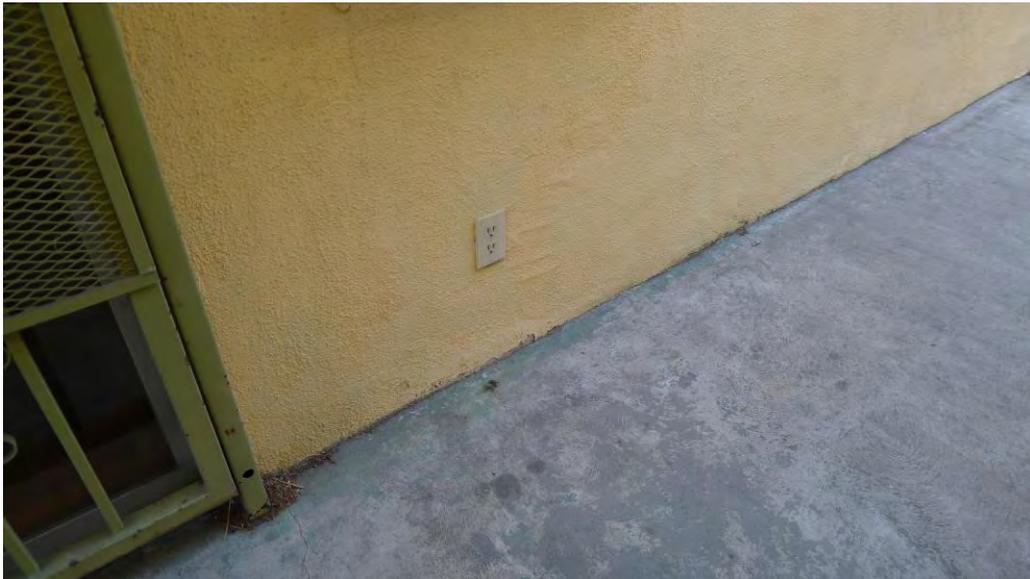
Figure 8: Electrical outlet with no waterproofing or GFCI

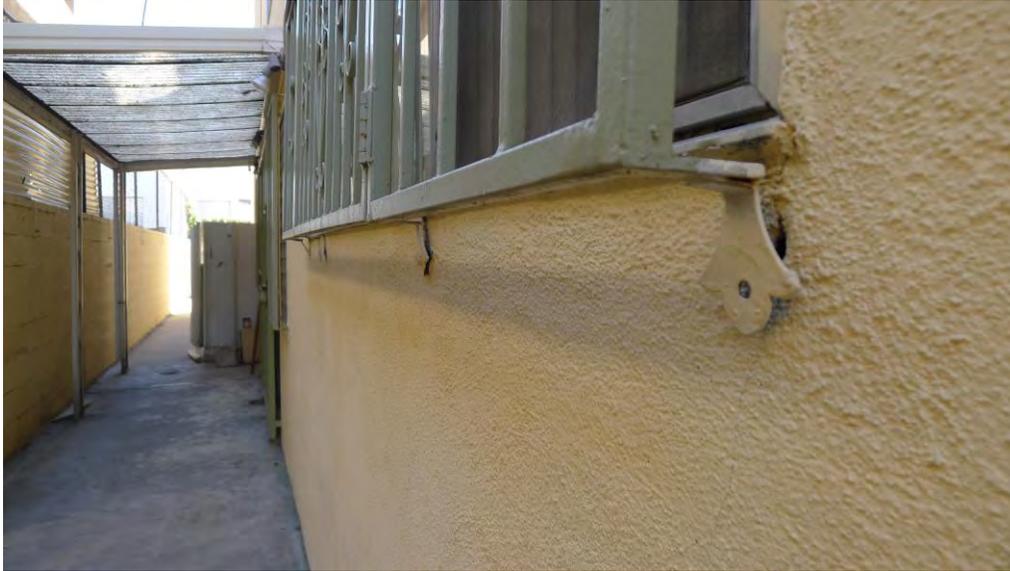
Figure 9: Missing anchorage from security bar

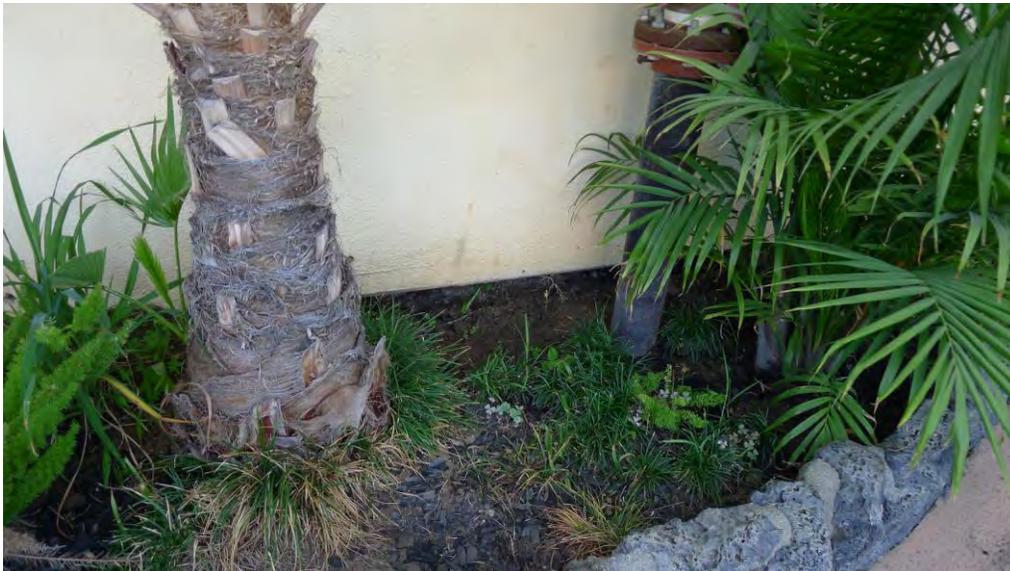
Figure 10: Vegetation at planters off the street

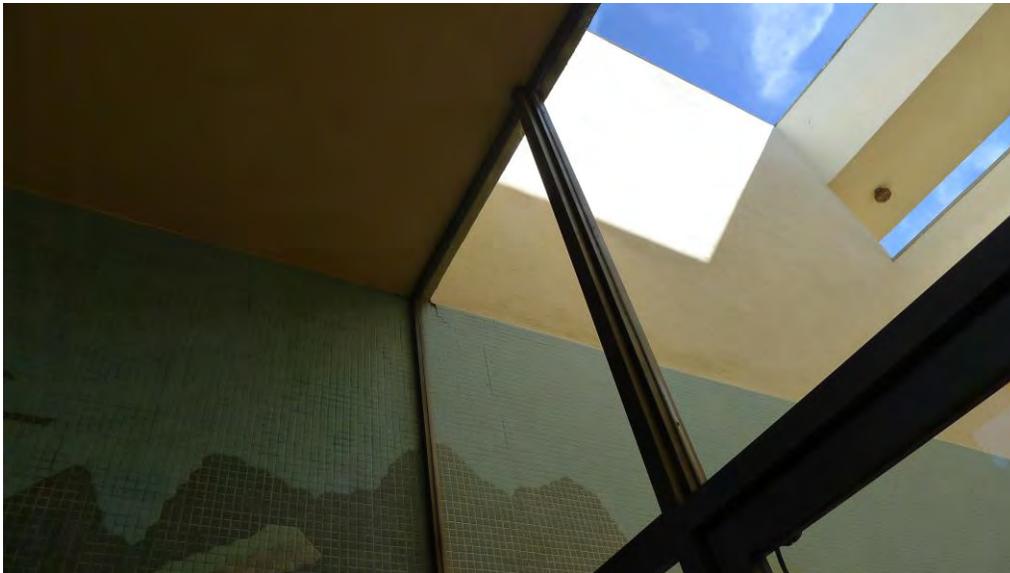
Figure 12: Crack in tile by front entry

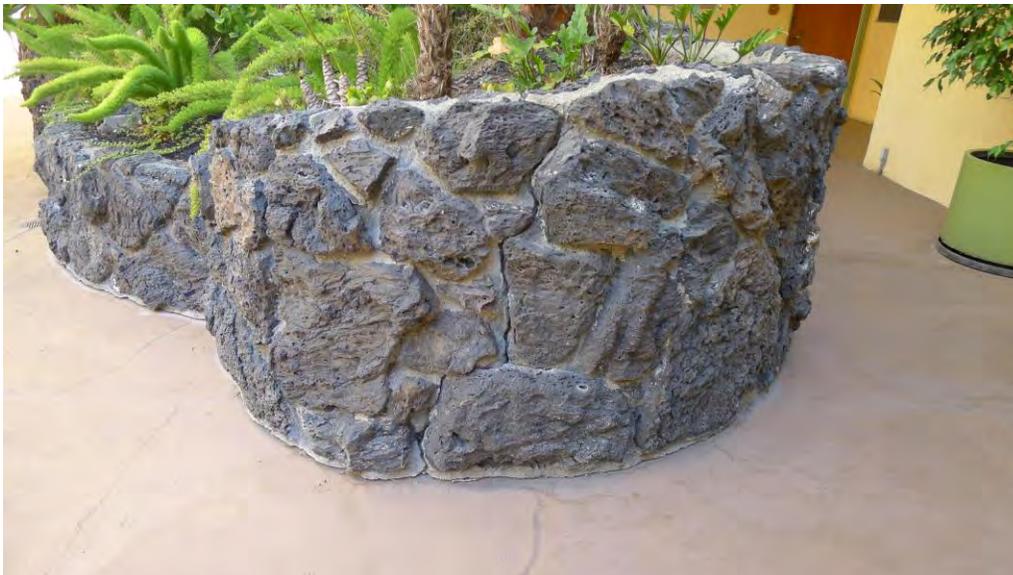
Figure 14: Crack in planter

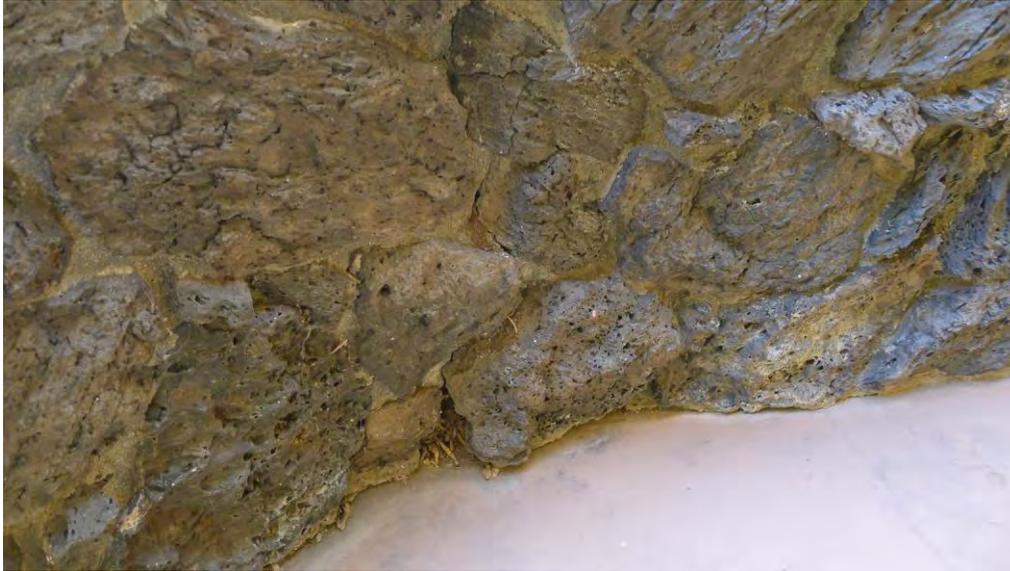
Figure 15: Roots growing out of cracks of the planter

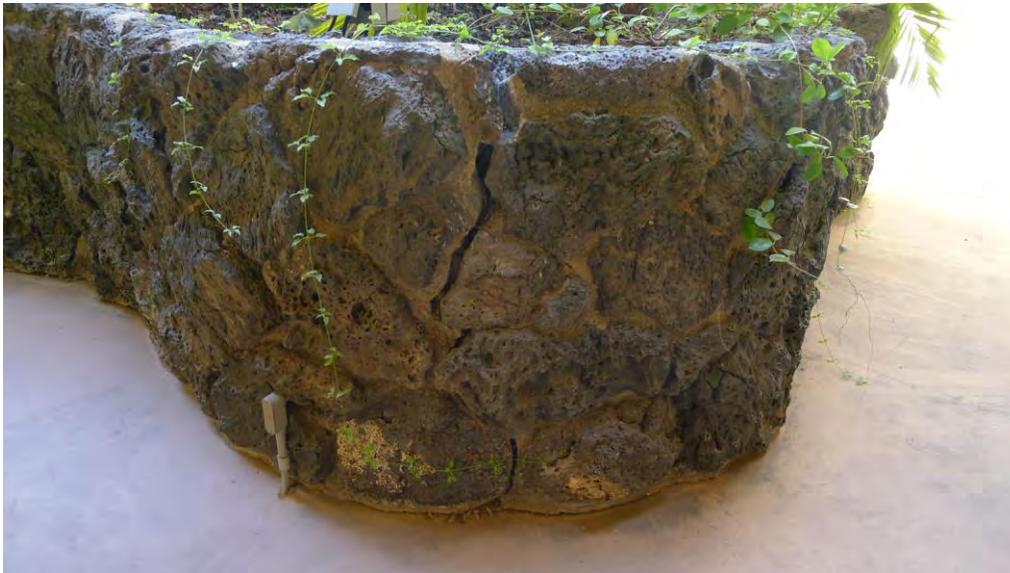
Figure 16: Large crack in planter

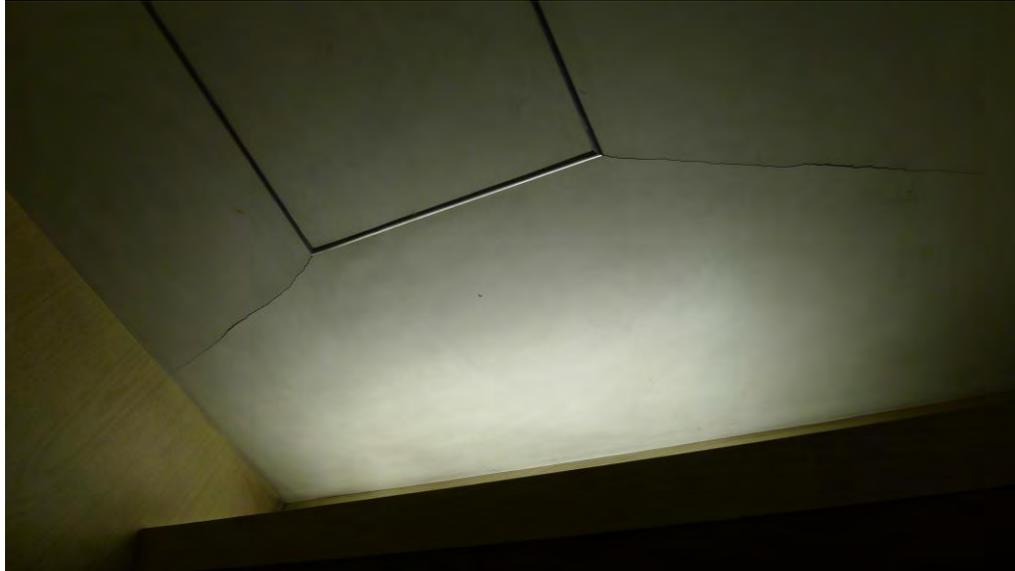
Figure 17: Cosmetic cracking in the ceiling at the common area

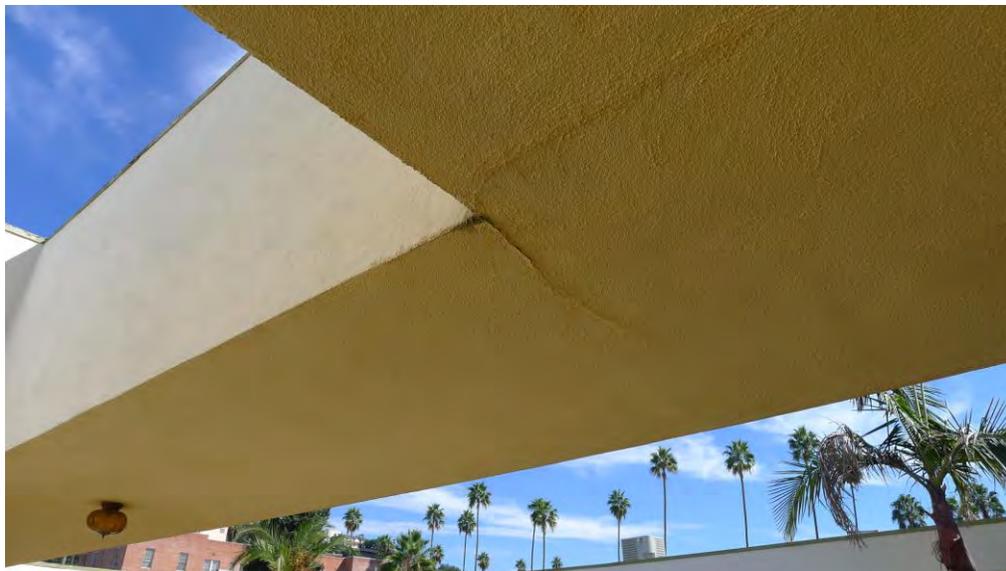
Figure 18: Cosmetic crack at walkway

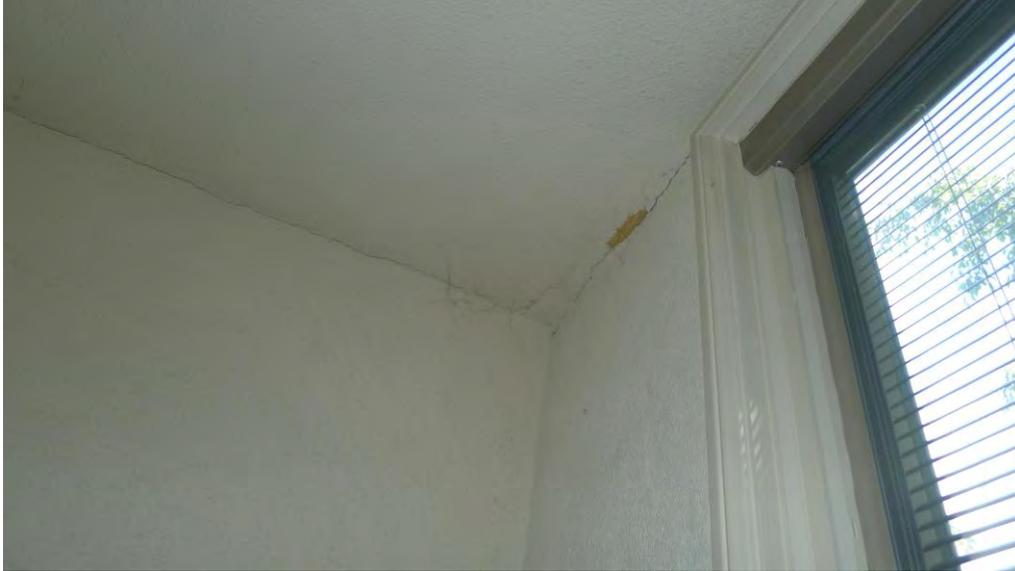
Figure 19: Minor cosmetic crack inside unit

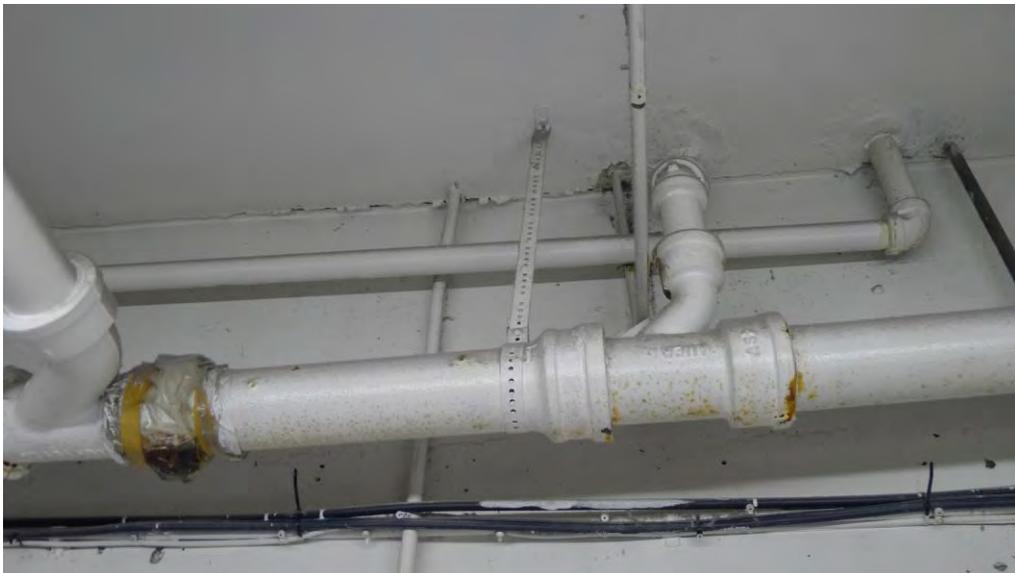
Figure 20: Previous patch work at penetration of concrete structural slab

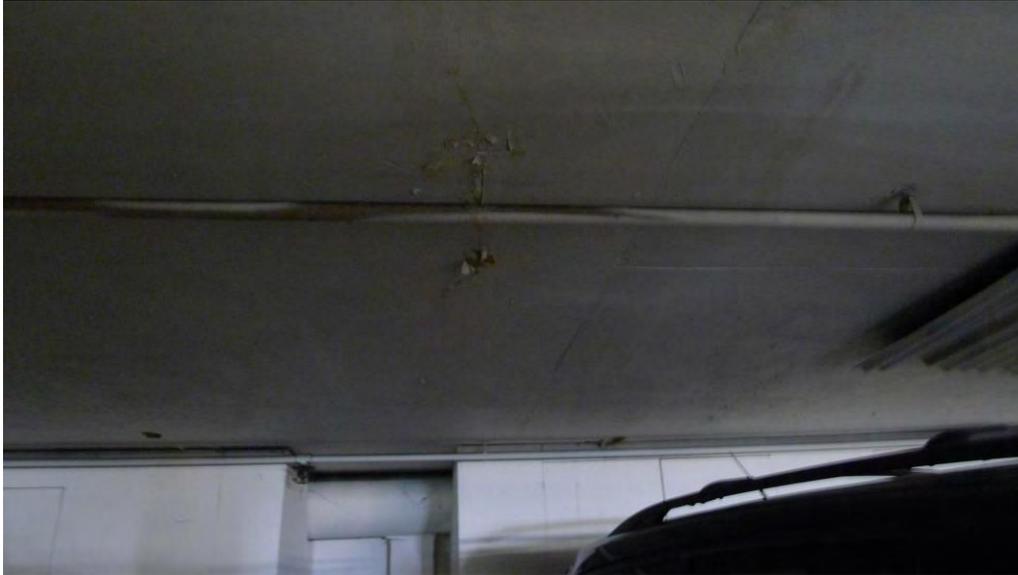
Figure 21: Water stain at concrete structural slab in garage

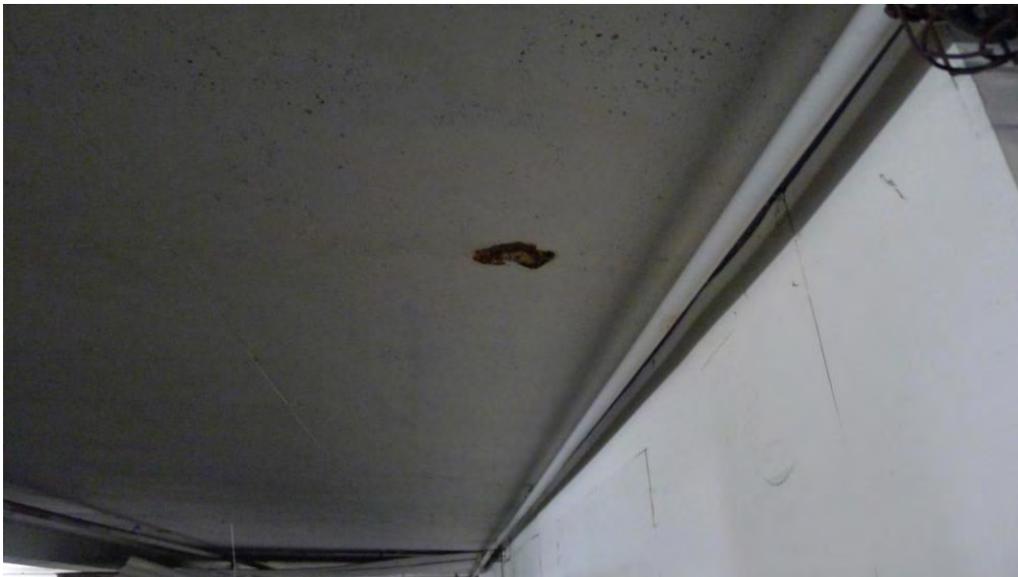
Figure 22: Rust stain at concrete structural slab in garage

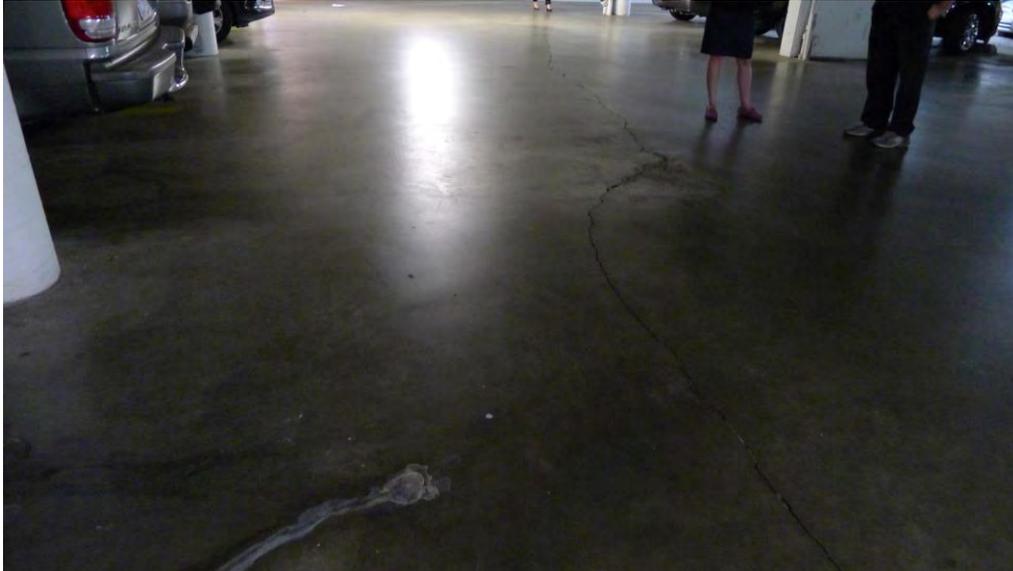
Figure 23: Cracked concrete in basement with evidence of previous patchwork

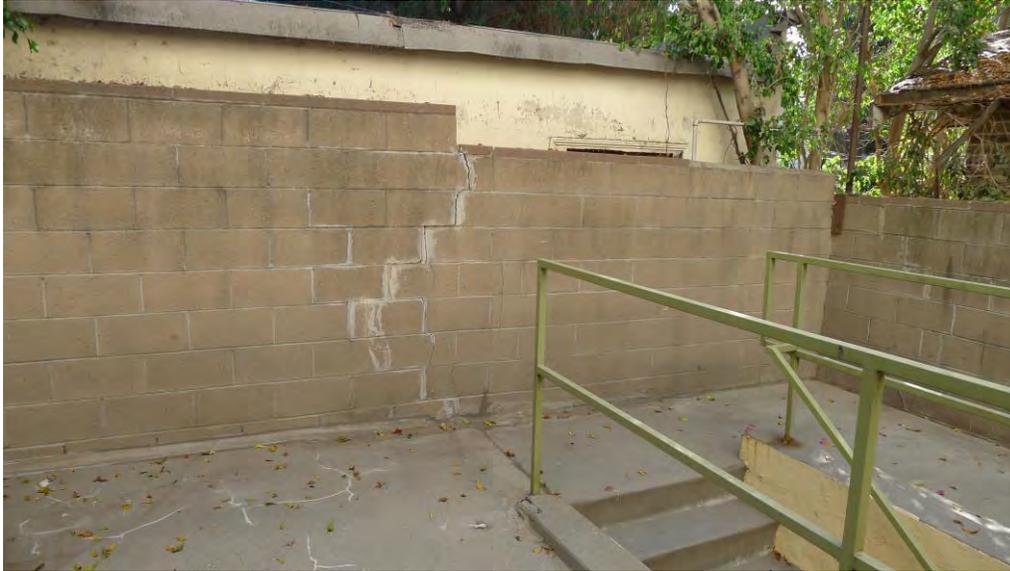
Figure 25: Cracked CMU wall at back of property

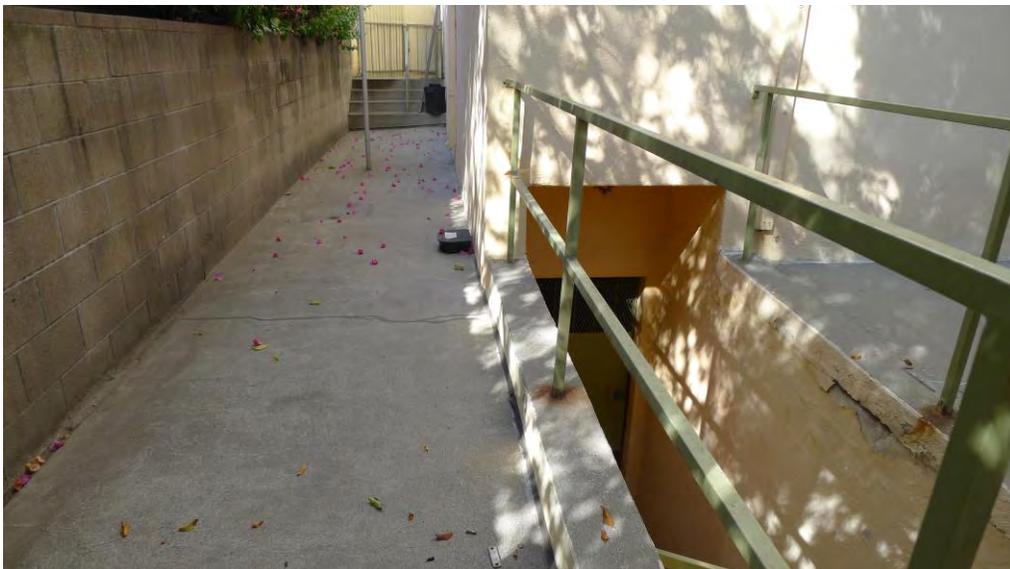
Figure 26: Rusted railing at embedment point

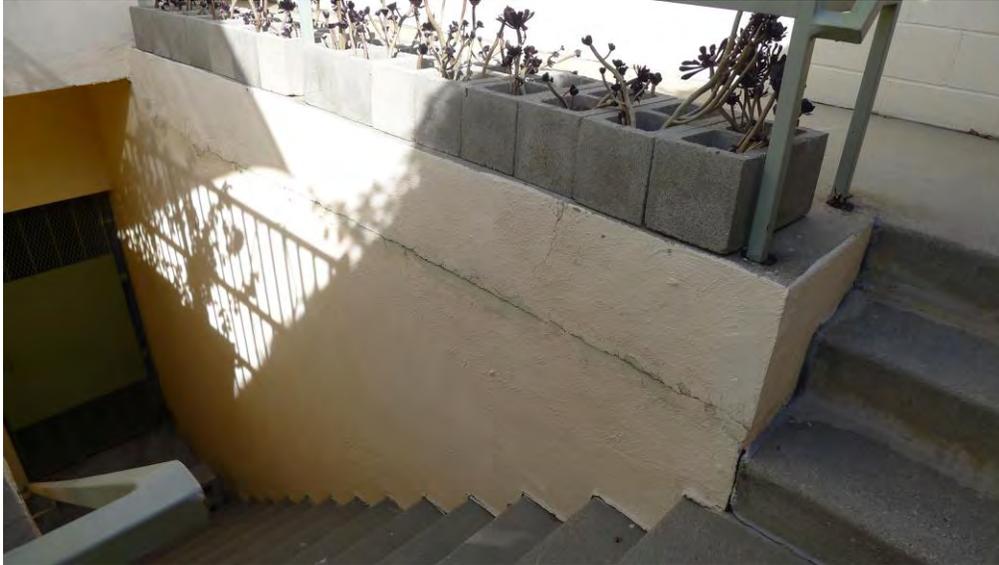
Figure 27: Crack in concrete and rusted railing

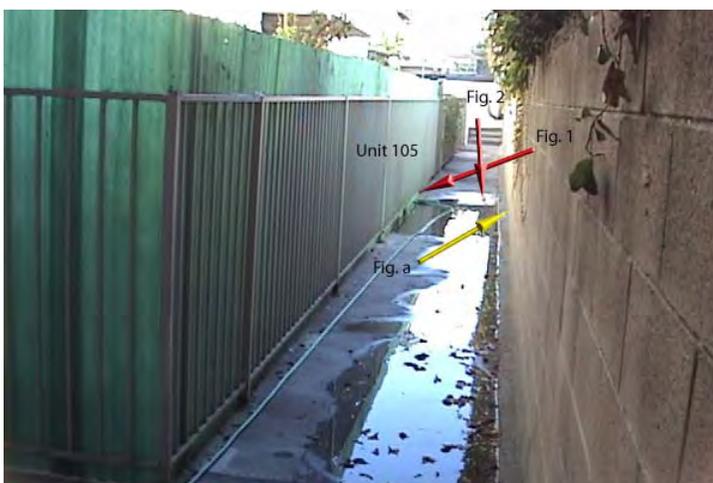
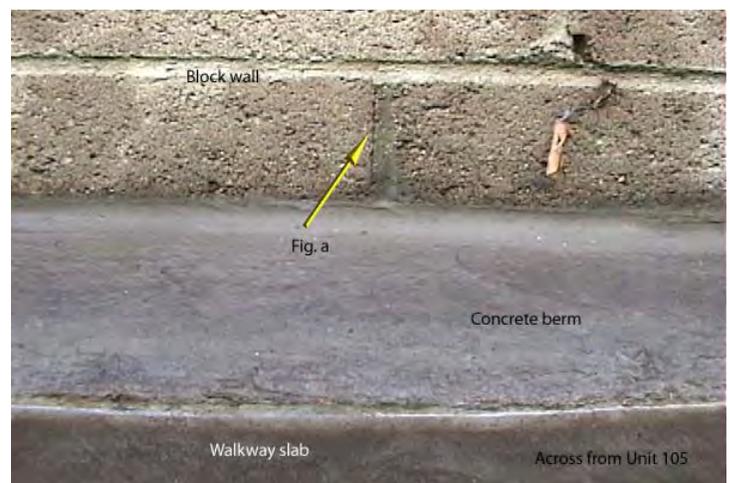
Figure a is a potential leak source where there are cracks between the block of the wall and the grout around this area at least. I could not validly test this since there were leak sources on the walkway and any water getting on this wall would get on the walkway leak sources and render the test invalid.

Once the walkway and patio crack leak sources are standardly repaired, you can test this wall for about 1-2 hours (or less if it starts leaking below) and see if it too is a leak source.

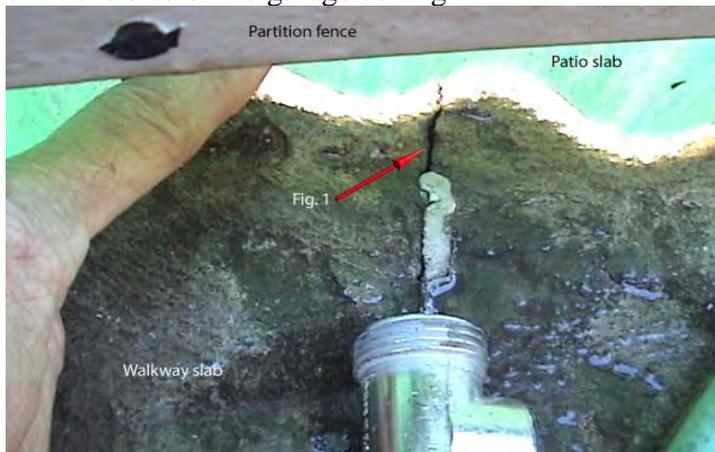
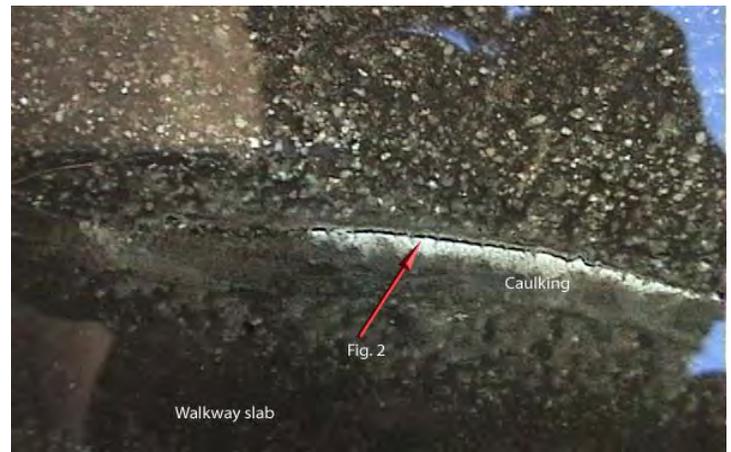
Figure 1 is a leak source where there is a crack in the walkway to patio slab by Unit 105 and allows water in the Unit 302 storage area below. There are cracks in the main structure slab of the ceiling of the garage below as well as this concrete slab that is on top of it (it appears that this is a concrete slab on top of the main concrete under it comprising the ceiling of the garage as I saw a few expansion joints on this walkway but no corresponding expansion joints in the ceiling below.) **Figure 2** is another crack that has been caulked but is coming undone and allows water in the ceiling below in the garage. Note: Any water getting in any of the cracks in the walkway or patio of Unit 105 will wind up in the ceiling area below in the garage due to the number of cracks in the concrete structure slab of the garage ceiling.

I suggest water proofing the entire surface of the walkway AND all of the patio of Unit 105 at least. You may try to patch each crack you can find and standardly seal it and see how it goes but note proper preparation is necessary for a good bond to occur. Fig. 2 shows that there was insufficient preparation before applying the sealant.
