RECOMMENDATION REPORT

CASE NO.: CHC-2015-3306-MAEX

PROJECT: 1830 N. Taft Avenue
Historic-Cultural Monument (HCM) No. 1070

The Polynesian
1830 N. Taft Avenue - Hollywood
Historic Structure Report

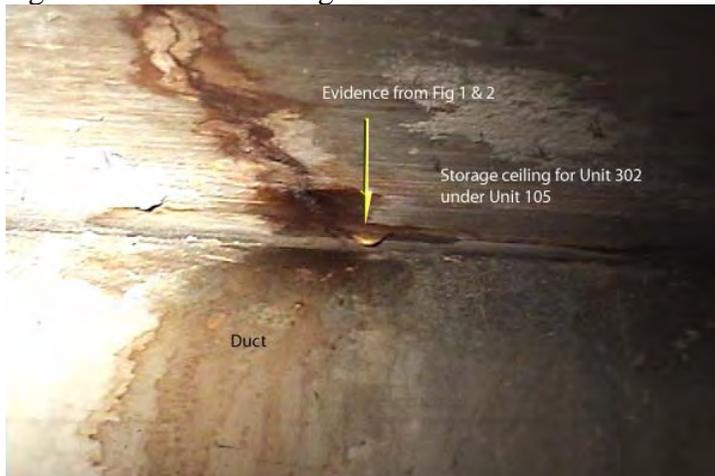
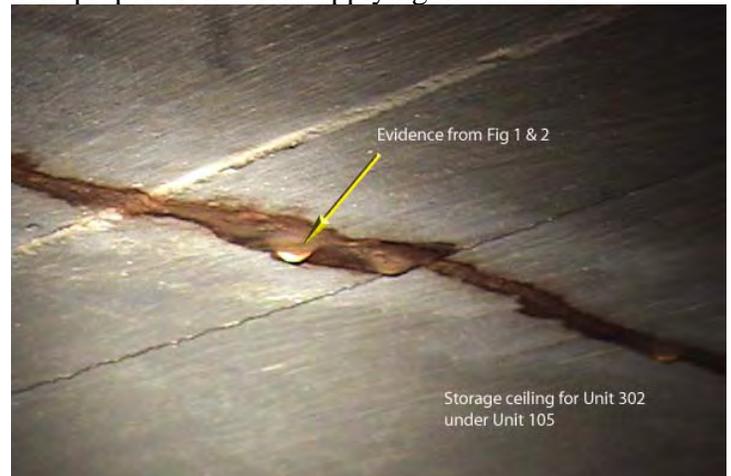
The 2 lower photos show evidence of the Fig. 1 & 2 leak sources above.
