APPENDIX I

GEOTECHNICAL REPORTS

December 31, 1998

Subject: **Geotechnical Considerations
Proposed Property Purchase
Ocean Woods Terraces Apartment Complex
17331-17333 Tramonto Drive
Pacific Palisades, California
Law/Crandall Project Number 70131-8-0618**

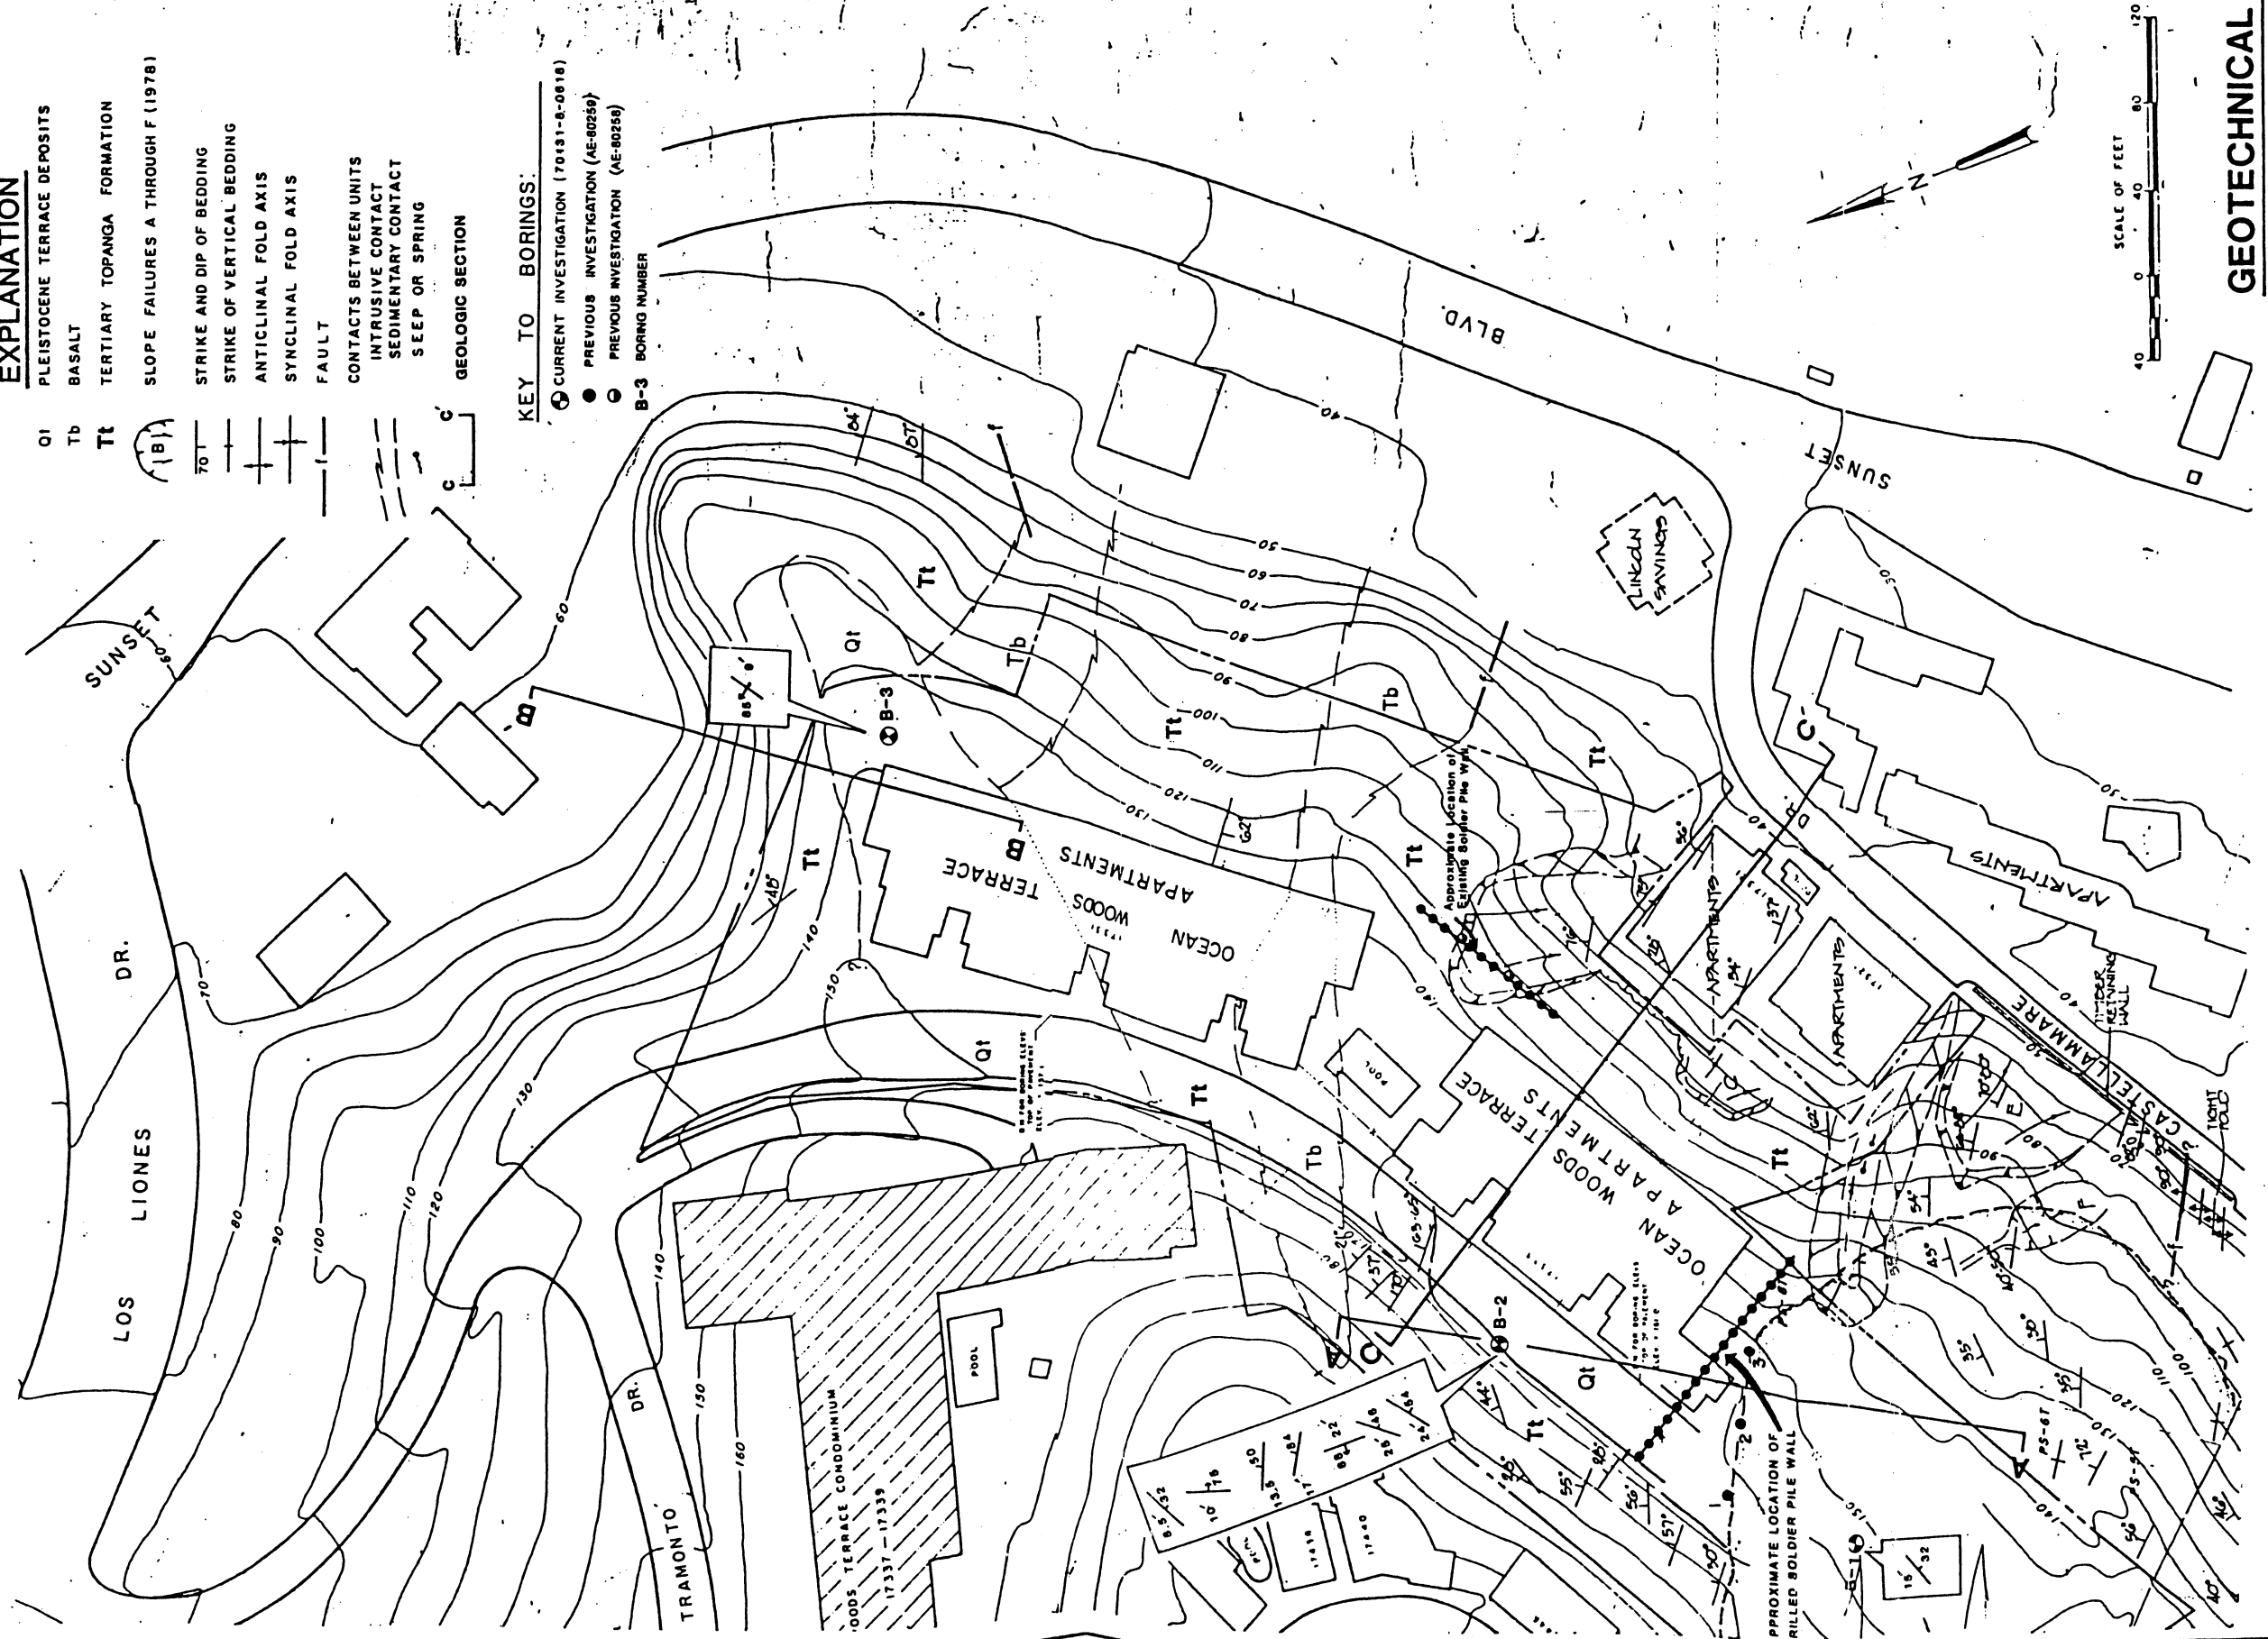
GEOTECHNICAL MAP

The apartment complex is bordered by the Revello landslide to the west and southwest. This landslide occupies an area of approximately 5 acres and extends generally from Revello Drive to the north and to Castellammare Drive to the south. The location of the Revello landslide is depicted on Figure 2, Geotechnical Map.

The Revello landslide initially failed in June of 1965 with associated damage and loss of the then existing residential structures and portions of Revello Drive. Several relatively small slope failures have occurred in the area as a result of heavy rains in January through March, 1978. These failures are depicted on Figure 2 and discussed in our Report of Slope Failure Investigation dated December 5, 1978.

A relatively small slope failure, unrelated to the Revello landslide occurred on the slope below the apartment complex pool deck as a result of heavy rains in January through March, 1978. This failure was determined to be due to saturated soil and weathered rock materials moving downslope approximately 5 to 6 feet, vertically. This failure was addressed in our October 28, 1980 report. As recommended in that report, a soldier pile wall was constructed in 1981 to stabilize this portion of the apartment complex. The approximate locations of these barrier walls are illustrated on Figure 2.

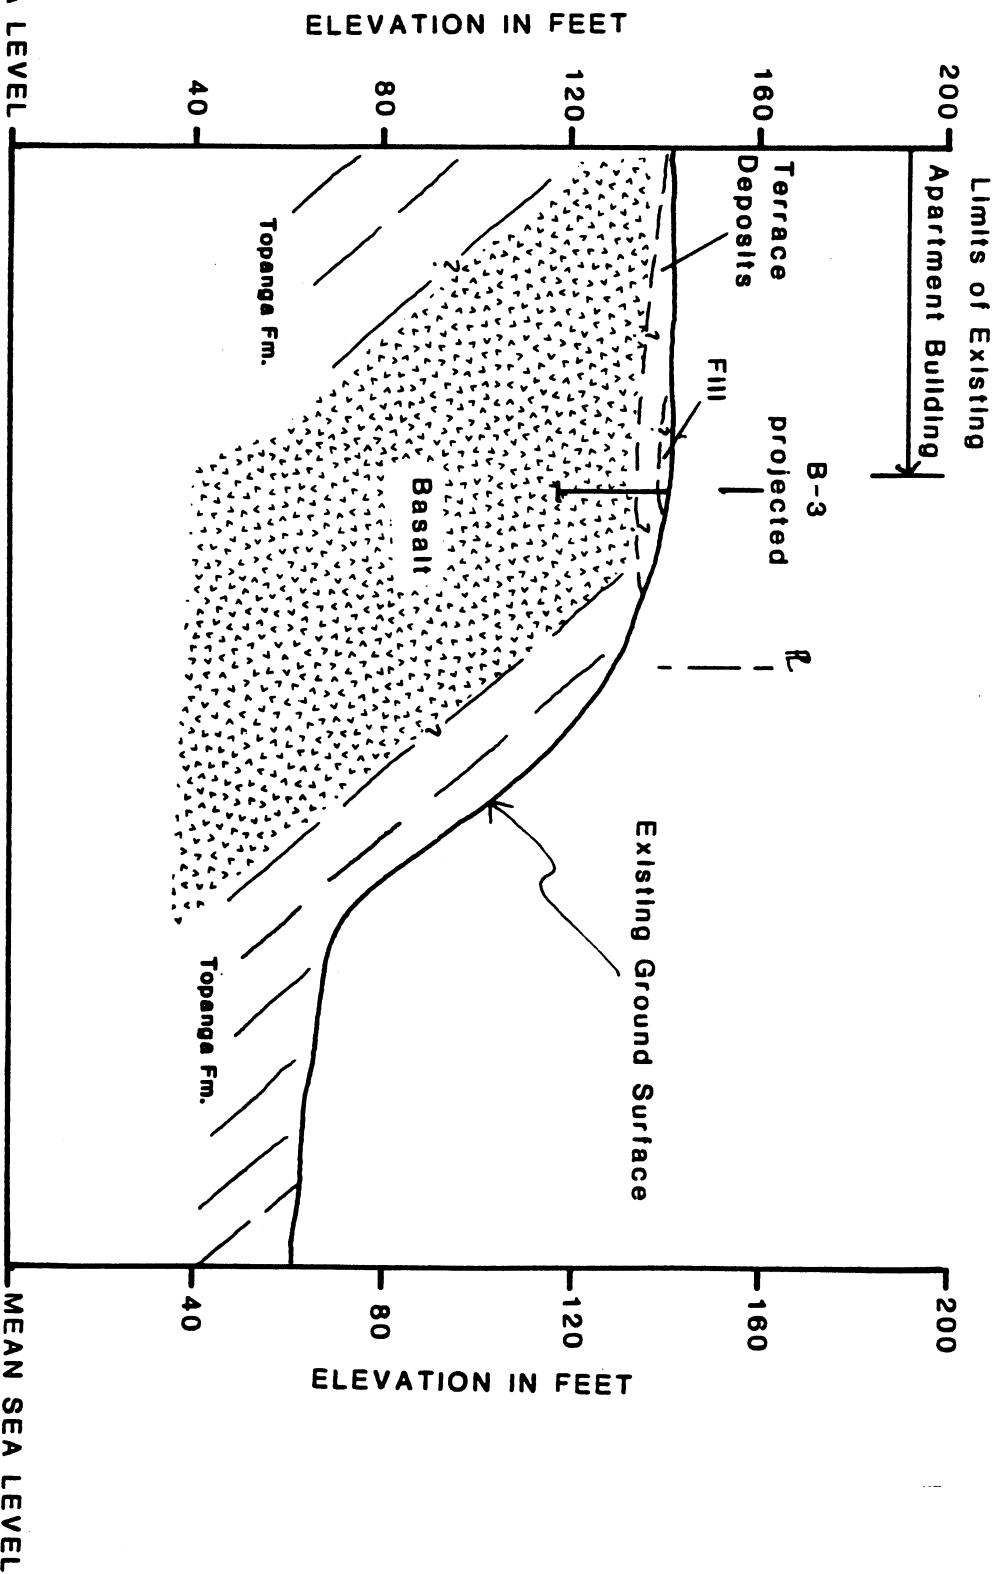
FIGURE 3.2

Geologic structure is characterized by moderately steep, northeasterly dipping bedding planes in the sedimentary units that are generally neutral to, or dip into the slope in this area. Minor folding and drag folding along faults result in minor departures from this preferred bedding plane orientation. Interpreted subsurface geologic conditions including geologic structure within the bedrock units and the relationship of various geologic units at the site are illustrated on Figures 3.1 to 3.3. Geologic Sections.
