RECOMMENDATION REPORT

CASE NO.: CHC-2015-1575-MAEX

PROJECT: 1950 N. Edgemont Street
Historic-Cultural Monument (HCM) No. 1068

Historic Structure Report

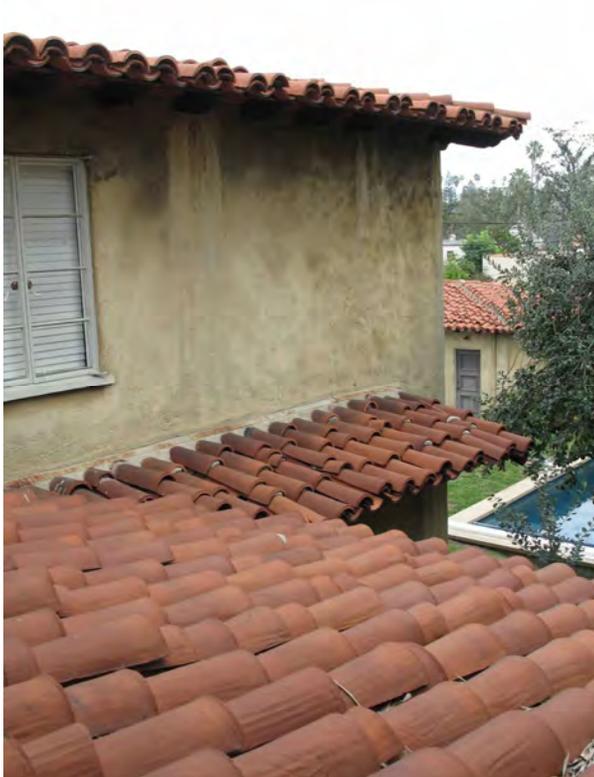
Fig. 2-4 rear roof note wall discoloration from leaks

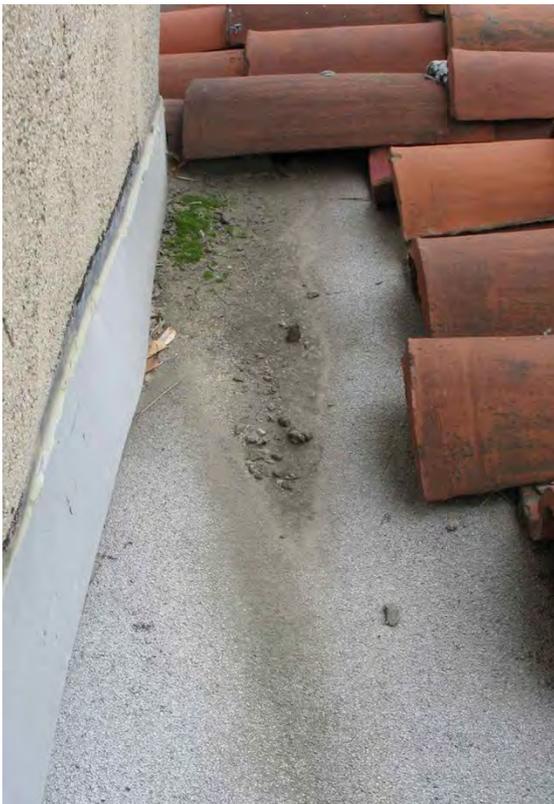
Fig. 2-9 Valley condition above living room
Note poor or blocked drainage

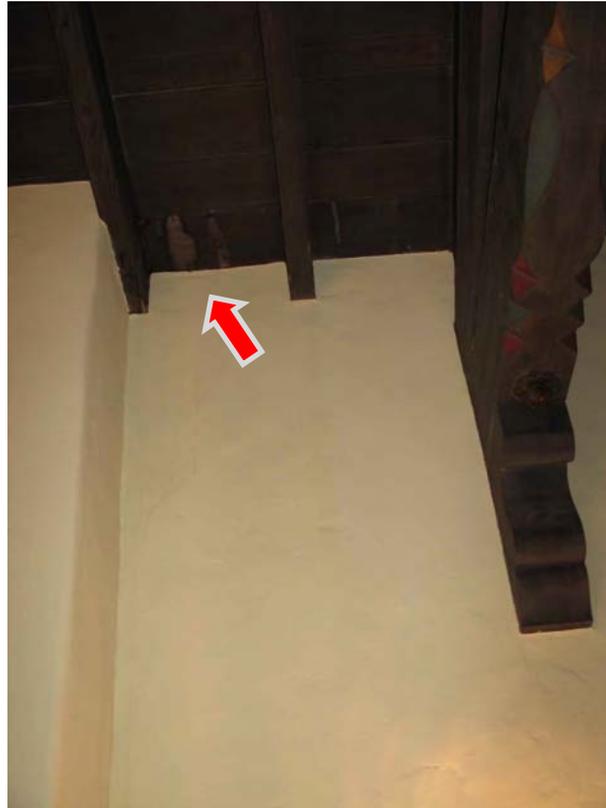
Fig. 2-10 Roof leak viewed from living room

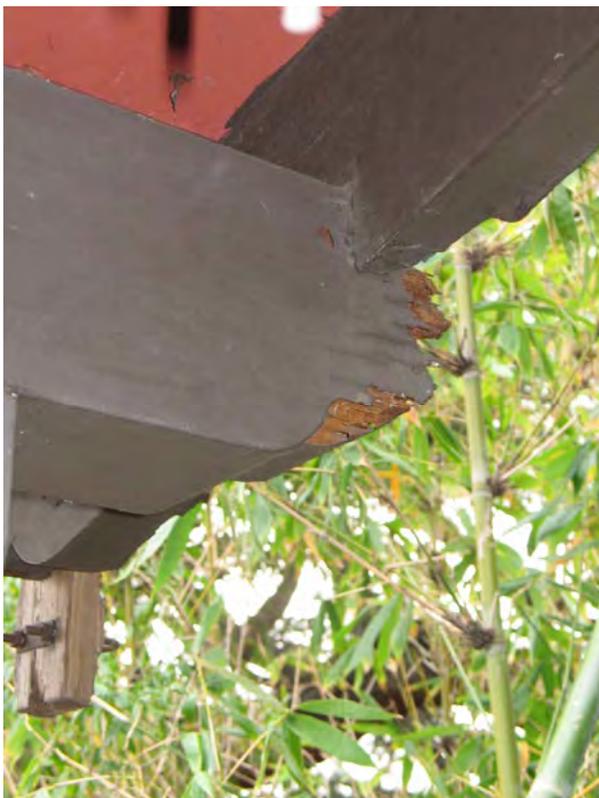
Fig. 2-11 Rafter Tail Rot (master bedroom balcony)

Description of work: Perform wood repairs for dry rot and install hidden covers to protect rafter tails from future rot. Restore damaged woodwork in other areas.

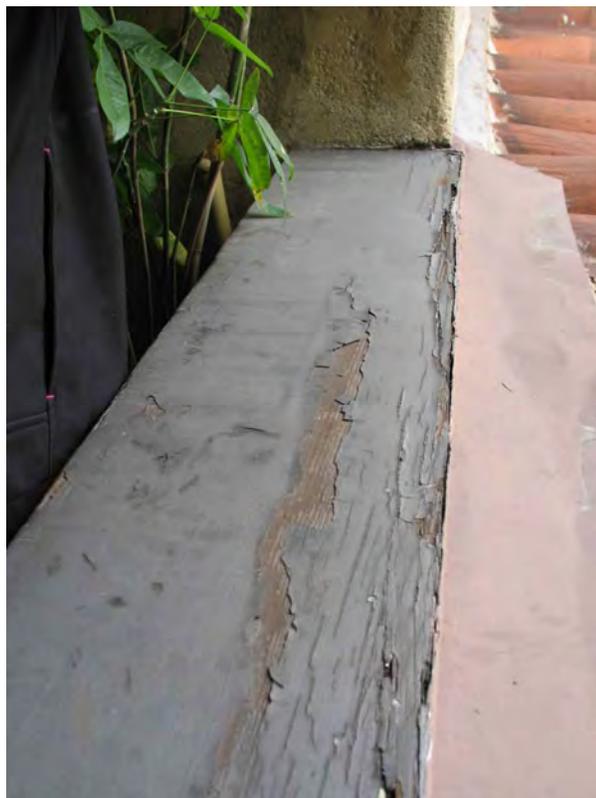
Fig. 2-12 Railing needing refinishing (master bedroom balcony)

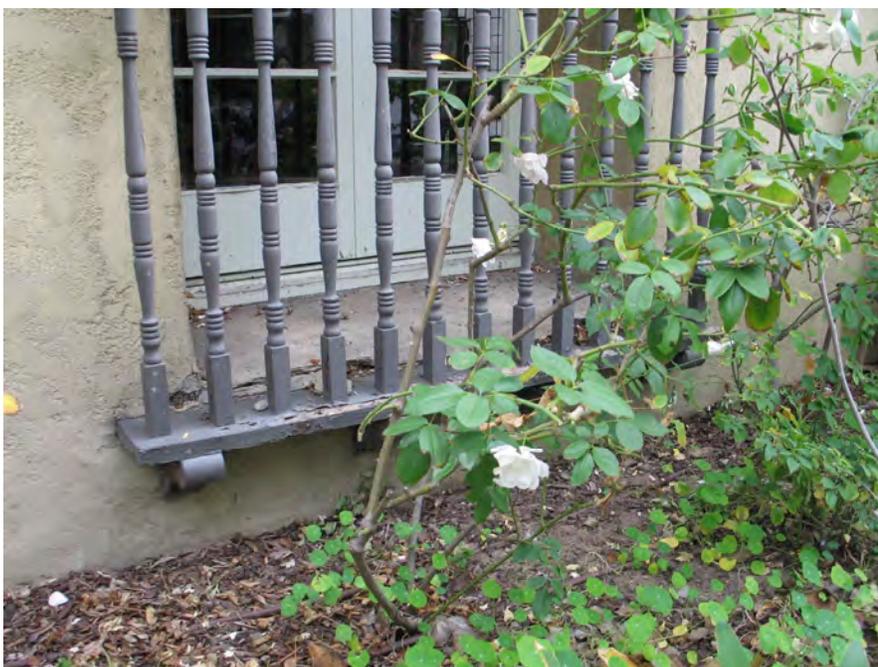
Fig. 2-13 Wood grill and sill with dry rot (living room balconette)

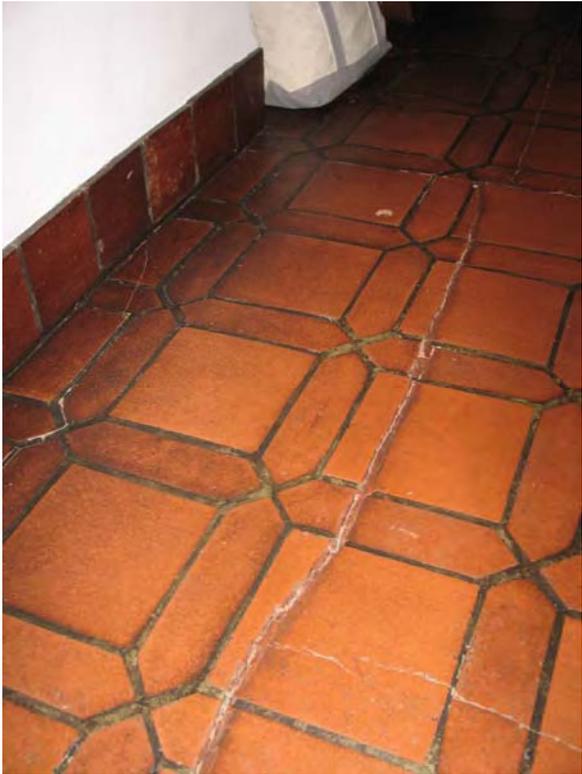
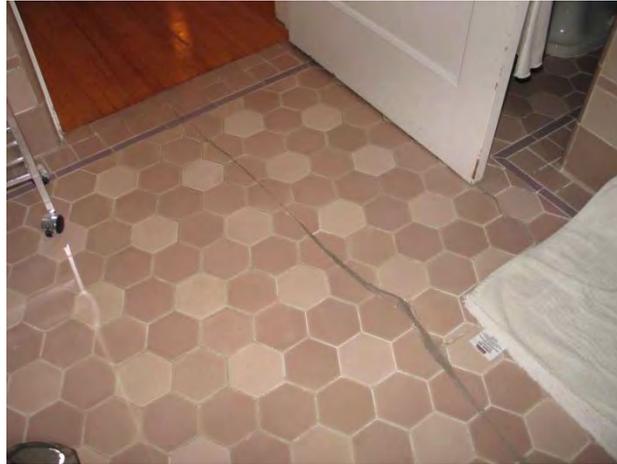
Fig. 2-14 Foyer tile indicating settling problems Fig. 2-15 Master Bath tile with crack

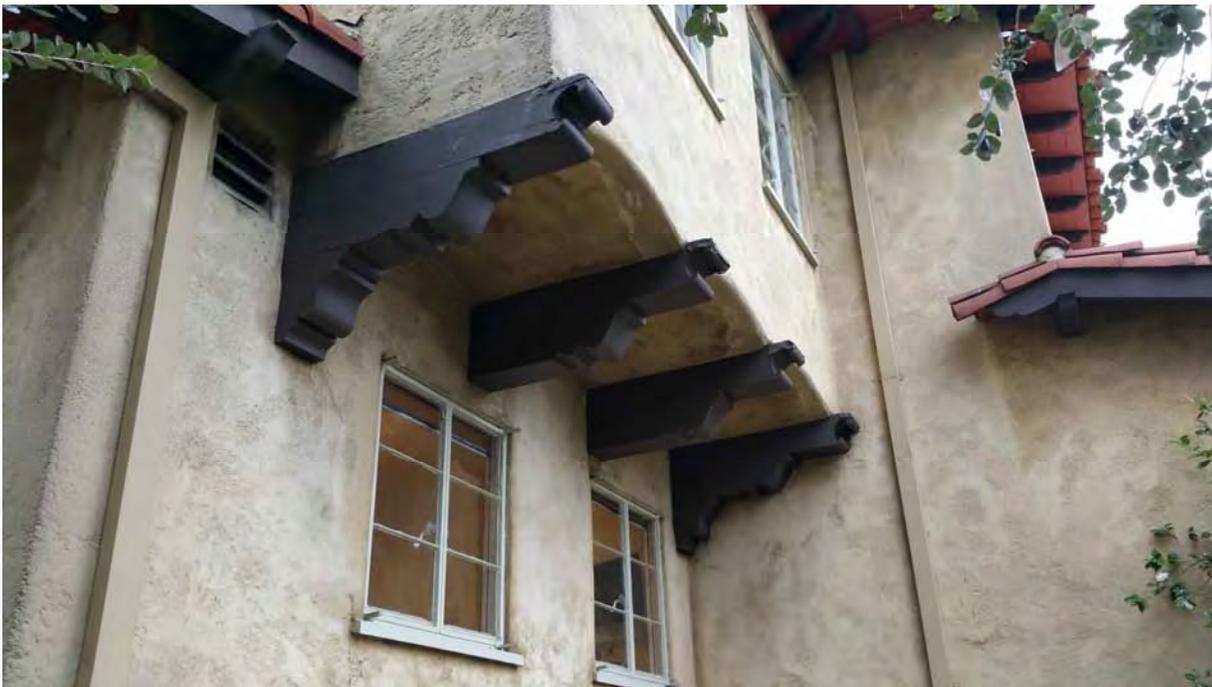
Fig. 2-16 Wood Brackets requiring attention

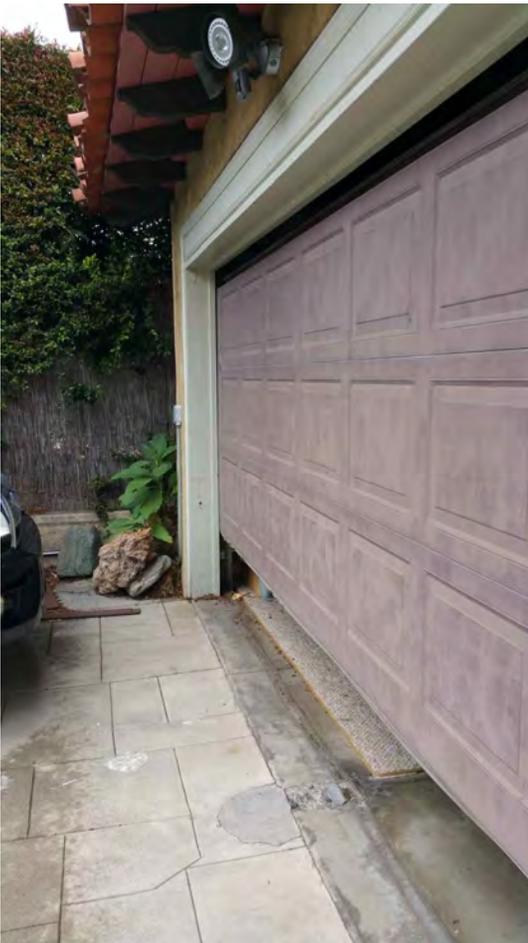
Fig. 2-17 Newer Aluminum Garage door

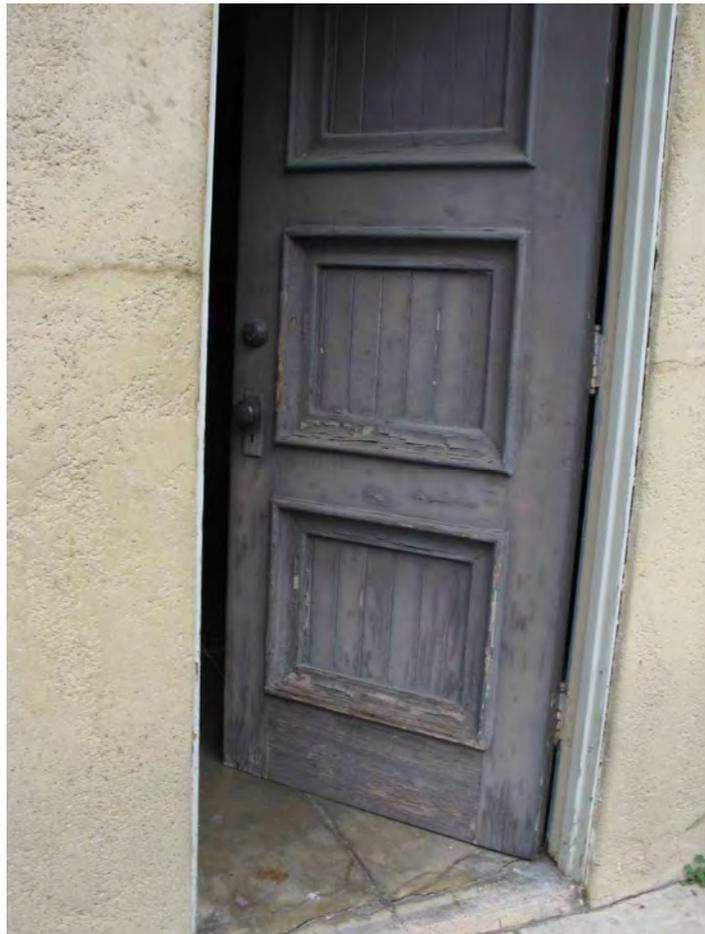
Fig. 2-18 Original man door showing weathering

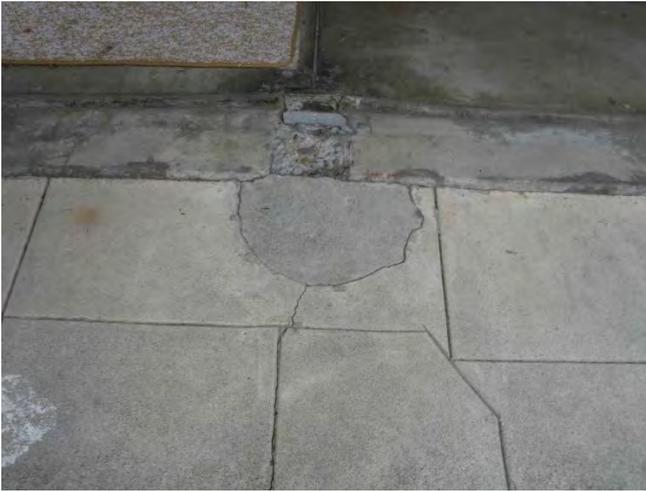
Fig. 2-19 Garage door - missing post

The treatment recommendation is to follow the main house guidelines for the barrel roof work to carefully remove all tiles and reroof and replace tiles. Shore the garage door header and replace the missing post and possibly replace the entire header. A structural engineer should provide the final sizing and details for the doorway stabilization. Note that the very heavy barrel tile roof is also adding to the door header load. A new period sensitive solid wood garage doors should be installed and the existing man door design may give insight as to the panel design for the garage door.

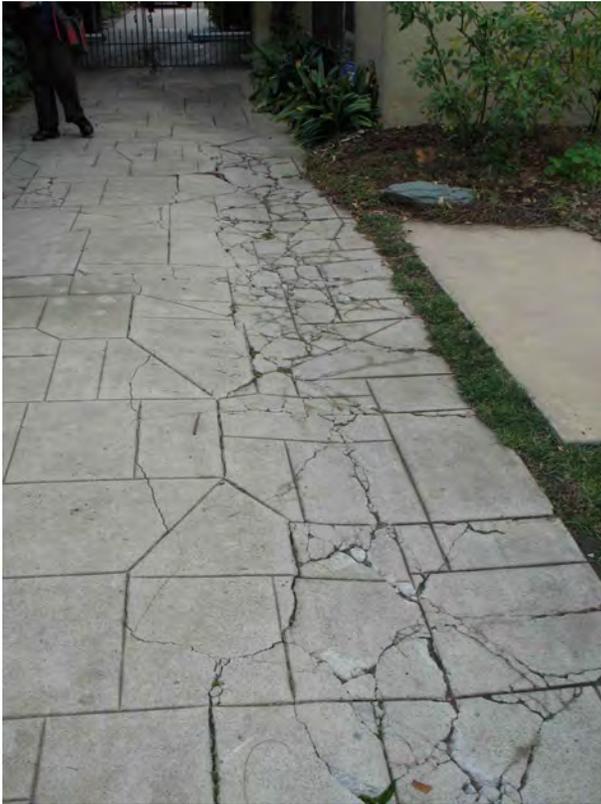
Fig. 2-20 Front driveway in poor condition.

Building Feature: DrivewayCost \$41,400.00 (round to nearest dollar) Contract Year of Proposed Work Completion: 2020Description of work: Document existing pattern, remove damaged portion, install new concrete matching original texture, color and pattern.

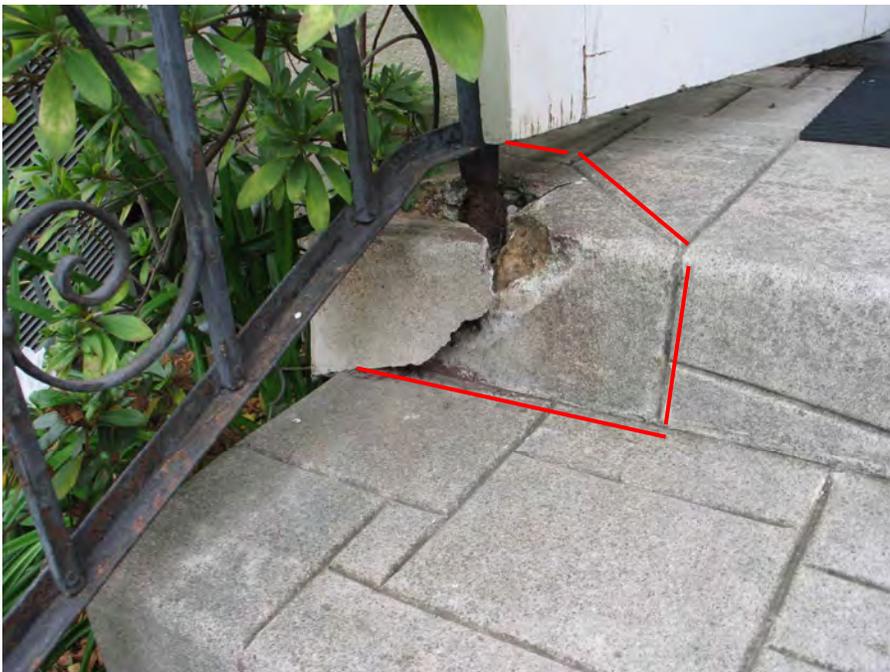
Fig. 2-23 Side door to kitchen with spalling concrete at top and lower step (not shown) Replace portion of concrete along existing score lines (in red) and reset existing railing

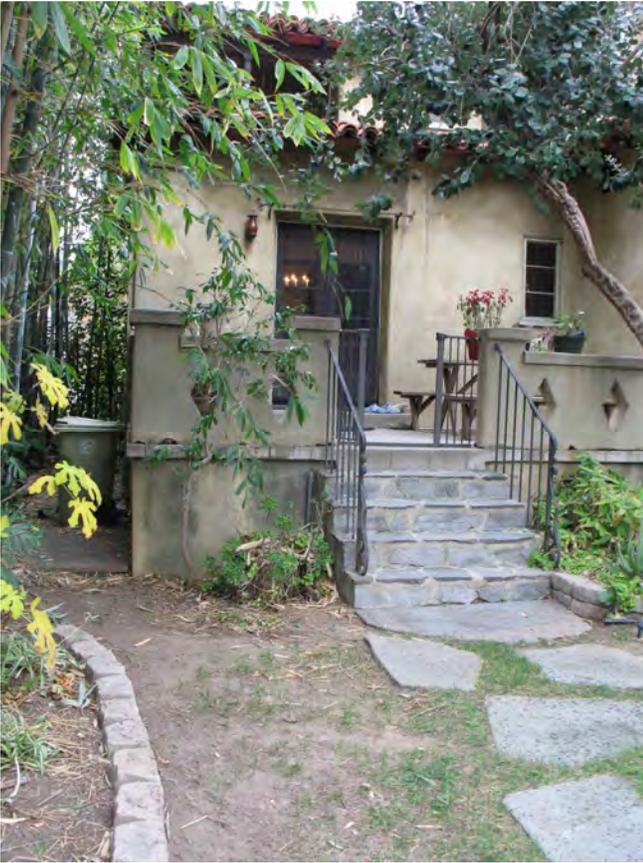
Fig. 2-24 Rear porch with drainage problems

Building Feature: Rear porchCost \$6,470.00 (round to nearest dollar) Contract Year of Proposed Work Completion: 2020Description of work: Properly repair railing and concrete around the base of railing, matching original.

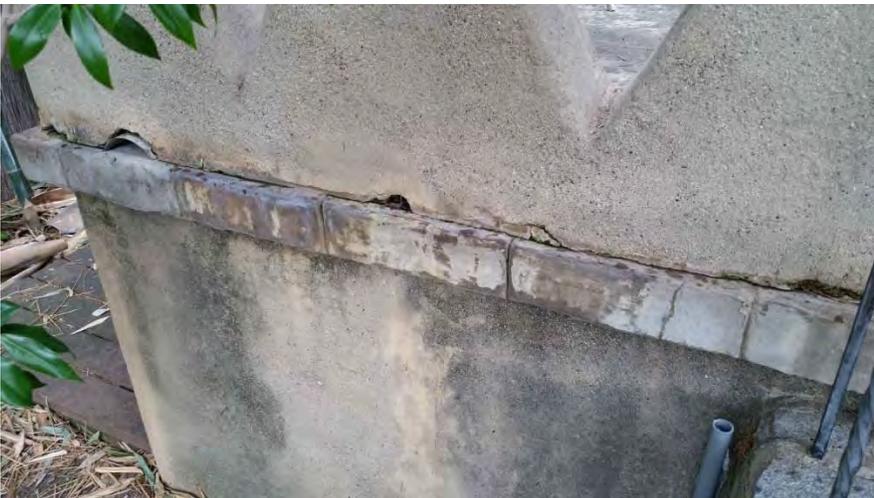
Fig. 2-25 Rear porch with potential water damage and drainage problems

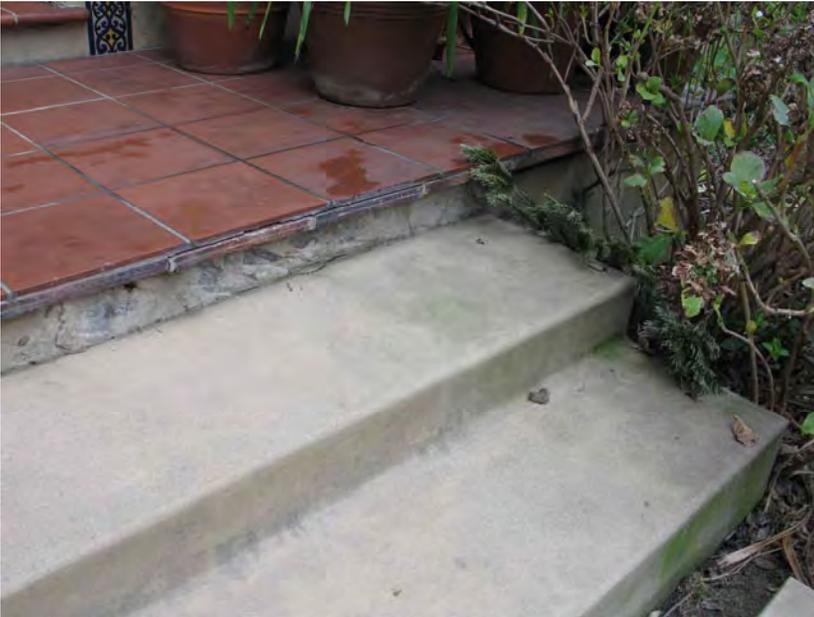
Fig. 2-29 Front steps with newer tile finish and unfinished stair nosing
Mechanical, Electrical, Plumbing, Heating and Cooling:

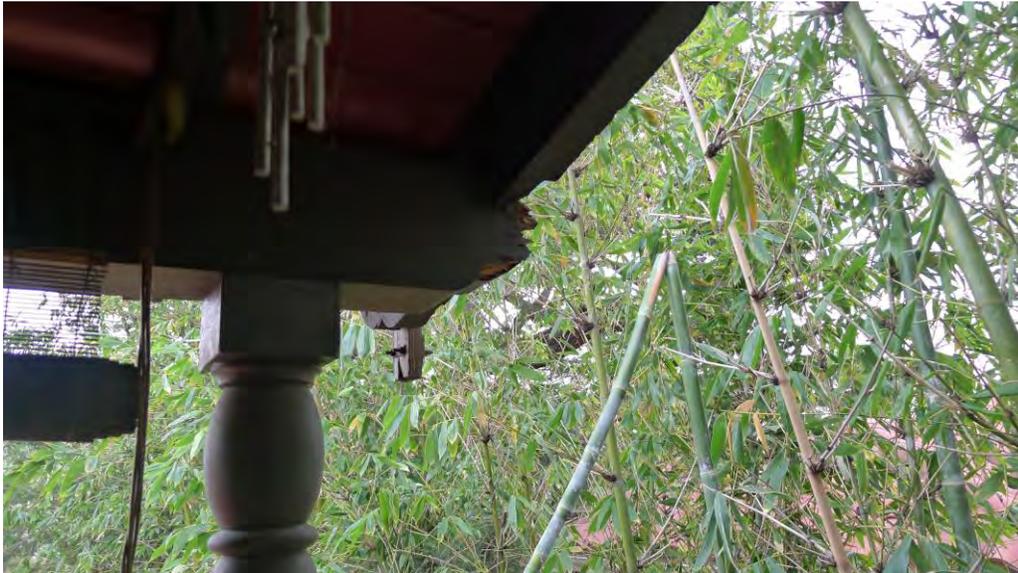
Figure 4: Dry rot at beam overhang at 2nd floor

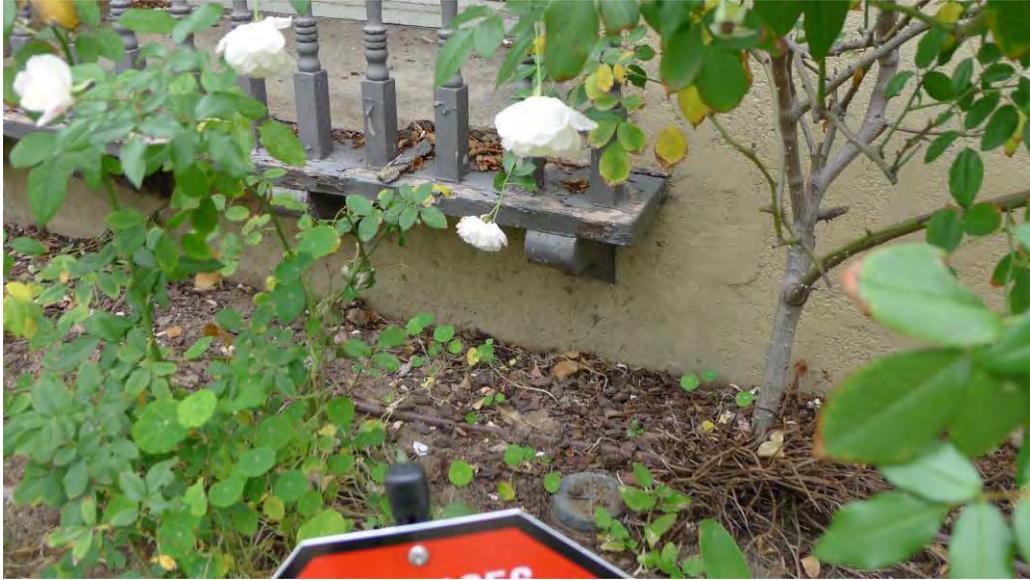
Figure 5: Dry rot at wood element at living room window front window

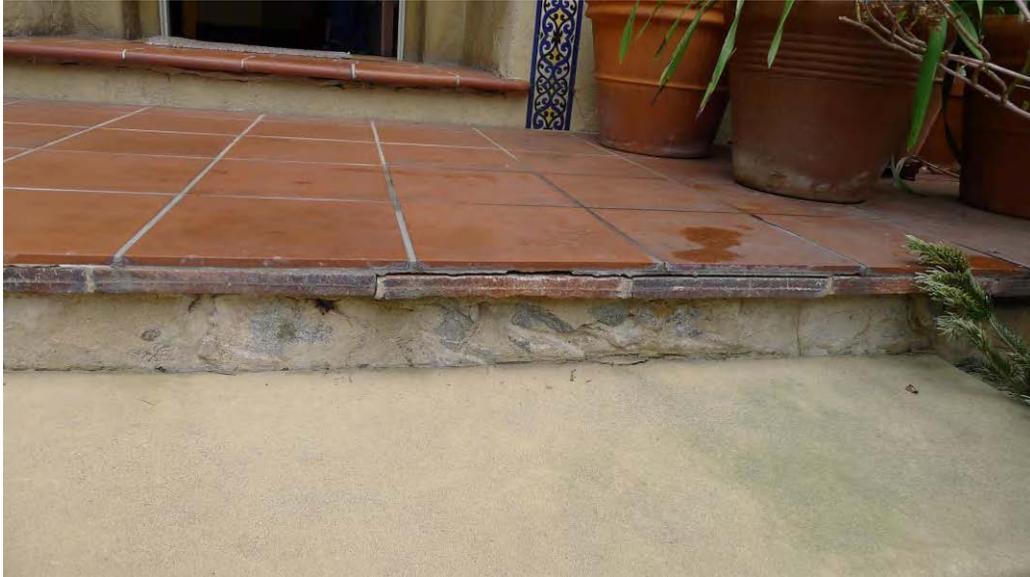
Figure 7: Cracking of the grout line at the front landing at the entry

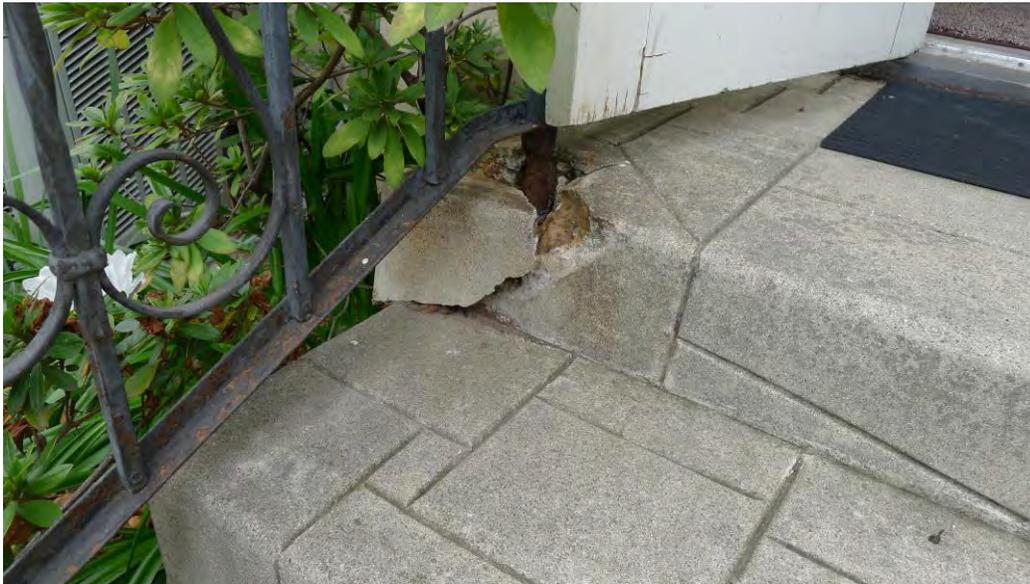
Figure 8: Concrete spalling at railing embedment

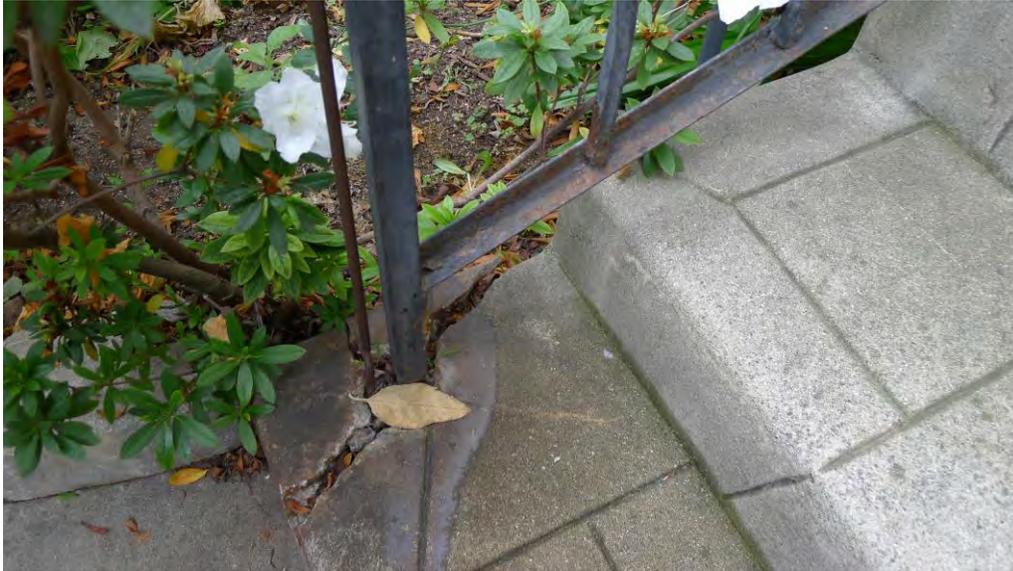
Figure 9: Concrete spalling at railing embedment (2)

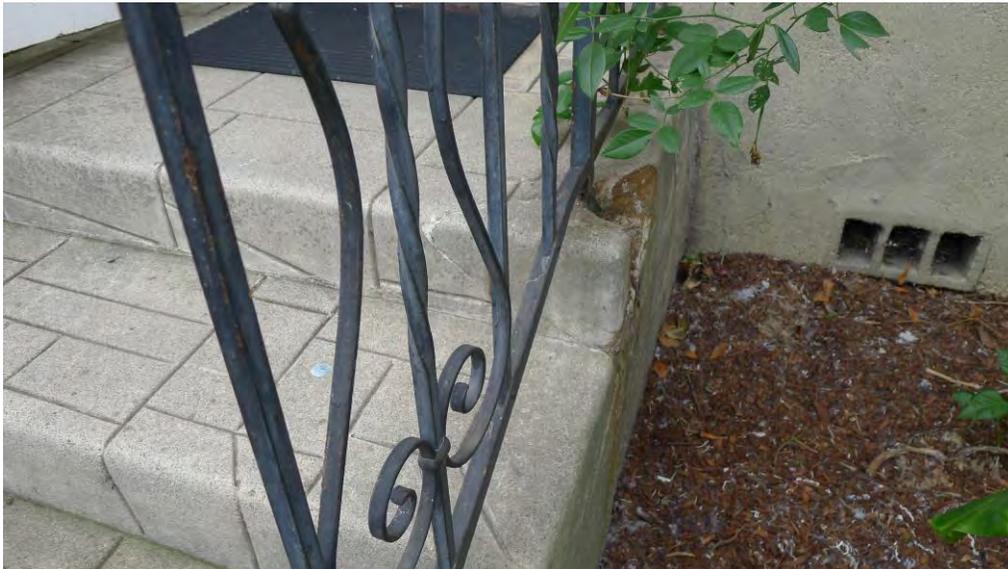
Figure 10: Concrete spalling at railing embedment (3)

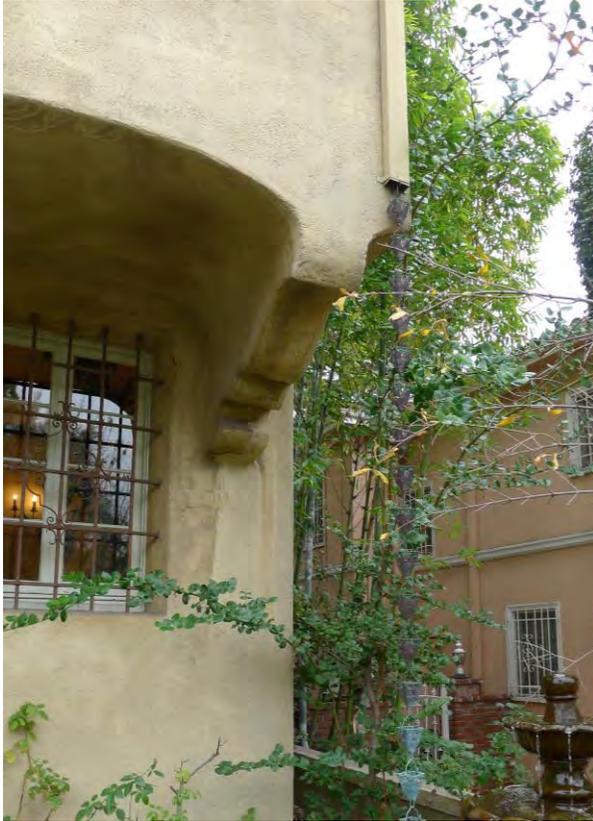
Figure 11: Gutter outlet onto face of building causing discolor of wall finish

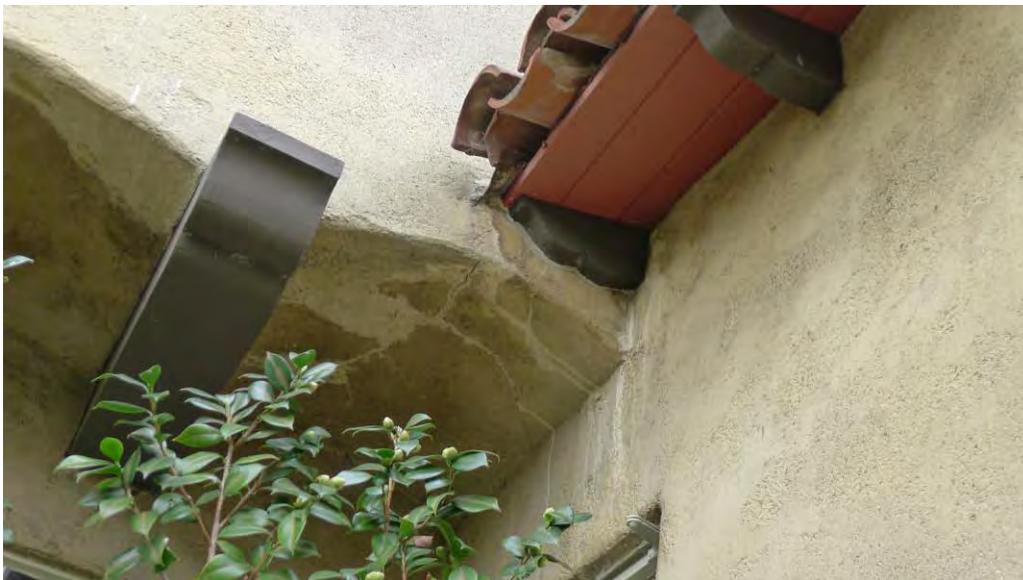
Figure 12: Conceal roof gutter outlet onto face of building causing cracks and discolor

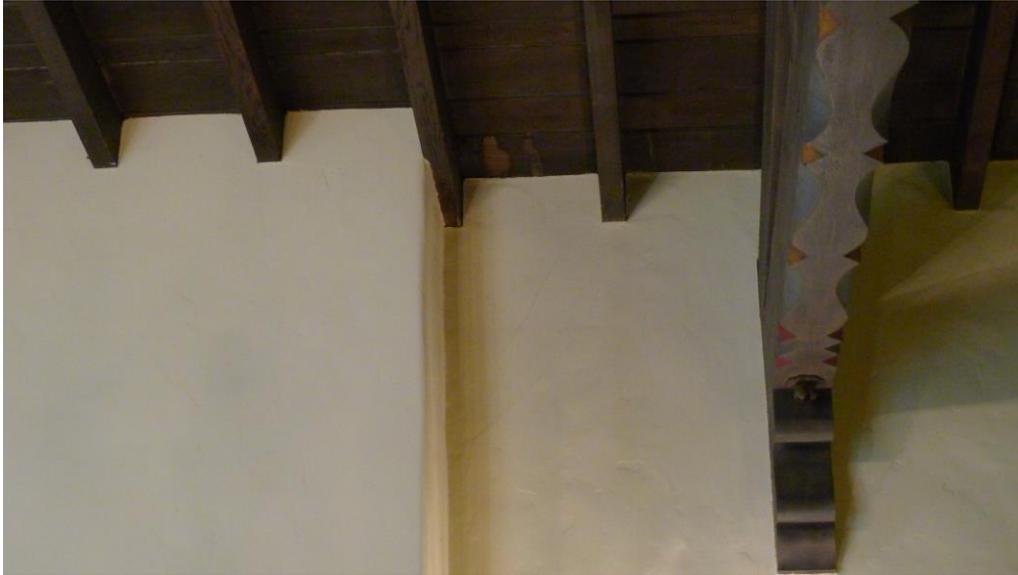
Figure 13: Water stain at roof of living room

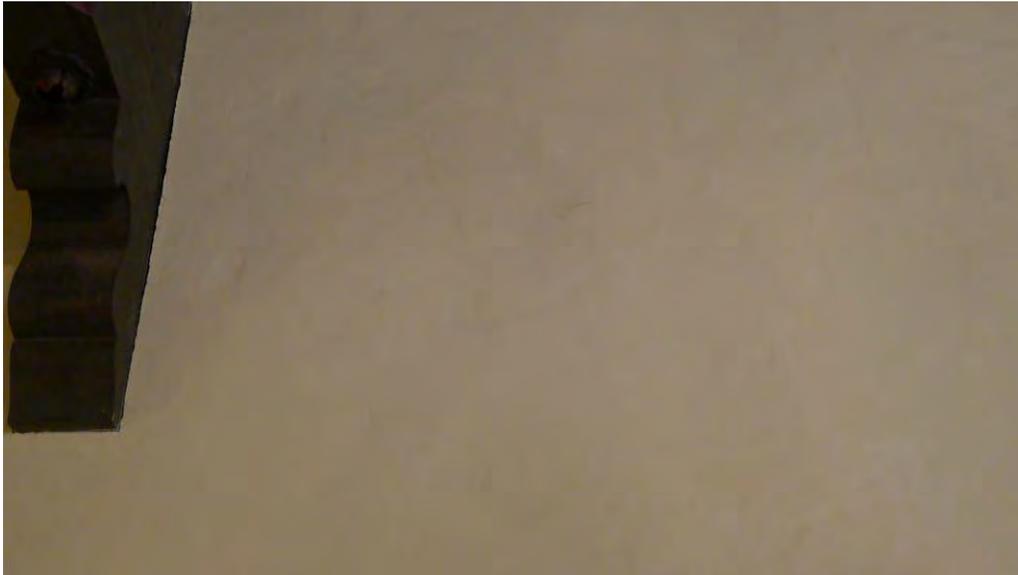
Figure 14: Water damaged paint at living room wall

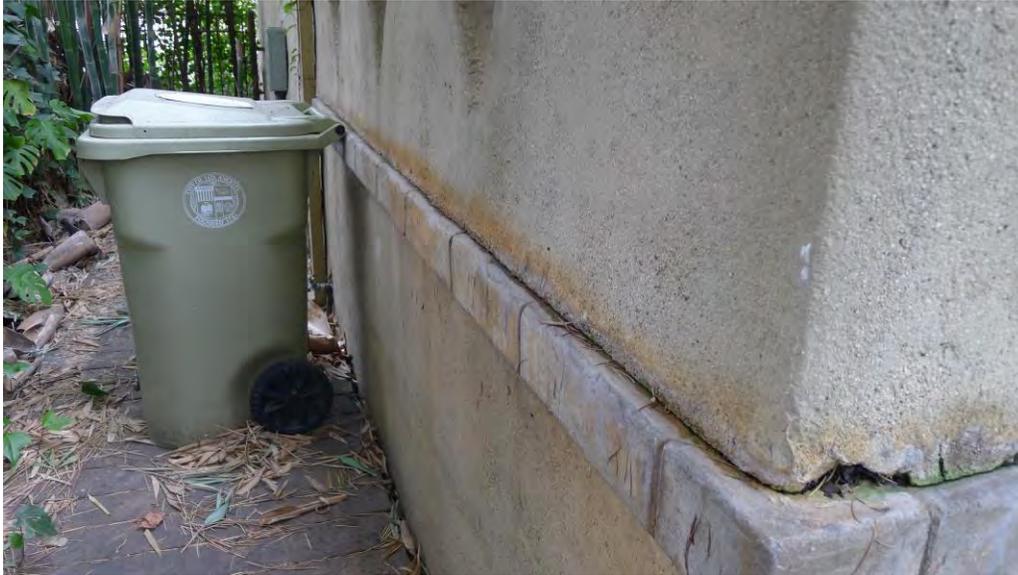
Figure 15: Discolor concrete at back concrete porch

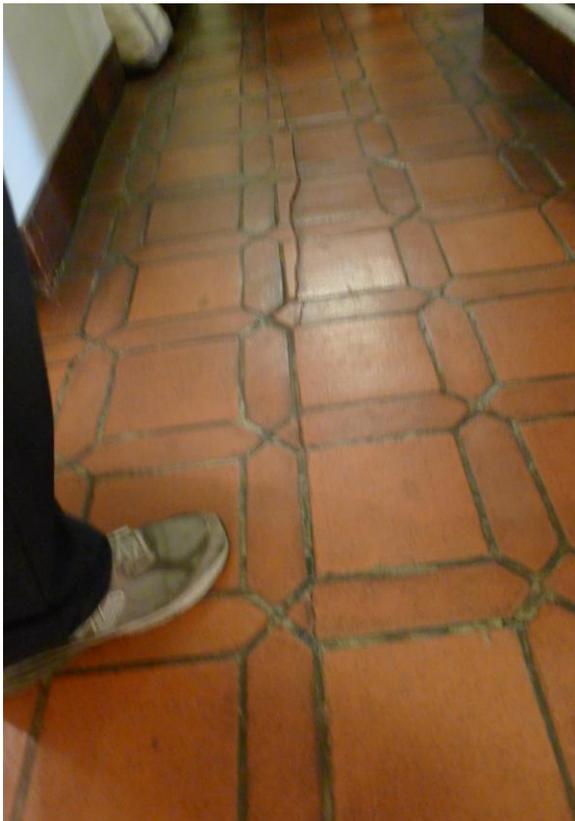
Figure 16: Crack in tile floor by staircase/foyer

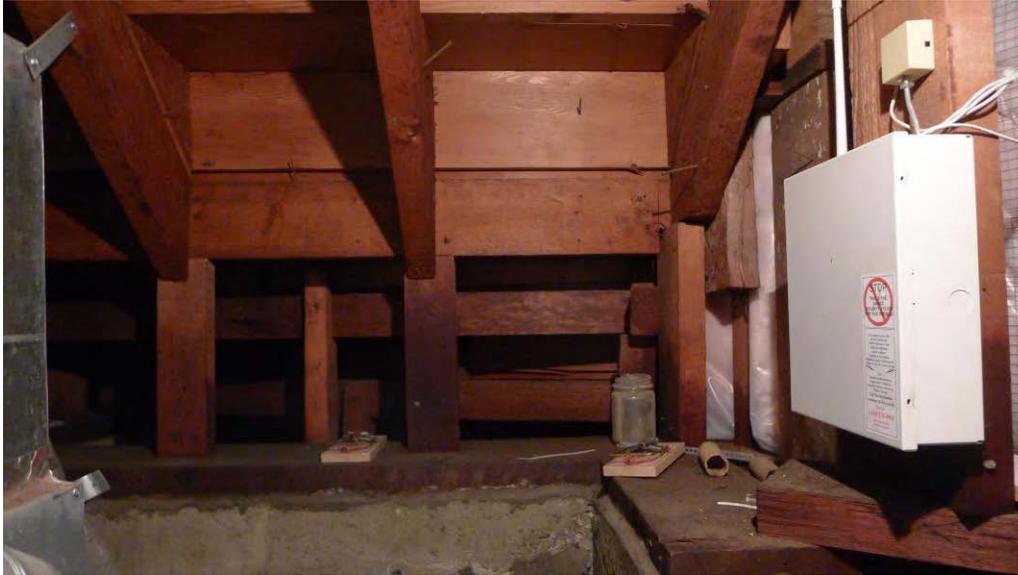
Figure 17: No anchor bolt at sill plate or plywood at cripple wall

Description of work: Upgrade foundation beneath the house.

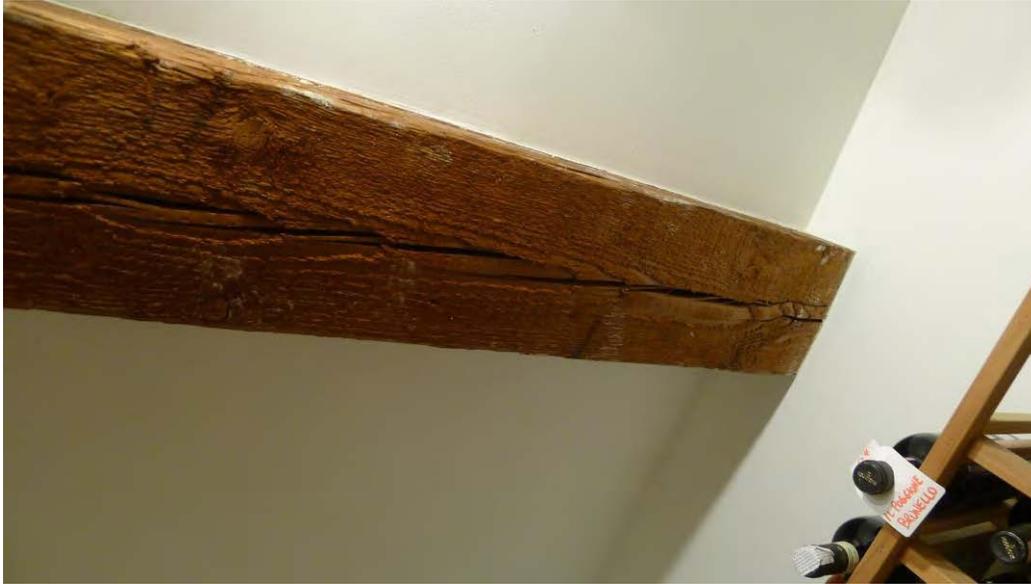
Figure 19: Crack at bottom of beam in wine cellar

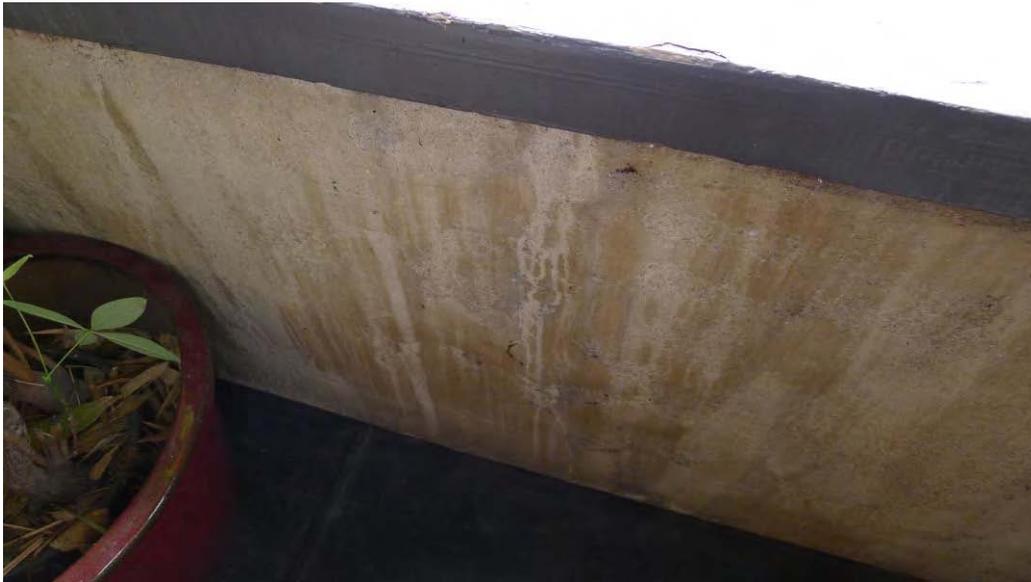
Figure 20: Water stain from water collecting onto master balcony

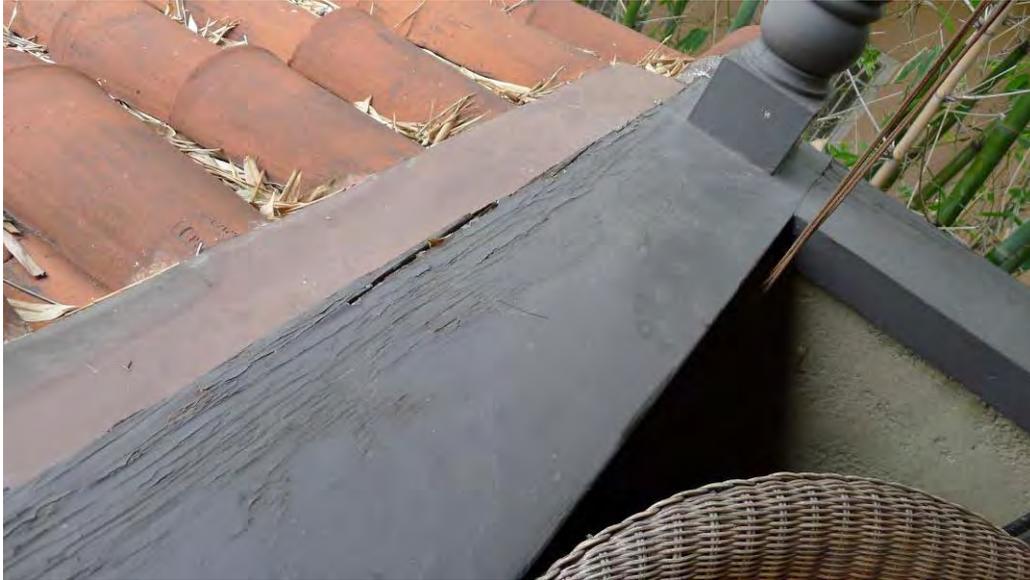
Figure 21: Rot of sill at master balcony

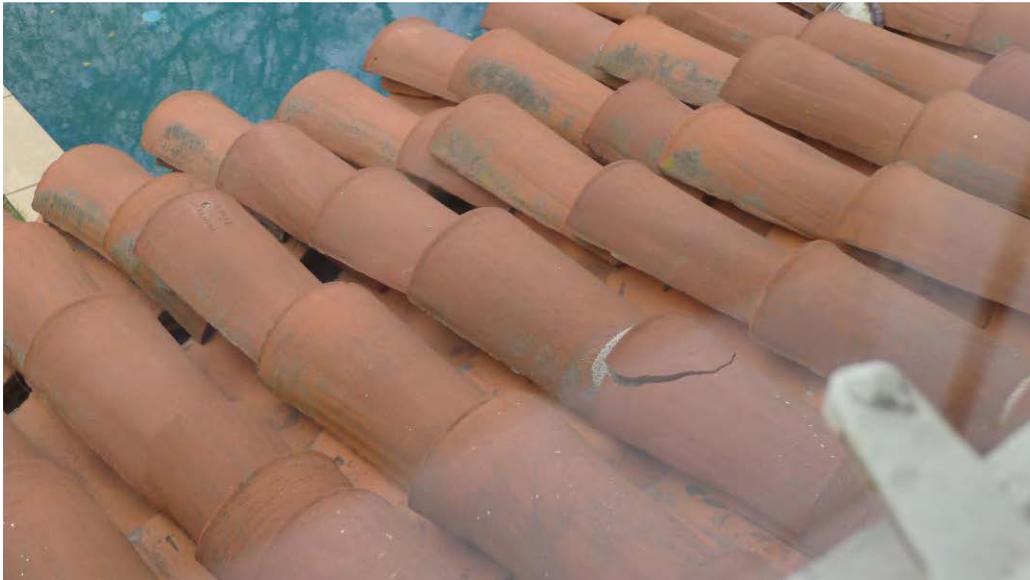
Figure 22: Cracked tile and concealed gutter

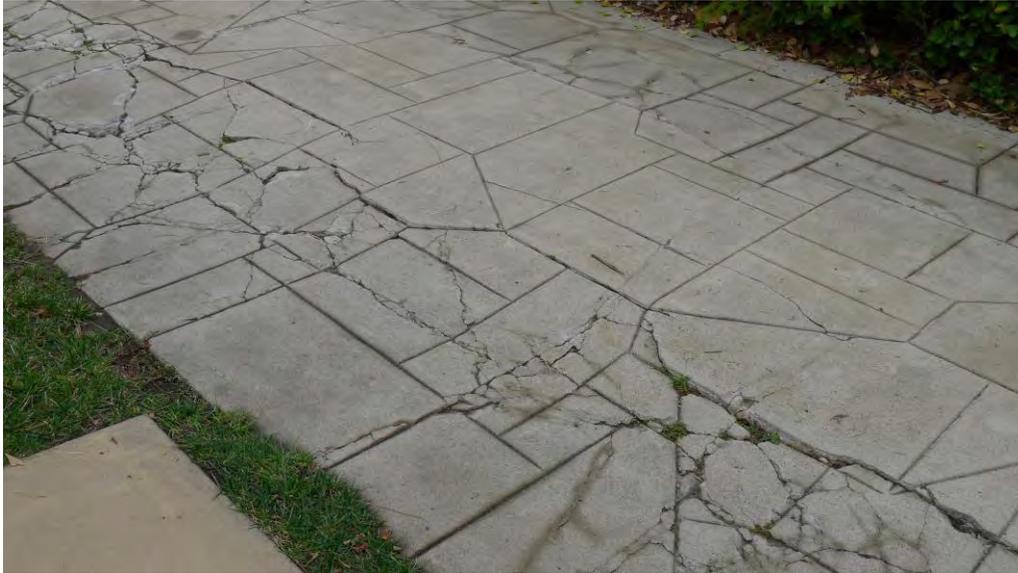
Figure 23: Cracked concrete driveway

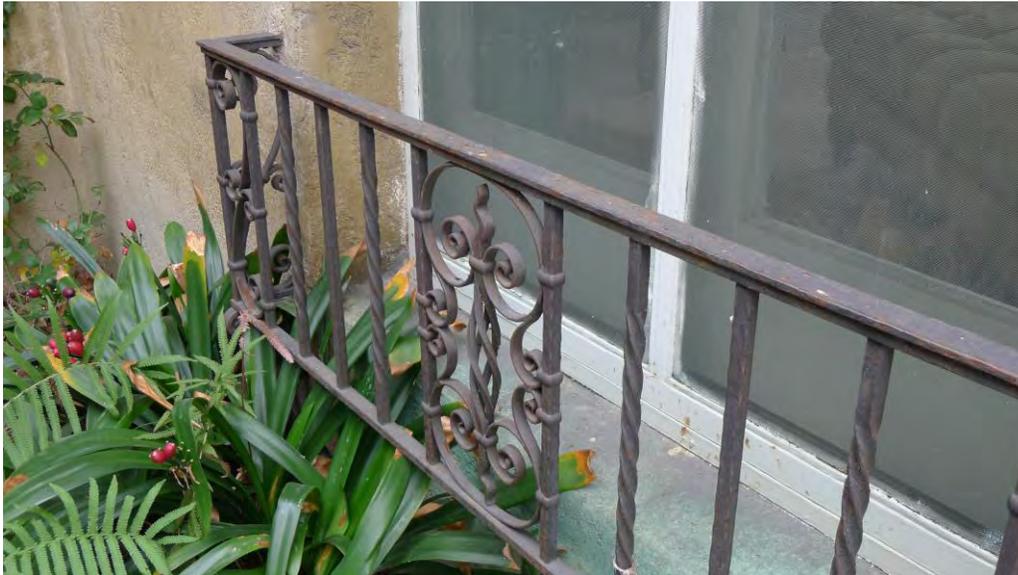
Figure 24: Rusty railing

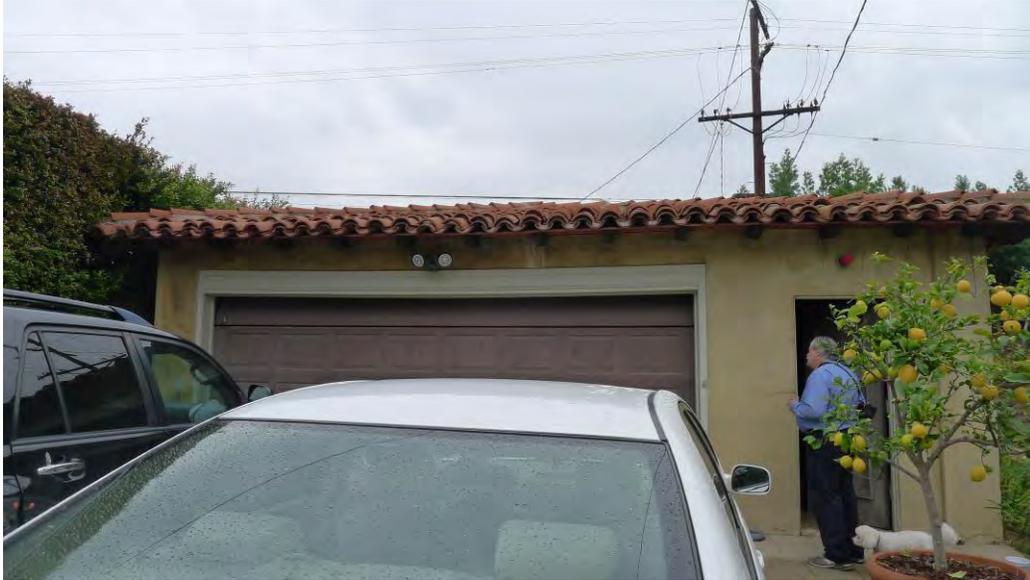
Figure 25: Header at garage opening deflection visibly at the center of the opening

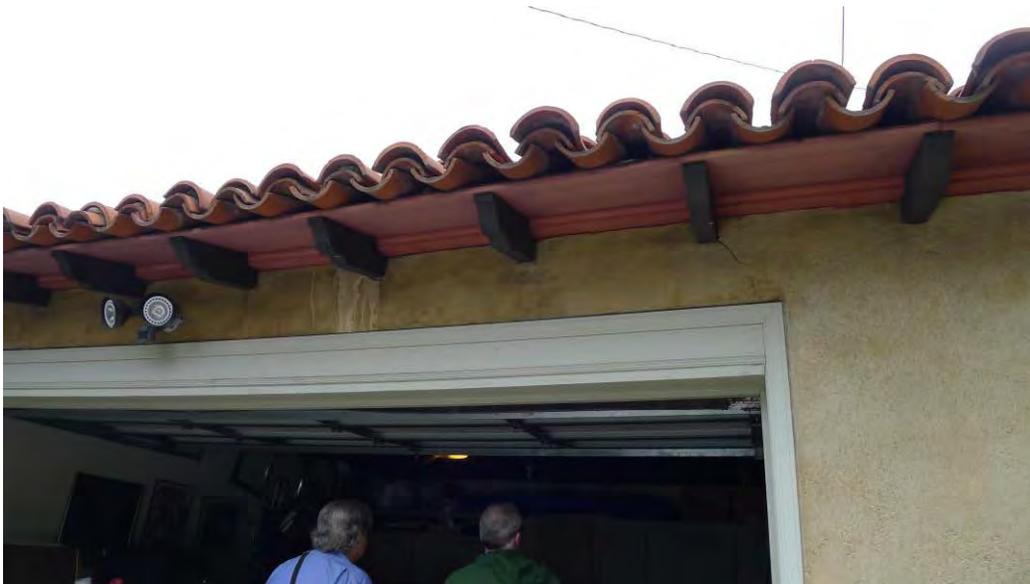
Figure 26: Crack at wall above garage opening

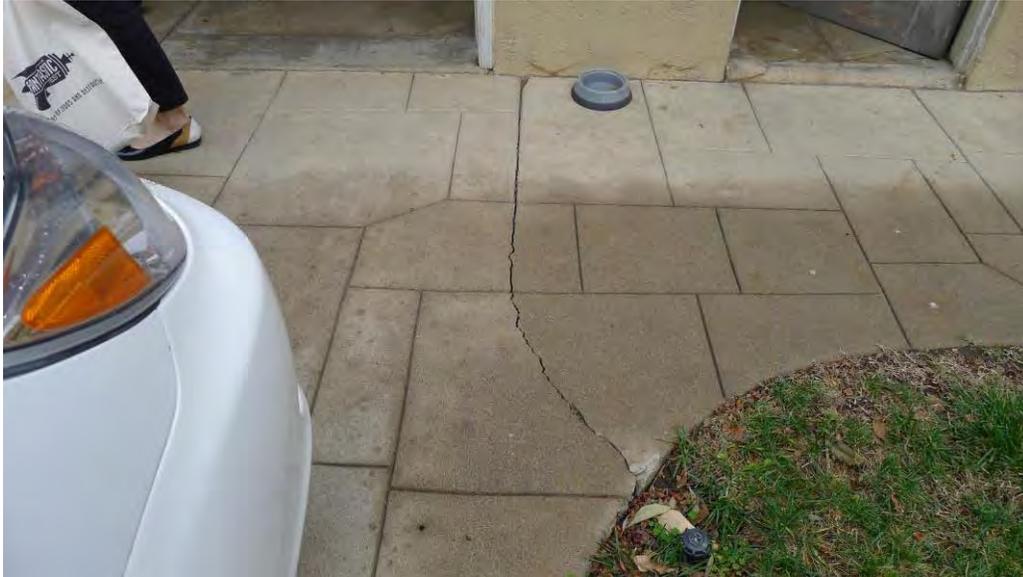
Figure 27: Crack in concrete slab at post of garage opening

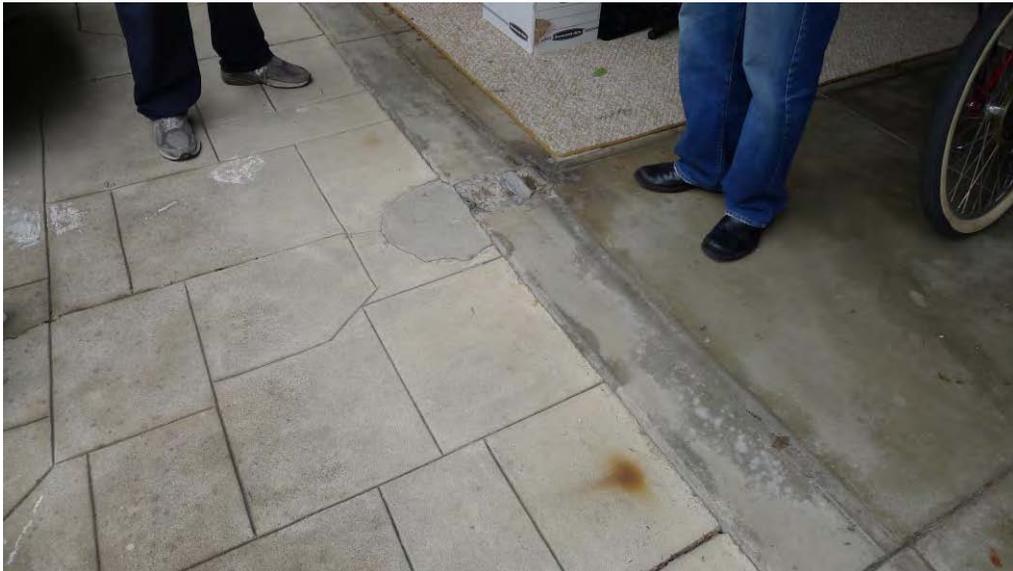
Figure 28: Concrete patch work where original post used to be located at the center of the door opening
