RECOMMENDATION REPORT

CASE NO.: CHC-2015-1575-MAEX

PROJECT: 1950 N. Edgemont Street
Historic-Cultural Monument (HCM) No. 1068

Historic Structure Report

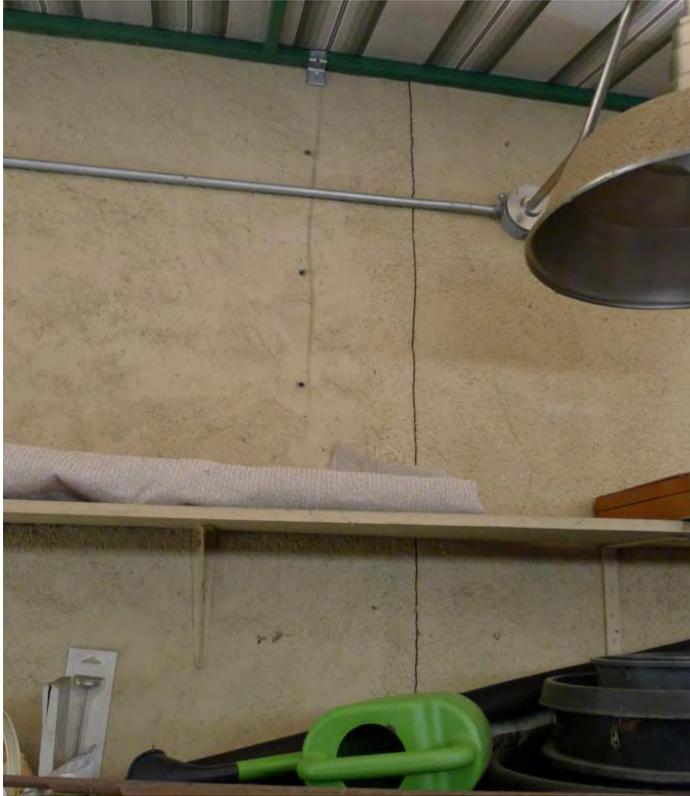
Figure 29: Vertical crack at back of garage
