**2640-2656 NORTH ABERDEEN AVENUE**  
Aberdeen House, Historic-Cultural Monument (HCM) #1171  
CHC-2019-1328-MAEX

**STAFF RECOMMENDATION REPORT**

CASE NO.: CHC-2019-1328-MAEX

**PROJECT:** 2640-2656 North Aberdeen Avenue  
Aberdeen House, Historic-Cultural Monument (HCM) #1171

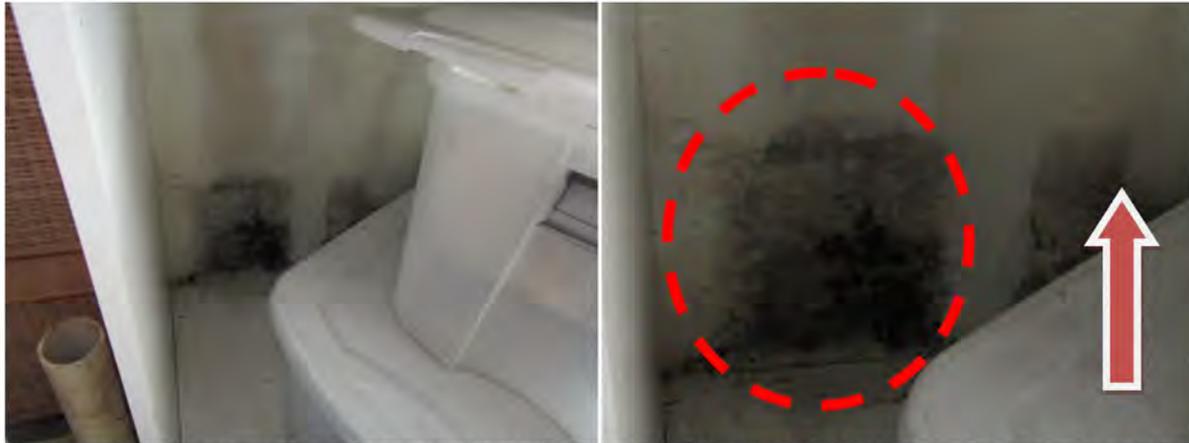
The single car garage has heavy mold amplification on the east wall or that wall in common with the West wall of the double garage. We also noted anomalies in the ceiling which included stains and existing openings. **Surface samples of the mold growing on this east wall were positive for Stachybotrys (commonly called black toxic mold), Ulocladium, and Penicillium Aspergillus. These Stachybotrys again, indicating very wet conditions and the Penicillium Aspergillus indicating slightly moist conditions. Professional remediation shall include this portion of the common wall. The source of the moisture must be determined and confirmed abated prior to any renovation. Consultation with the forensic water intrusion expert is also recommended.**

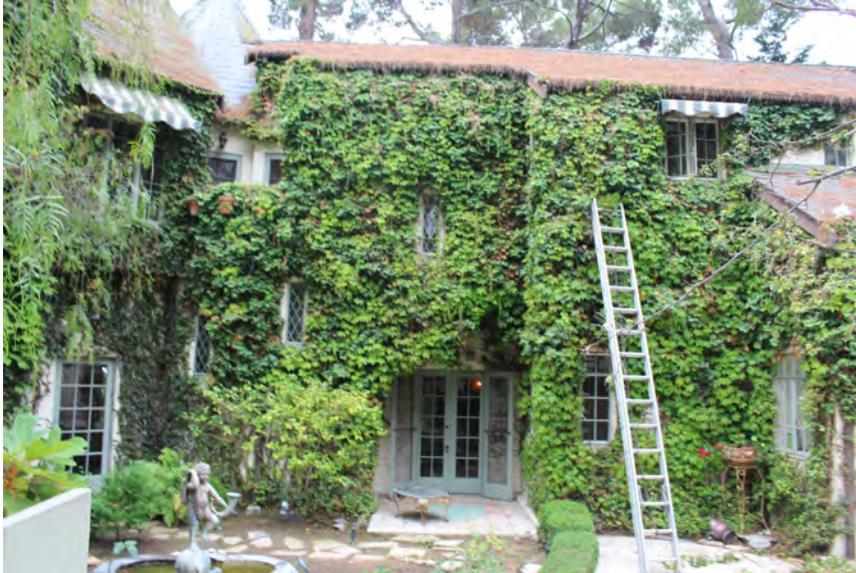
*Landscape:* Ivy covers the exterior of the residence and the overall landscape appears in overgrown condition. There is no evidence of a known historic landscape architect associated with the property. Large pine trees are planted very close to the front elevation of the main house. The massive amount of foliage up against the house causes a host of issues.

Figure 5 Ivy covering rear exterior of residence, 2017. Photo credit: Stuart Gulland.

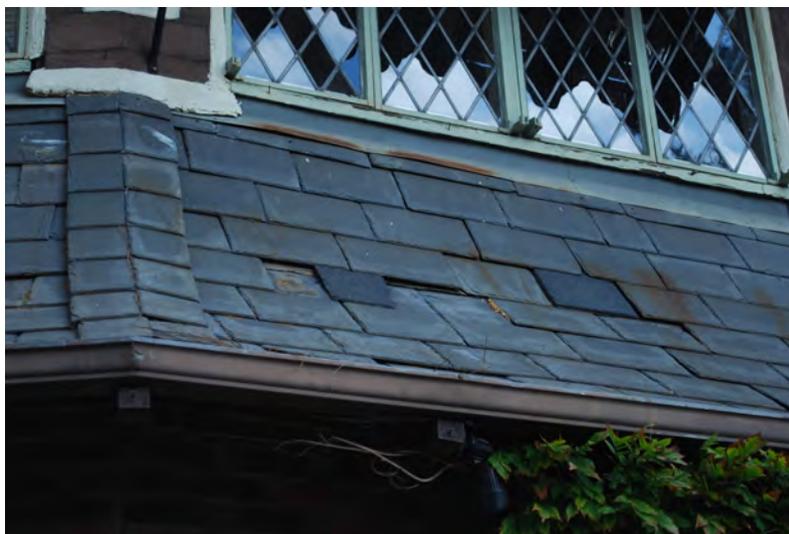
Figure 8 Slate roof detail showing missing slates, 2017. Photo credit: V. Withers

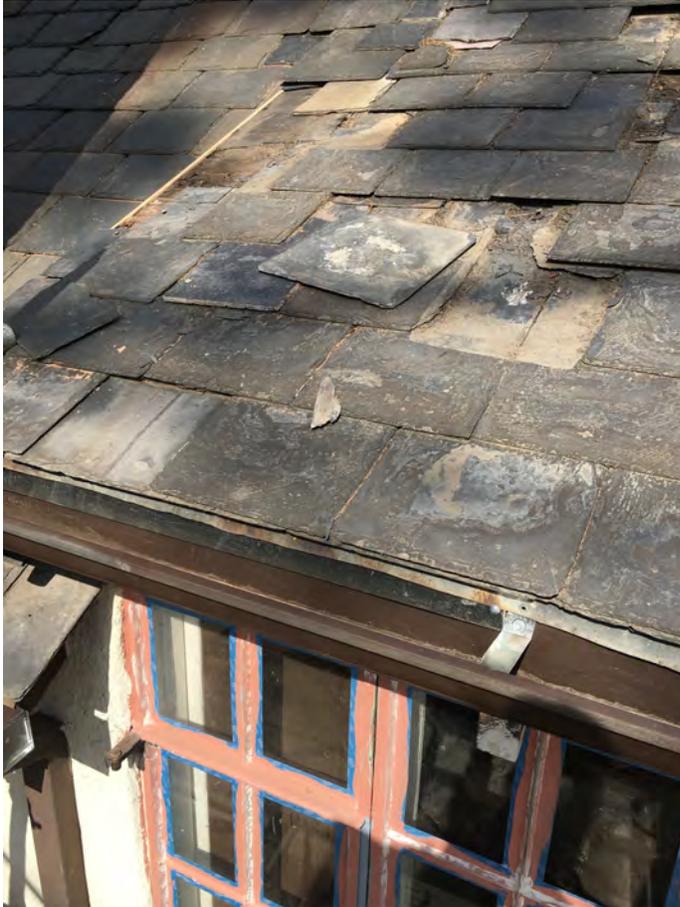
**Figure 9 Slate roof condition (detail), 2017. Photo credit: Stuart Gulland**

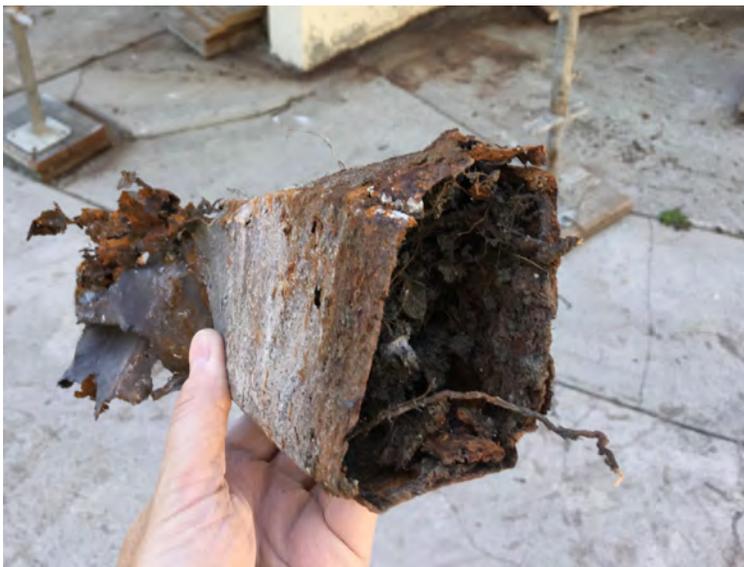
Gutters and Downspouts are an important part of the roof system and are designed to carry water away from the building. Aberdeen House has gutters with scuppers and downspouts that are in poor condition.

**Figure 10 Portion of gutter, showing deterioration, 2017. Photo credit: Stuart Gulland**

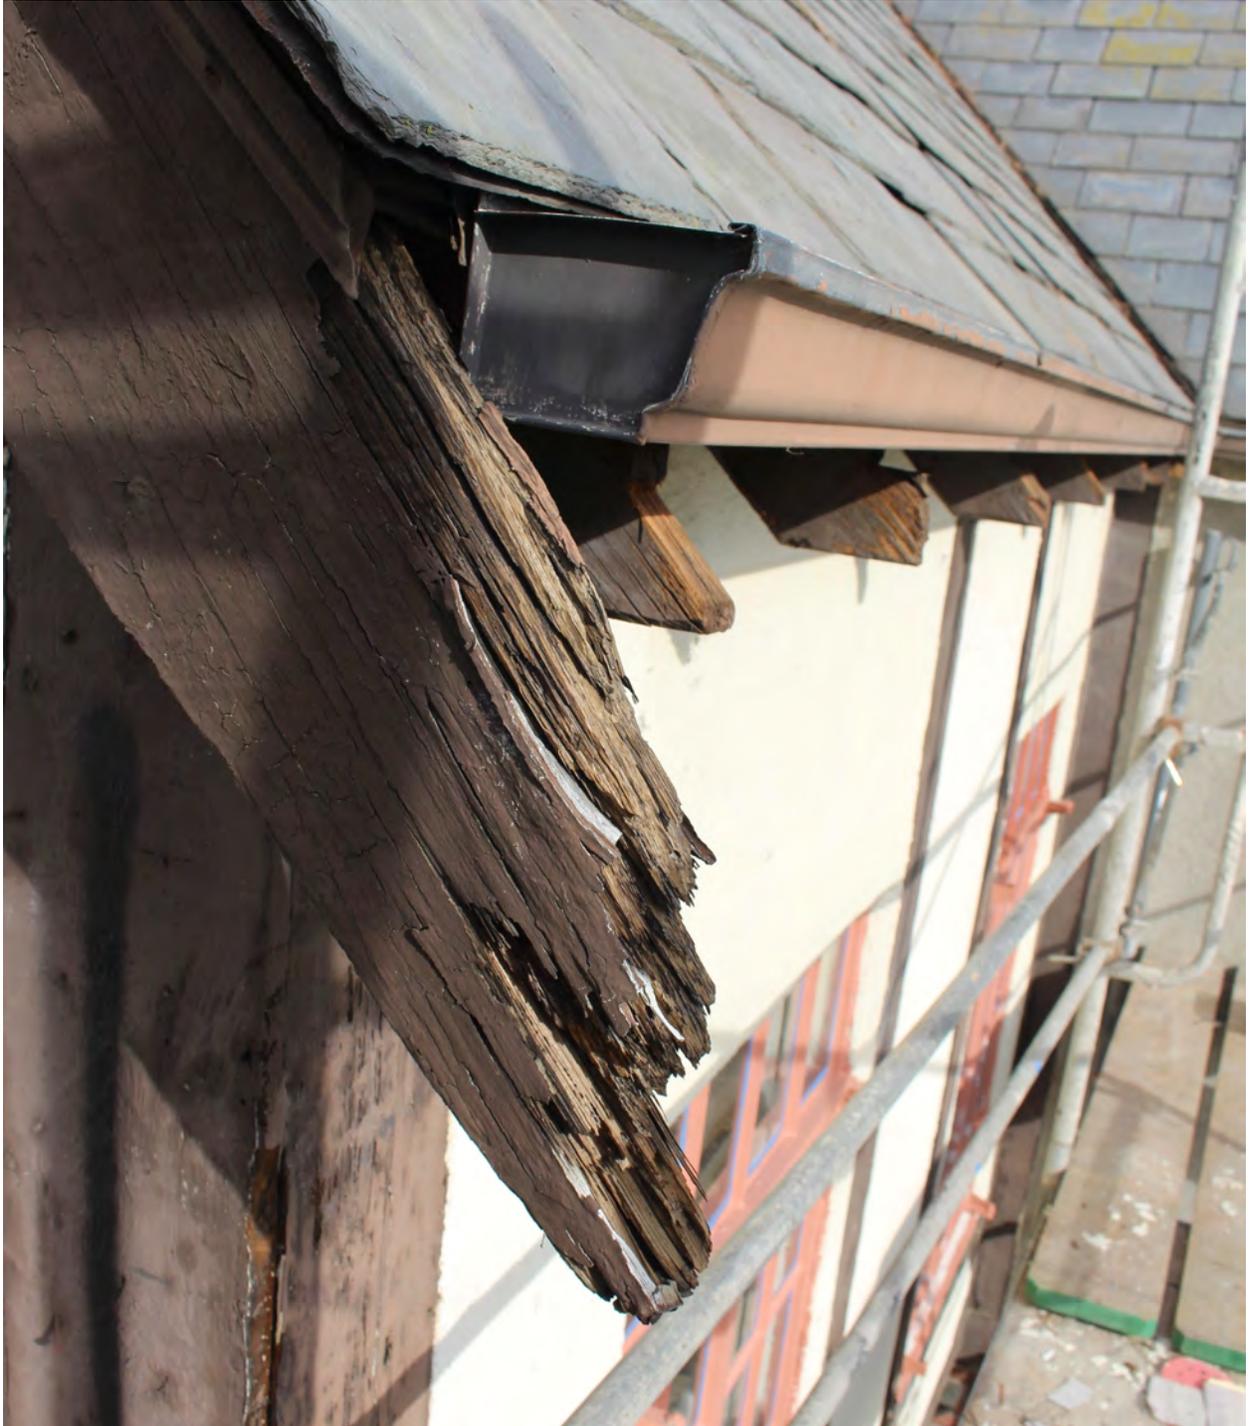
Aberdeen House is a Tudor Revival style residence with iconic half-timbering at the upper story. This wood detailing is in poor condition and it is estimated that many boards will need to be replaced due to the level of deterioration observed.

**Figure 11 Exposed architectural wood elements suffering from deterioration, 2017. Photo credit: Stuart Gulland**

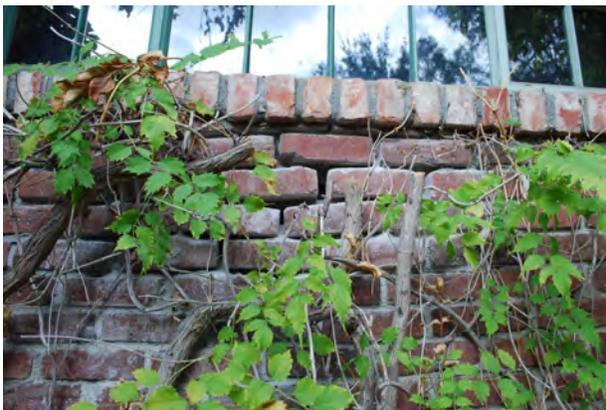
Aberdeen House has been covered in vines for many years, holding water against the masonry, and likely one of the largest contributing factors to brick and mortar deterioration.

**Figure 12 Brick condition, 2017. Photo credit: V.Withers**

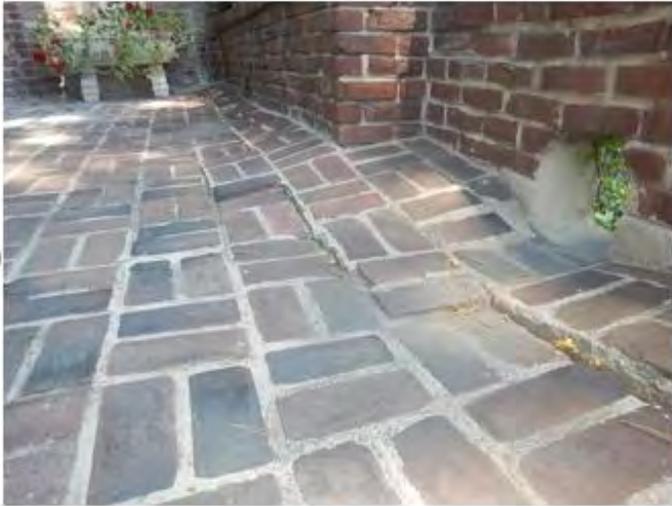
**Figure 13 Front Terrace with subsidence of substrate, 2017. Photo credit: Stuart Gulland**

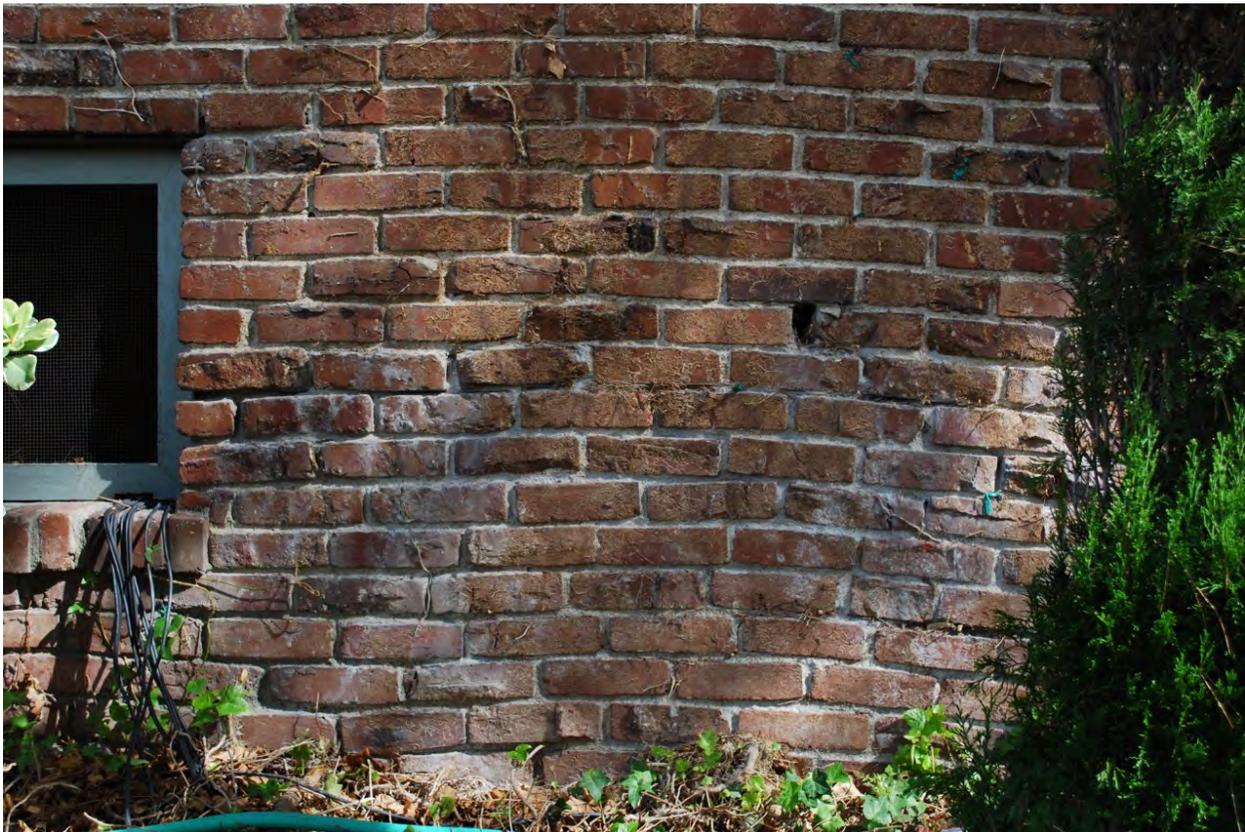
**Figure 14 Representative brick wall, showing repair mortars, 2017. Photo credit: V. Withers**

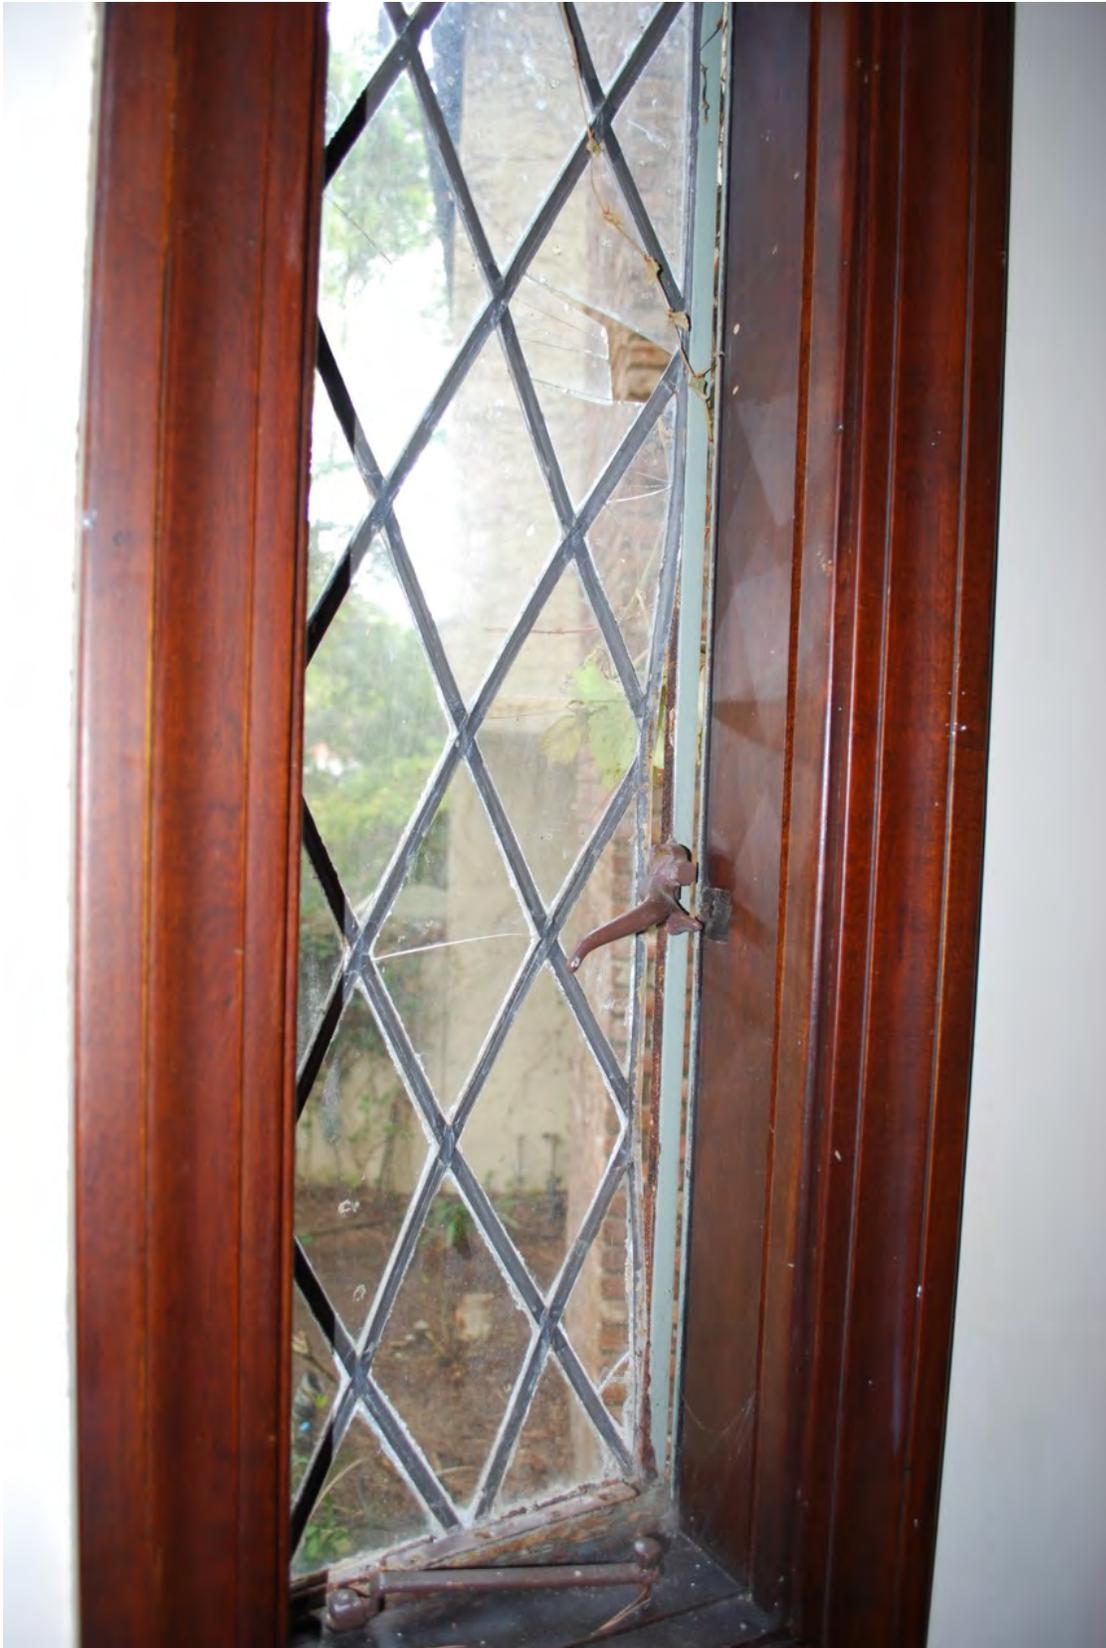
Aberdeen House has many steel casement windows and decorative leaded glass windows. They range in condition from fair to poor. Original windows are character-defining to this building.

Figure 15 Leaded glass casement window showing damage, 2017. Photo credit: V.Withers

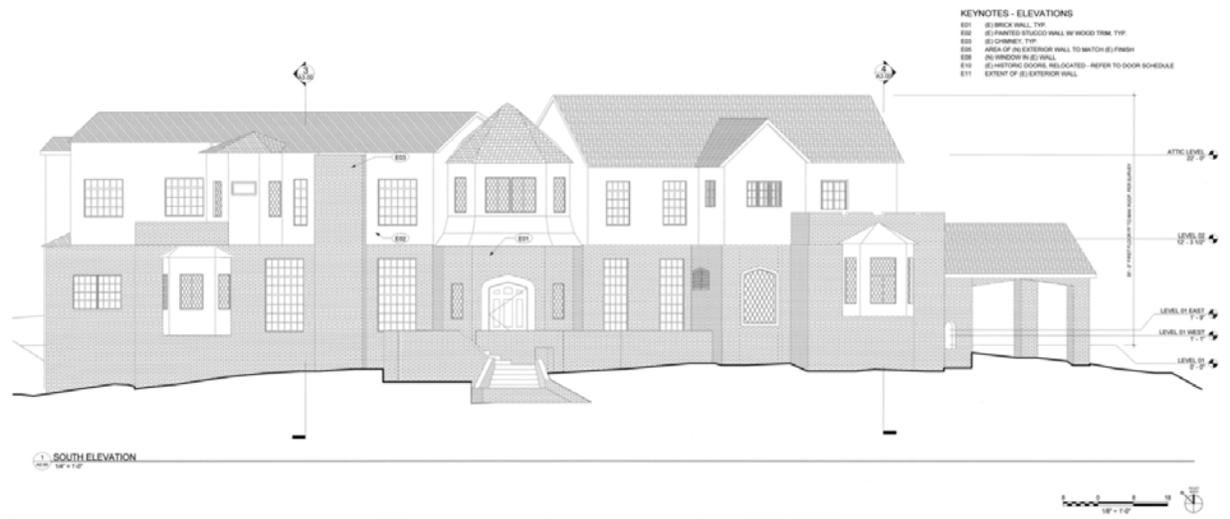
Figure 16 South (Front) Elevation

The front elevation is in poor condition when subject elements are considered individually – the brick is deteriorated, the stucco is covered in ivy and in fair condition underneath, the windows are in need of rehabilitation, and the roof is in fair to poor condition. Each of these elements is discussed in their own section of the report.

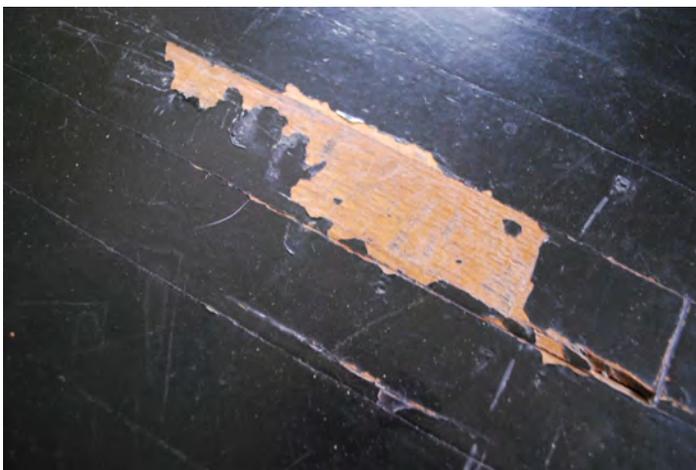
The second floor of Aberdeen House contains bedrooms and bathrooms. The rooms are in fair to poor condition. A hallway and bedroom spaces were reconfigured in areas. A full set of plans showing the changes is included as an appendix. The flooring of the upstairs is in poor condition.

Figure 31 Sample of upstairs flooring, showing condition, 2017. Photo credit: V.Withers

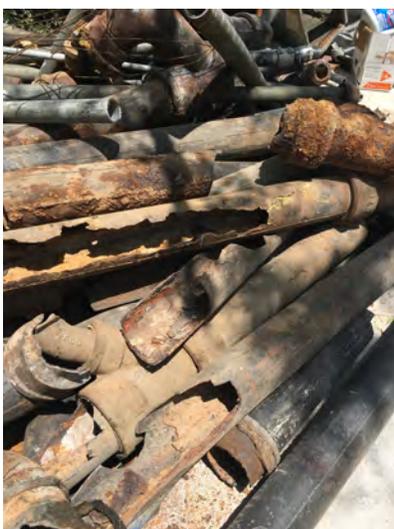
**Figure 34** Old plumbing once removed from residence, showing poor condition, 2017. Photo credit: Stuart Gulland

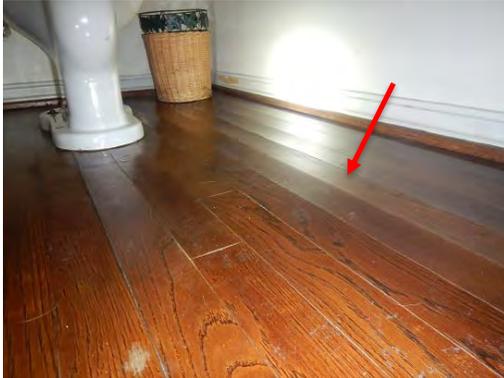
We observed “cupping” in portions of the hardwood flooring, particularly in the downstairs bathroom off the study. This is often related to elevated moisture levels. **This is a moisture related issue that is beyond the scope of this report and should be addressed by others. See photo below.**

Cupping in the hardwood flooring at the downstairs bathroom off the study.

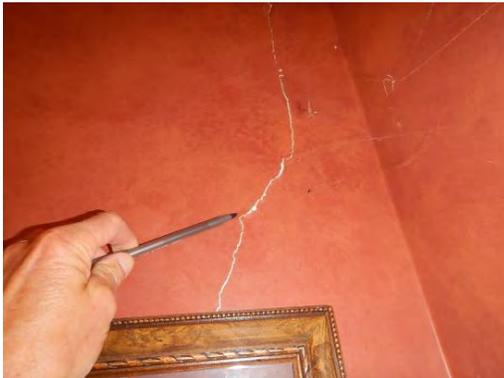
Vertical plaster crack at the west wall of the southwest breakfast room.

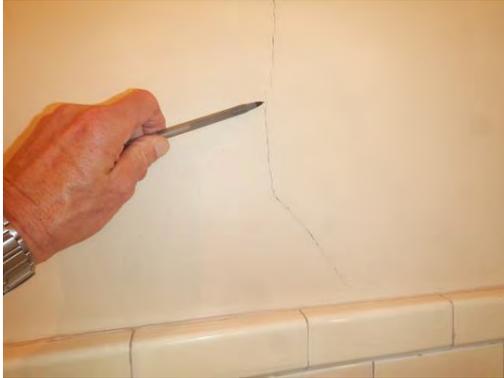
Vertical plaster crack at the south wall of the upstairs west bathroom.

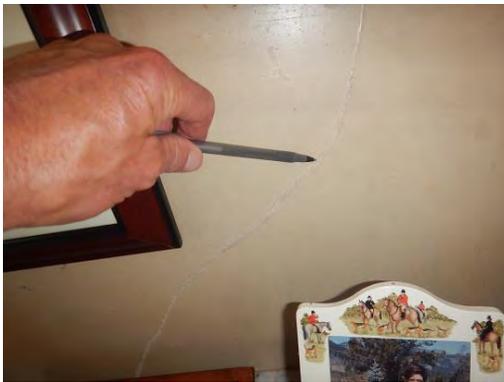
Diagonal plaster crack at the west wall of the southwest bedroom.

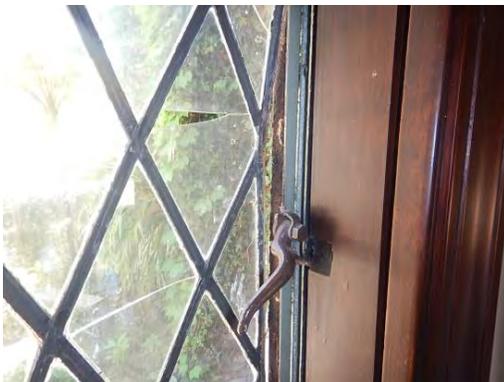
Several of the leaded glass windows are damaged and are in need of replacement or rehabilitation. See photo below.

This is one of the damaged leaded glass windows at the north wall of the entry stairwell.

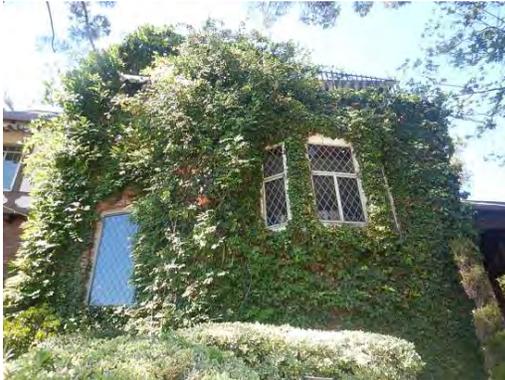
This photo shows an example of some of the heavy plant growth attached to the exterior of the residence.

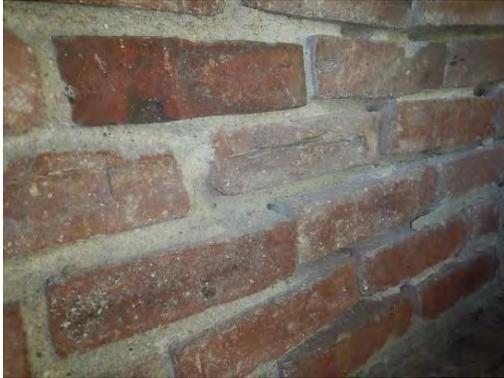
Example of mortar deterioration at the east wall of the residence.

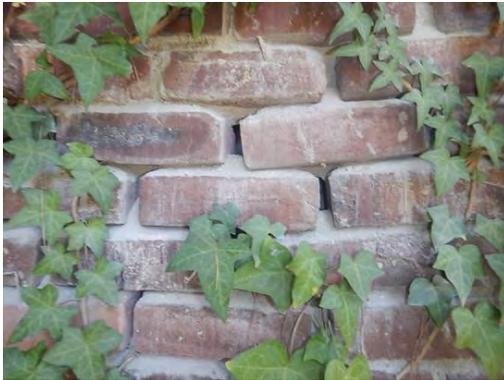
Example of severe mortar deterioration and shifted bricks at the southwest corner of the kitchen.

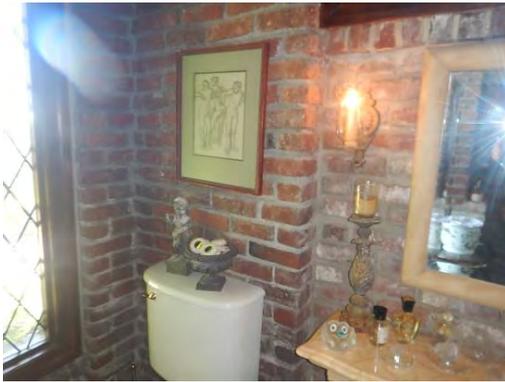
We suspect the walls surrounding the downstairs southeast bathroom may be constructed with unreinforced masonry.

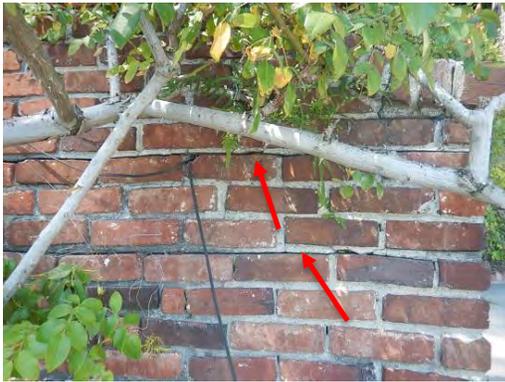
Large cracks in the brick retaining wall at the south side of the lower landing.

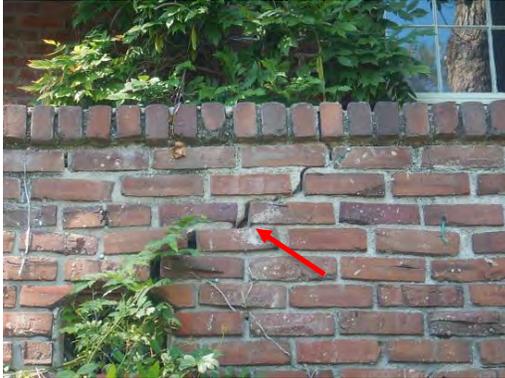
Large cracks in the brick retaining wall that surrounds the entry porch.

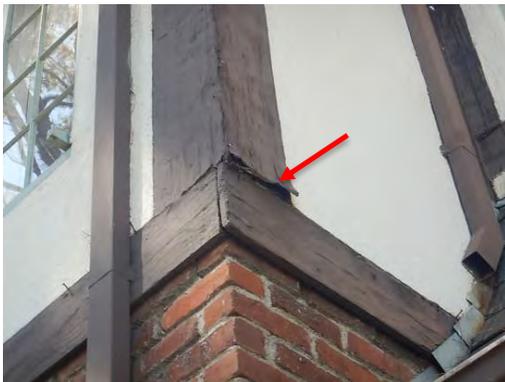
Decay in the wood trim at the south wall above the southeast corner of the dining room.

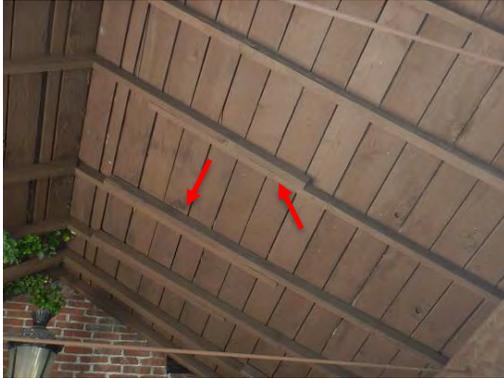
Approximately eight of the 2 x 4 rafters associated with the portico roof have been spliced and a substandard manner.

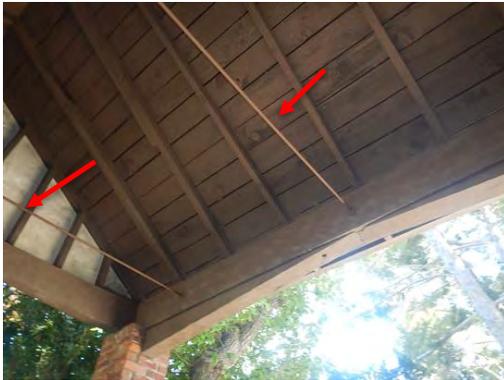
The horizontal steel tie rods are spaced further than the building code recommended 4 foot maximum intervals.

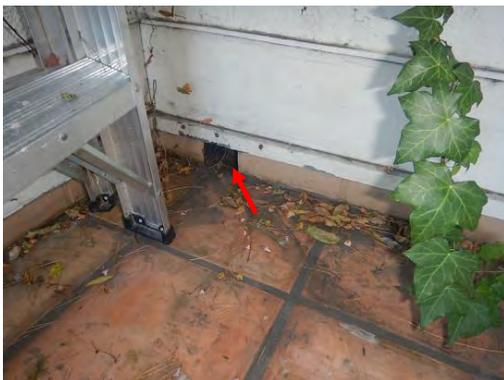
There is only one scupper drain for the southeast second floor deck.

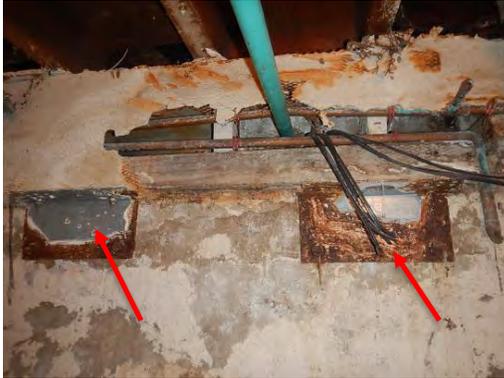
Moisture damage and severely corroded foundation anchor plates at the north wall of the basement.

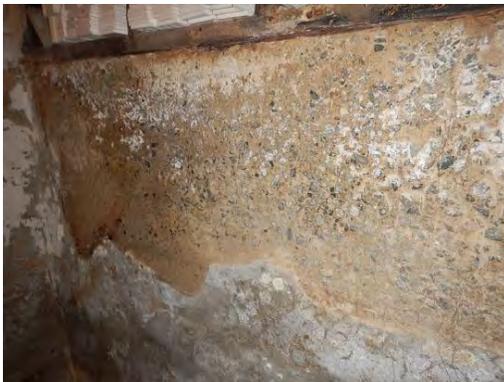
There has been prior moisture seepage and surface deterioration of the retaining wall at the south side of the basement.

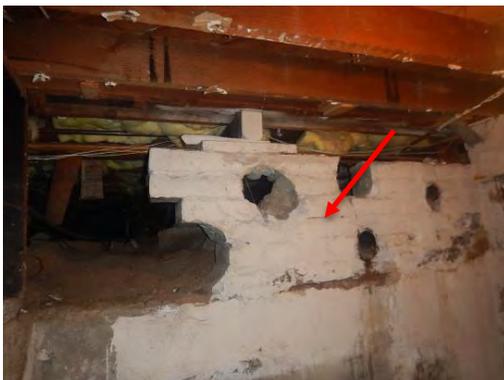
This compromise section of concrete block wall is supporting the floor girder and should be replaced.

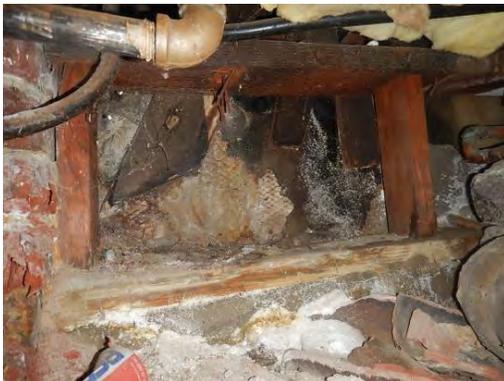
This section of cripple wall framing at the north wall of the building, just west of the mechanical basement, is improperly retaining soil and is water damaged.

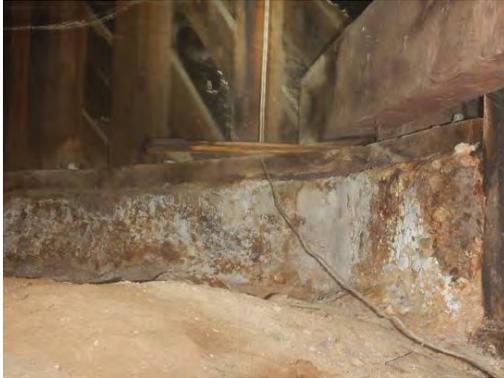
There has been moisture intrusion at the foundation at the north side of the entry stairwell due to high-grade conditions where the soil is above the level of the foundation.

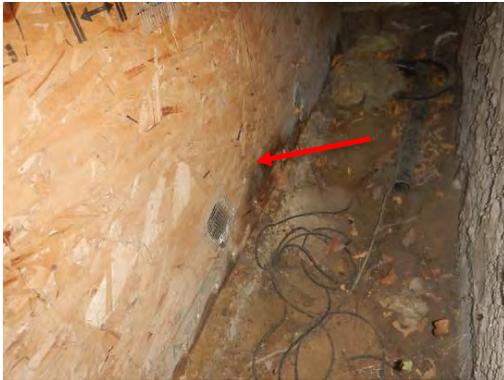
The exterior soil is above the level of the foundation and is damaging the cripple wall framing at the south side of the southeast den.

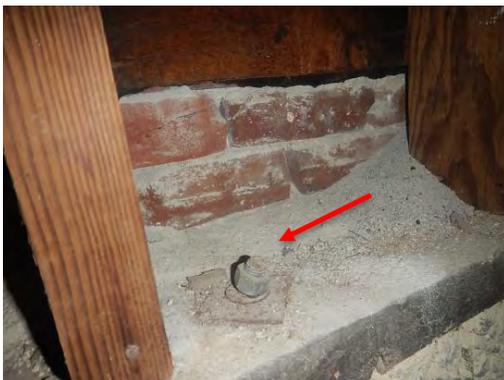
Some of the foundation bolts were installed at a severe angle.

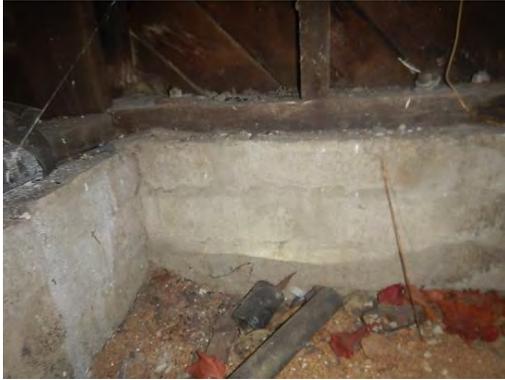
Some of the foundation bolts were installed into older concrete blocks that may not contain reinforcing steel.

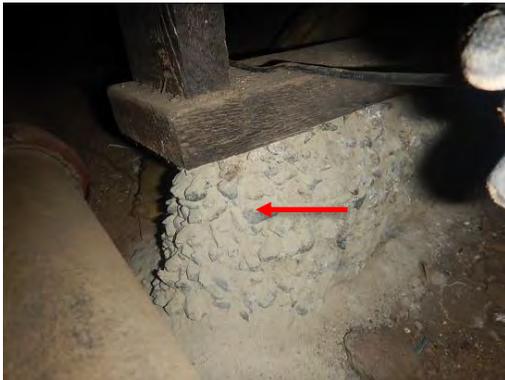
Example of some of the concrete deterioration we observed. This occurs at one of the interior foundations below the eastern portion of the home.

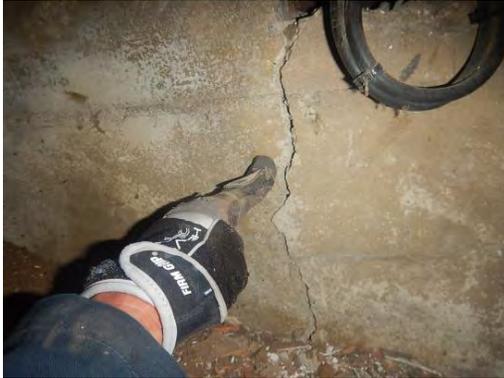
This is one of the foundation cracks we observed at one of the interior footings below the western portion of the home.

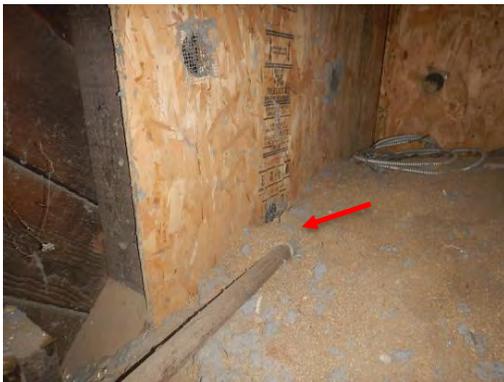
Soil is built up against the cripple wall framing at the south foundation below the western portion of the home.

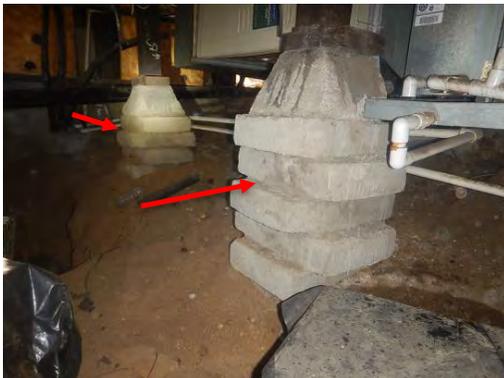
Example of some of the substandard foundation piers we observed.

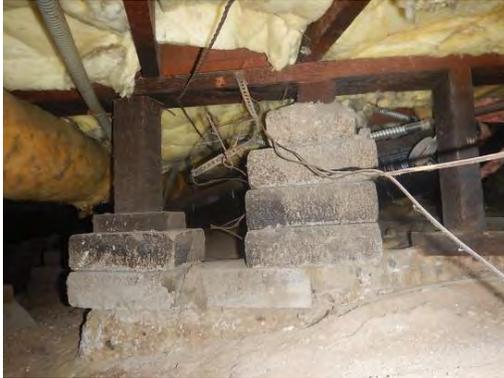
Another example of substandard foundation piers.

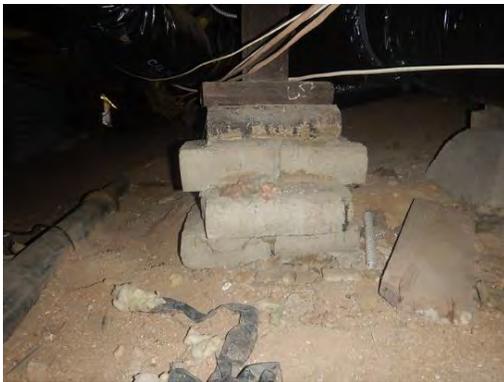
Yet another example of one of the substandard foundation piers we observed.

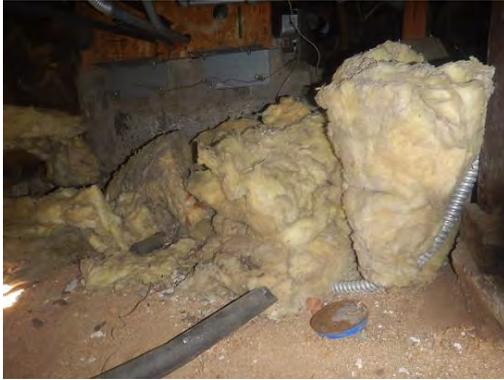
Example of some of the fallen insulation materials we observed.

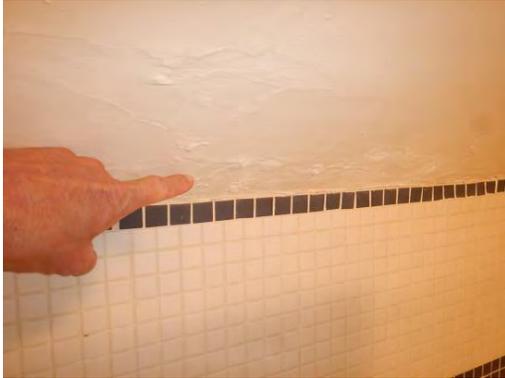
Water damage in the ceiling and walls above the guesthouse bathtub/shower.

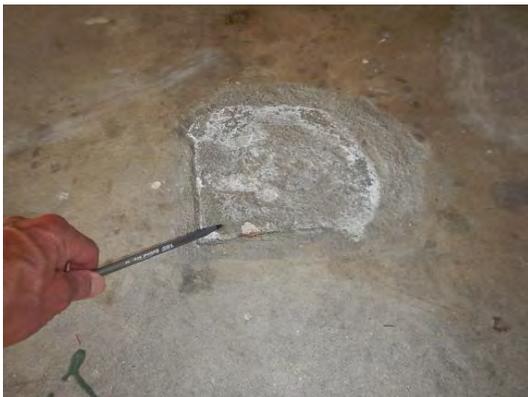
This is where a support post was removed in the garage.

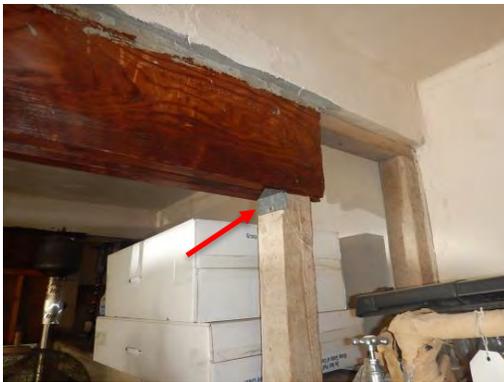
The connection at the north end of the added beam is substandard.

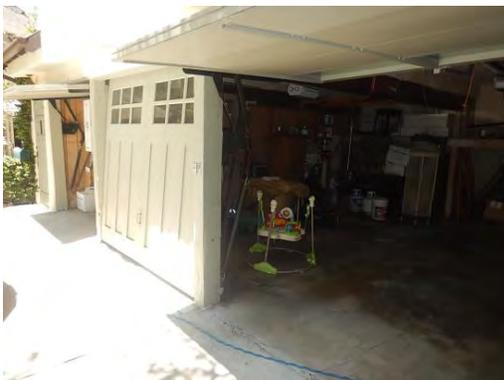
The south wall of the garage consists of door openings with little or no solid shear wall to resist earthquake's.

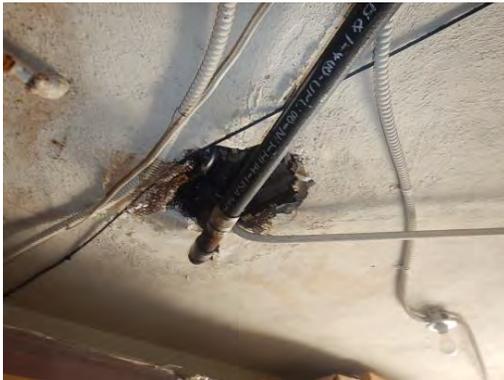
Hole in the garage ceiling.

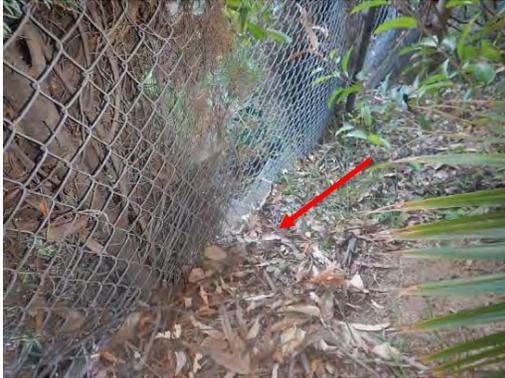
Soil and leaves or built-up against the chain-link fencing at the east side of the property.

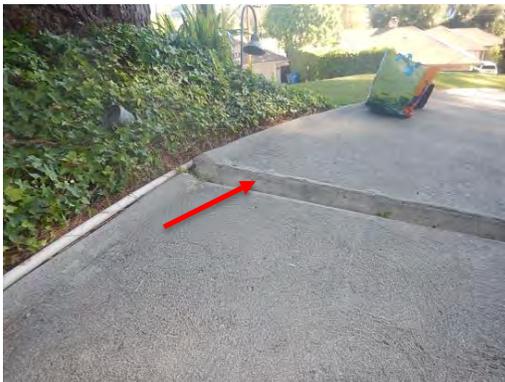
A portion of the driveway slab has been uplifted by tree roots.

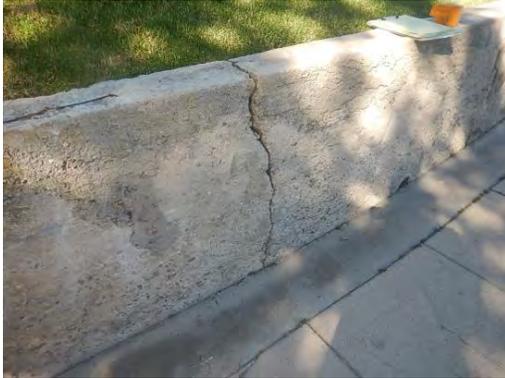
The retaining wall at the south and southwest portions of the property has several large cracks and was measured to be leaning 3 inches.

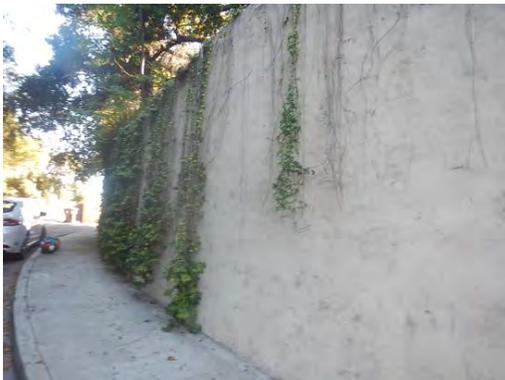
The approximate 12 to 14 foot tall retaining wall at the southeast portion of the property appeared in good structural condition.
