## TREE REPORT

**ADDRESS OF PROJECT:  
Westfield Sherman Oaks Fashion Square  
14006 Riverside Drive  
Sherman Oaks, Ca**

**REPORT PREPARED BY:  
ROBERT HANSEN  
REGISTERED CONSULTING ARBORIST**

February 1, 2006

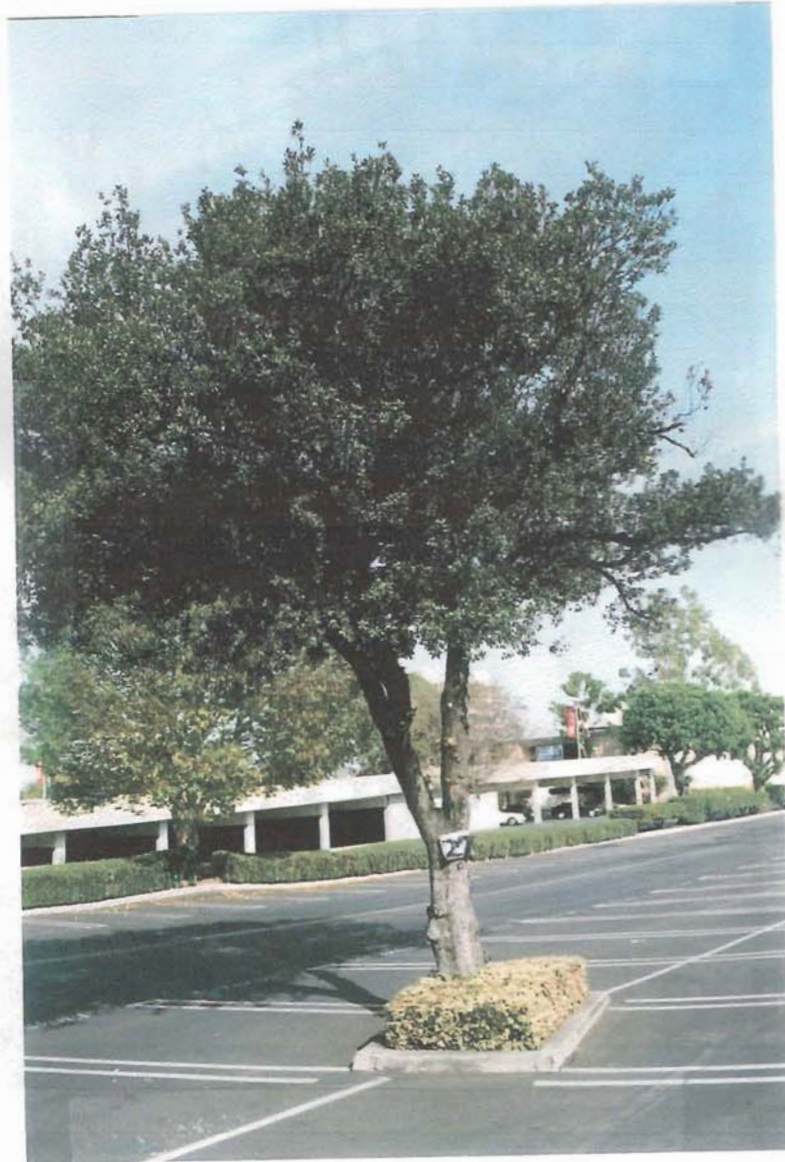
This is a picture of Holly Oak # 27 located in parking lot rear of Macy's.

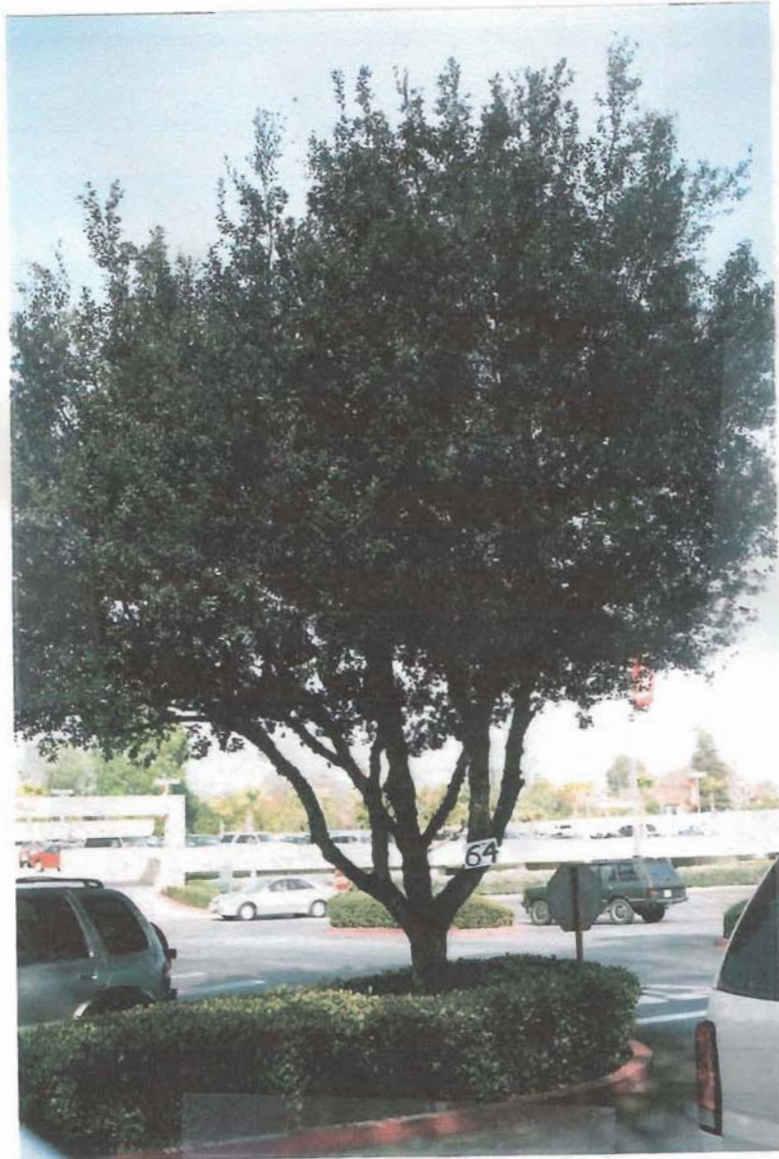
This is a picture of Holly Oak # 64 located in parking lot rear of Macy's.

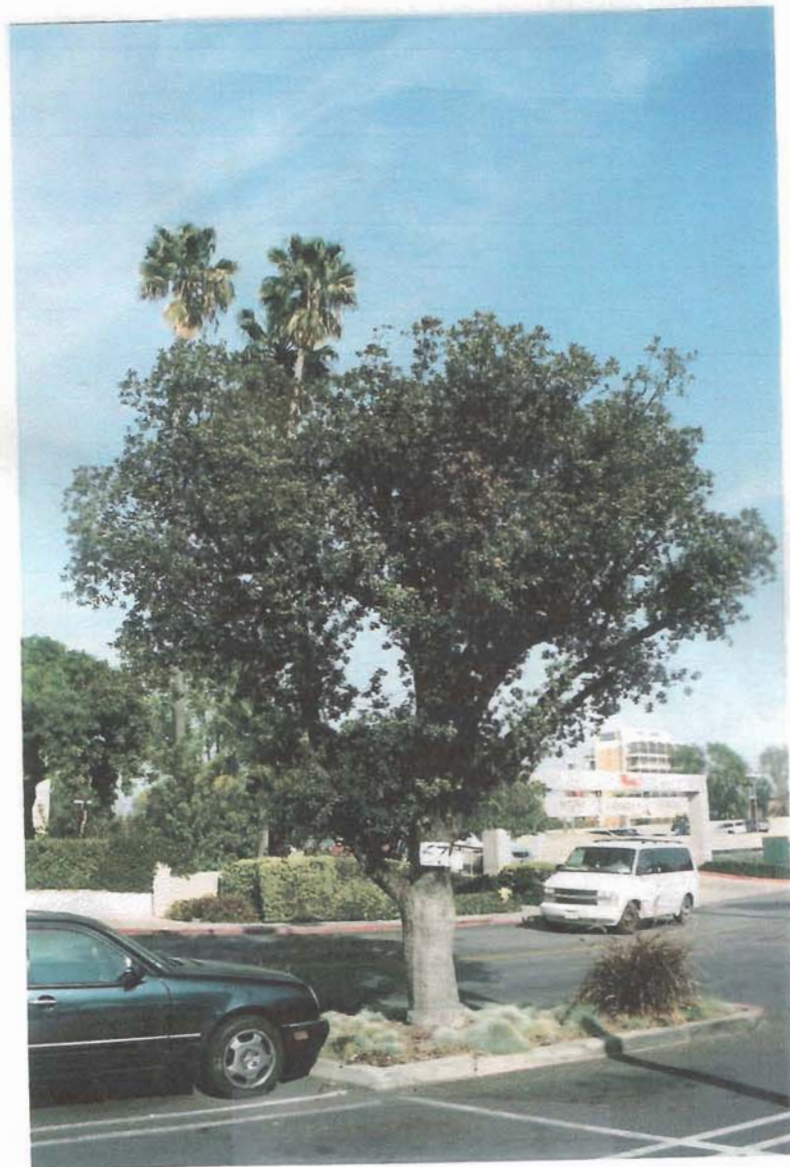
This is a picture of Holly Oak # 67 located in parking lot rear of Macy's.

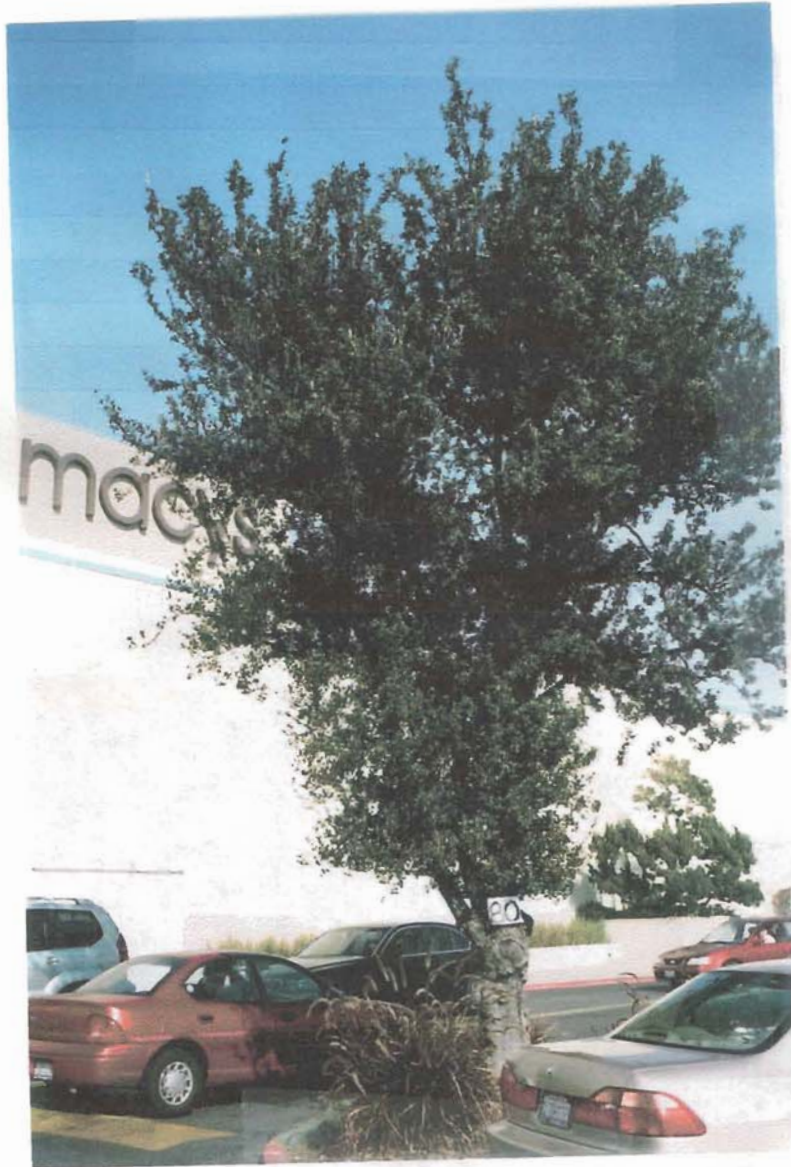
This is a picture of Holly Oak # 80 located in parking lot rear of Macy's.

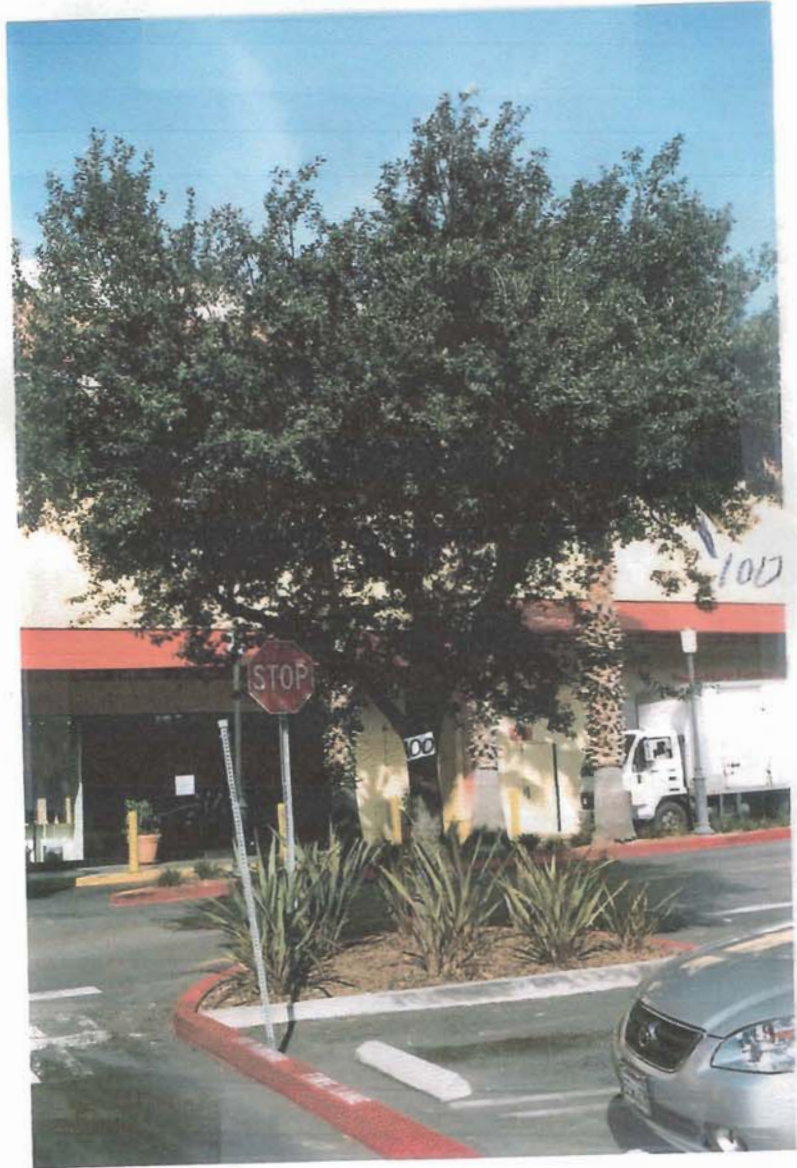
This is a picture of Holly Oak # 100 located in parking lot rear of Macy's.

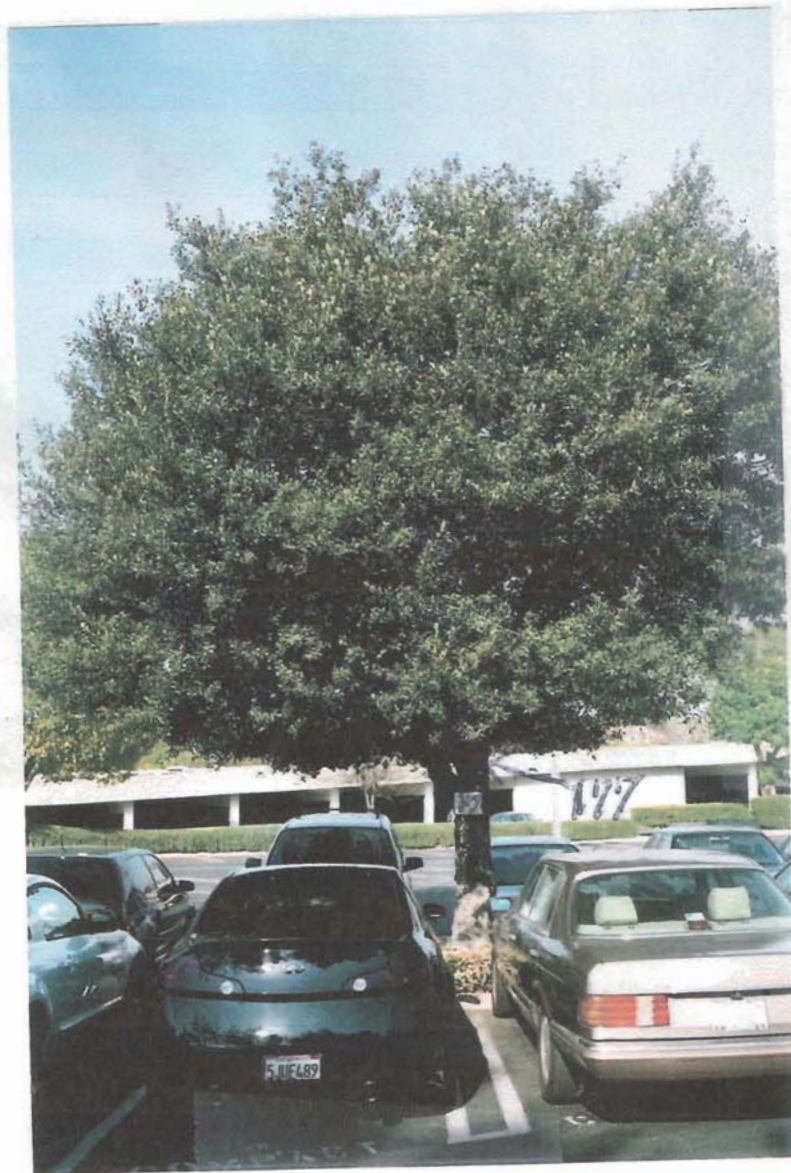
This is a picture of Holly Oak # 177 located in parking lot rear of the parking structure East of Macy's.

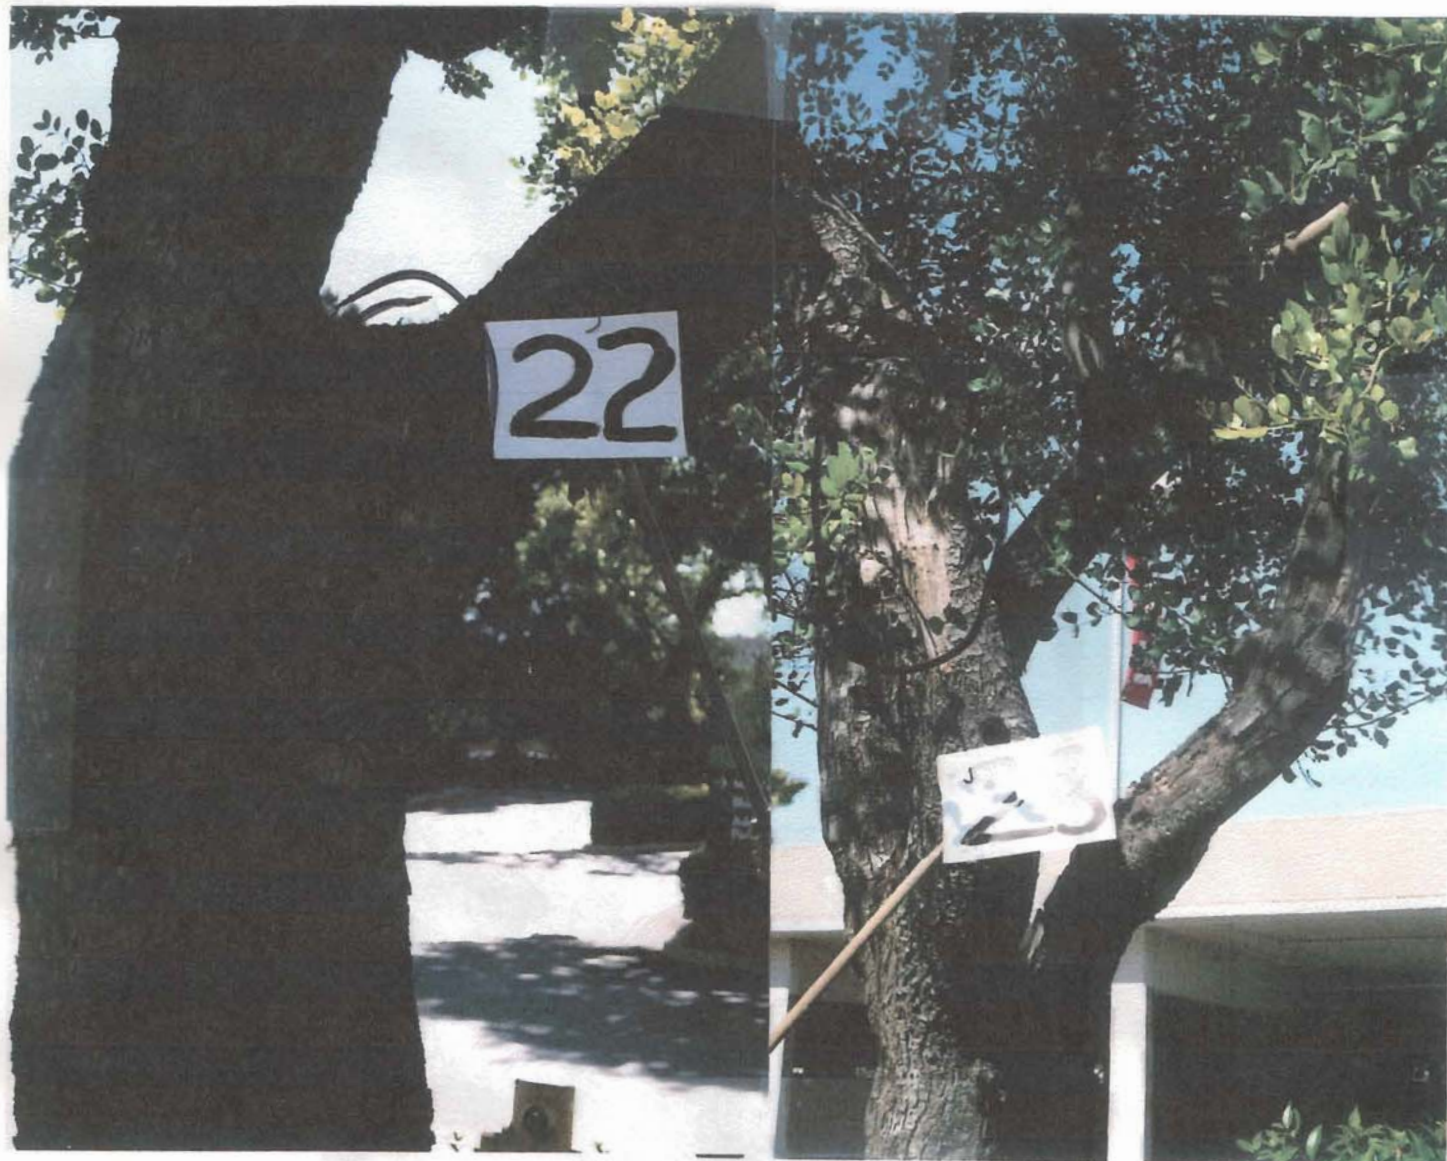
This is a view of wounds from branch failures in tree #22 and #23 these wounds may contribute to failures in the future if these trees are to remain.

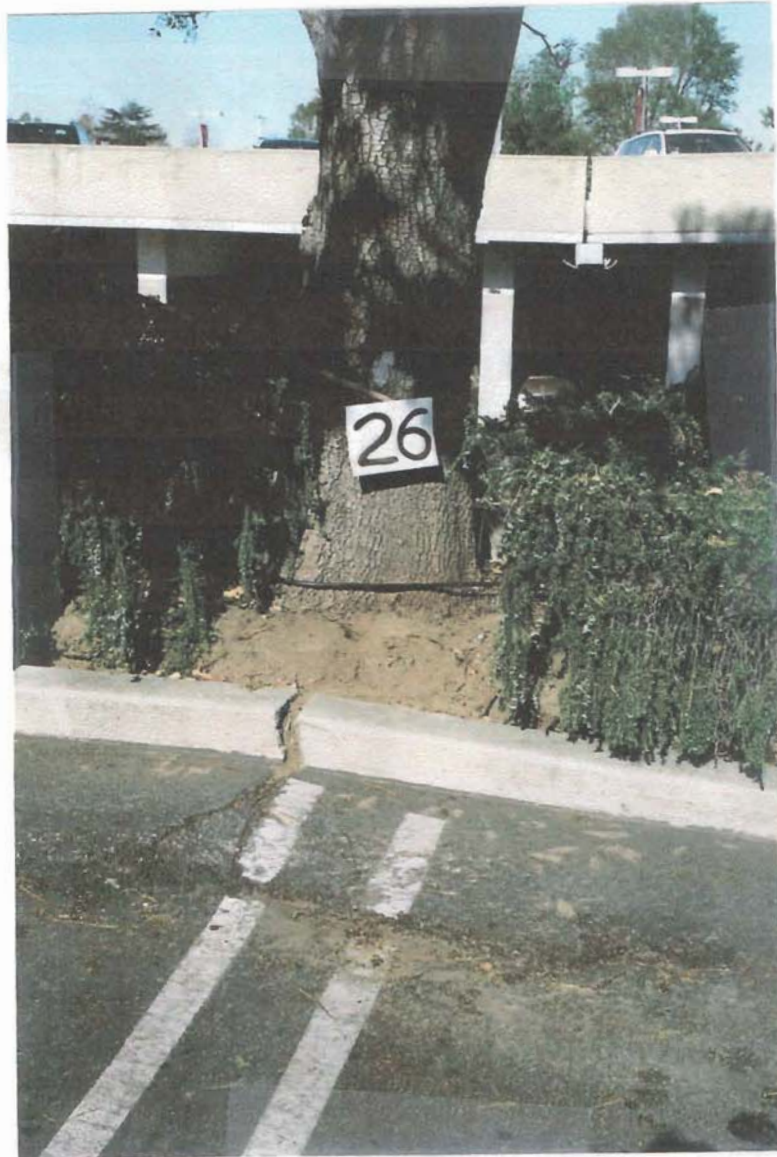
This is a view of the displaced curb and parking surface resulting from the roots of tree #26. This tree should be removed.

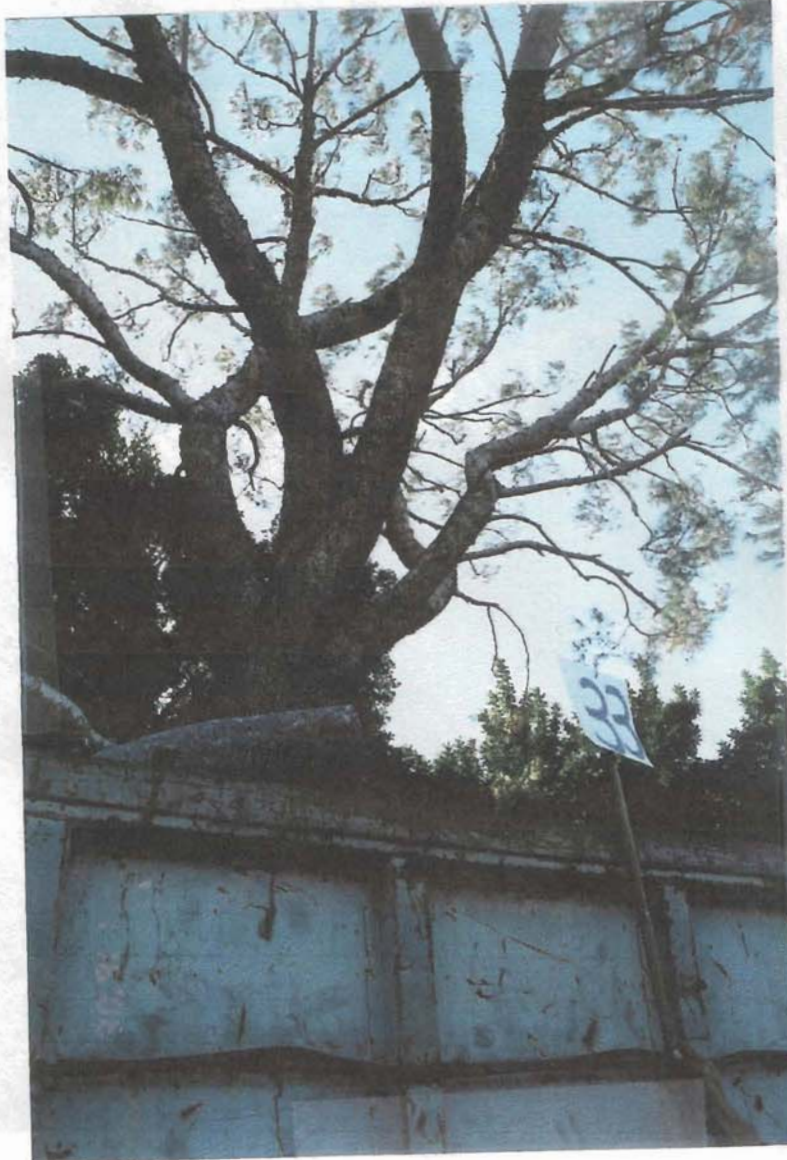
TREE # 33 Aleppo Pine (*Pinus halepensis*) Poor branch attachment may contribute to failures.

Aleppo Pine Tree #33 is a good example of a tree that has been excessively thinned. This places the tree under stress and may contribute to its decline.

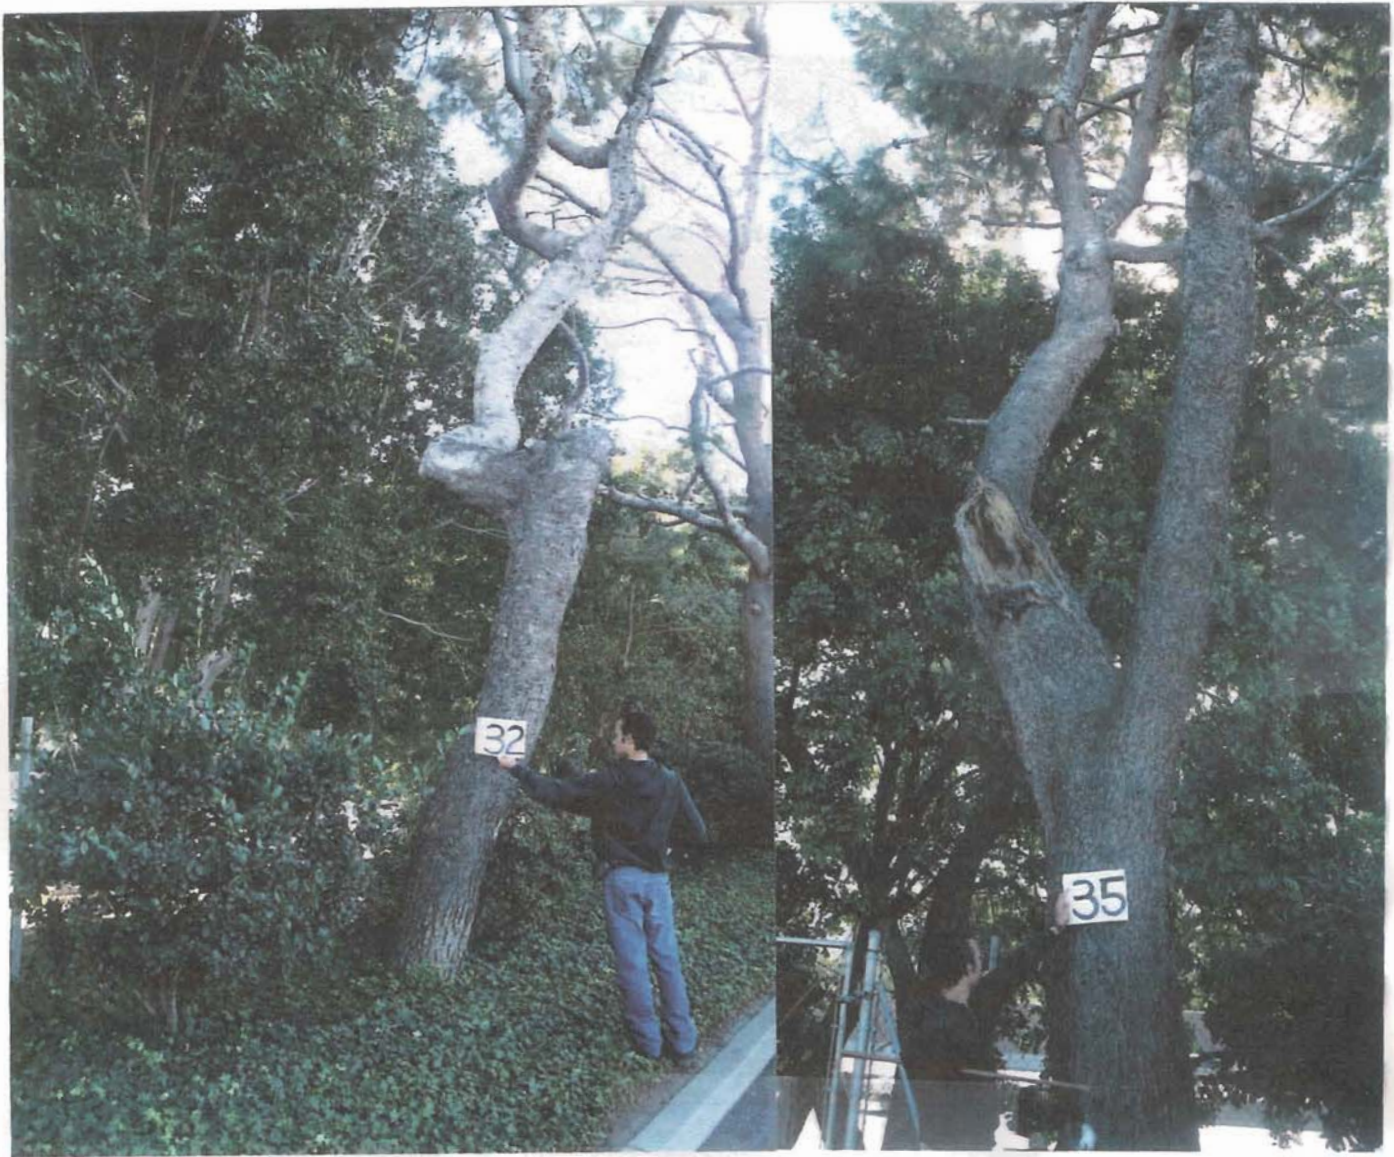
TREE # 32 Aleppo Pine (*Pinus halepensis*) Poor structure may contribute to tree failure.

This is a view of Aleppo Pine Trees #32 and 35. These trees are prone to failure the target area is property and probably humans. I recommend these trees be removed.

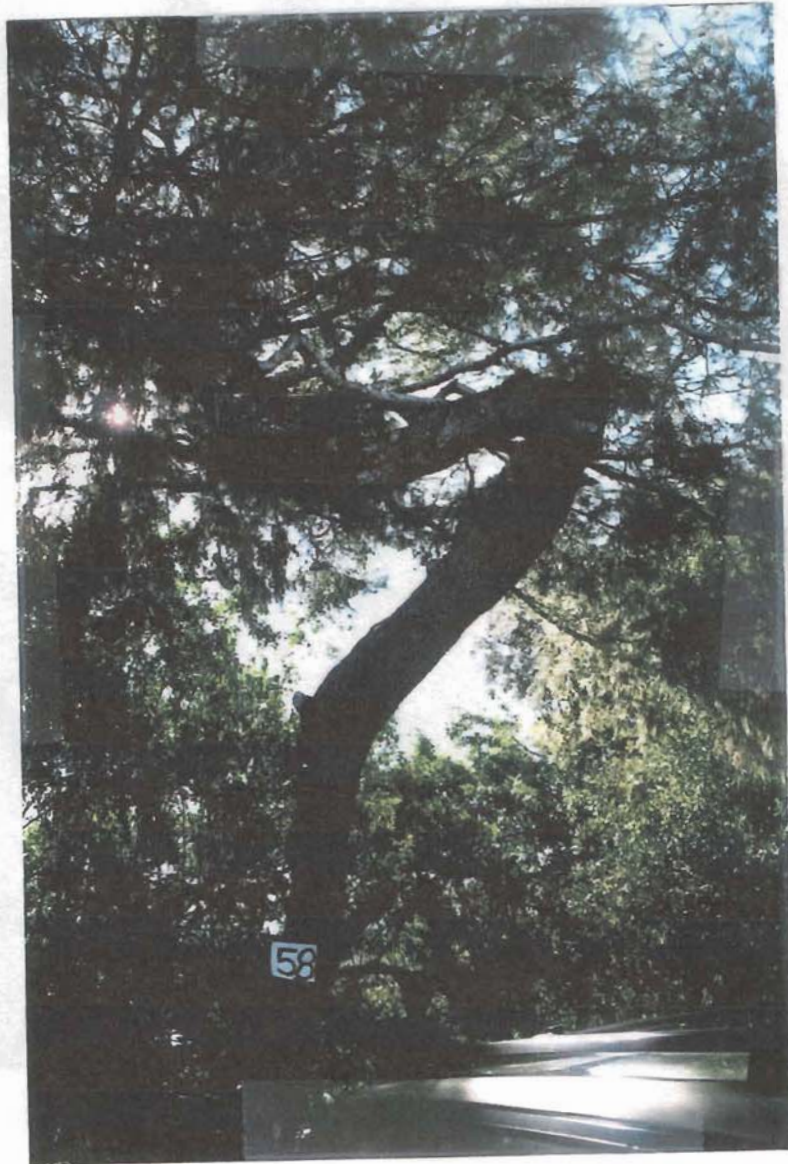
TREE # 58 Aleppo Pine (*Pinus halepensis*) Recommend removal, poor structure prone to failure.

This is a view of Aleppo Pine Tree #58 and its poor structure. This tree is prone to failure. I recommend it be removed immediately. The target if this tree fails is property and probably humans.

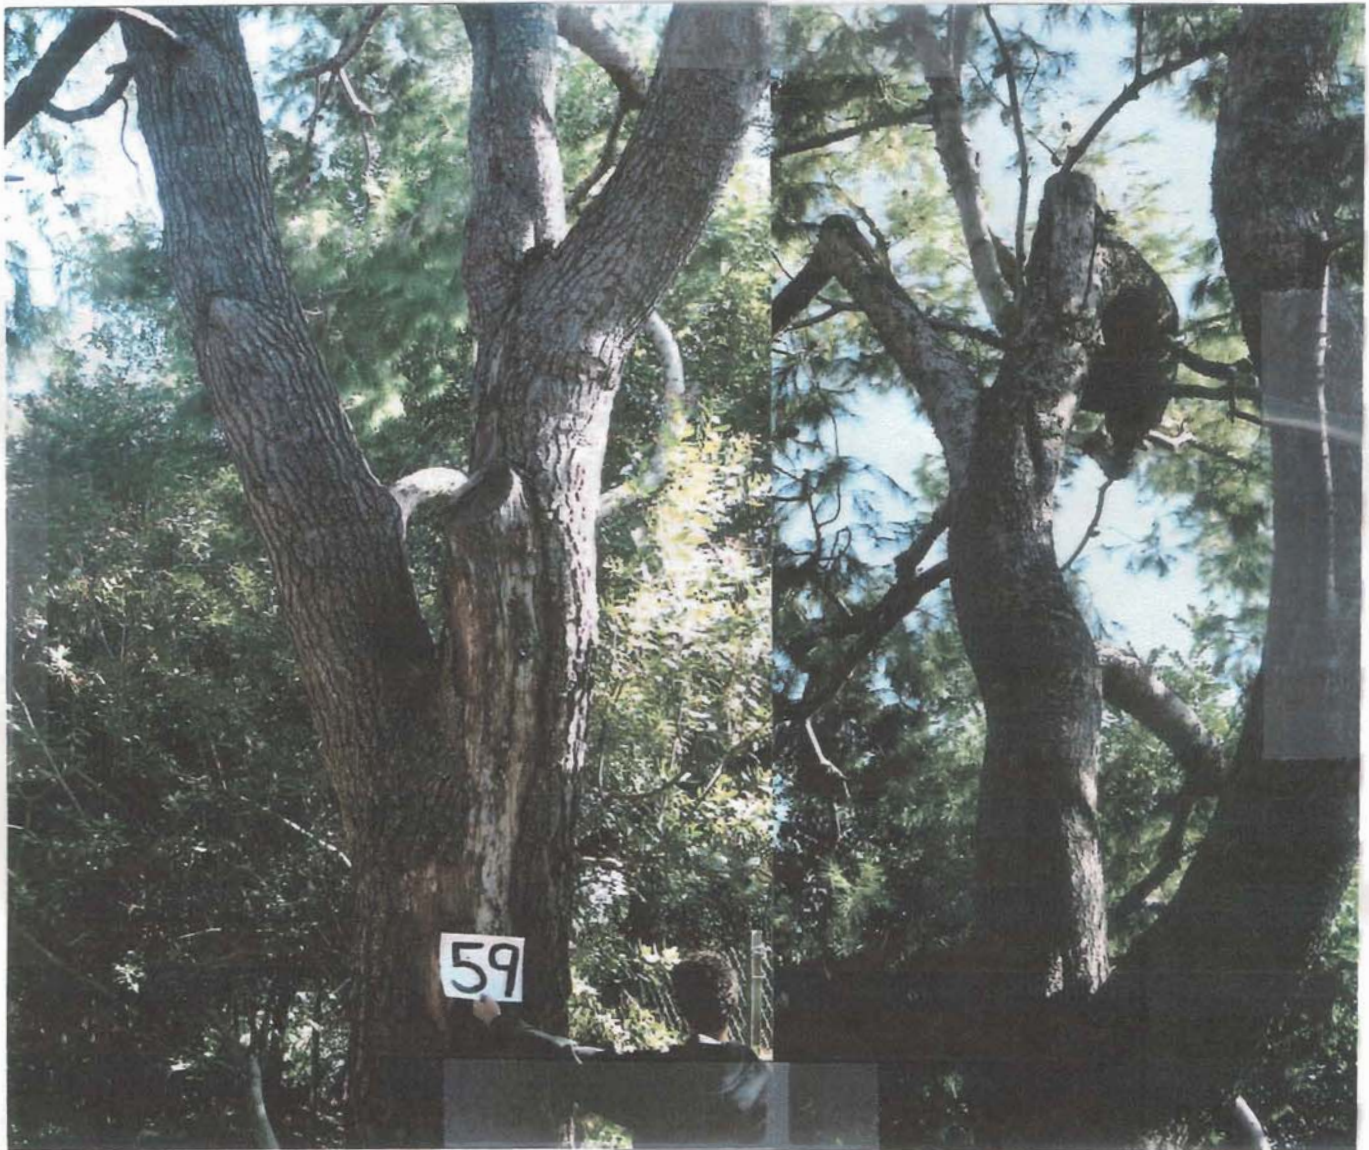
TREE # 59 Aleppo Pine (*Pinus halepensis*) Remove immediately due to decay in trunk, prone to failure.

This is a view of Aleppo Pine Tree #59 and its poor structure. This tree is prone to failure. I recommend it be removed immediately.

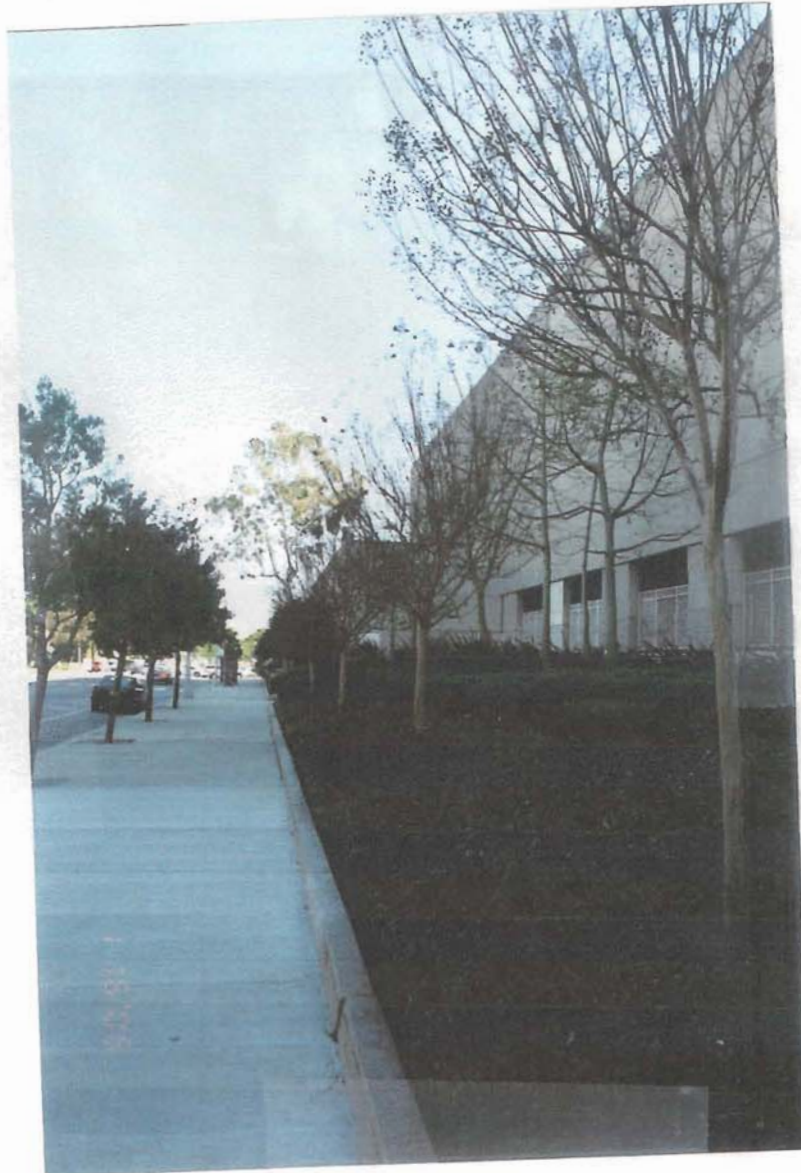
This is a view of the Crape Myrtle trees located in the planter area on the Riverside Drive side of the property. These trees are less than 12" in diameter however they are worth saving and relocating on the property if this area is to be re-landscaped.

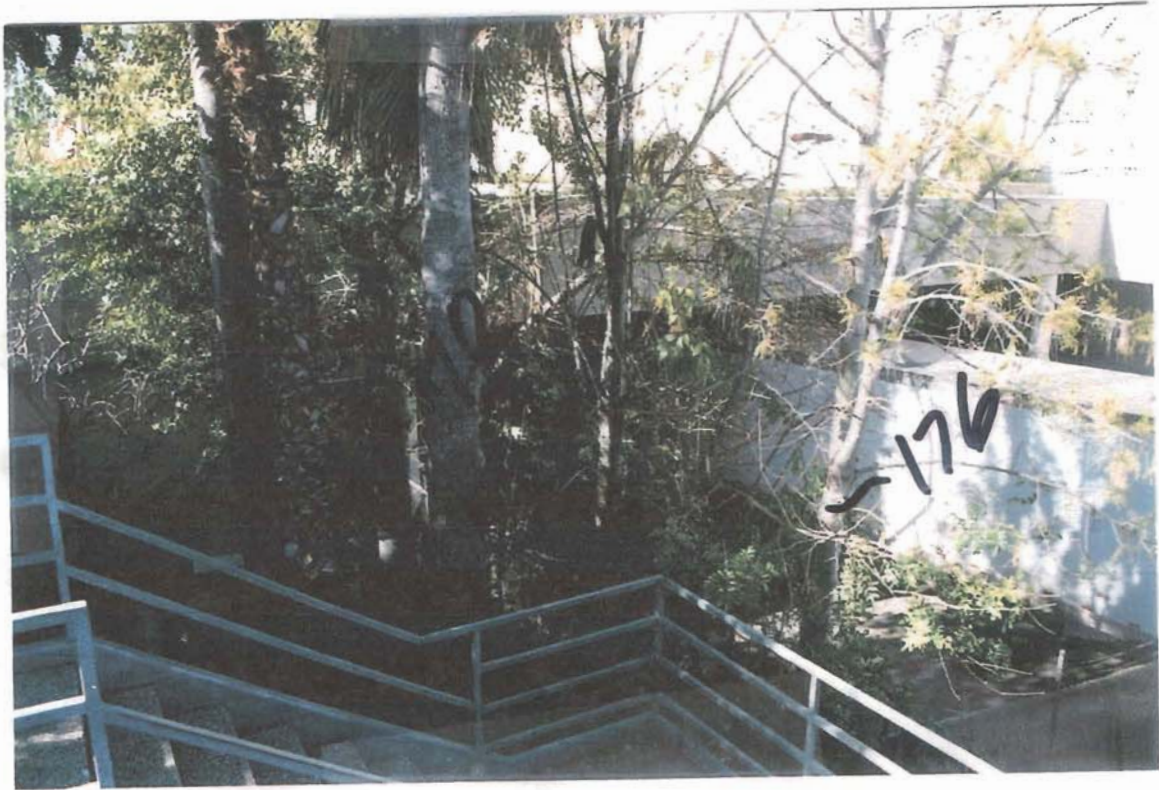
This is a view of tree #70 and 176 located near the stairs going down to the first floor parking area.
