CALIFORNIA GEOLOGICAL SURVEY FAULT EVALUATION REPORT FER 253 SUPPLEMENT NO. 1

THE HOLLYWOOD FAULT in the Hollywood 7.5' Quadrangle

Los Angeles County, California

by Janis L. Hernandez Engineering Geologist November 5, 2014

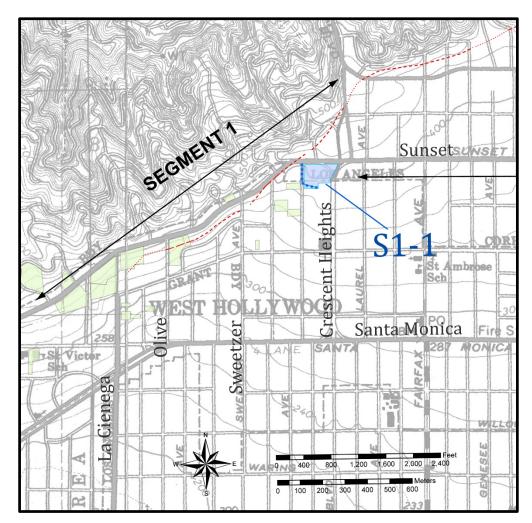
<u>Golder Associates, Inc. (2014a, b)</u> prepared a Surface Fault Rupture Hazard Assessment and Geotechnical Exploration study for a residential and commercial development located on the southwest corner of Sunset Boulevard and Crescent Heights (locality S1-1) as shown on Figure 3. Golder's site evaluation included a CPT transect and hollow stem auger boreholes along the western and southern site boundaries. They interpreted this transect to show continuous alluvial stratigraphy across the site. They reported silts and gravelly sands deposited less than 7 thousand years ago (ka) to depths of about 40 feet. Lower deposits ranged in age from 9 ka to 13 ka at depths of about 60 to 80 feet. They concluded the site has not had major disruption from Holocene faulting.

The data presented by Golder Associates are consistent with the interpretation presented in the initial FER that the Hollywood Fault lies north of this site as shown on the preliminary Alquist-Priolo Earthquake Fault Zone map.

Figure 3 – Study site locality S1-1 indicated in blue shaded area. Boring transect shown as dark blue patterned line. Previous study sites included in the initial FER shown in light green.

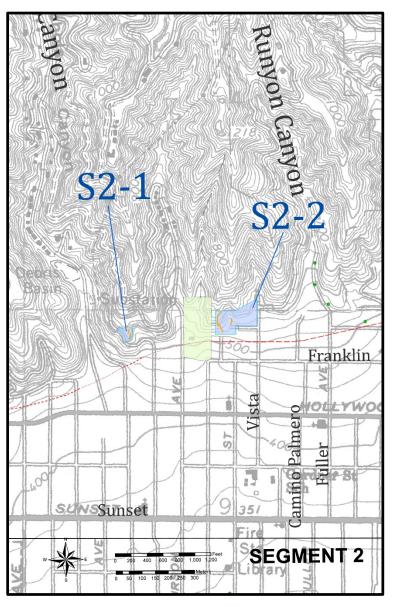
Irvine Geotechnical, Inc. (2014) performed a fault investigation for a residential project located near the base of the Santa Monica Mountains at locality S2-1 (Figure 4). Geologic mapping and shallow trenches were performed as part their study. A geologist for the City of Los Angeles observed the excavation during the study, where un-faulted quartz diorite bedrock was exposed.

<u>Grover Hollingsworth and Associates, Inc. (2014)</u> conducted a fault investigation for a project located along the southern edge of the Santa Monica Mountains, near Runyon Canyon at locality S2-2 (Figure 4). They excavated three fault trenches across the site and observed a thin layer of soil overlying quartz diorite bedrock. Caliche-lined faults were observed in Trenches 1 and 3, but clay gouge and slickensides were not observed in the fault zone. With field review and discussion with the City of Los Angeles geologist, Grover Hollingsworth considered these faults to be pre-Holocene.

The data presented by Irvine Geotechnical and Grover Hollingsworth and Associates for localities S2-1 and S2-2, respectively, is consistent with the interpretation that no Holocene faults cross these sites north of the fault shown on the preliminary Alquist-Priolo Earthquake Fault Zone map.

Figure 4 – Index map showing new localities S2-1 and S2-2. Trench locations indicated as orange line segments. Previous studies included in original FER shaded green.

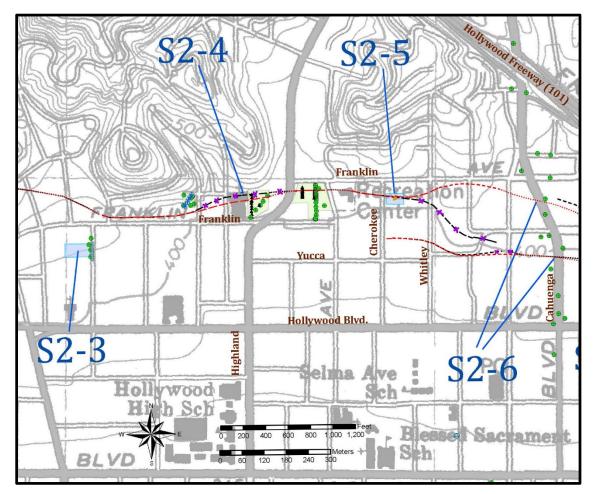
<u>Byer Geotechnical, Inc. (2014)</u> prepared a fault rupture hazard investigation for a site south of Franklin Avenue near La Brea Avenue at locality S2-3 (Figure 5). They utilized continuous core borings and seismic refraction for their study. An age date from bulk AMS C14 samples collected near the base of the young alluvium was reported as 7.1 ka. Bulk samples just below the upper contact of the old alluvium yielded ages of 20.1 ka, and 22.0 ka. Their analysis indicated unbroken stratigraphy underlying the site and they concluded there is no direct evidence for the presence of active faulting at the site.

<u>At locality S2-4 (Figure 5)</u>, (locality 12 in Hernandez and Treiman, 2014), CGS reevaluated the fault strands at this site and compared them to the well-defined and wellconstrained fault data immediately east of this location (Hernandez and Treiman, 2014), locality 13), as well as new data to the east at locality S2-5 (described below). There were several fault strands indicated in investigations at this site, and the re-assessment of the data led us to select a different strand as the dominant trace.

<u>CGS made observations of two fault trenches at locality S2-5</u>, south of Franklin Avenue and N. Cherokee Avenue (Figure 5). Two separate visits were made to this site by J. Treiman (CGS). The southern trench, first visited on December 31, 2013, exposed southeast dipping Topanga Formation siltstone and sandstone, with interbedded or injected volcanics. No faults were observed in this trench at this time. A northern trench, visited on January 15, 2014, revealed a broad fault zone (about 20 to 30-feet wide) within the Topanga Formation. Bedrock to the north and south of the fault zone dipped moderately to the northeast. Within the fault zone, bedding and shears had an east-west strike with steeply north to vertical dips. Shearing increased toward the northern margin of the zone which had a sharp vertical shear and a soil-filled fissure. The north margin of this soil-filled fissure appeared planar, indicating the soil was faulted, rather than just falling into a shaking-related fracture. A visit to a freshly cleaned exposure at the initial southern trench, also on January 15, showed a shallowly north-dipping shear within the bedrock to the graded surface. Soils overlying the bedrock in the northern trench appeared to be very young. To date no report has been submitted by the owner to the City of Los Angeles or CGS.

Our observations confirm the location of the northern strand of the Hollywood fault as presented in the initial FER.

Figure 5 – Localities within Segment 2; S2-3 through S2-6. Red lines indicate mapped fault trace locations for the Official Zone Map. Black fault traces with purple hachures indicate where the fault trace was modified from the preliminary zoned trace. Green and black symbols are boring/CPT locations or transects. Orange lines are trench locations. Light blue shaded areas indicate reports received subsequent to the issuance of the FER.

Based on our re-evaluation of these data, we suggest a modification of the fault trace slightly to the south to project through this preferred trace, connecting the well-located fault to the east with better defined scarps to the west.

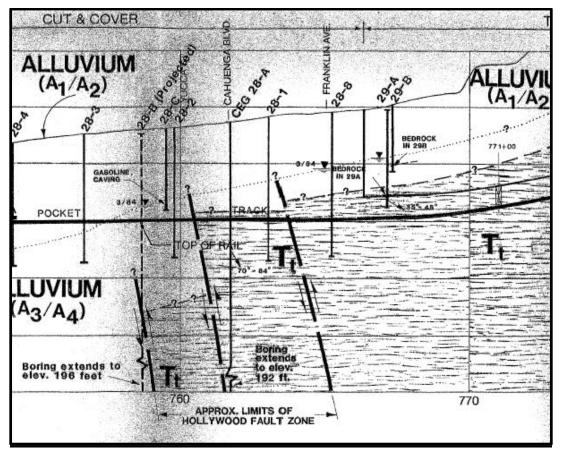
<u>Converse Consultants, Earth Sciences Associates, Geo/Resource Consultants (1984) –</u> <u>locality S2-6 (Figures 5 & 7);</u> CGS acquired a geotechnical report prepared by Converse Consultants et al (1984) for the Metro Rail Red Line Project that was not available for the initial FER (Hernandez and Treiman, 2014). The initial FER relied on data from Converse Consultants et al, (1981, 1983) and Crook and Proctor (1992), and, although the borehole data from the 1984 report were described by Crook and Proctor (1992), the original borehole logs were not in the 1981 and 1983 reports that they reference.

The data presented by Converse Consultants et al (1984), specifically a cross section (Figure 6 herein) and boring logs, combined with observations of the fault at locality S2-5, support an eastward continuation of the northern fault trace, rather than the southeast trending orientation shown in the initial FER (that was based on Dolan et al., 1997)(Figure 7). We find the stratigraphy within the MTA boreholes reveals lateral discontinuities within the upper alluvial soils above the principal fault strands, in addition to offset bedrock as illustrated in the cross-section (Figure 6). The Converse Consultants data also supports the location of the southern trace of the fault where it crosses Cahuenga Boulevard as shown on the preliminary Alquist-Priolo Earthquake Fault Zone map. Additionally, the cross section shows a third fault that projects toward the ground surface at Yucca Street, roughly between the northern and southern strands (Figure 6). Due to uncertainty as to how the various strands of this complex fault zone connect to the east and west we are only depicting the northern and southern fault traces on the Official Zone map.

Figure 6 - Cross section from the Metro Red Line subway project. Portion of figure from Converse et al, 1984.

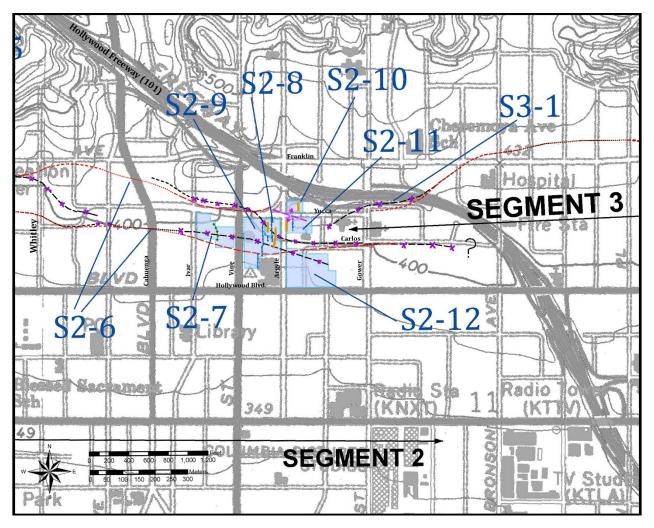
<u>A comment was submitted by Mr. David Waite of Cox Castle Nicholson, LLP</u> on April 8, 2014 to the SMGB (Comment # 10, Table 1), with reference to localities S2-7 and S2-9 (Figure 7) and included a request to extend the public comment period. He referenced ongoing studies in the vicinity of Yucca Street and Argyle Avenue, and requested that this information be considered prior to issuance of the final map. Mr. Waite specifically mentions the Hollywood Millennium project, and a fault study for this project that was performed by Langan Engineering (2012). He also states that conclusions from this site-specific data were not relied upon by CGS in preparation of the fault map. Further, he concludes that the lack of evidence of a fault traversing the Millennium project does not represent a "sufficiently active, and well-defined fault." They suggest that the map should "simply delineate supportable fault zones in which individual properties would undertake subsurface investigations, as it is fault zones which signal to localities and other constituencies that additional investigation is required." Mr. Waite also states that additional subsurface data will be submitted to the City of Los Angeles and the State Geologist in the coming weeks and months so it could be considered in preparation of the final map.

CGS was invited to most of the sites referred to by Mr. Waite, where we performed limited review of trenches in the Yucca and Argyle area. Regarding our initial review of data and preparation of the initial FER, data from the Langan Engineering report for the Hollywood Millennium project was considered. However, our analysis of the subsurface correlation between borings and review of the C14 data arrived at different conclusions. Our review of the Langan (2012b) borings showed a major discontinuity between borings B-1 and B-5. This subsurface discontinuity is the boundary between gently southdipping alluvial fan deposits to the north and fine-grained clayey deposits to the south. We interpret that this abrupt contrast in lithology indicates the presence of a fault. Regarding the statement that additional data will be submitted for this project, CGS has received no additional data for the site west of Vine Street at the time of this supplemental report, and only limited data for the site east of Vine Street.

Figure 7 - Site index of the eastern portion of Segment 2, featuring localities S2-6 through S2-12. Areas shaded in blue include new reports submitted after the initial FER was prepared. Red fault traces indicate revised map traces. Black fault traces with purple X indicate modified areas from Preliminary EFZ map. Blue patterned line indicates boring/CPT transect, gold lines indicate fault trench locations. Magenta line at Site S2-10-11 is approximate anticline axis based on new reports by GDC (2014c)

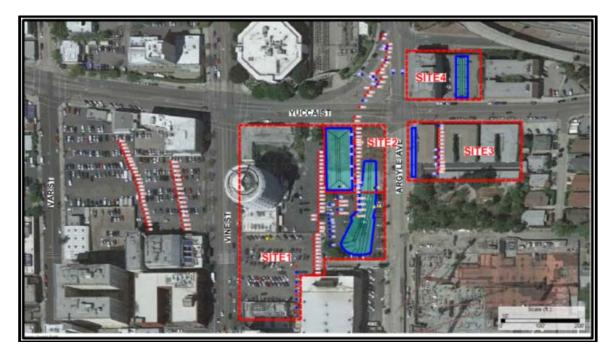
Fault studies for localities S2-8 through S2-11 were conducted by Group Delta Consultants, Inc. (GDC) over the timespan between about February and July, 2014. CGS was provided the opportunity to perform periodic trench review of some of the trenches for these sites, however some limitations were implemented, either based on site conditions, property owners restrictions, or other reasons. A table summarizing CGS site visits in this area is provided in Appendix B of this supplemental report.

Figure 8 – Group Delta Consultants, Inc. numbered site investigations in the Yucca/Argyle area of Hollywood. Figure modified from Group Delta's submittal to the State Mining and Geology Board on August 14, 2014. Only data for Sites 2 and 3, and the CPT line for Site 1 were submitted to CGS in time for consideration in this Supplemental FER.

<u>A comment was submitted by Mr. Michael Reader of Group Delta Consultants,</u> <u>Inc. (GDC) on March 13, 2014 to the SMGB for locality S2-8 (GDC Site 2, Figure 8).</u> Mr. Reader stated that although there are mapped locations where the Hollywood Fault is somewhat well-defined, in the area between Cahuenga Boulevard and Gower Street the Hollywood Fault is concealed by alluvial fans, and that no data in this area have located the active trace. He also reported that the geologic community agrees the active trace of the Hollywood Fault lies "somewhere" in this area. However, he questioned the delineation of the zone for this area, with such sparse available data.

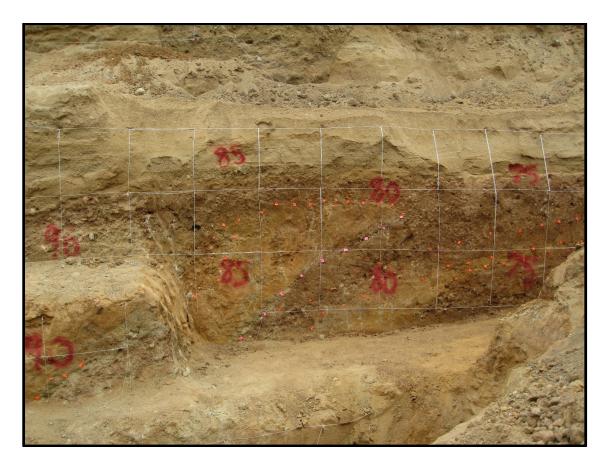
CGS viewed several stages of the eastern trench investigation that was placed to potentially expose faulting that may project onto GDC Sites 1 and 2 from GDC Site 3 (to the east). Faulting was observed in this east trench at approximately 80 feet from the northern trench end, placing this fault at about the same location and orientation as the trace mapped by CGS in the Preliminary EFZ map. Further observations of this fault during June and July, 2014, revealed that age of faulting appeared to be constrained by an overlying, unfaulted mudflow deposit and paleosol, estimated to be about 30 ka by R. Shlemon (GDC, 2014c). The soil structure within the soil that overlies the fault does not exhibit rotation of pedogenic faces and appears undisturbed by movement along this particular fault trace. Two older faults, below and cut by this fault, were also observed in the tilted fan deposits but were not logged by GDC.

Figure 9 - View looking west at south dipping pre-Holocene bedding plane fault with a possible reverse sense of displacement in GDC's east trench. This trench was excavated across the southeastern portion of Site 2, and extends into Site 1; fault noted by pink flagging in the center of the photo. The upward termination of this fault, located right of Station 80 (about station 77), is within a fissure fill, which upon close inspection, is overlain by a mudflow deposit and soil, reported to be about 30 ka. In this photo, the Pleistocene age older alluvium (debris flow deposits) are overlain by a thin mudflow deposit, overlain by sands of the Argyle Channel.

Based on this new trench data, as well as other data, we have relocated the northern fault strand to project along Yucca Street toward the north. The southern fault strand is also modified in this area based on data from locality S2-9 (GDC Site 1), described below.

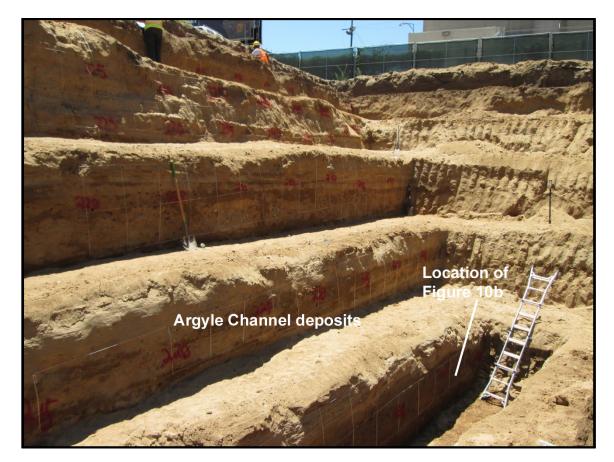
CGS was invited to the site for periodic trench review between June 30, 2014 and July 11, 2014, where we observed unbroken Argyle Channel deposits overlying an older unbroken unit that was tentatively correlated by GDC staff to mudflow deposits observed to the north. In the northern portion of Site 1 near the boundary with Site 2, the late-Pleistocene mudflow unit appears to be draped over the underlying folded debris flow units, and what may be the same unit appears near-horizontal as it extends to the southern end of the trench (Figure 10a). We received no logs of this part of the trench to clarify these relationships. Figures 10a, 10b show the stratigraphy in the south end of the trench. Our review of the CPT data for this site, and some earlier core borings (from GDC Site2) indicates a discontinuous south-dipping Quaternary stratigraphic section, with a prominent stratigraphic break toward the southern end of the property indicative of a fault. The orientation of this break appears to be north-dipping, projects upward toward the ground surface near the southern property boundary (south of the trench exposure), is in alignment with the fault scarp located north of Carlos Avenue immediately to the east, and is in alignment with an inferred fault trace from the Langan data west of Vine Street (locality S2-7) to the west. On the basis of these observations, the southern trace of the Hollywood Fault has been moved to the southern boundary of locality S2-9, just south of the trench exposure.

Figure 10a – View looking southeast at the southern trench portion of the long eastern trench that extended from GDC Site 2 into Site 1. Trench reveals unbroken Argyle Channel deposits extend in depth possibly to about the upper string line at the lowest bench, just left of the ladder. A bioturbated layer and thin gravel bed of uncertain age below the bottom string line below the lowest bench also appears unbroken (see Figure10b below).

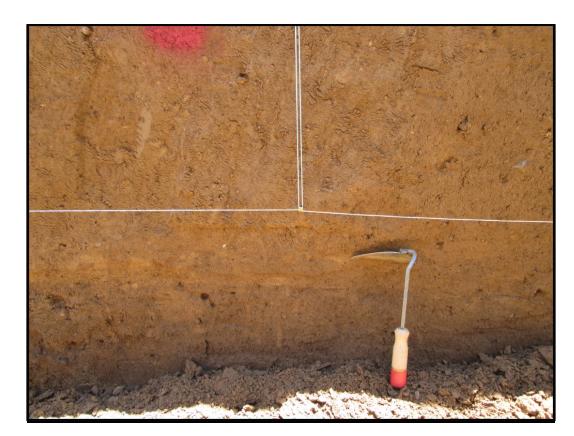
Figure 10b – View looking at east wall at about station 235, of east trench, GDC Site 1. Close-up of poorly sorted fine-grained deposits that underlie Argyle Channel deposits. Contact with a darker, bioturbated layer is near the base of the trench, just below the blade on the scraper tool. Where exposed, unit appears continuous and unbroken through the southern end of trench bottom. Total length of trench at base is approximately 240 feet extending across GDC Site 2 toward the southern boundary of Site 1. Bottom of southern trench end is approximately 45 feet north of the southern property line.

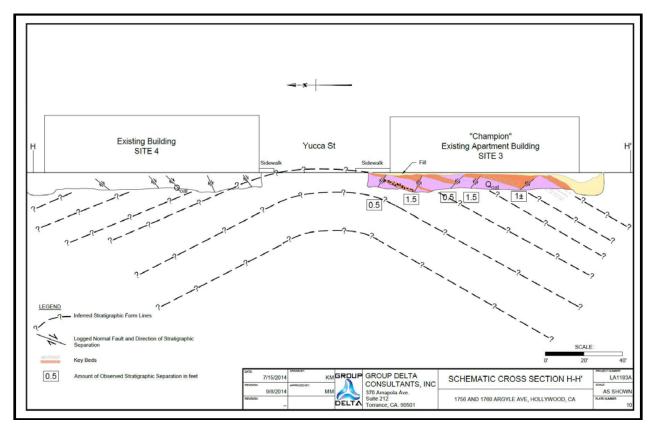
<u>At locality S2-11, (GDC Site 3, Figure 8)</u>, Group Delta (2014c) reported the site is underlain by fill materials and older alluvial debris flows, which in turn are underlain by Modelo Formation. Their site investigation included both CPT and core borings, and an approximate 8foot deep trench on the west side of the site. GDC reported the older alluvial unit consists of Pleistocene debris flows, and state that this unit is faulted. They associated this fault with a localized west-northwest oriented anticline, which extends north to GDC Site 4, as shown in their cross-section (Figure 11). They interpret these features to be due to regional transpression and not to seismogenic faults. They report the age of the faulting at this site is older than 35 ka based on unbroken mudflow deposits found to the west at Site 2.

Figure 11 – Cross-section from GDC Site 3 showing anticlinal folding of Pleistocene debris flow deposits, inferred stratigraphic form lines and faults that offset this unit. Numbered annotation at each fault reflects GDC's observed stratigraphic separation at each location. Figure from GDC, 2014c.

The data presented in the GDC report is consistent with the interpretation that the deposits are of Pleistocene age although it is unclear why these "debris flow" deposits are differentiated from the similarly comprised and deformed older alluvial fan unit exposed and described at site 2.

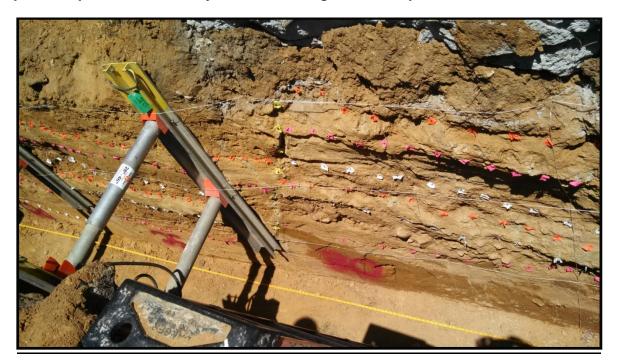
Interpretation that the faults are local bending moment faults is not consistent with CGS field observations within the trench. CGS noted a significant lack of correlation across the southernmost fault, and that thickness of units changed across most of the faults, which indicates a component of lateral displacement (Figure 12). The southernmost fault appeared to be a prominent fault, as correlative units across the fault were not found, suggesting this fault trace may have seen the most displacement. No evidence for, or against, Holocene faulting was reported on this site because Holocene deposits, if present, were likely removed during site development.

Figure 12 – At GDC Site 3, locality S2-11, view looking easterly at faulted Pleistocene alluvial fan deposits, yellow flag indicates fault to right of shoring near the center of the photo. Gray zone at the top of the photo is concrete. Bedding gently dipping to the south (right), with steepness increasing to the south. Of the 7 faults CGS observed, most faults indicated a difference in unit thickness across fault. The southernmost fault did not have any correlative units across the fault.

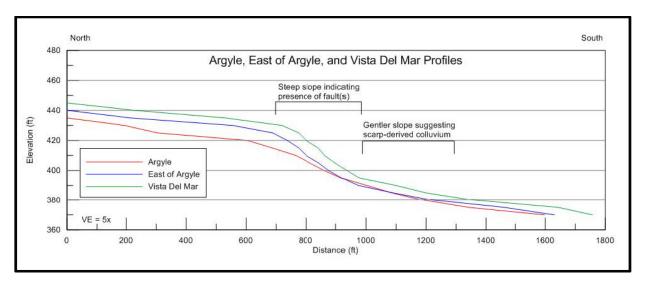
<u>A comment was submitted by Lettis Consultants International, Inc. (LCI), accompanied</u> <u>by a transmittal letter by Elkins Kalt Weintraub Reuban Gartside, LLP</u> on April 8, 2014 to the SMGB to specifically address the BLVD 6200 property located at 6201 Hollywood Boulevard in Hollywood (locality S2-12, Figure 7). In their report, they present data and analysis of the site and vicinity, with additional focus on the southern, discontinuous trace of the Hollywood Fault that is mapped on the Preliminary EFZ map to underlie the site. LCI presented detailed topographic profile analyses consisting of 3 sets of data including: review of historical 6-minute topographic maps, high-resolution lidar imagery, and high resolution ground survey topographic profiles along 8 closely-spaced, north-south oriented streets. These profiles were located within the streets adjacent to the BLVD 6200 site and along other nearby profile lines. They identified breaks in slope within the profiles of these transects, and included locations of scarps previously mapped by Dolan et al. (1997), the projection of fault traces mapped by CGS in FER 253, and the BLVD 6200 project boundary. LCI stated that in addition to the prominent break in slope located immediately north of their site, a subtle break in slope is expressed across the southern portion of the site. They reported this southern slope break is located south of the southern discontinuous fault trace mapped by CGS. They suggest that subtle breaks in slope can be related to several factors: change in slope direction on the ground surface, or thickness and directional changes within the alluvial fan system. Their analysis noted that the subtle slope break is coincident with an east-west trending apparent scarp mapped by Hill et al. (1979), and a possible fault scarp mapped by Weber et al. (1980). In their review of the 1926 topographic maps, they indicated that Argyle Avenue did not yet exist at this location, and that possibly the subtle break in slope observed in the street may have been created during subsequent construction of Argyle. Alternatively, they concluded that this subtle break in slope reflected in the composite topographic profiles (Figure 13), is most likely related to scarp-derived colluvium from the steep break in slope to the north.

Figure 13 – Topographic profiles constructed from 1926 historical topographic maps, located within and adjacent to the BLVD 6200 project. These profiles prepared by LCI, indicate steep portions of scarps suggest they were created by fault movement, whereas gentle slopes suggest formation by down-slope movement of scarp-derived colluvium. Modified from LCI, 2014.

Summarizing earlier work, LCI reported that construction observations made by Geotechnologies, Inc. (2013) during the nearly 50-foot deep excavation for the BLVD 6200 project revealed no faulting or folding of units was observed during cleaning and installation of lagging of the sidewalls, prior to building construction. Regarding a steep groundwater difference underlying the northern portion of the site, LCI suggests that more detailed, closely spaced data is required to determine if the groundwater step is produced by a fault, or other barrier in the subsurface.

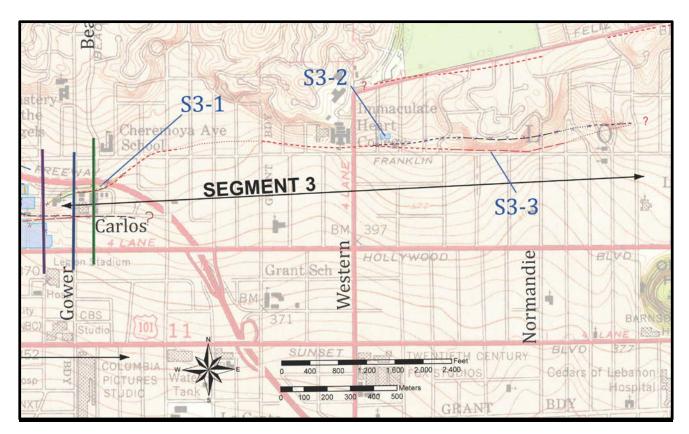
<u>As described above, LCI (2014)</u> prepared several topographic profiles along north trending streets in the vicinity Yucca Street and Argyle Avenue, which included portions of both Segments 2 and 3. Their analysis included identification of breaks in slope in the area of locality S3-1 (Figure 14). LCI inferred these features were attributed to either: tectonic fault scarps (steep breaks), or alluvial fan or colluvial deposits eroding off the fault scarps (subtle breaks).

The data presented in the LCI report is helpful for reviewing the magnitude of breaks in slope as they trend from west to east across this portion of Hollywood. As a result, the western portion of the fault trace along Segment 3 appeared to be mapped a few feet north of the base of a subtle break slope, as indicated in the LCI profiles. We have modified the fault trace closer to the base of the slope break as shown in Figure 14. This modification has no effect on the EFZ boundary at this location.

Figure 14 – Localities within Segment 3. North-south lines near Gower are elevation survey transect locations by LCI. At locality S3-1, the red fault trace indicates the revised fault trace location based on breaks in slope identified within the LCI surveys. Purple cross hatch on the black fault trace indicates location of fault trace as reported in the FER. Locality S3-2 is the Bay City Geology study site. Locality S3-3 indicates the modified fault trace (in red) based on revised interpretation of the scarp utilizing the 1926 topographic base map as described in the text.

Bay City Geology, Inc. (2014) performed an investigation for a site located within the Preliminary EFZ at locality S3-2 (Figure 14). Three large diameter borings were drilled, revealing a thin layer of older alluvium, underlain by weathered Topanga Formation siltstone and sandstone, grading to less weathered bedrock at about 21 feet bgs. Bedding planes in Topanga measured in the borings had northwest strikes, with dips to the southwest. Bay City stated that similar geologic units were encountered in all of the borings at similar depths, where they indicated this was positive evidence for continuous, unfaulted geologic units across the site. From these data, they inferred the Hollywood fault is located south of the site.

As a result of this minor adjustment, the EFZ boundary has shifted slightly to the south.

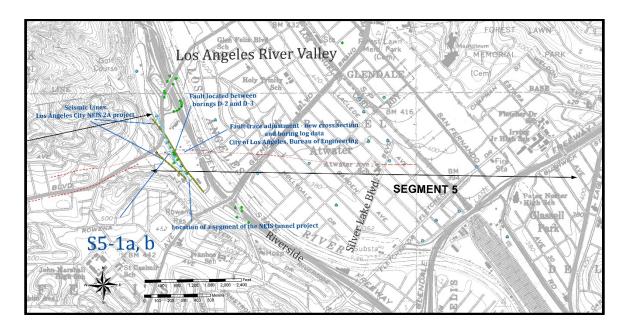
Patrick Schmidt, and Fred Burnett, (2014): Mr. Schmidt and Mr. Burnett of the City of Los Angeles Bureau of Engineering (BOE) provided CGS a technical paper they prepared in February, 2014 that was submitted to the Underground Construction Association's North American Tunneling Conference (NAT). In this paper, they discussed some of the exploratory methods implemented during the Northeast Interceptor Sewer project (NEIS), including: borings with down-hole geophysics, packer and pressuremeter testing, CPT testing, Remi surveys and surface geophysics lines. They reported some of the difficult conditions they anticipate encountering during tunneling along the fault zone, including: squeezing and running ground conditions, high methane gas concentrations, and up to 5 bars of water pressure. They reported the main Hollywood Fault was located between exploratory borings M08-B4 and M08-B5, where interpolation of the geophysical surface survey data identified two north dipping fault planes with three south-dipping secondary faults in the hanging wall that merge at depth.

This technical paper describes conditions the City of Los Angeles BOE will encounter during tunnel excavation operations. No additional details regarding active faulting either outside or within the tunnel alignment were noted. However, their description of difficult tunneling conditions keys into the general width and local structure of the fault zone along the west bank of the Los Angeles River Valley.

Figure 15 - Localities S5-1a, b show where additional information was received from the City of Los Angeles, Bureau of Engineering Department for the NEIS 2A project. Figure shows adjusted location of the Hollywood Fault trace, based on these new boring logs, cross section, and consideration of comments received from D. Perry. Red lines are final fault trace, purple cross hatch on black fault trace indicates location of fault trace as reported in the FER. Light blue line represents a segment of the NEIS tunnel alignment. Yellow lines indicate seismic profile transects. Green and blue symbols along the alignment represent core borings and monitoring wells, respectively.

<u>City of Los Angeles (2013)</u> conducted an additional fault study that included 3 borings that were drilled during April - May 2013 for the NEIS 2A sewer project. These borings were drilled to further define the limits of the deep older alluvium associated with the active trace of the Hollywood Fault at locality S5-1b. The borings also helped to define the artesian groundwater pressures, depth of bedrock, and methane concentrations they will likely encounter during tunneling operations.
