Consulting Arborist's Report
December 2, 2013

Tree Evaluation and Preservation Study

MGA, Chatsworth

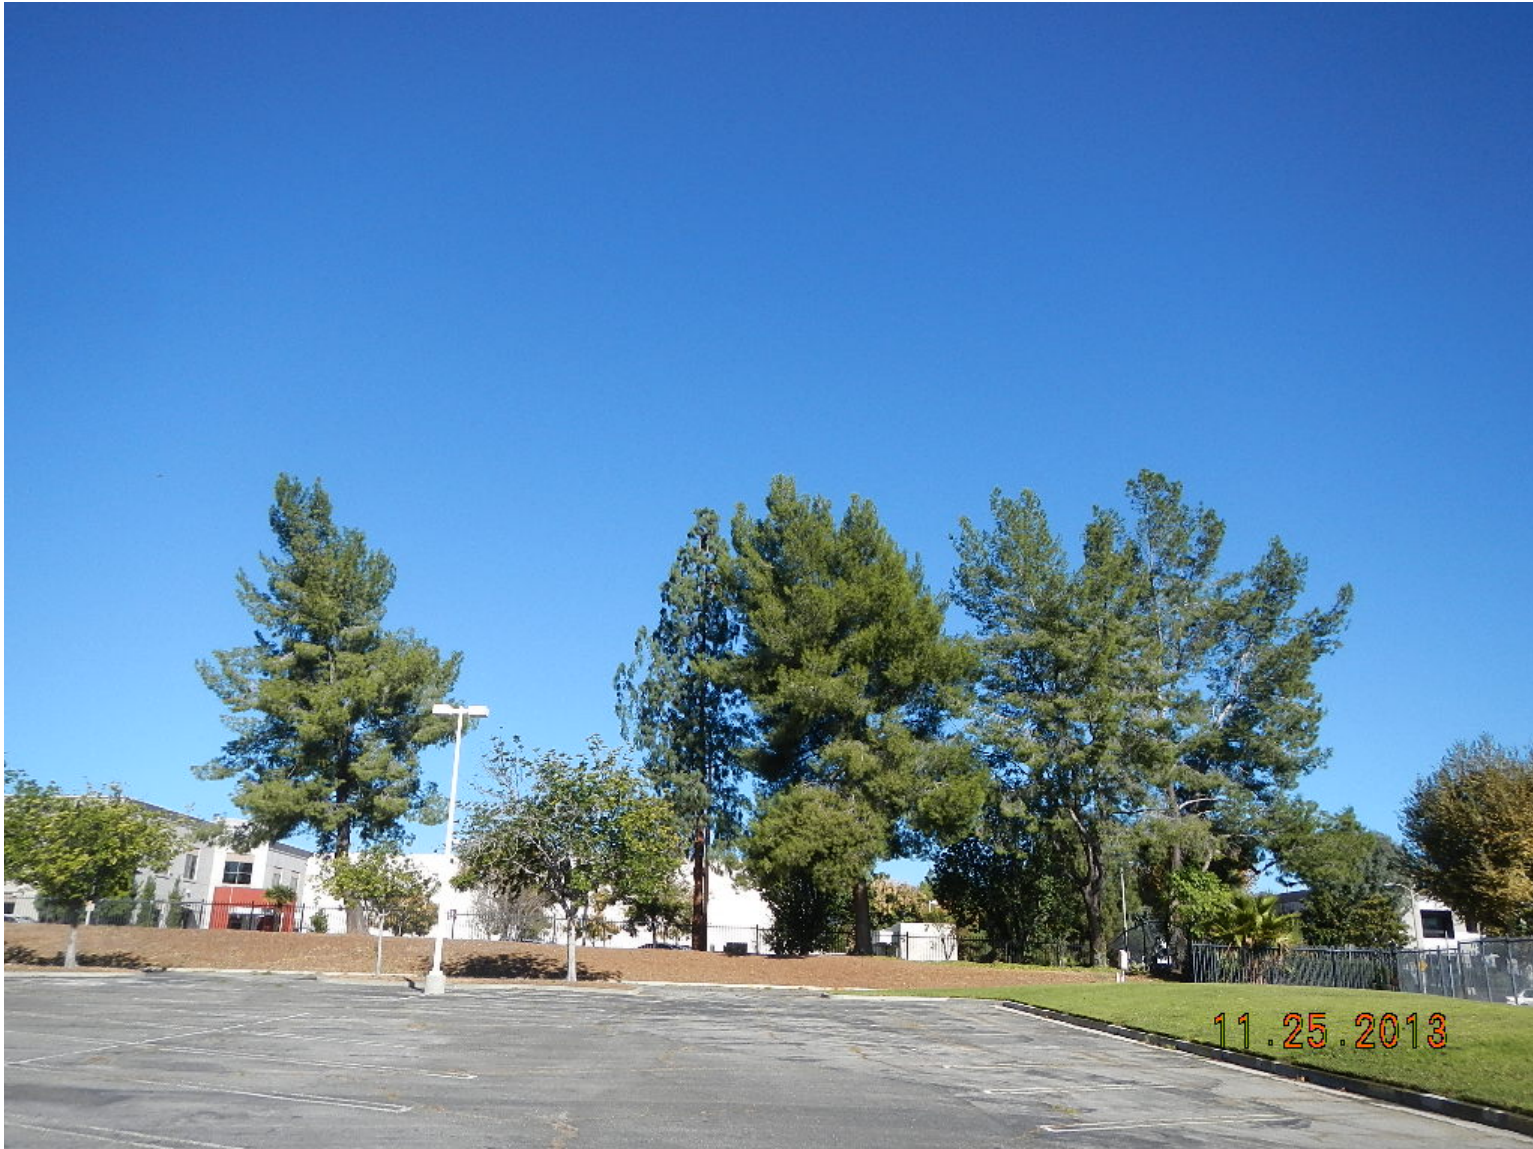
The northeast corner of the site. Note the sparse carrotwoods and tall Aleppo pines.

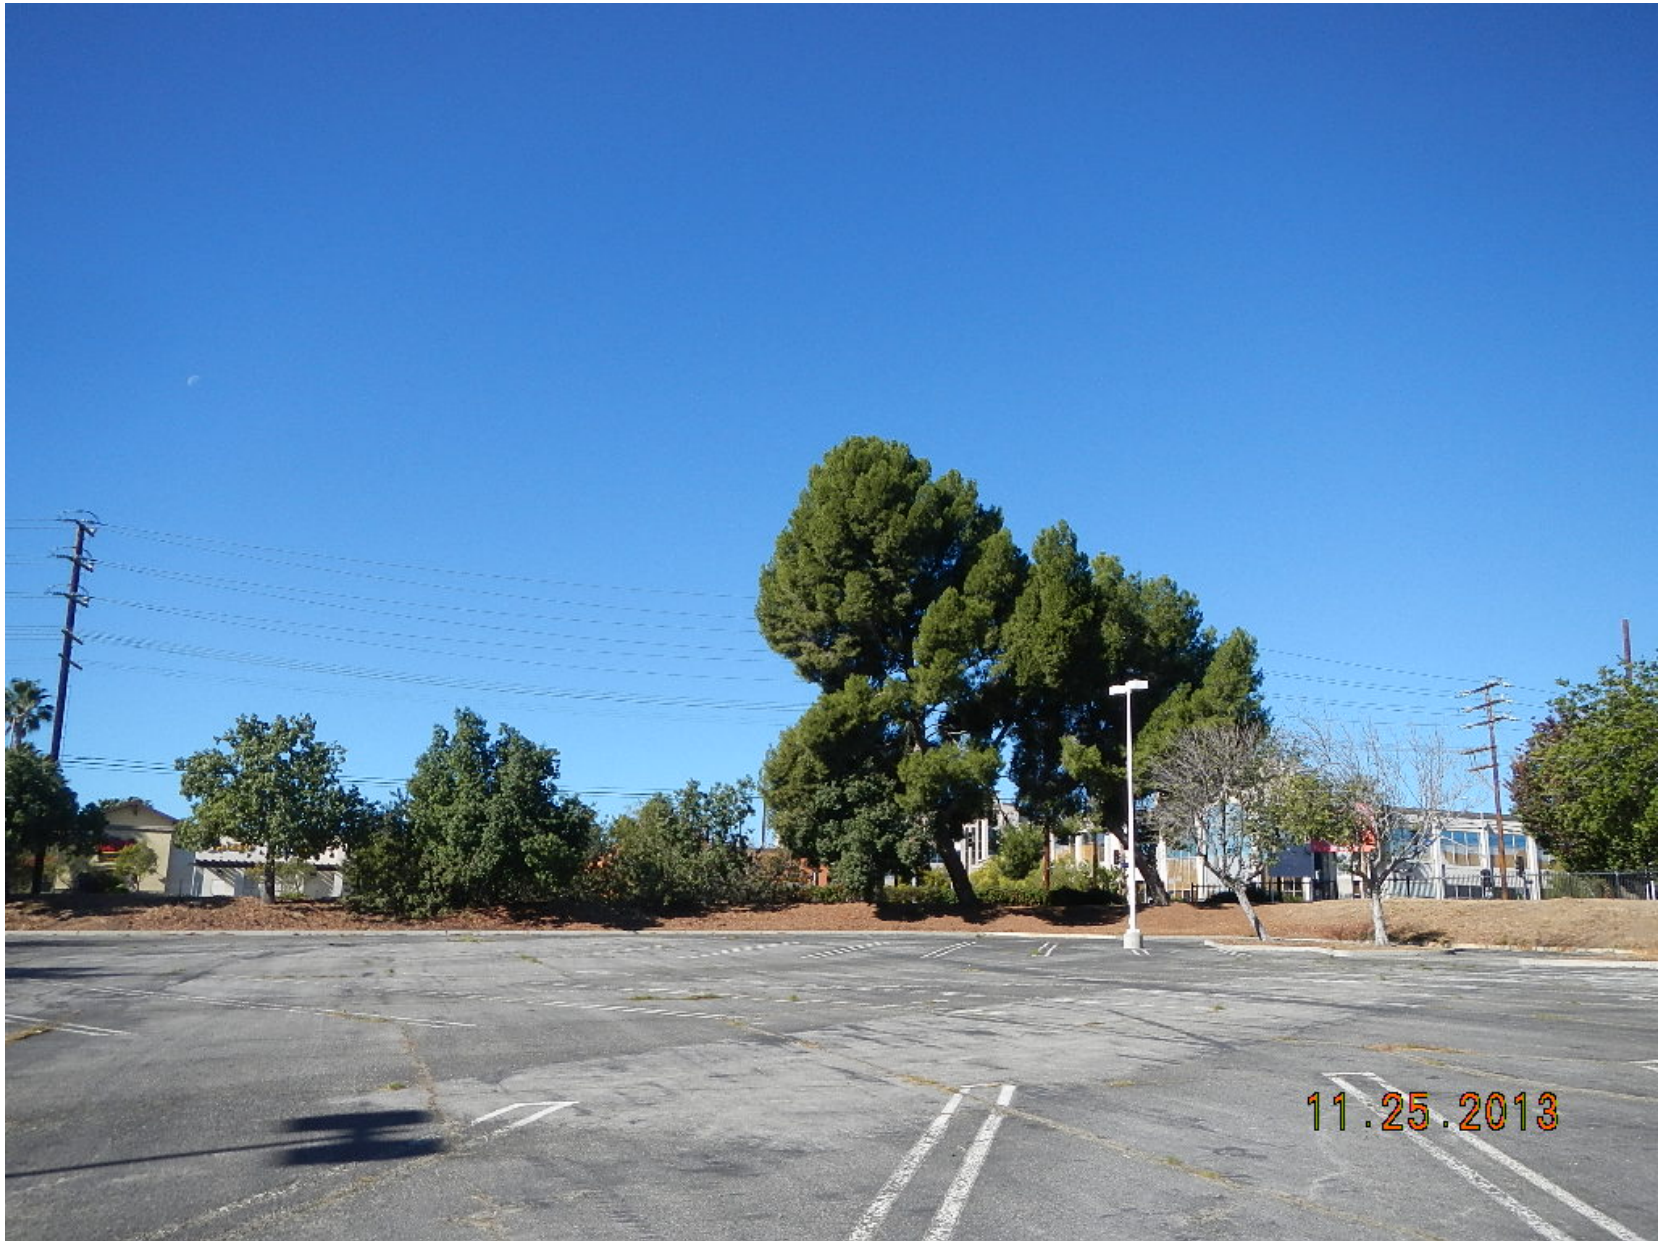
The northwest corner of the site. Note the sparse carrotwoods and leaning Aleppo pines.

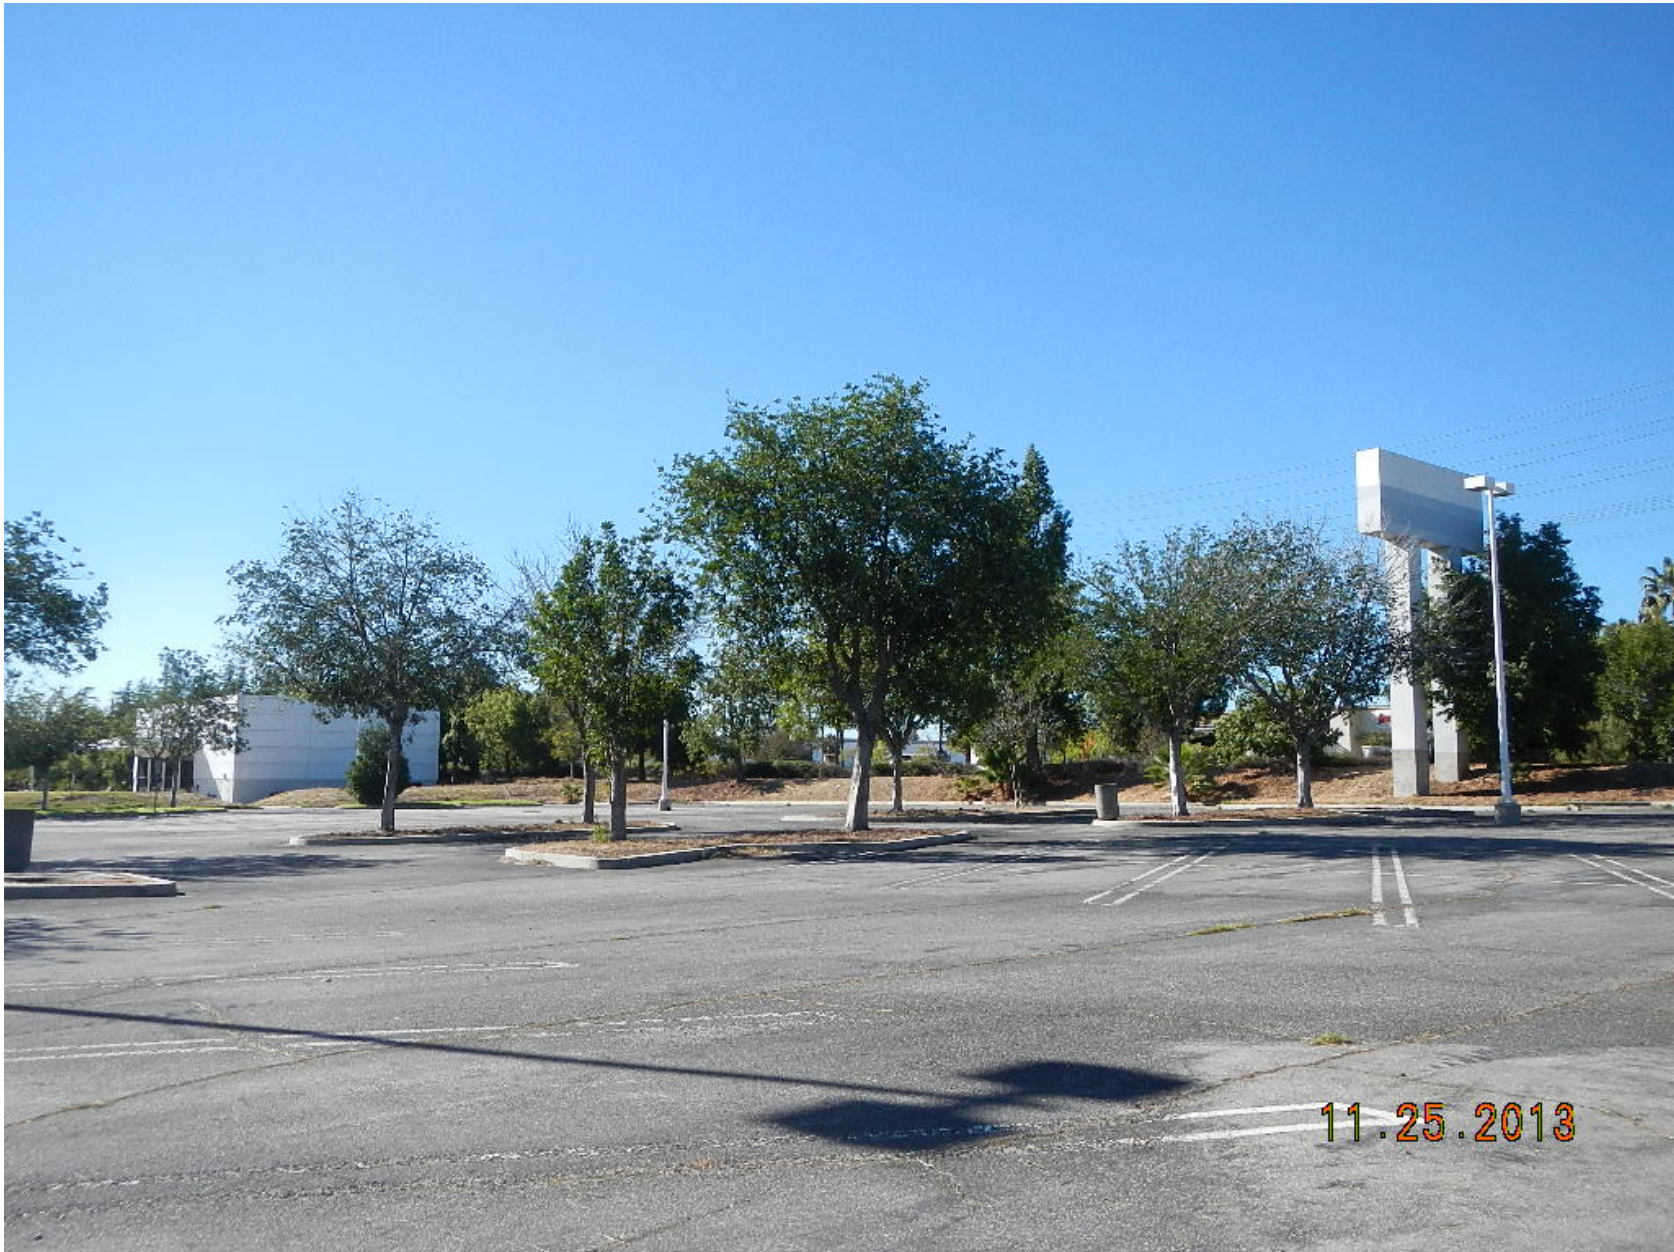
Carrotwoods in the parking islands and outside islands are sparse and declining, and their structure is weak.

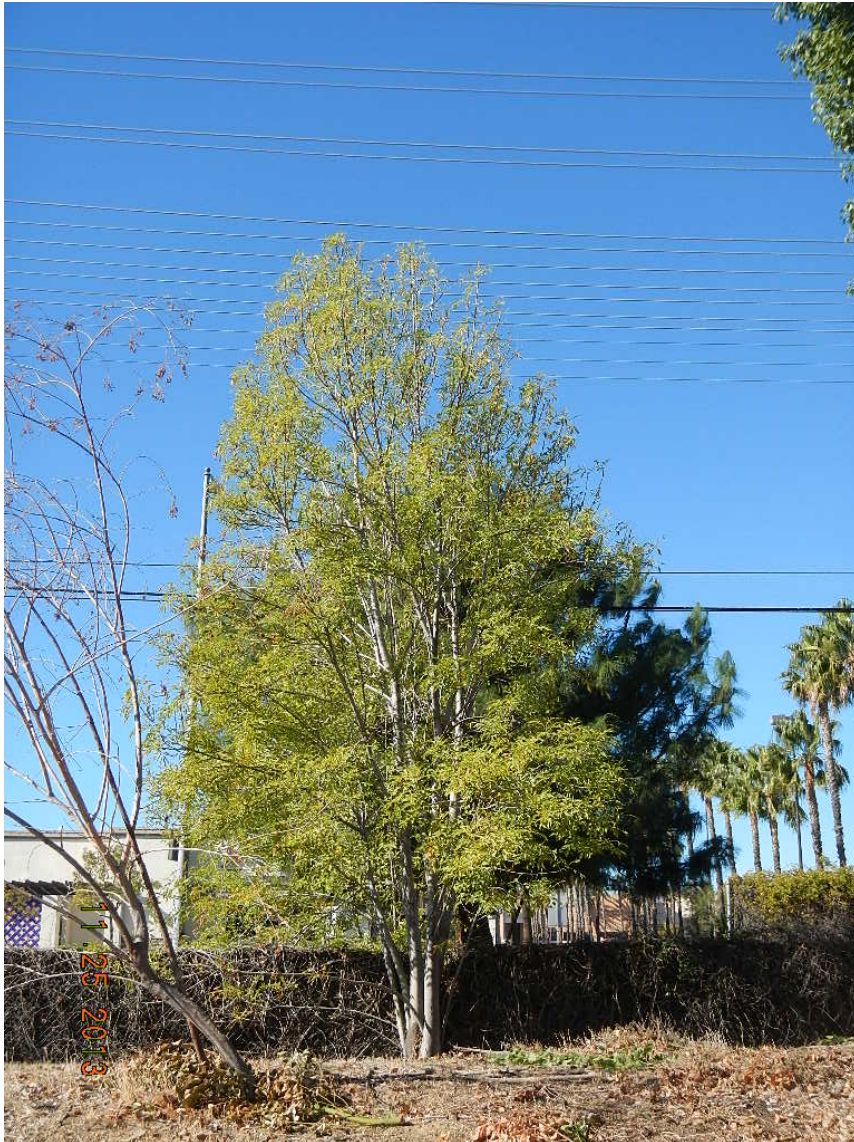
All the Shamash ash are weeds along the edge of the channel or east wall.

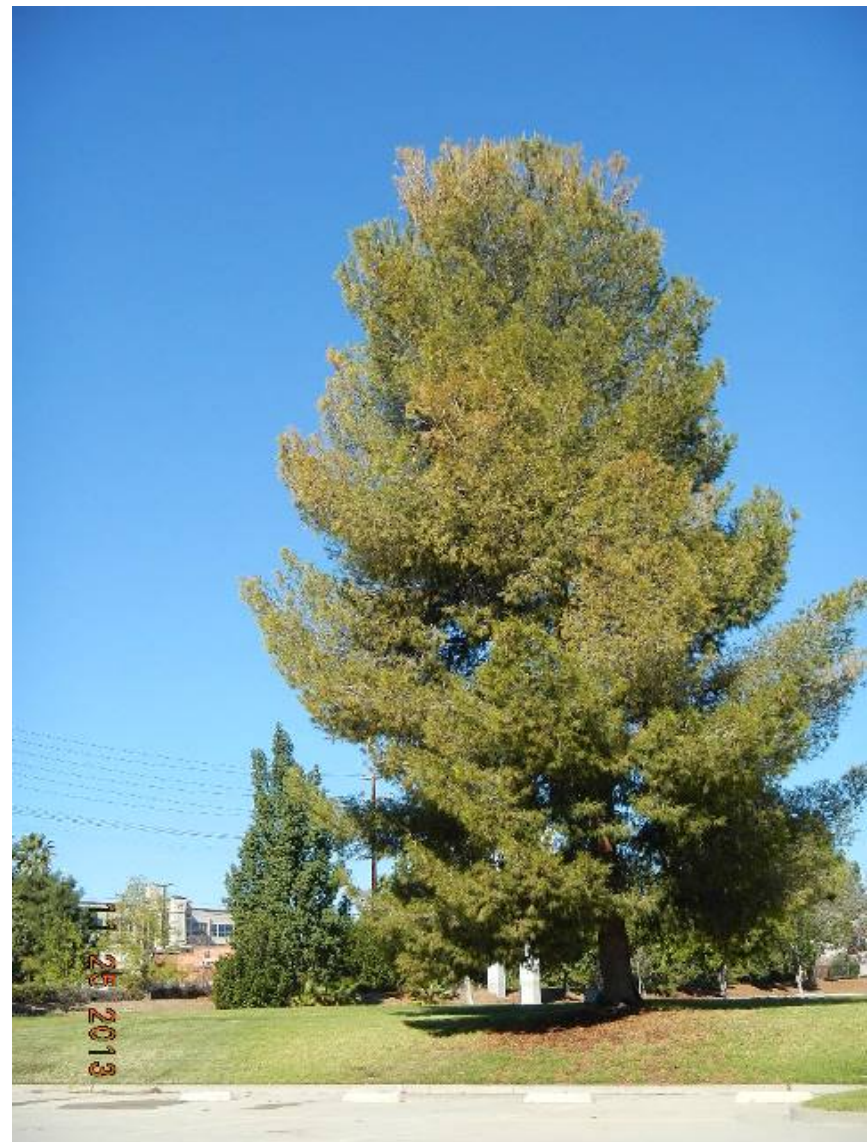
The browning of this Aleppo pine is probably due to a mite infestation.

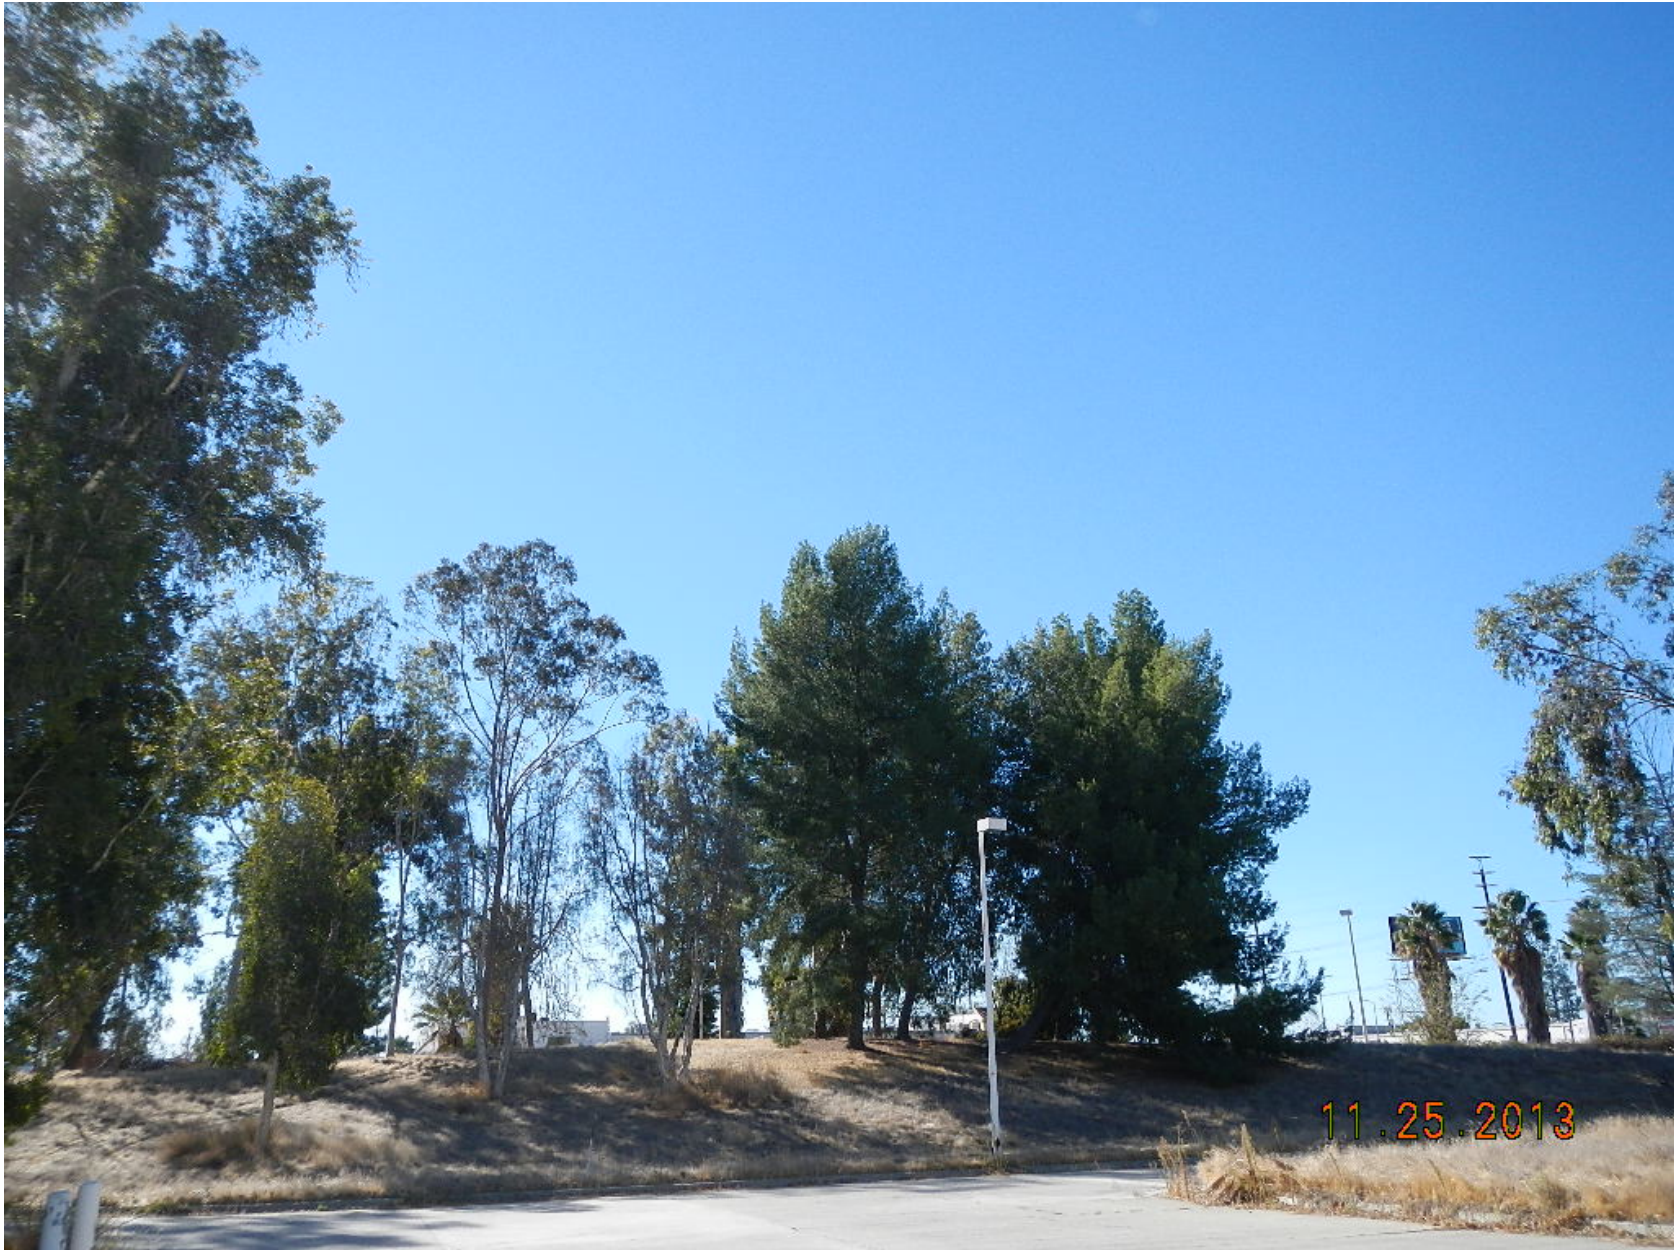
West corner of the southern portion. The sparse trees in the foreground are paperbarks and behind are the lemon gums.

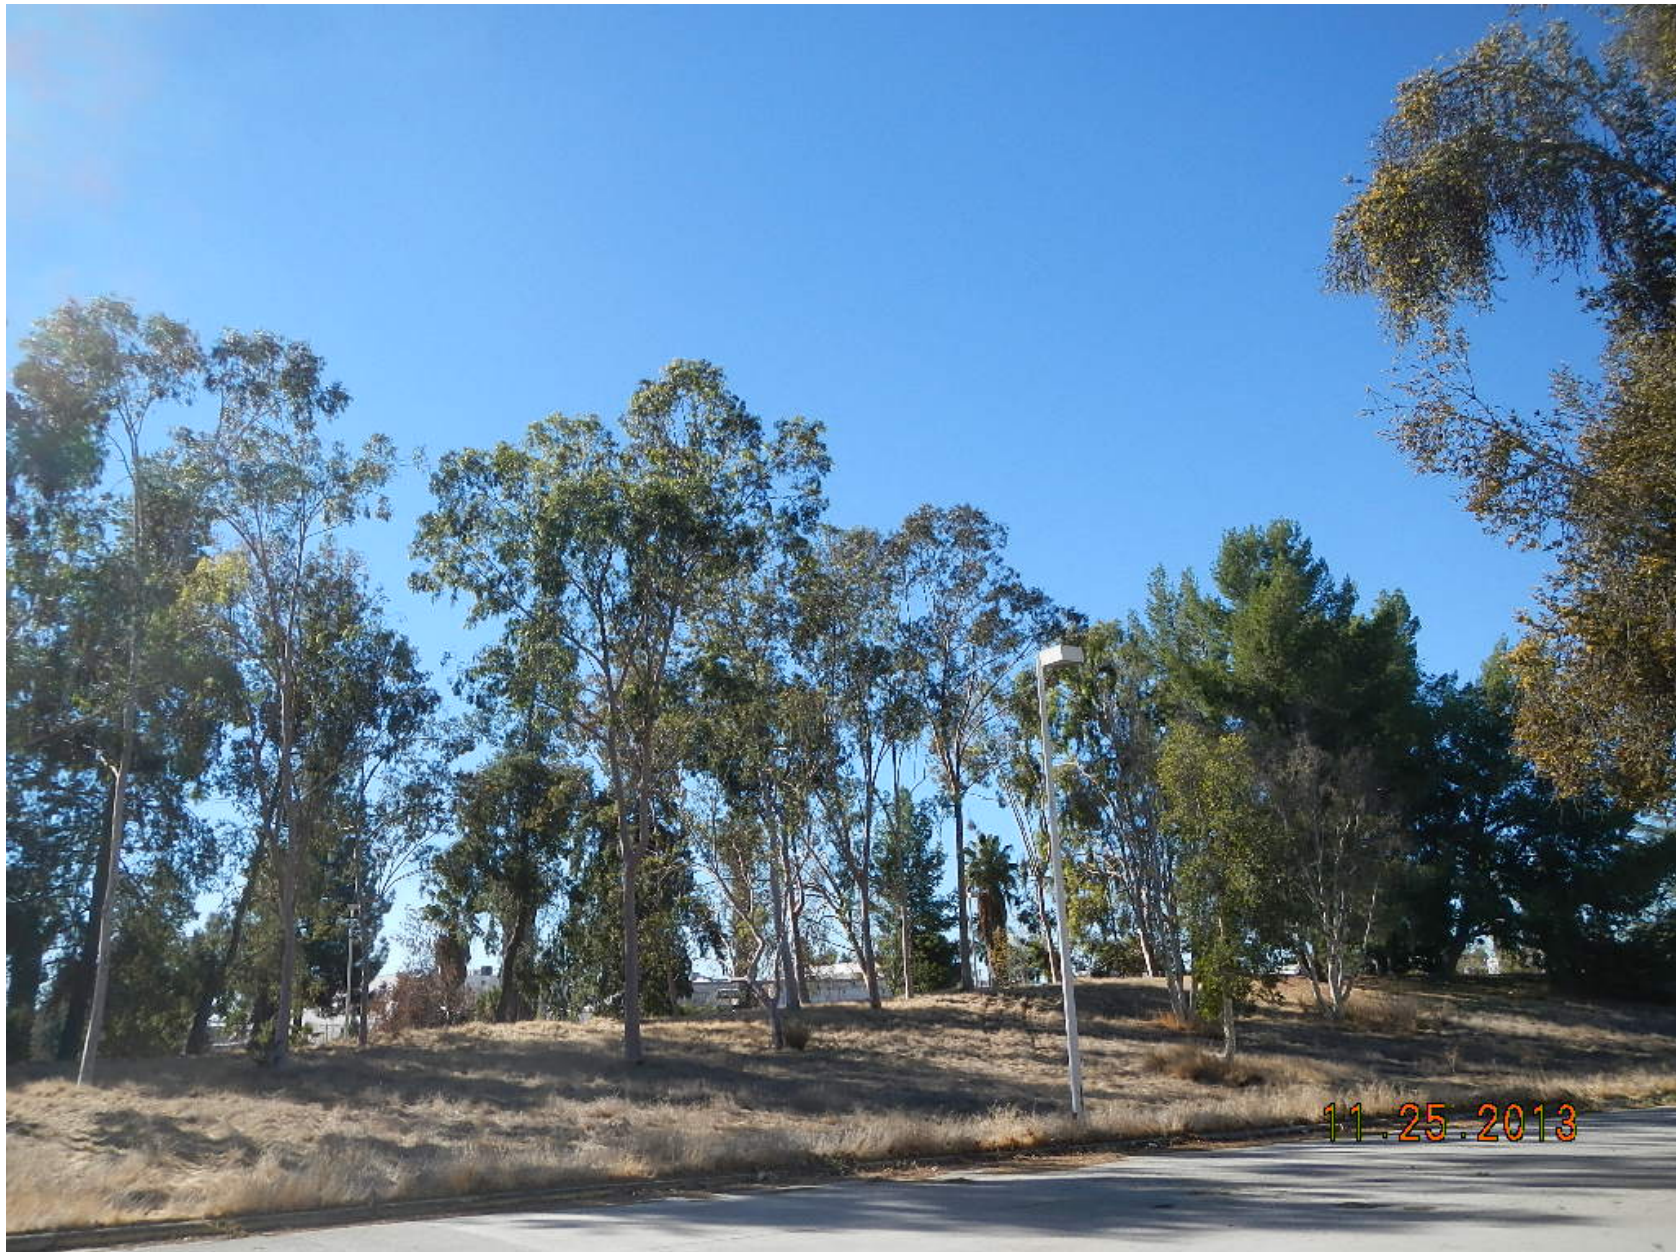
More sparse lemon gums and paperbarks. The Aleppo pines are more drought tolerant and healthier.

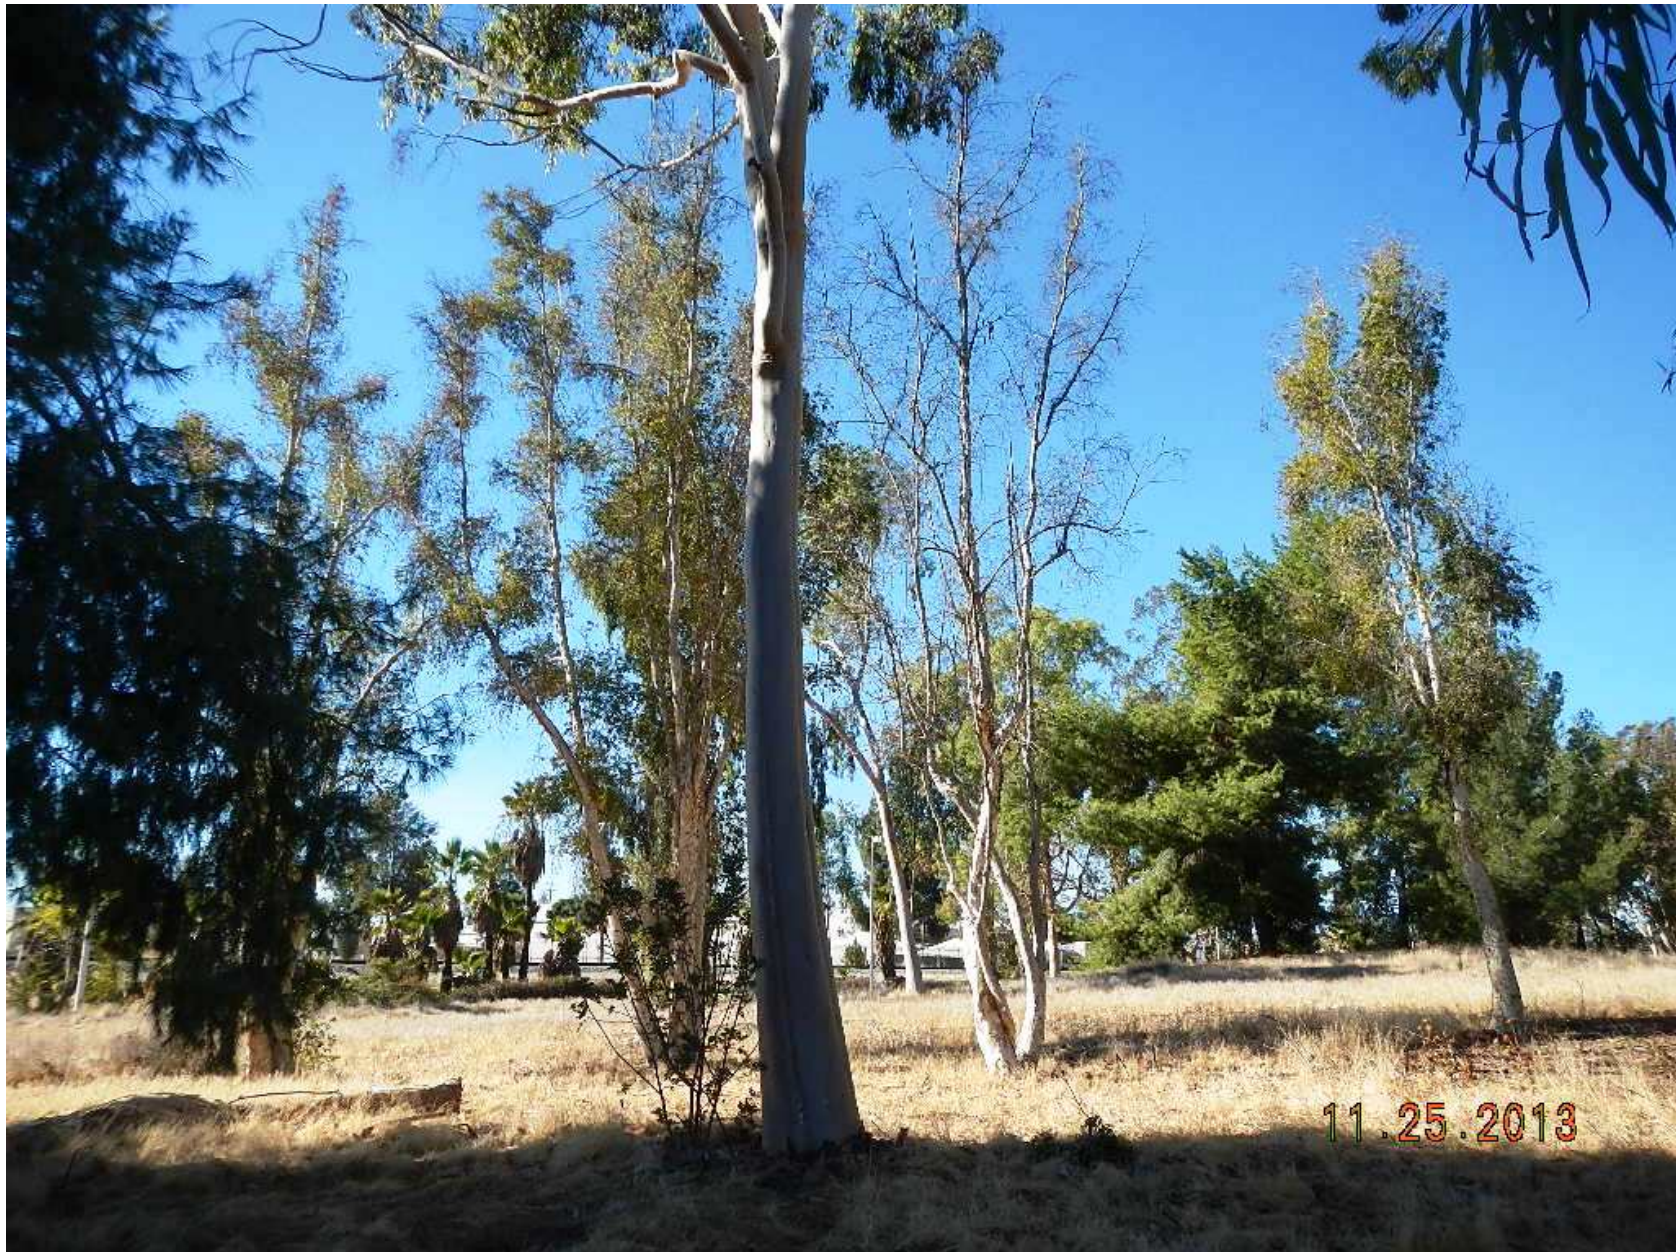
Paperbarks need more water and are declining in most areas.

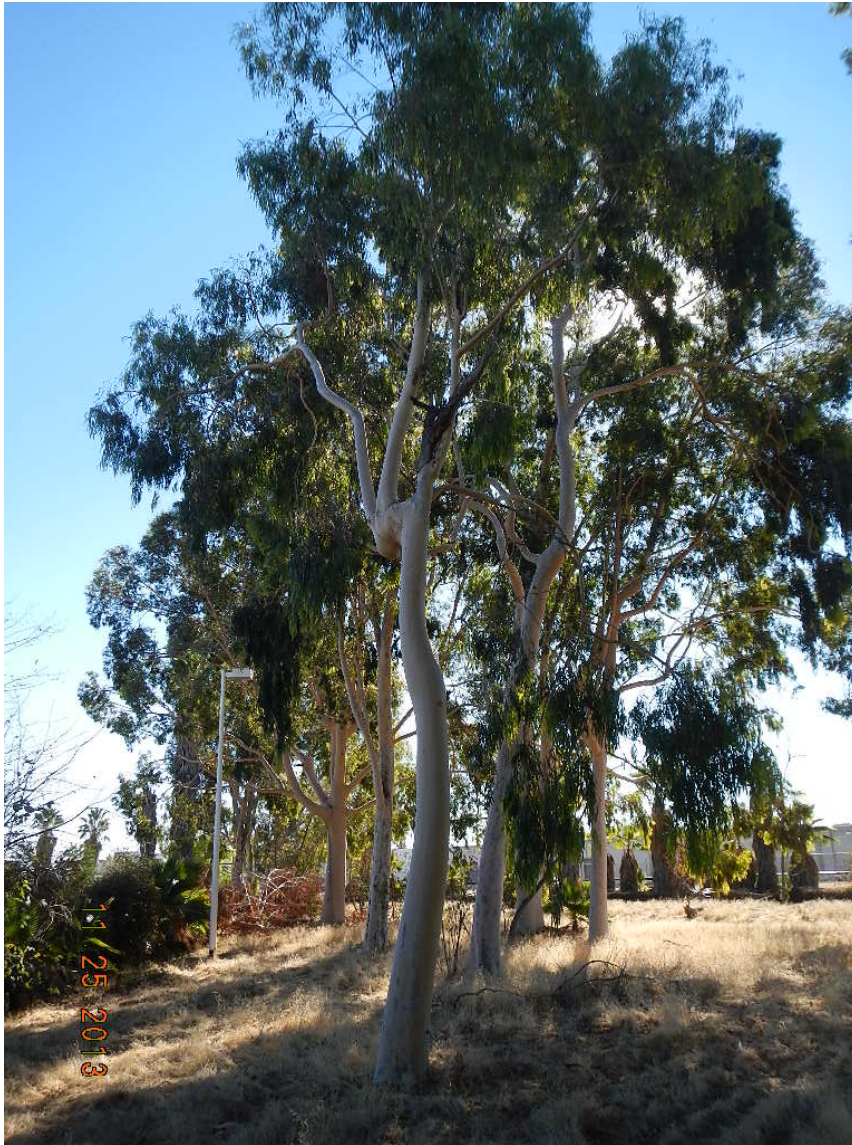
Lemon gums along the southeast edge are healthy but weak structurally.

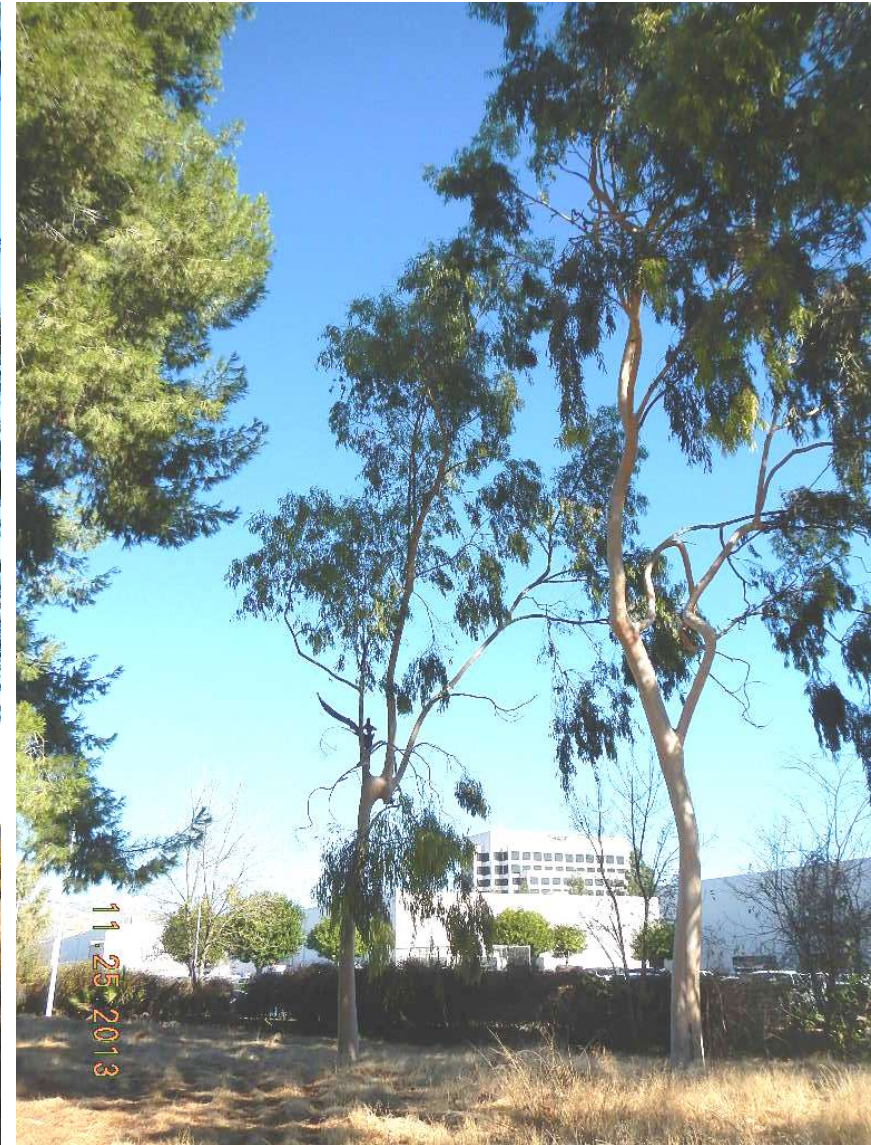
These lemon gums need corrective pruning and dead wood removed.

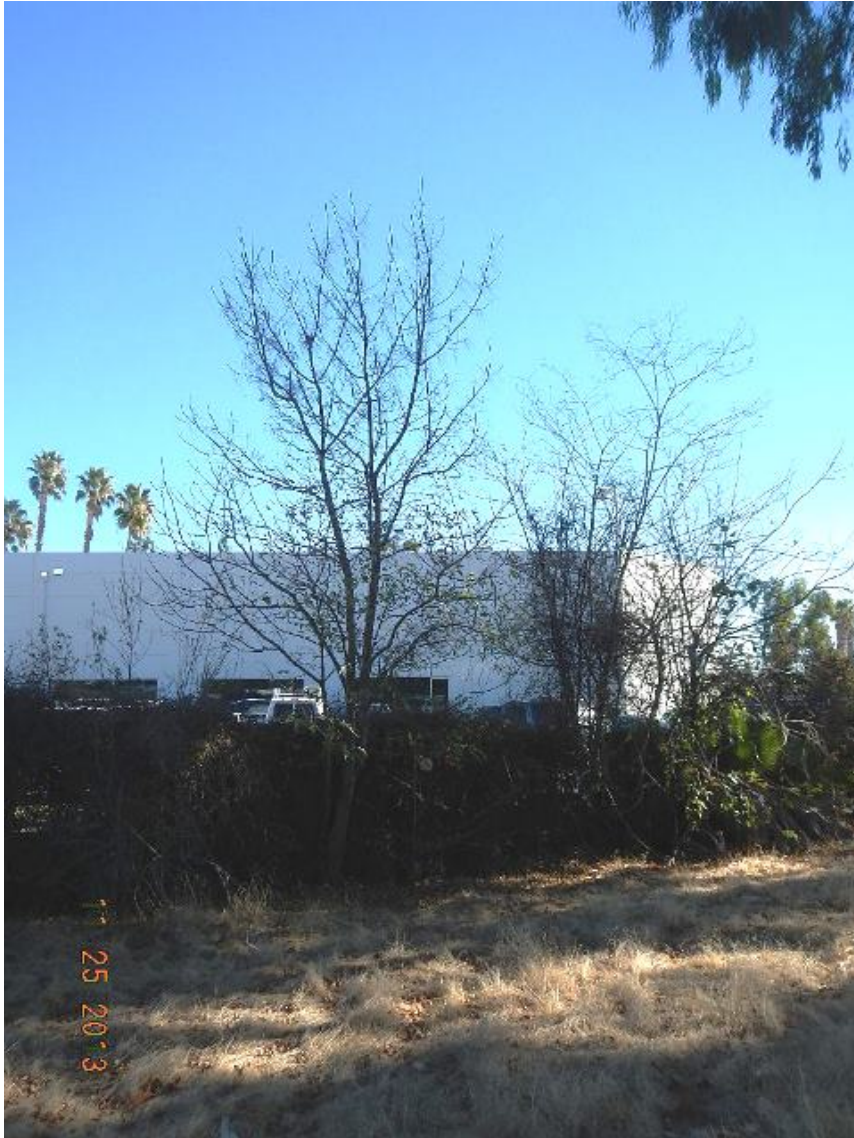
More Shamel ash weed trees along the southeast edge.

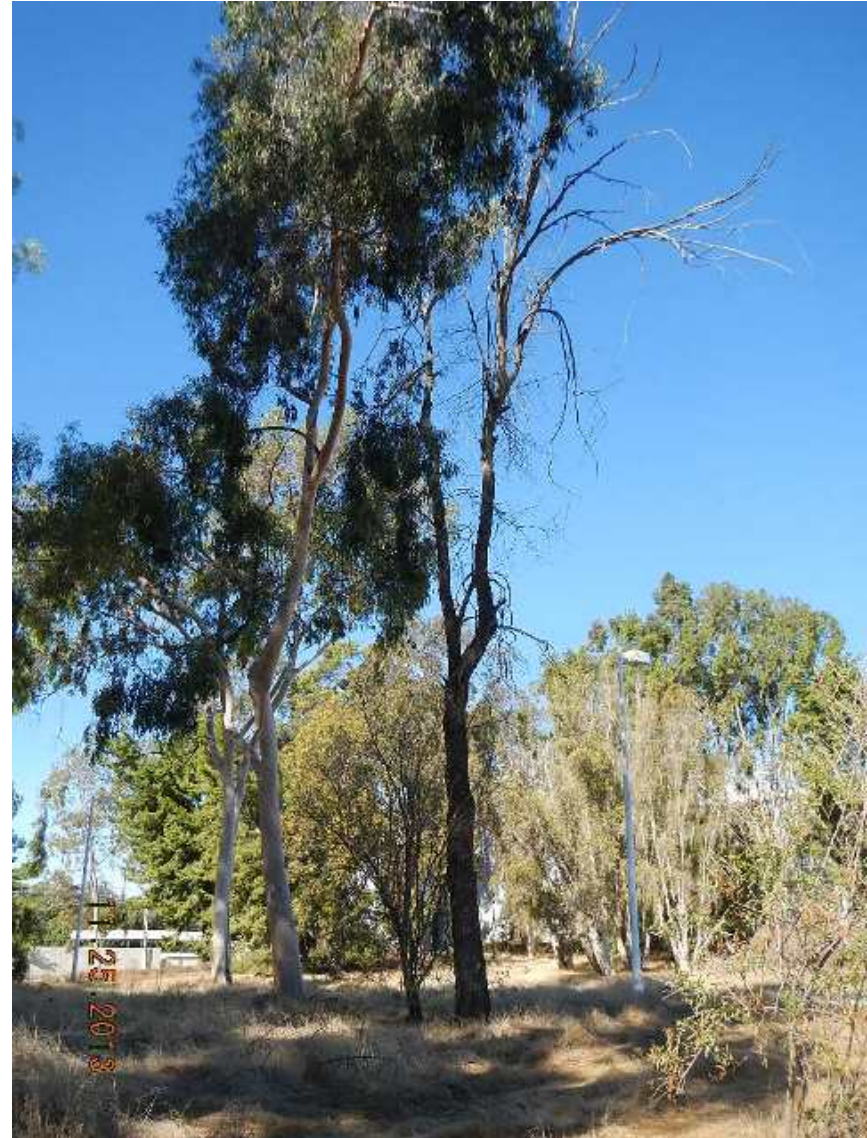
Dead and declining trees are mixed in.

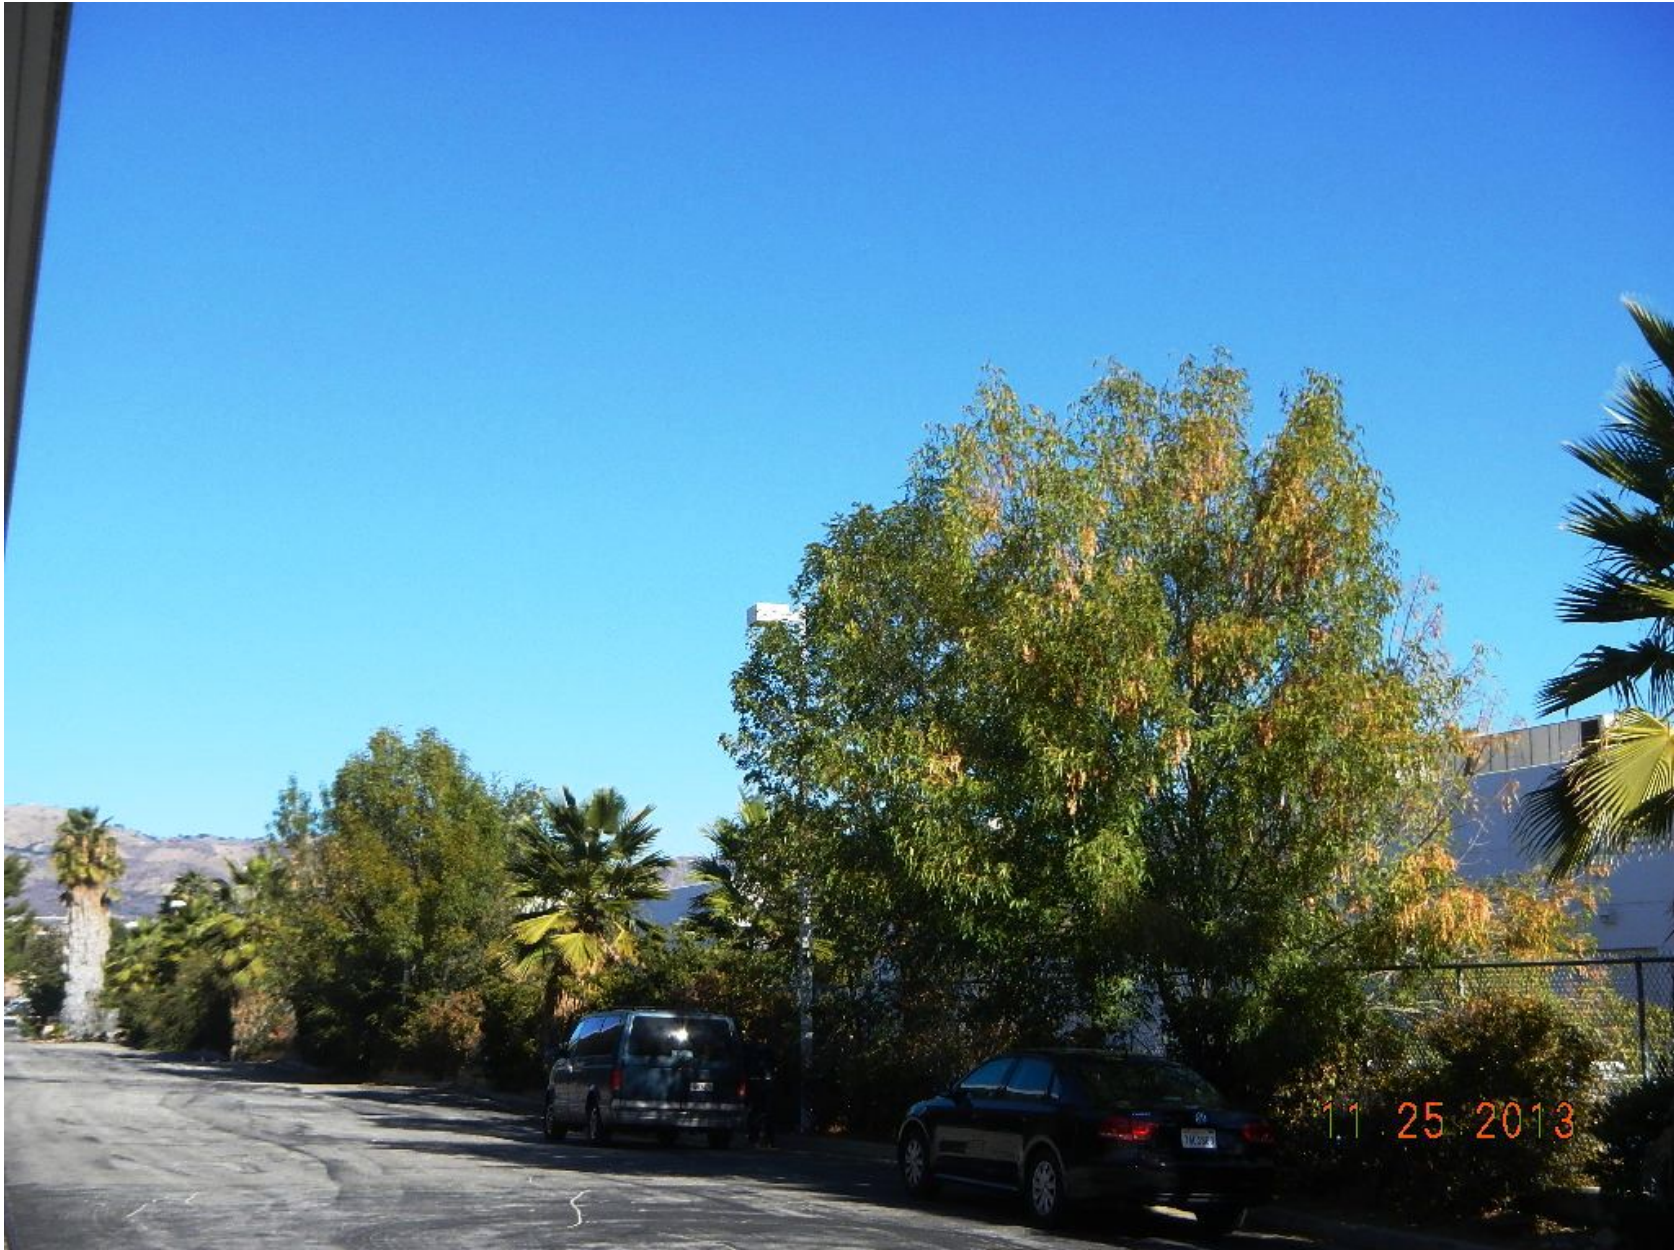
More Shamel ash weed trees along the east edge.

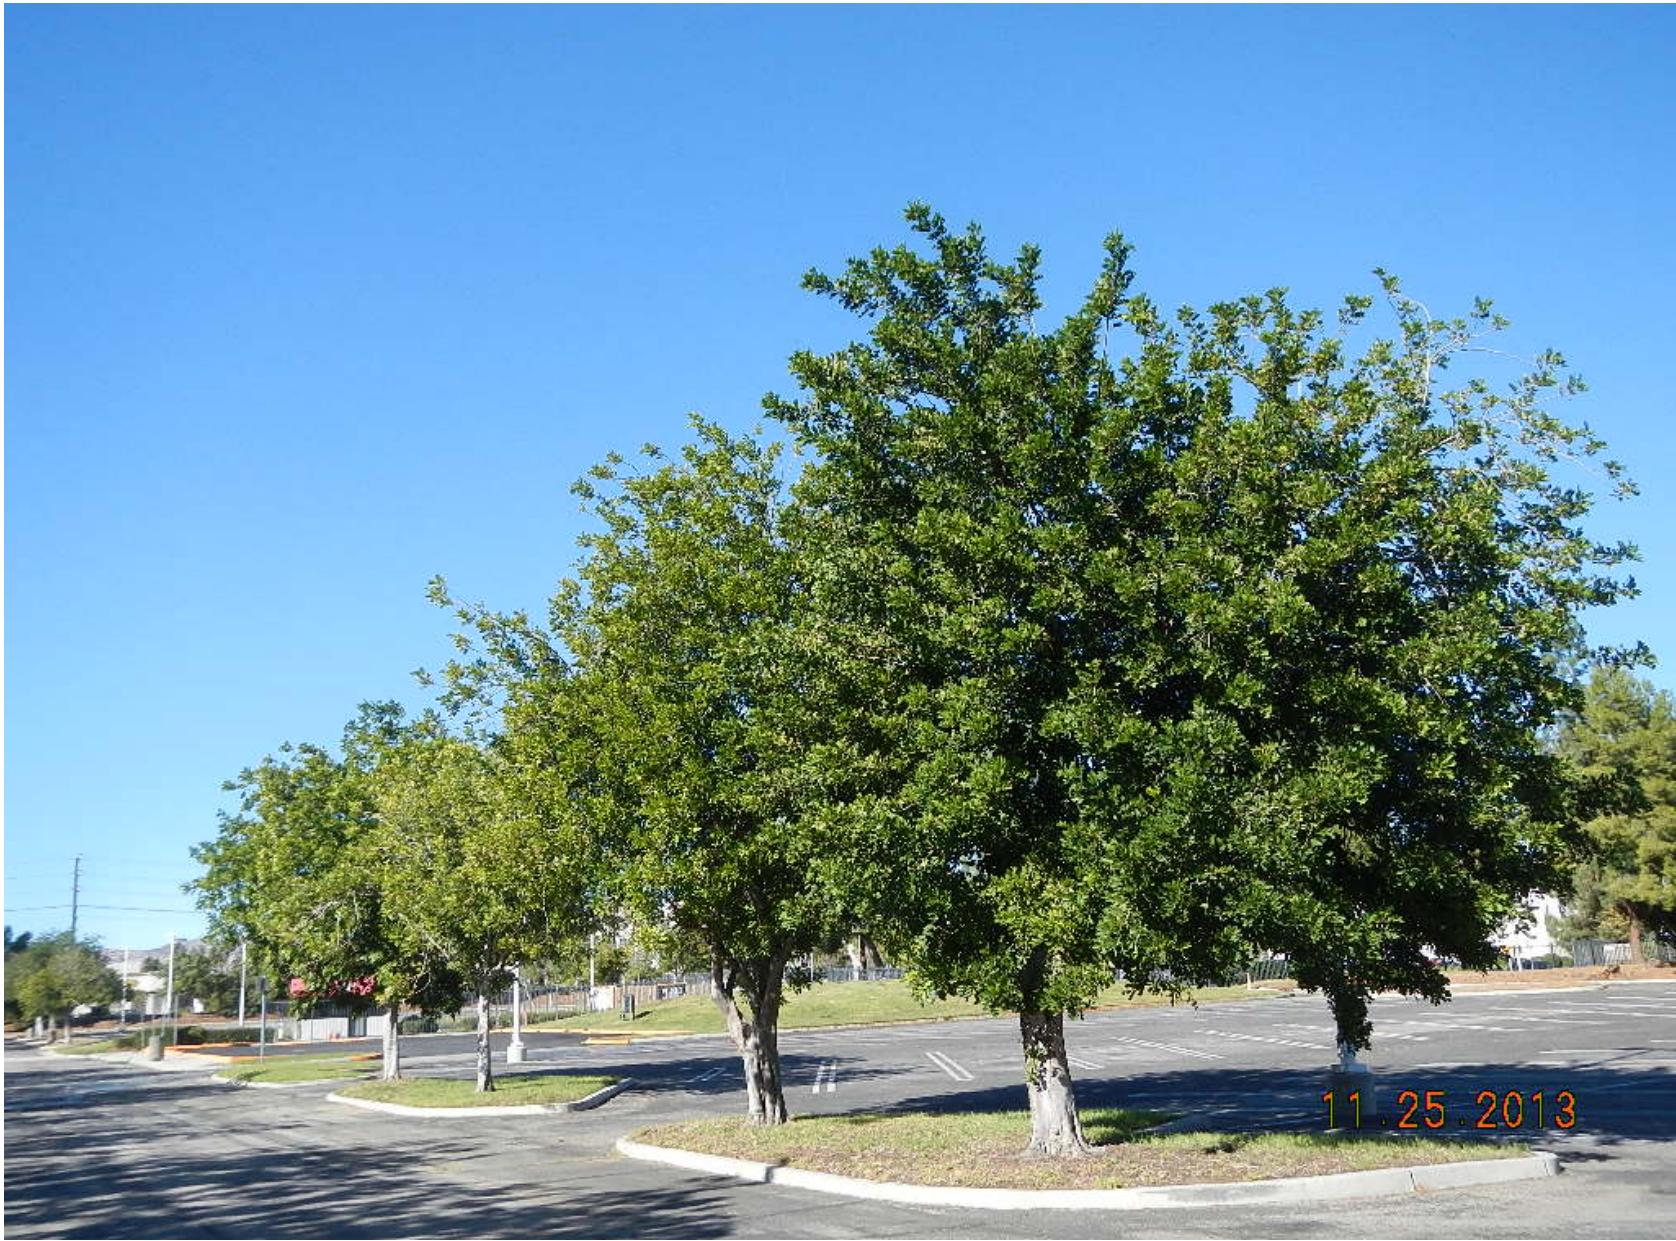
Carrotwoods are healthier in the northeast parking area, but weak structurally.
