Consulting Arborist's Report
December 2, 2013

Tree Evaluation and Preservation Study

MGA, Chatsworth

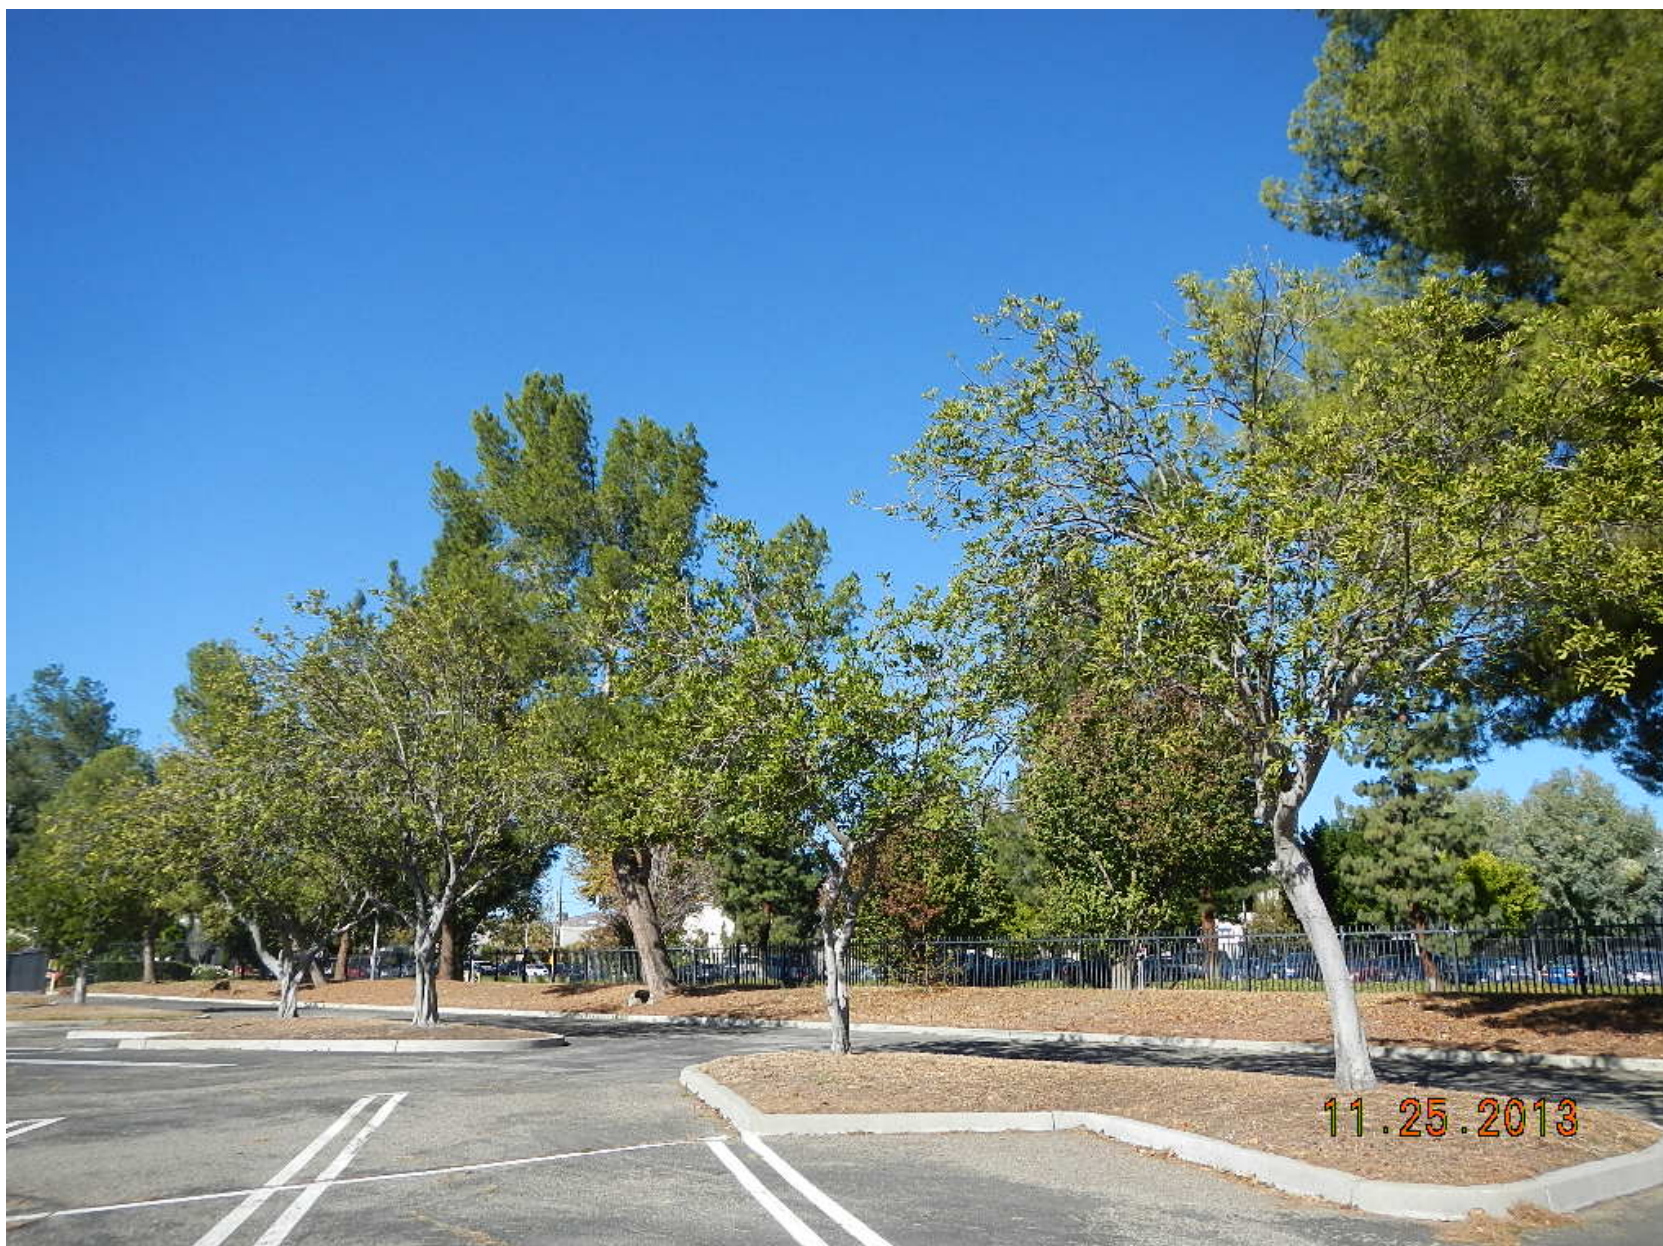
Carrotwoods are less healthy on the higher north edges of both sides, probably due to irrigation difference due to elevation.

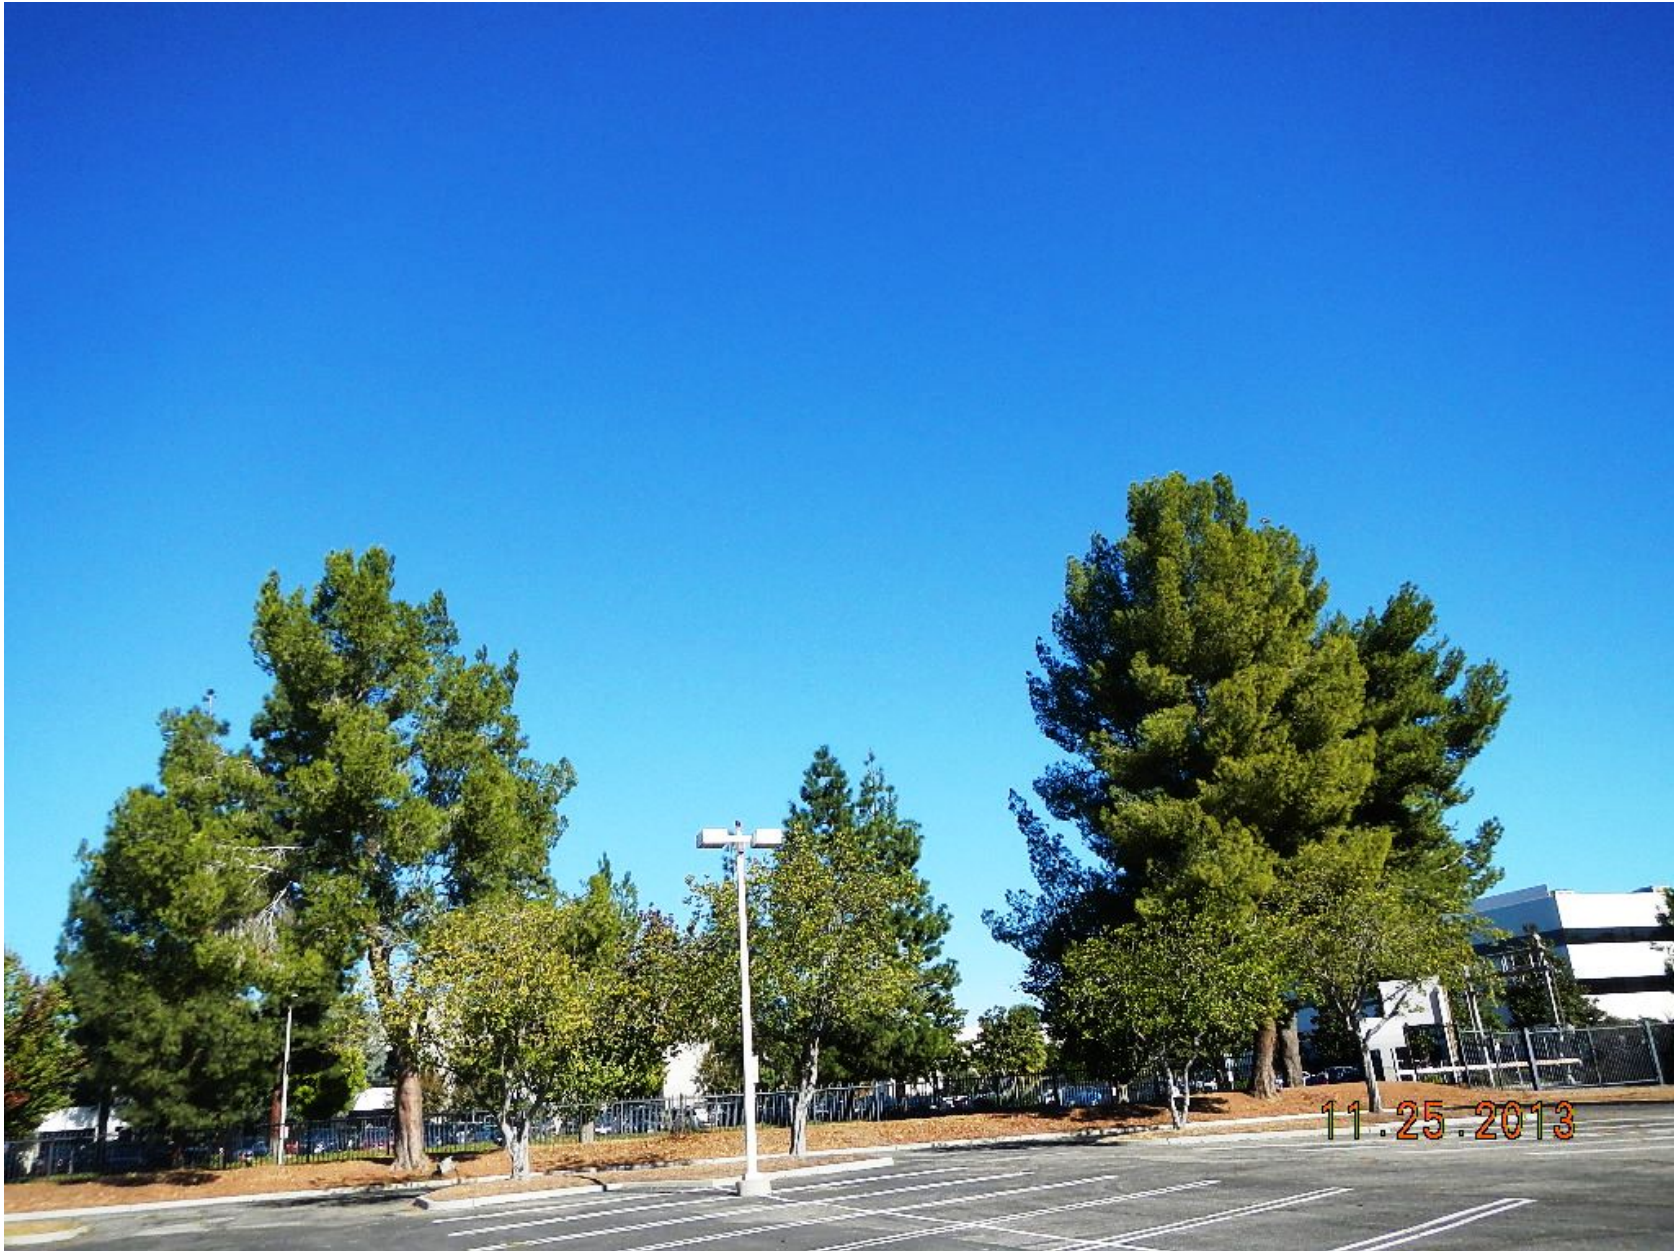
While the Aleppo pines are generally healthy, they have many structural weaknesses.

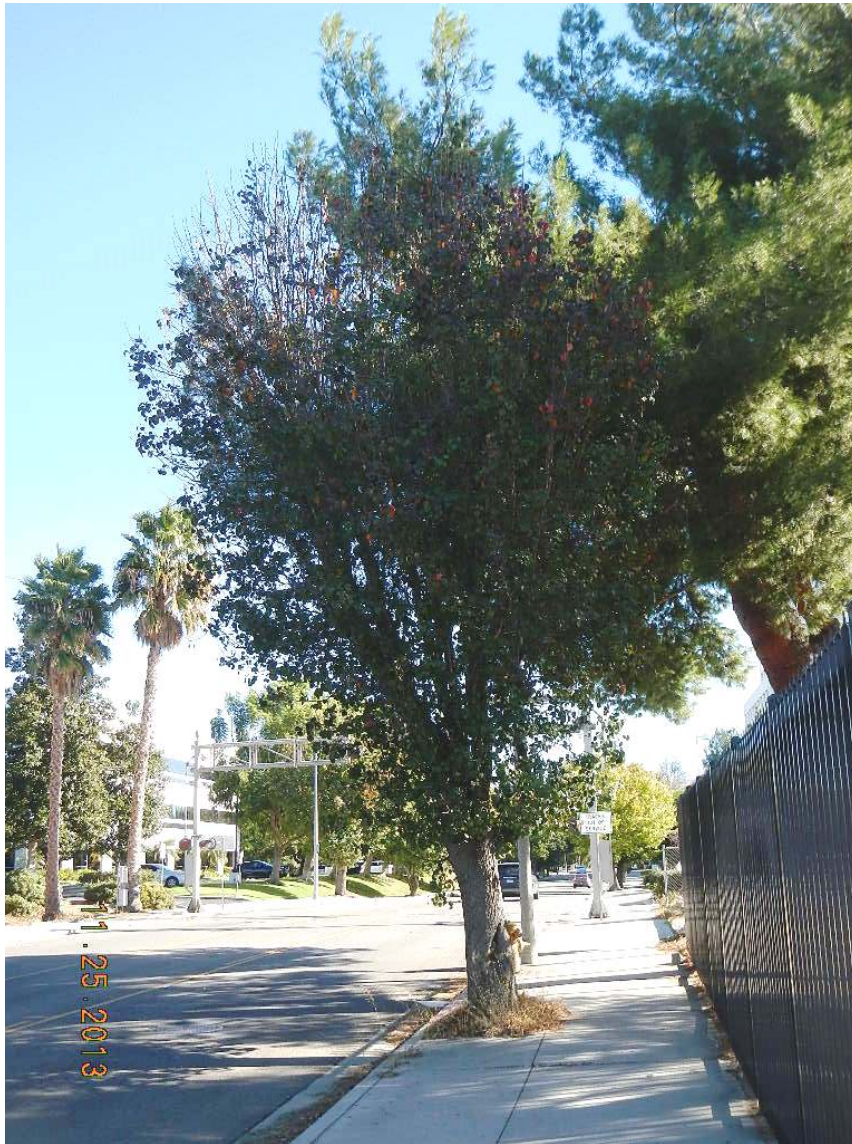
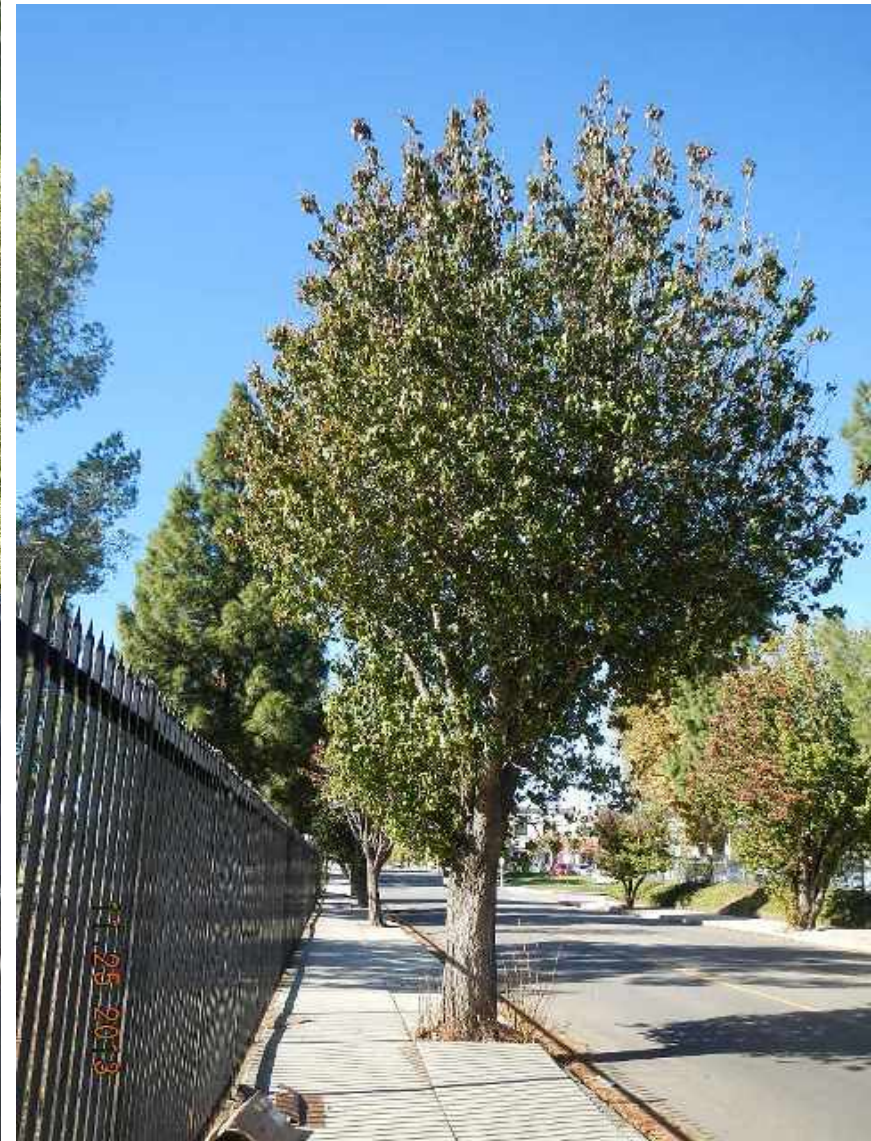
The Bradford pears are lifting the sidewalks and structurally weak. Their openings could be enlarged, but they are not long lived.

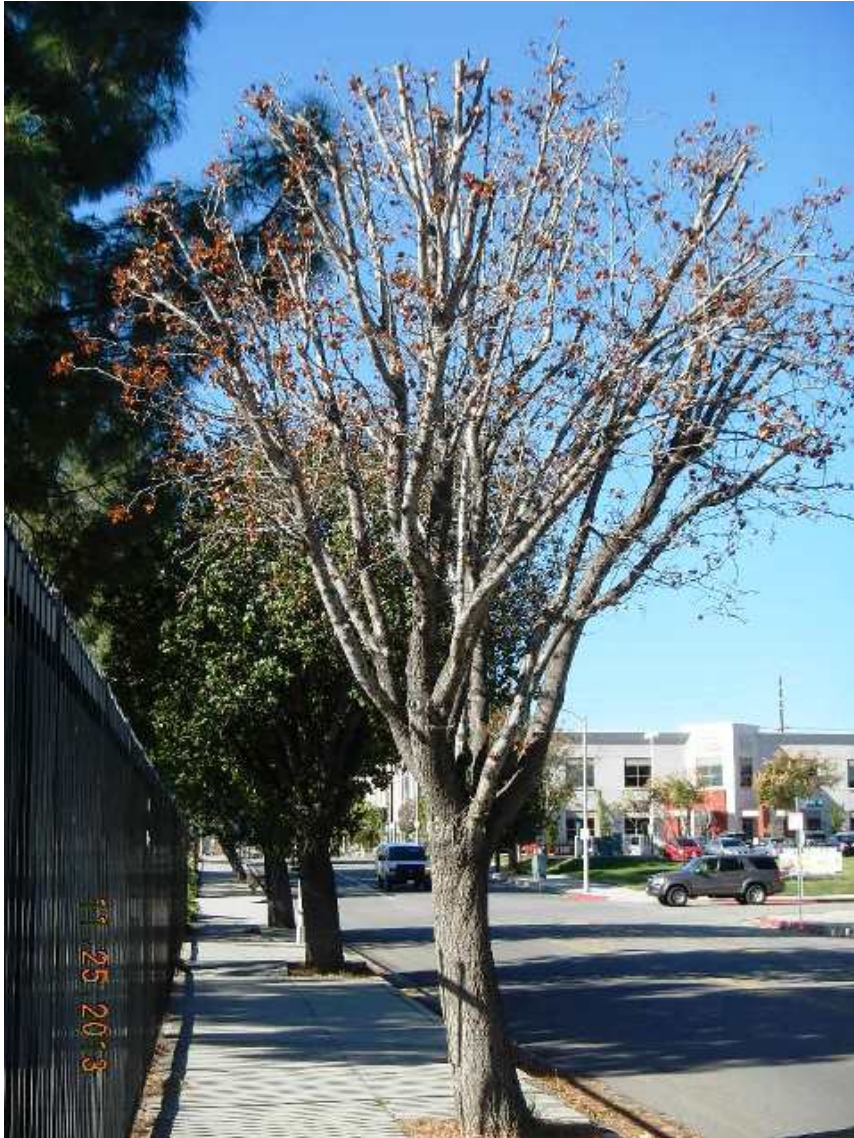
A dead Bradford pear.

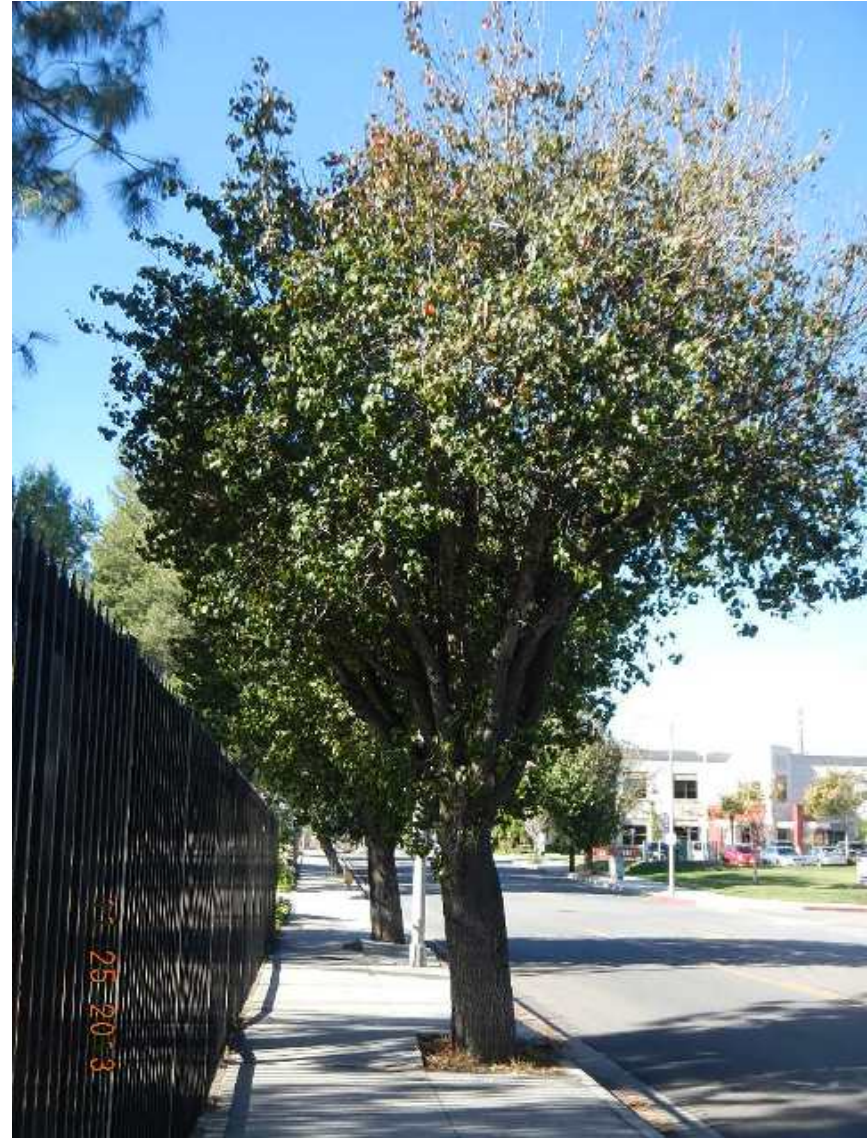
They all have crowded scaffold limbs and weak attachments.

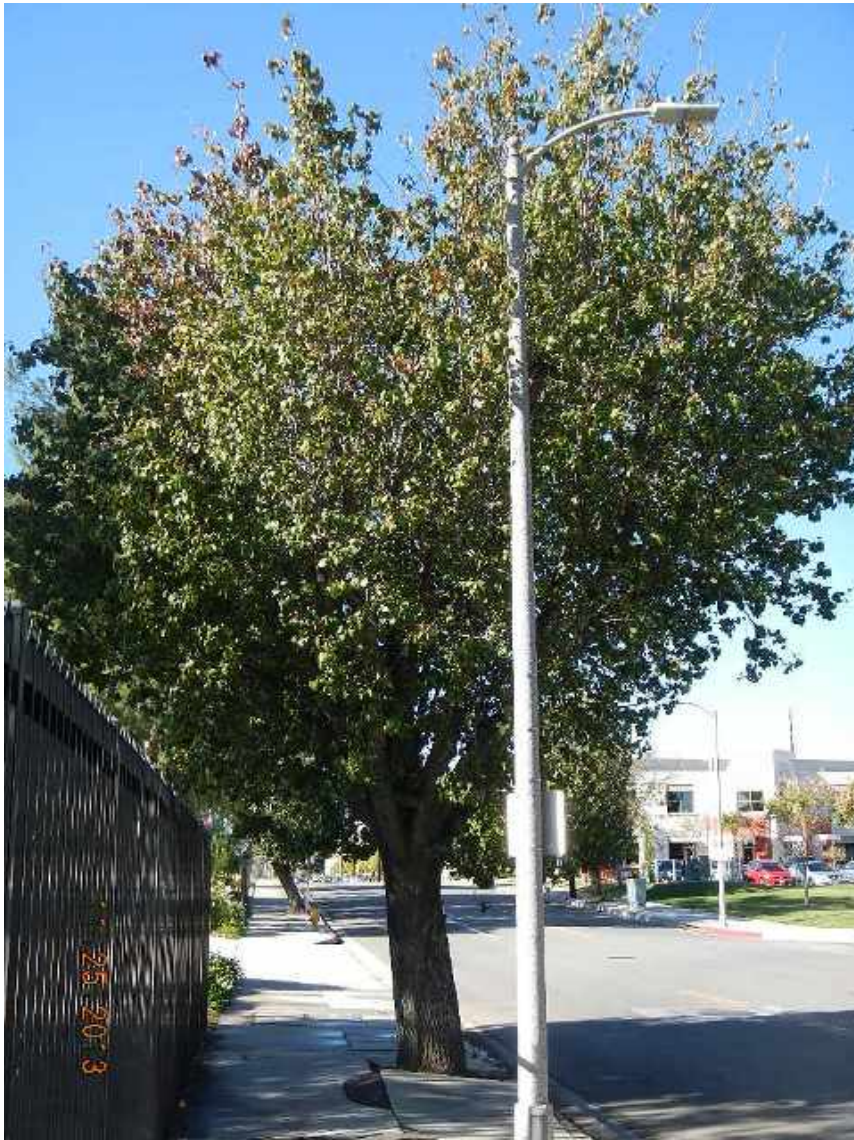
Note the lifted sidewalk.

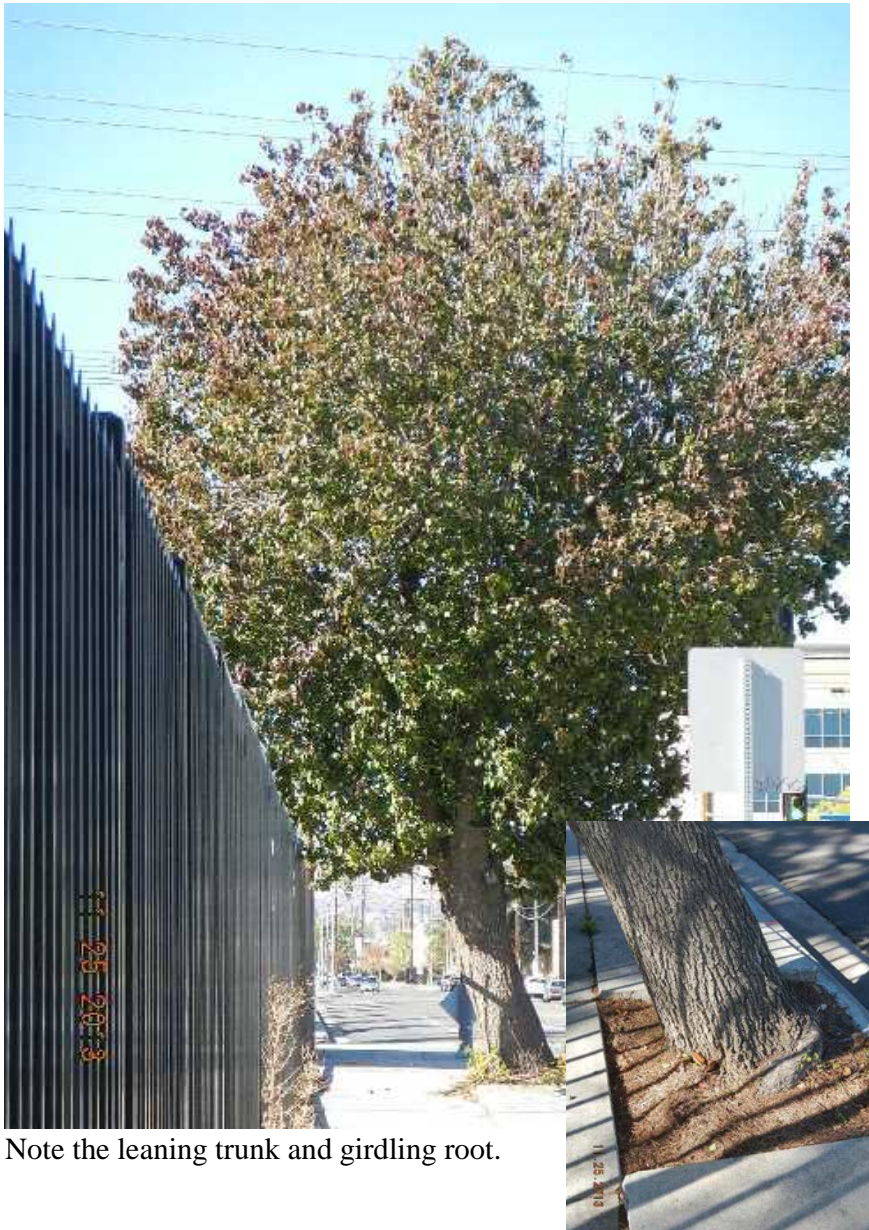
Note the leaning trunk and girdling root.

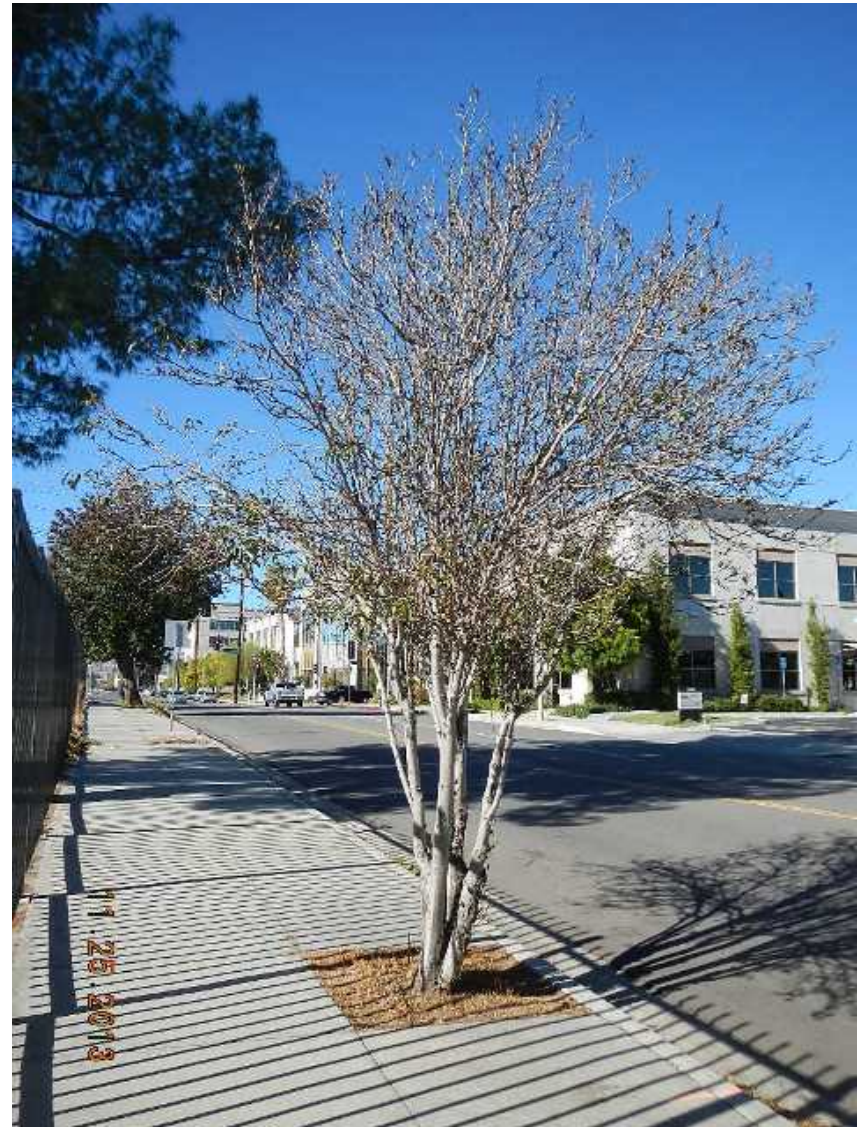
→ These trunks are stump sprouts from the previous Bradford pear. The next tree well is unoccupied.

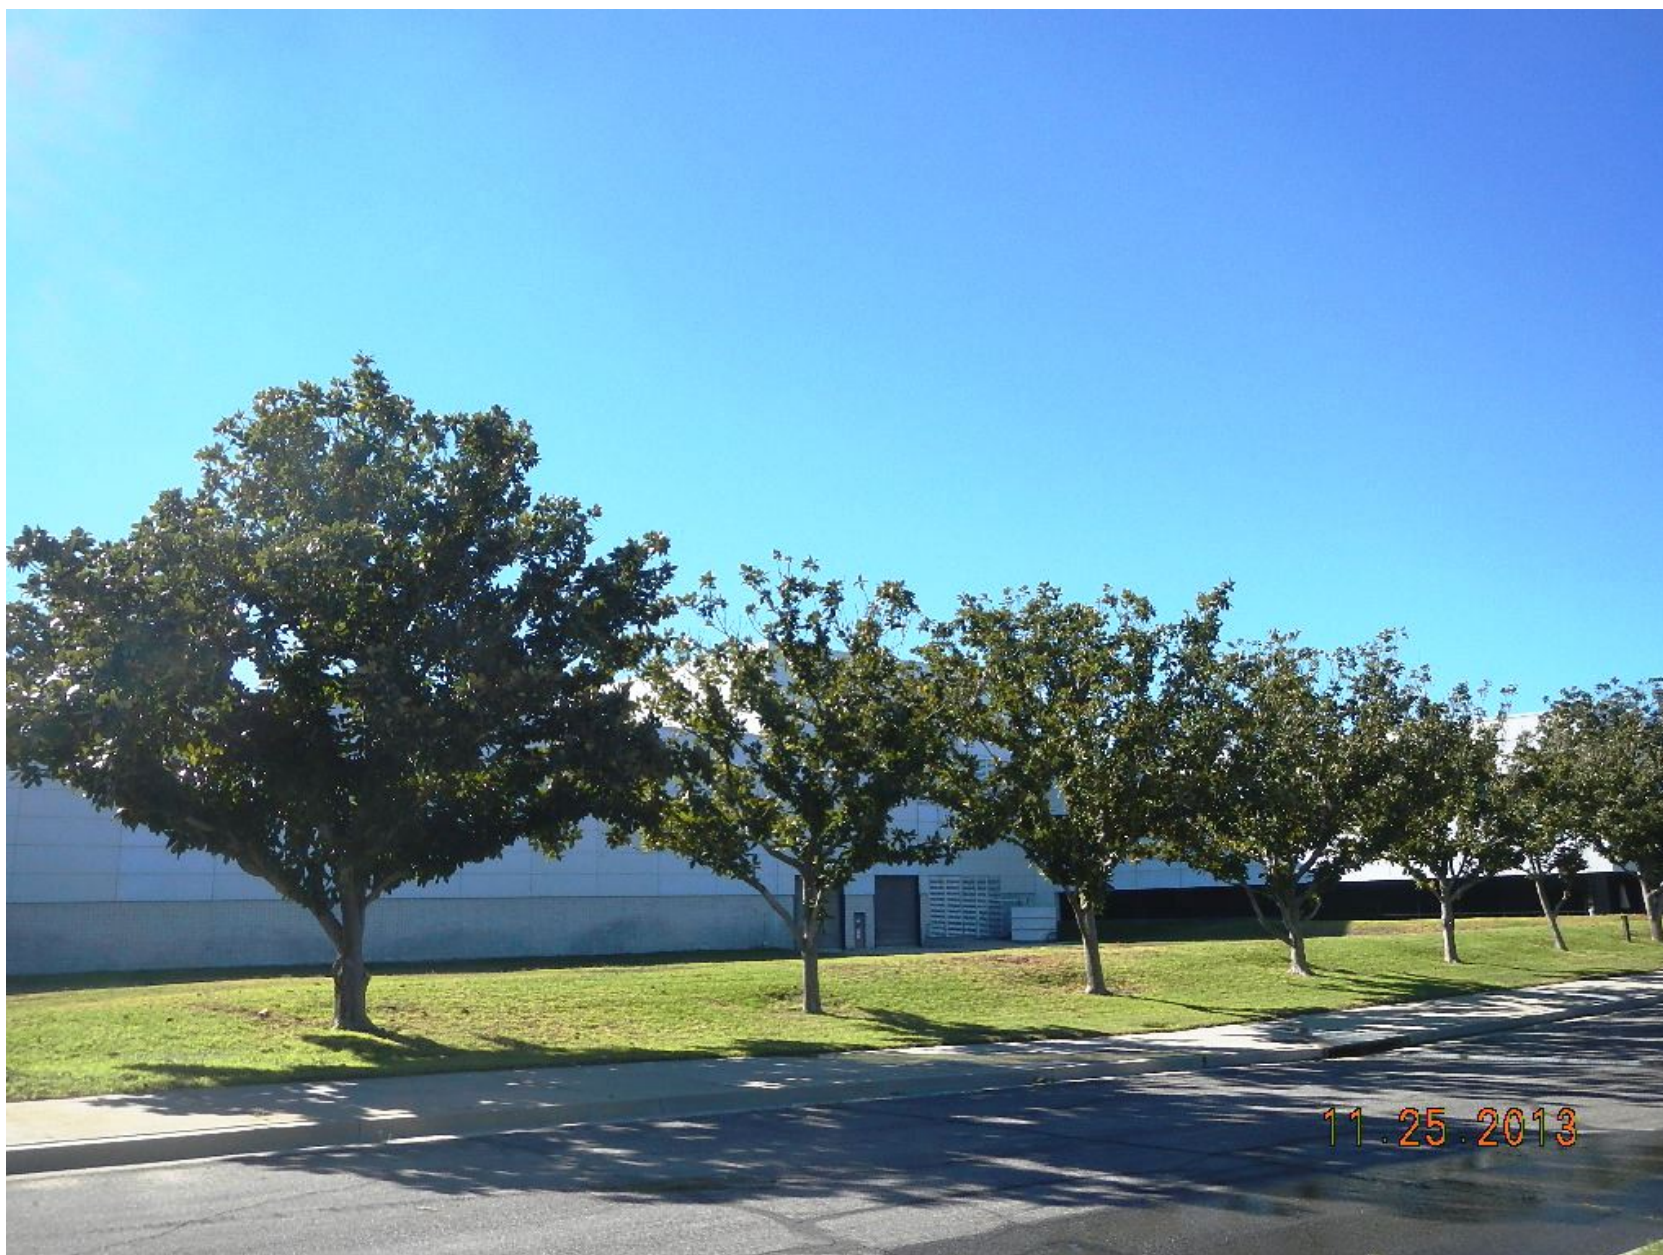
Southern magnolias on the north side of the building are clones but vary widely in health.

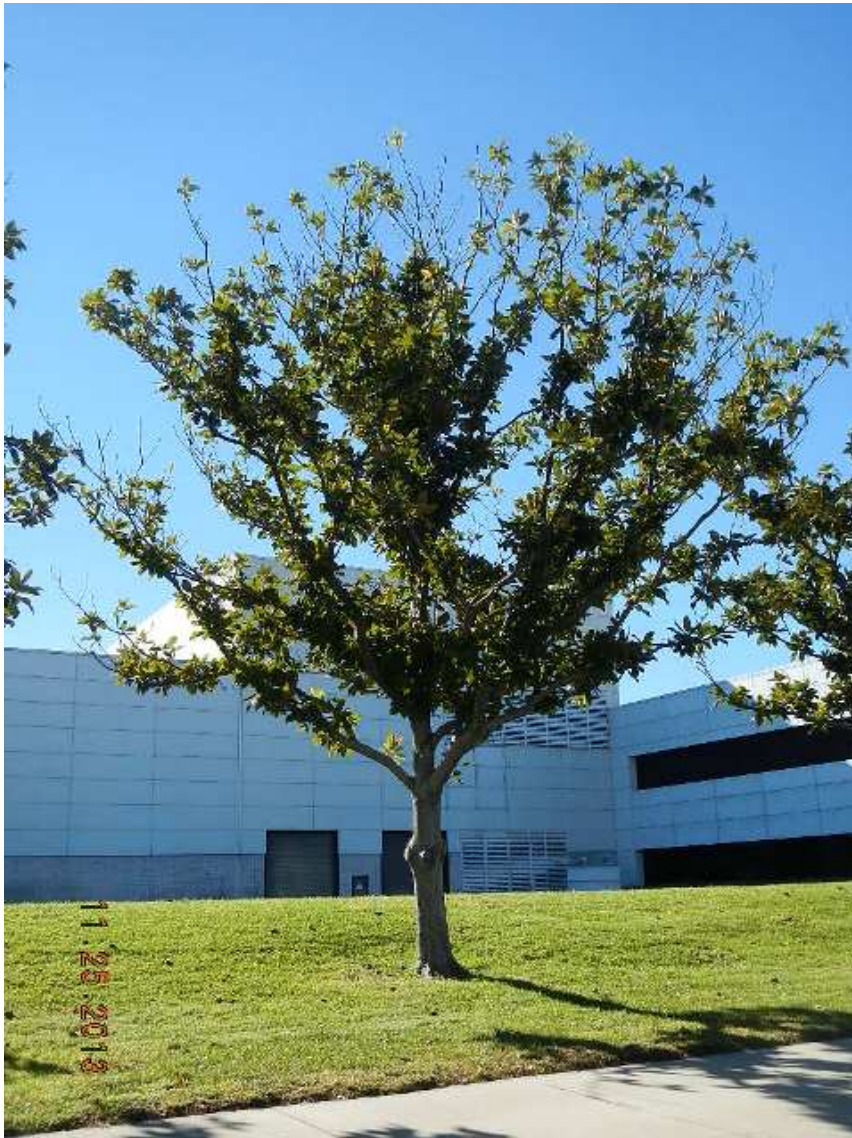
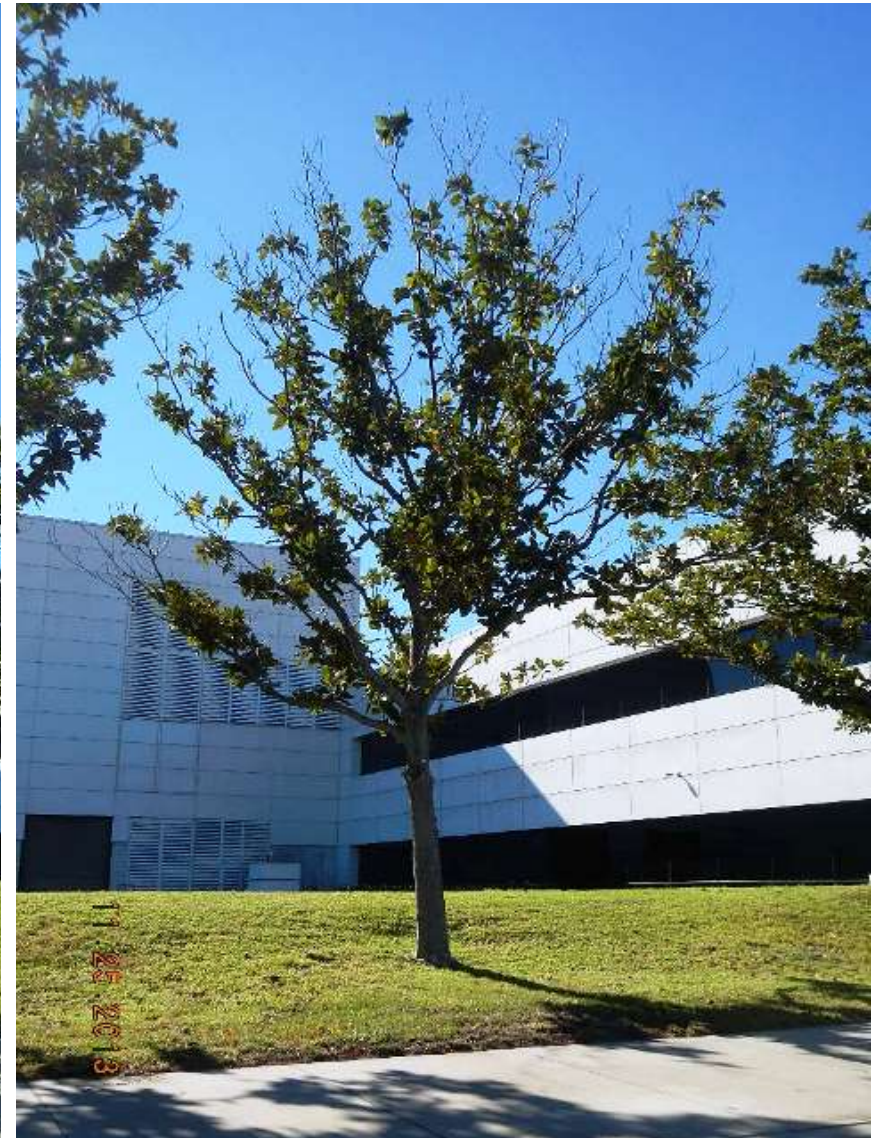
The sparse top indicates root problems or drought, but since the lawn is green, root defects are more likely.

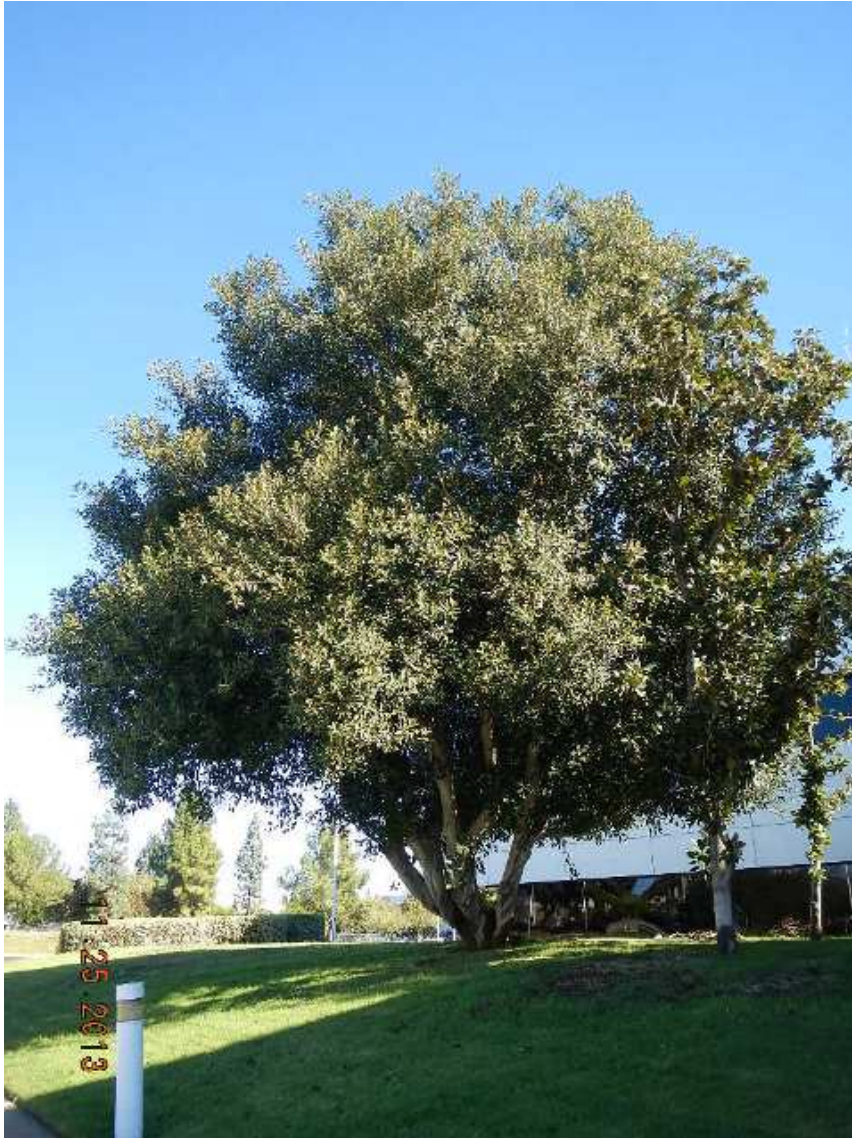
The large ficus is very healthy, but has shallow roots and weak structurally.

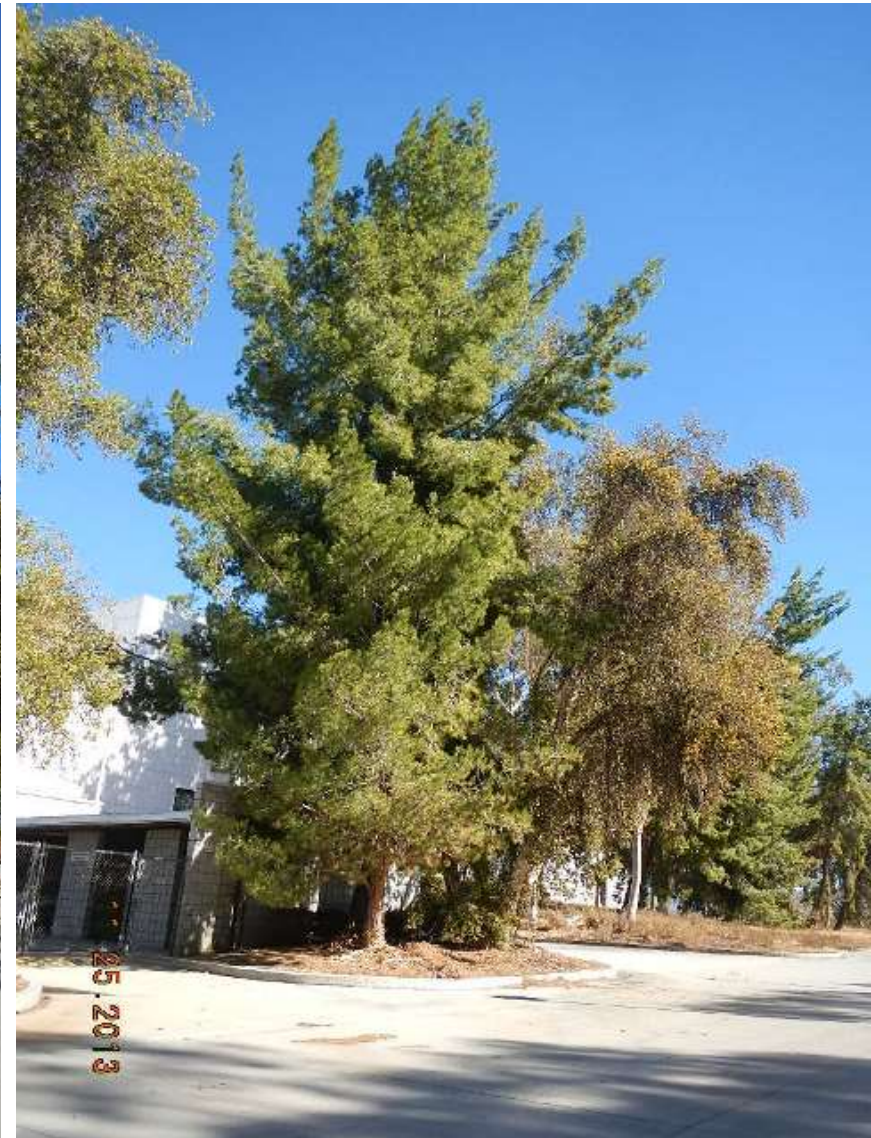
The Aleppo pine is healthy, but the paperbark is declining.

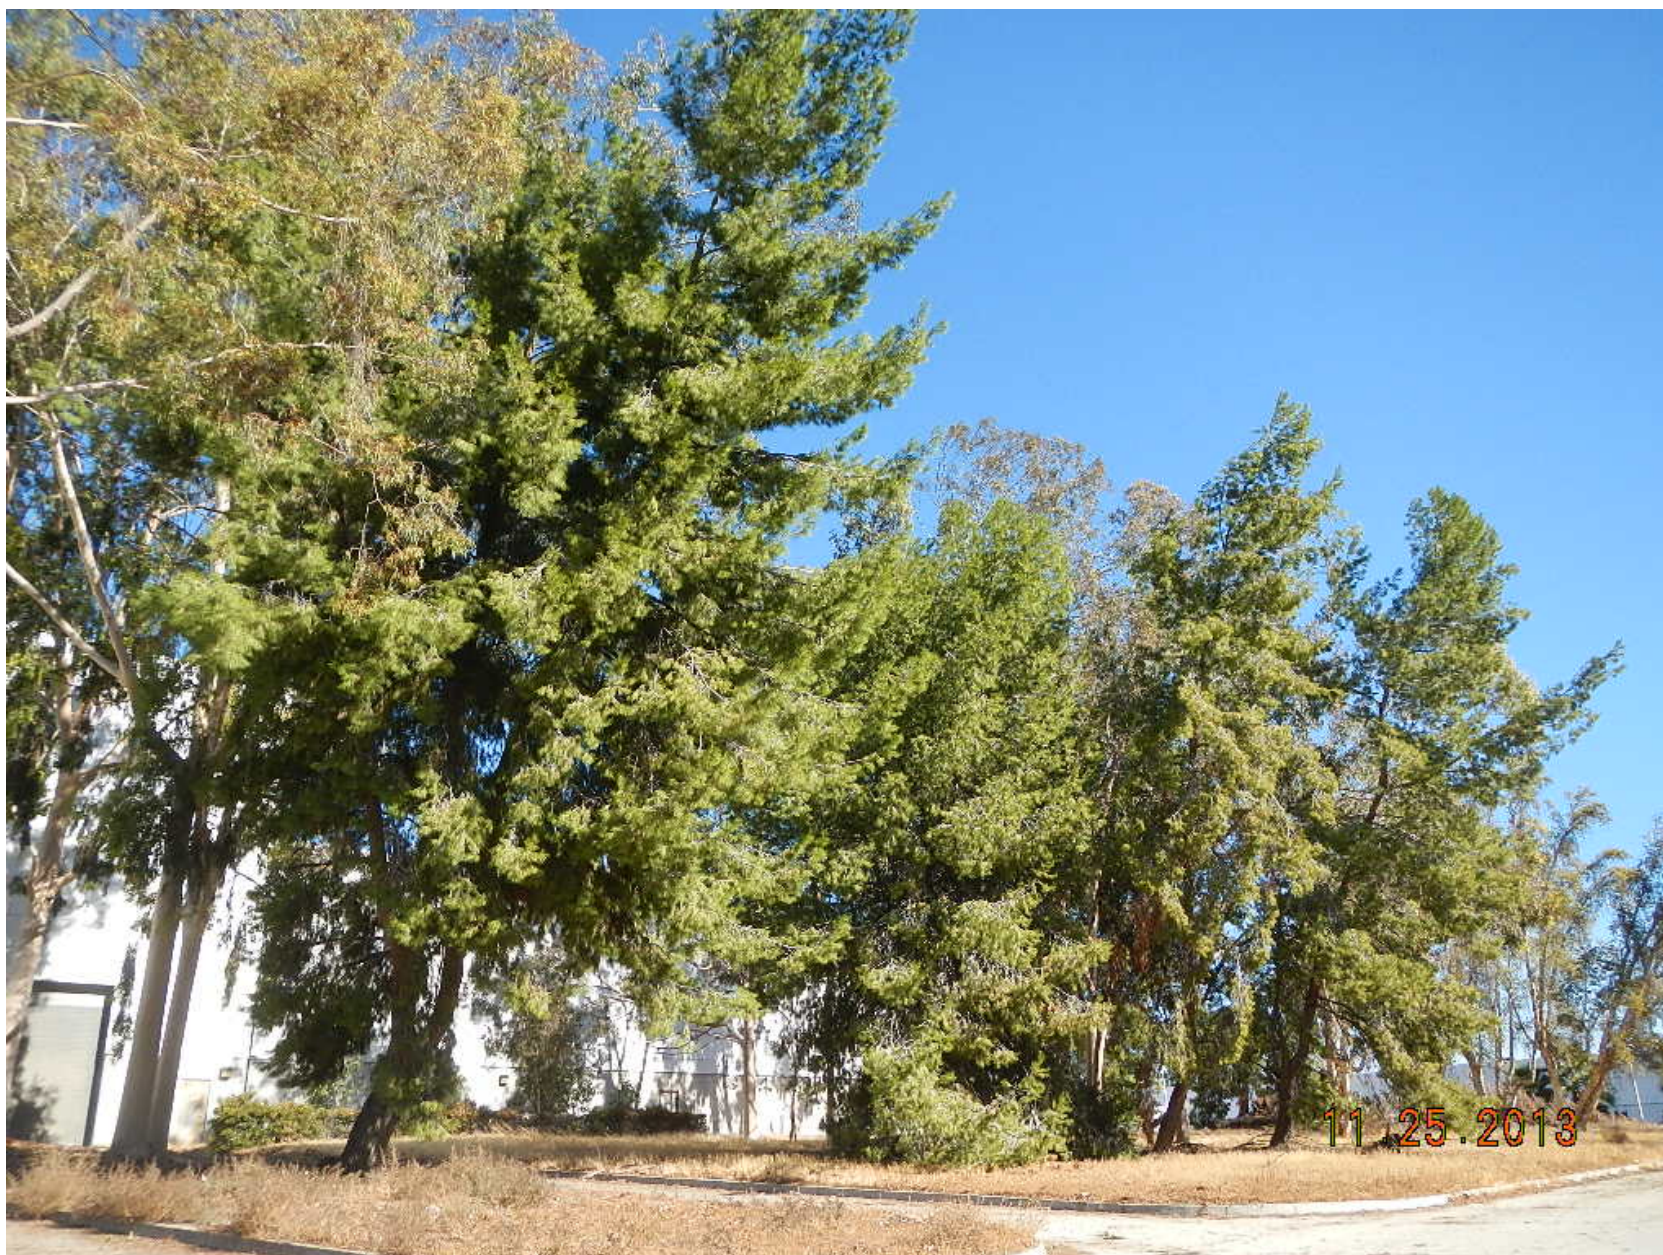
The pines lean out away from the building.

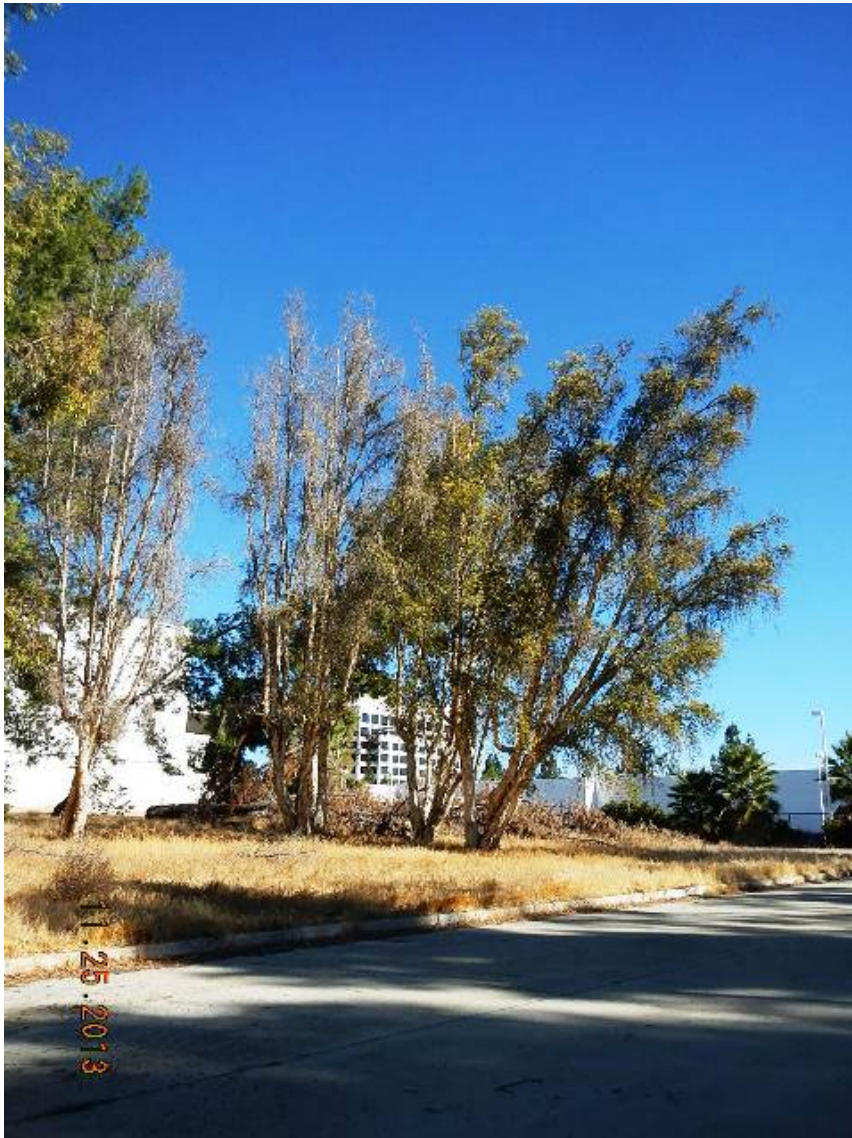
The rest of the paperbarks are severely declining.

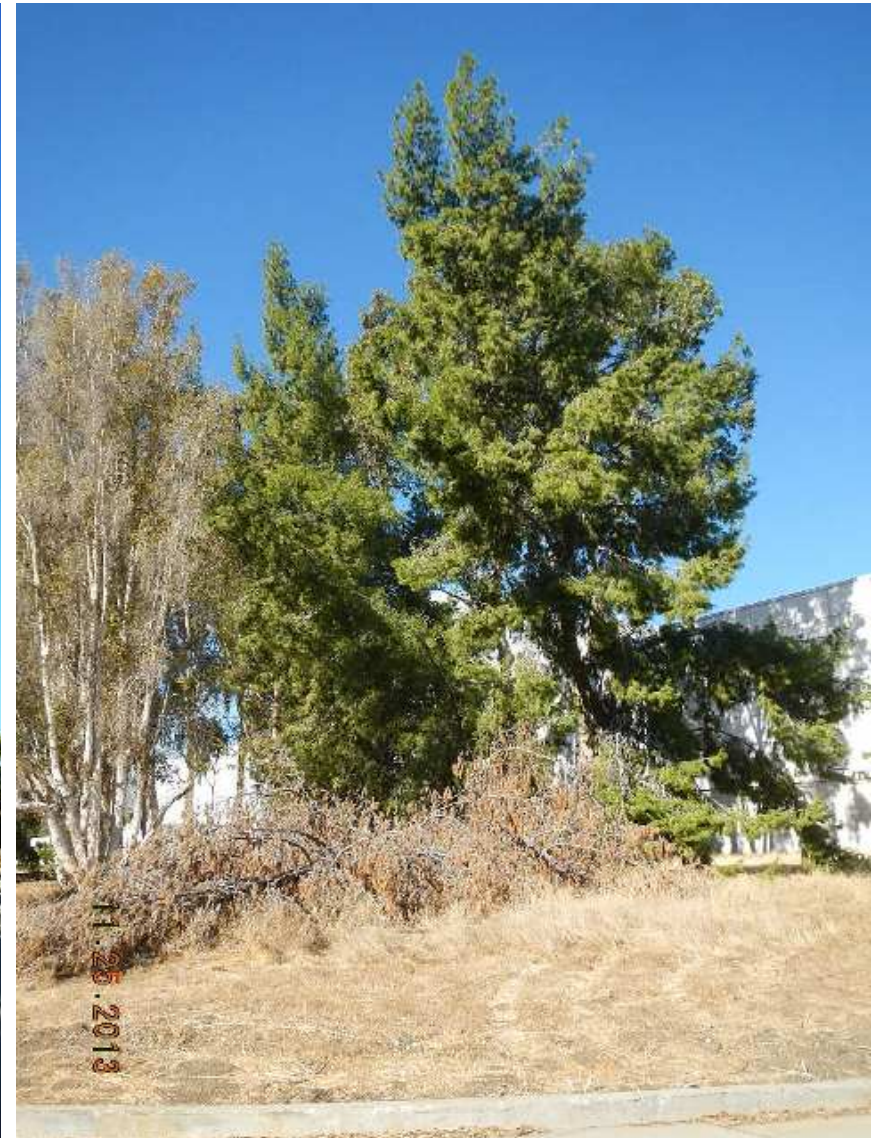
Note the fallen Aleppo pine in the foreground.

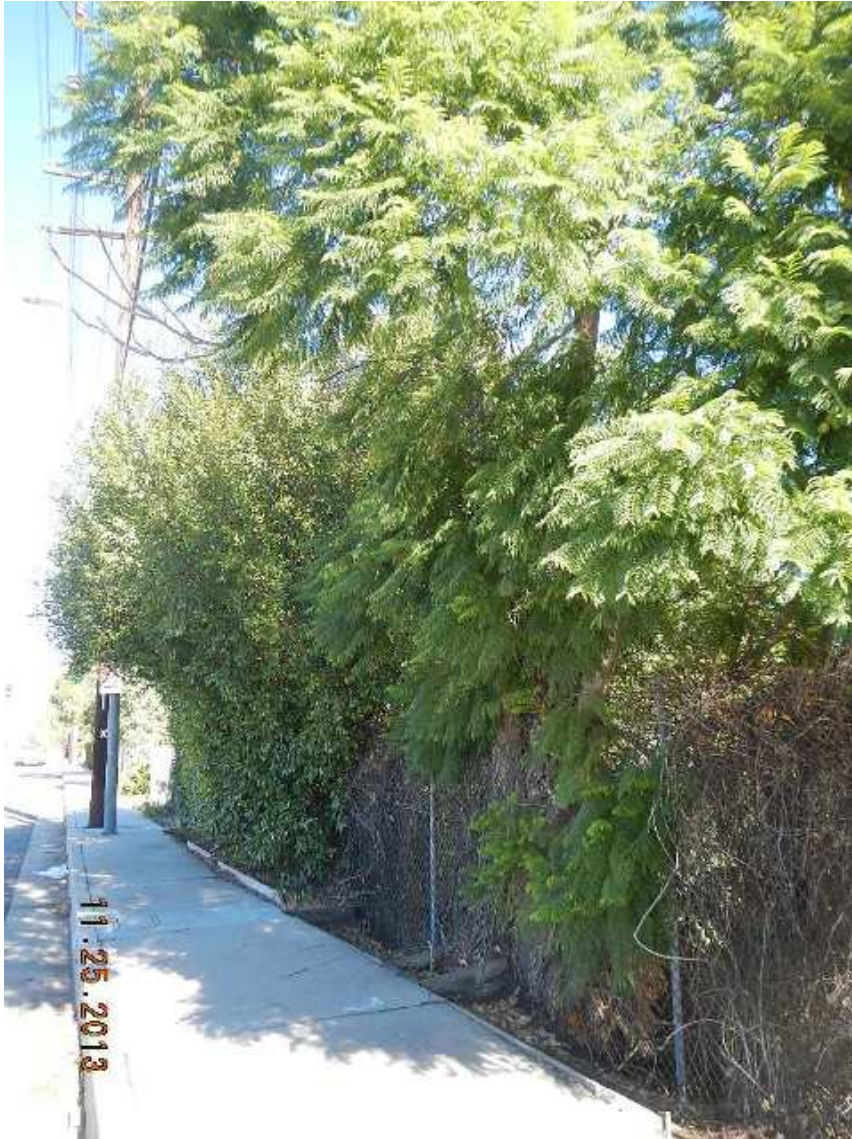
A jacaranda in a small opening and intertwined in the fence.
