Consulting Arborist's Report
December 2, 2013

Tree Evaluation and Preservation Study

MGA, Chatsworth

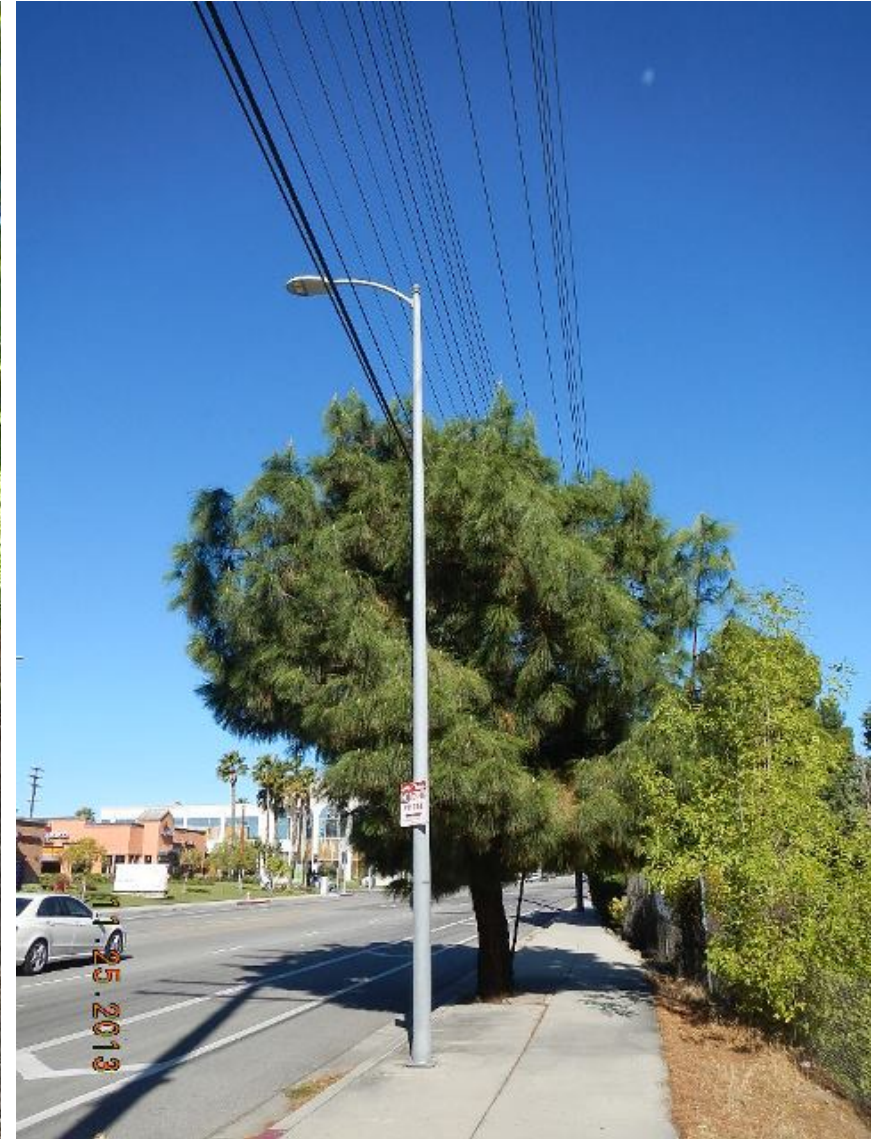
Planting Canary Island pine street trees below the wires was a mistake

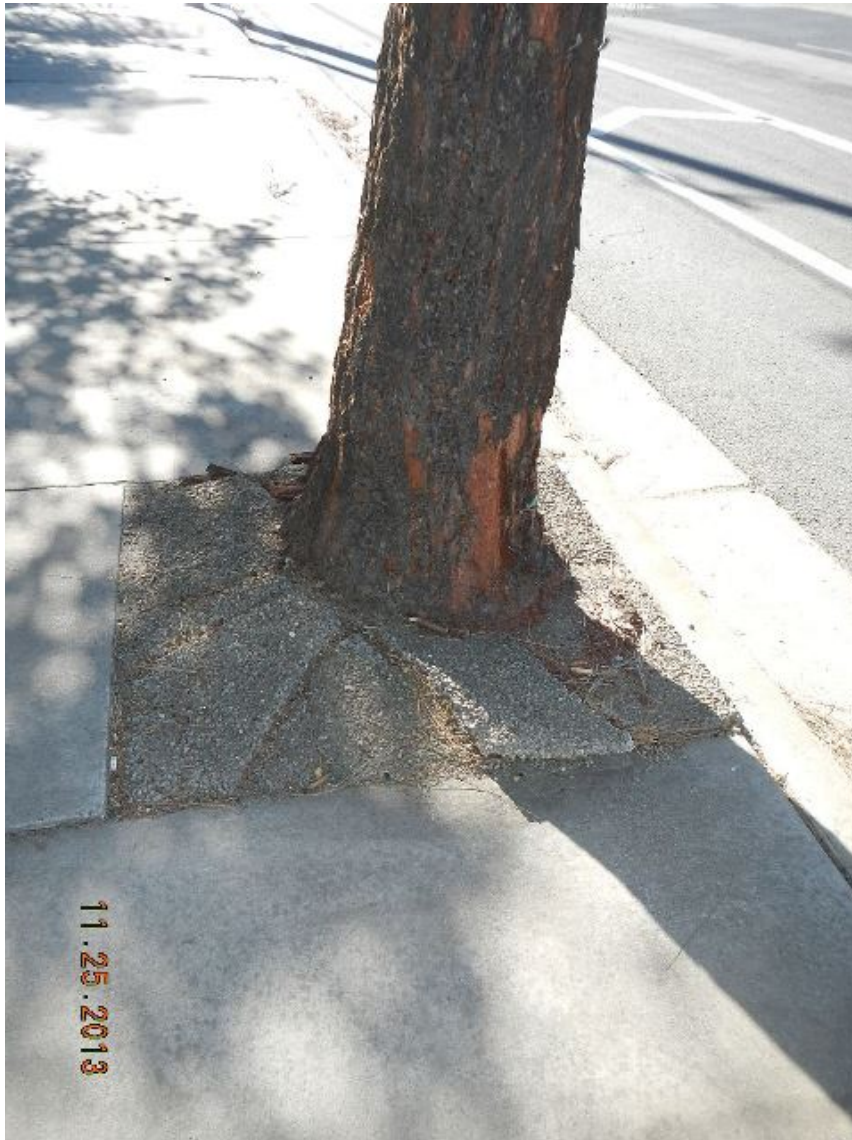
The tree wells are also too small for these pines.

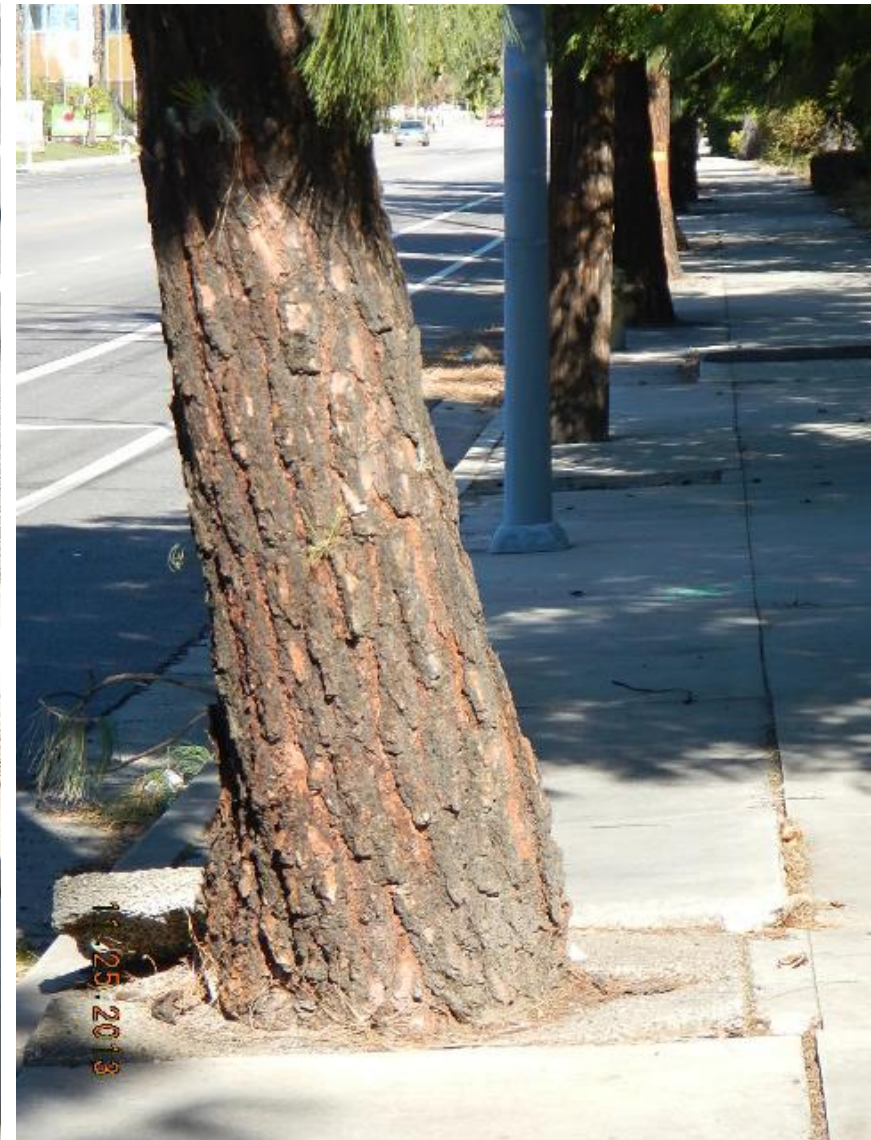
The collars around the base are girdling the trunks.

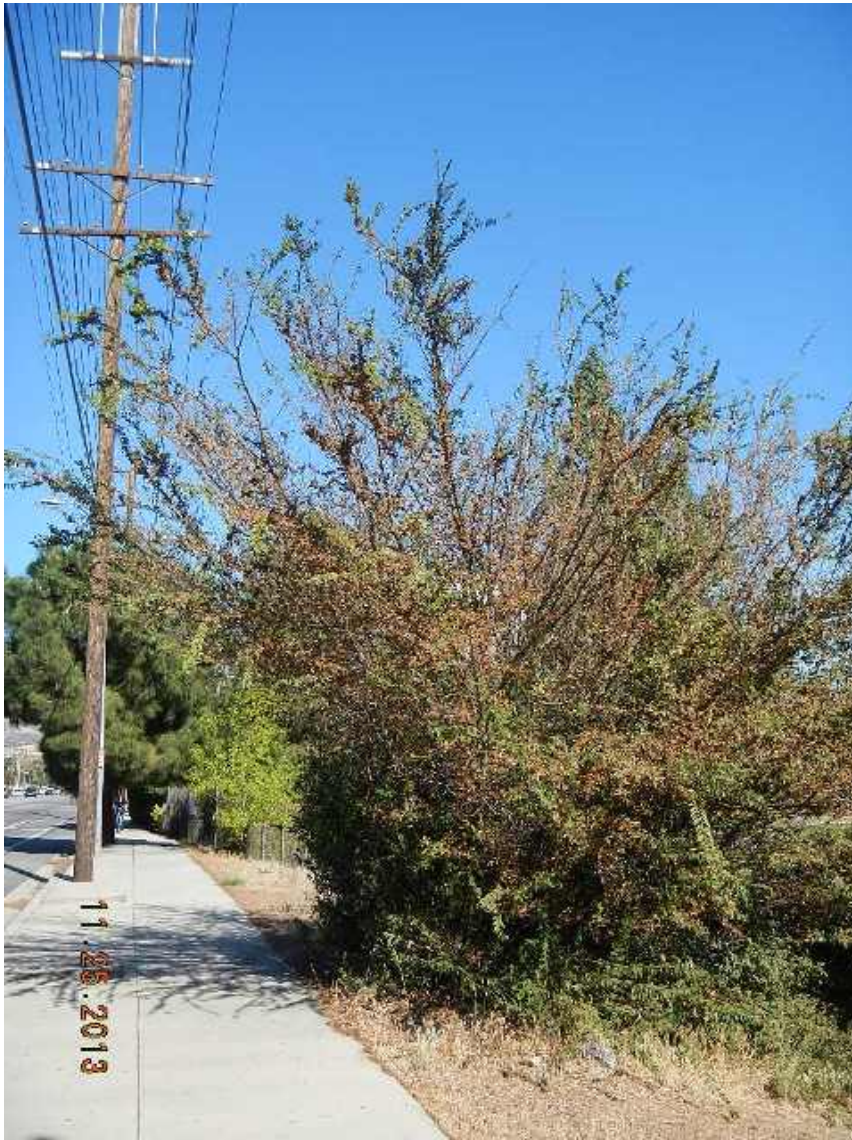
This Chinese elm is also a weed tree or stump sprout.

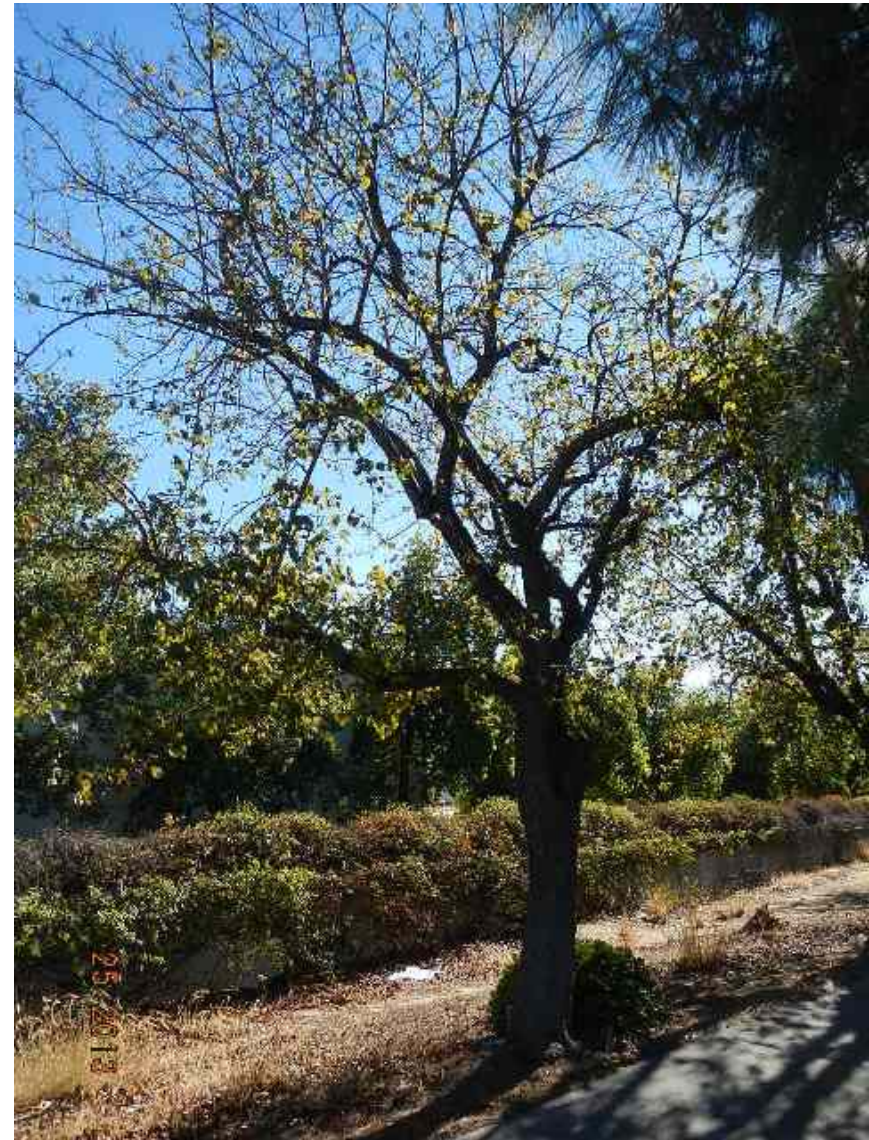
The evergreen pears are drought stressed and weak structurally.

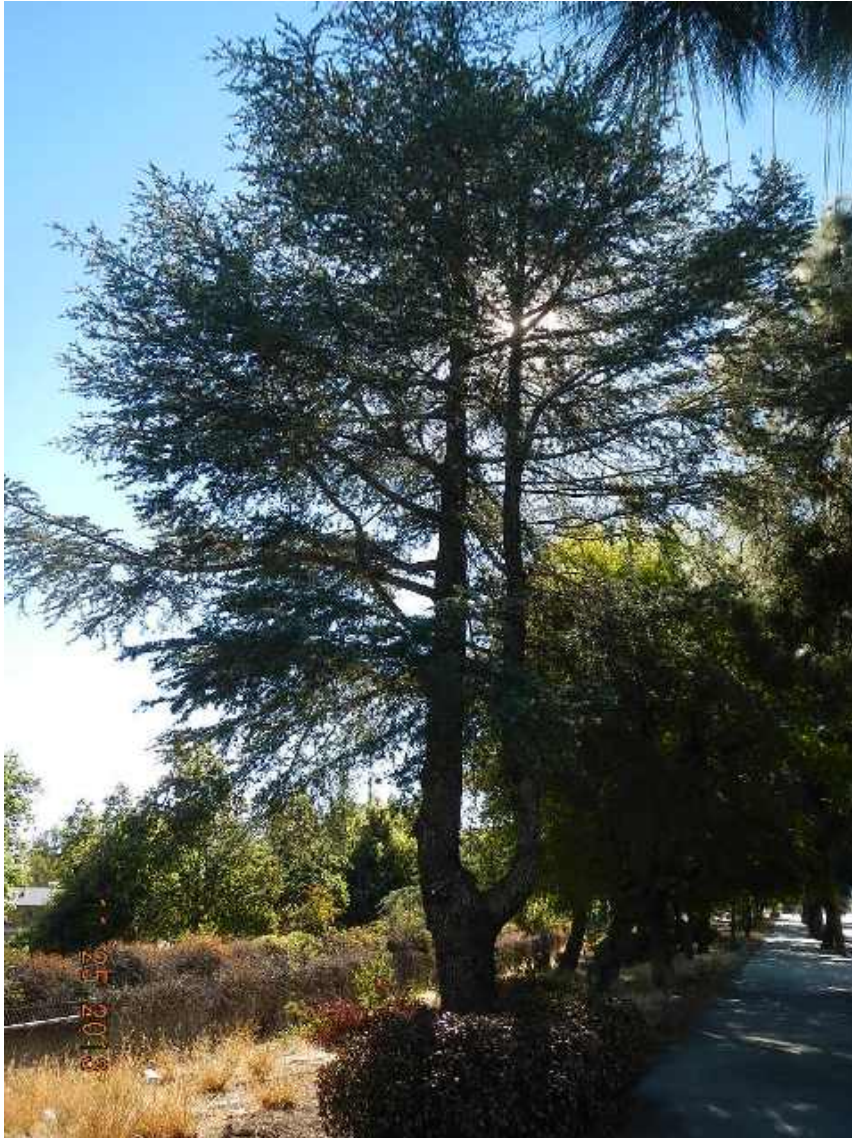
Many of the deodars were topped and codominant.

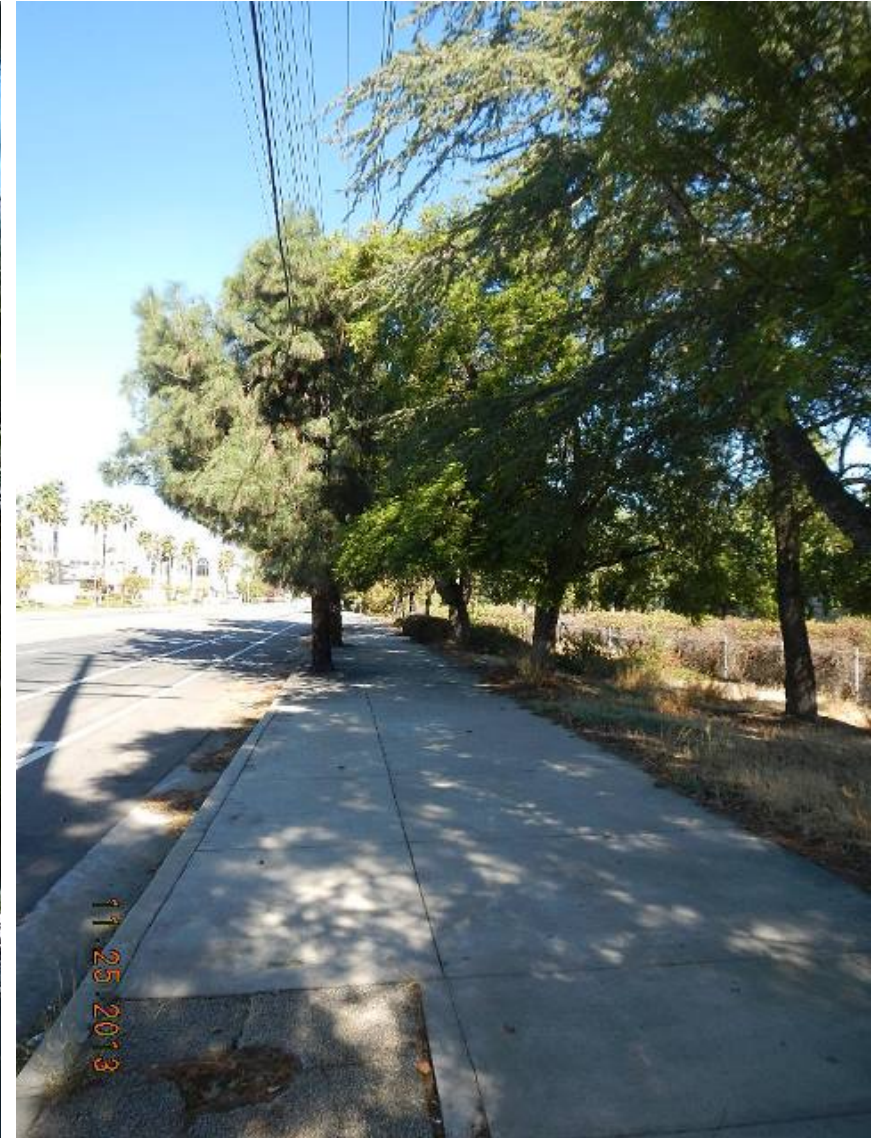
The street trees are crowded above and below ground.

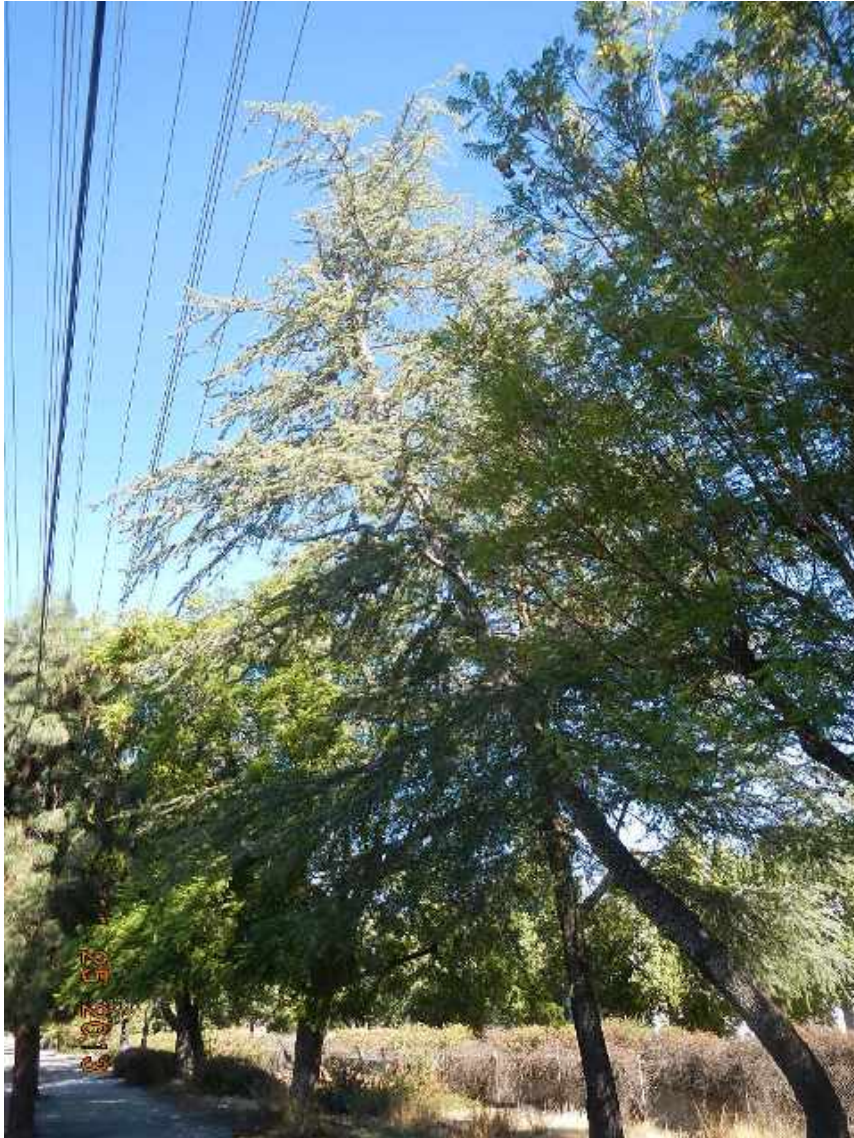
This deodar was leaning into the wires and had to be topped.

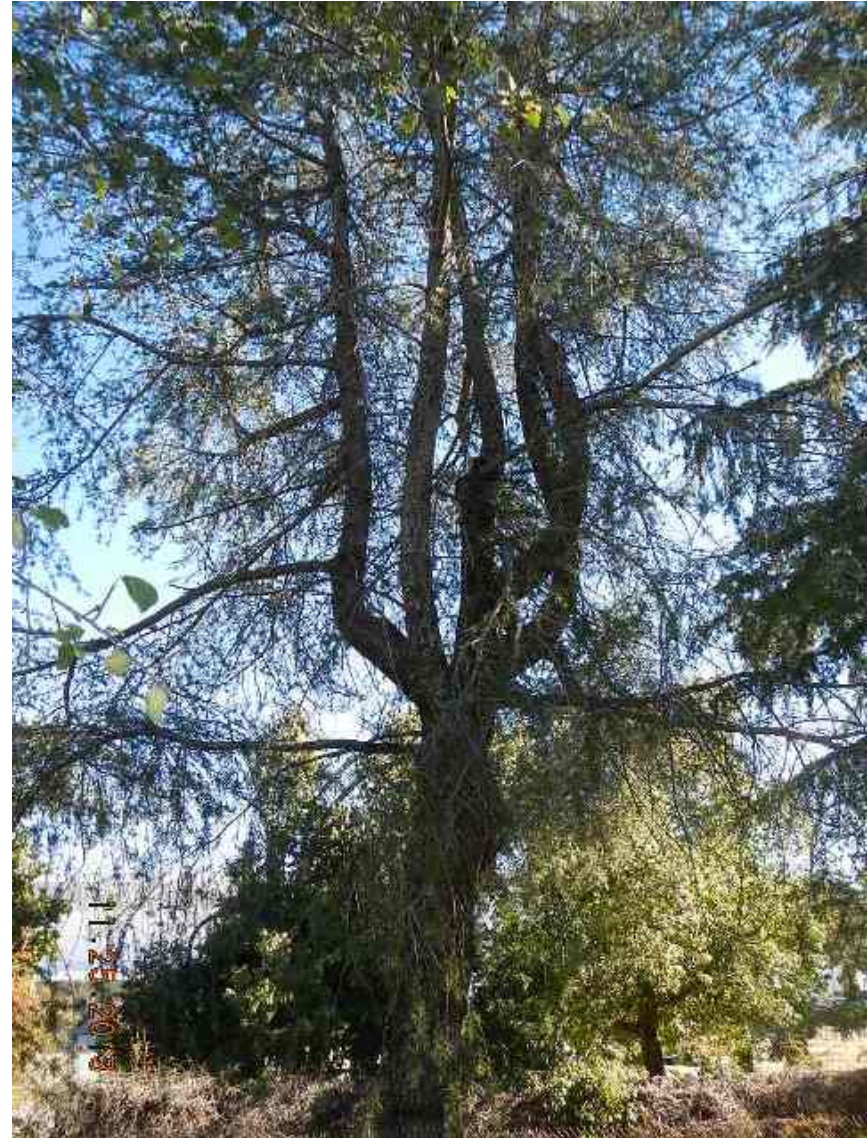
Who knows why this deodar was topped.

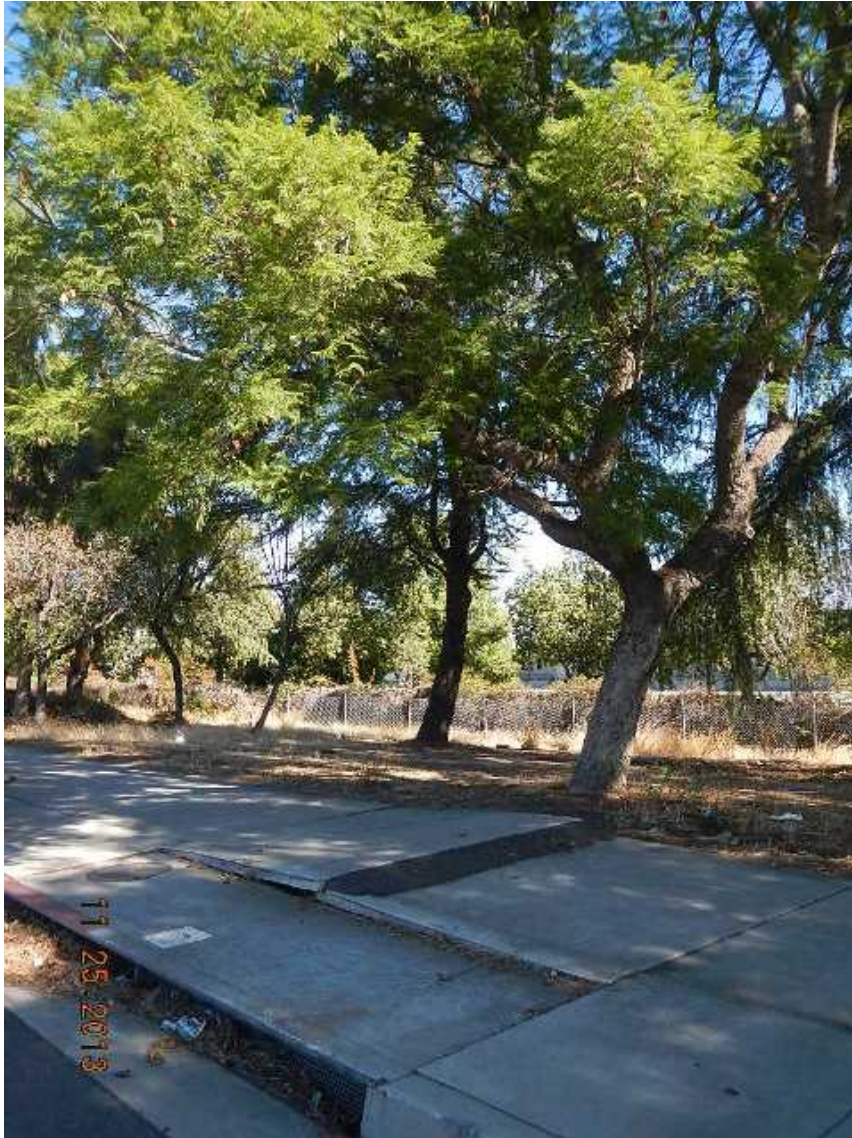
This larger jacaranda is lifting the sidewalk.

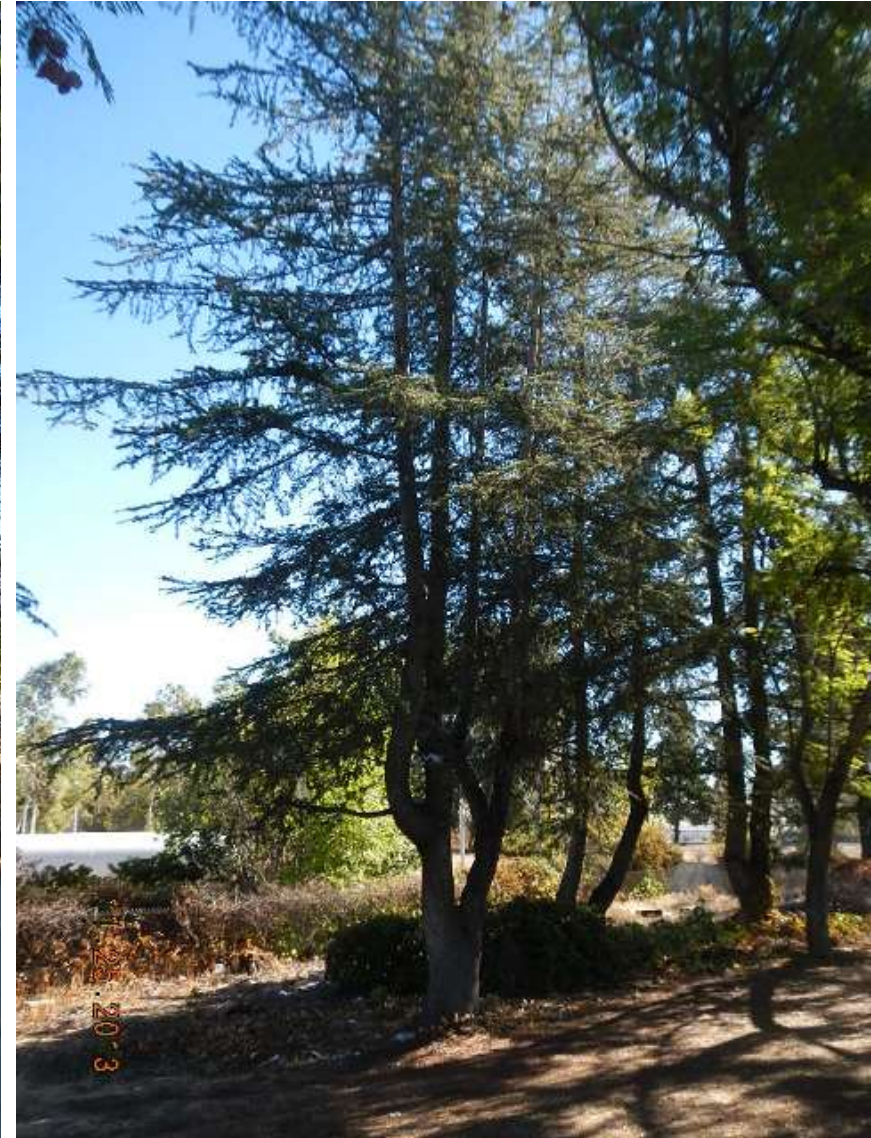
More topped and crowded deodars.

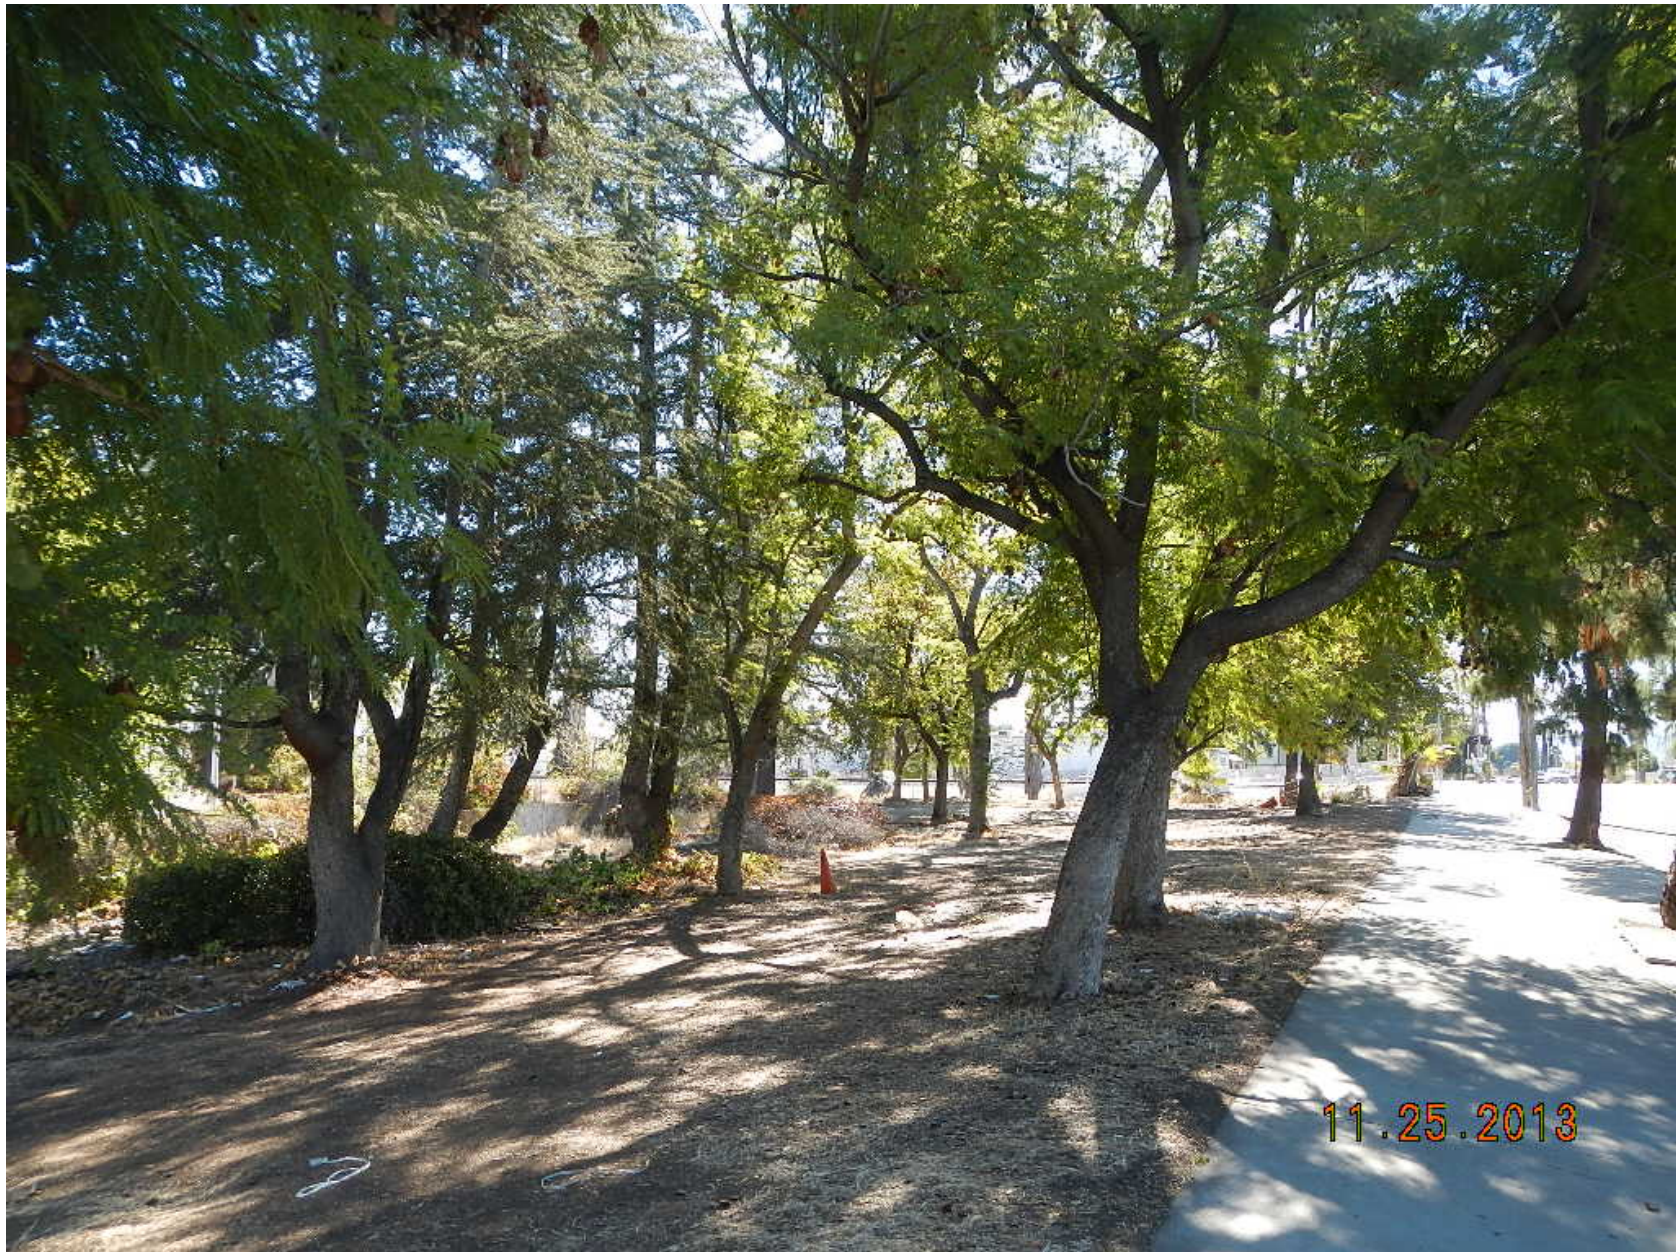
Many of the trees at the south end of the western strip are over-crowded and have awkward form.

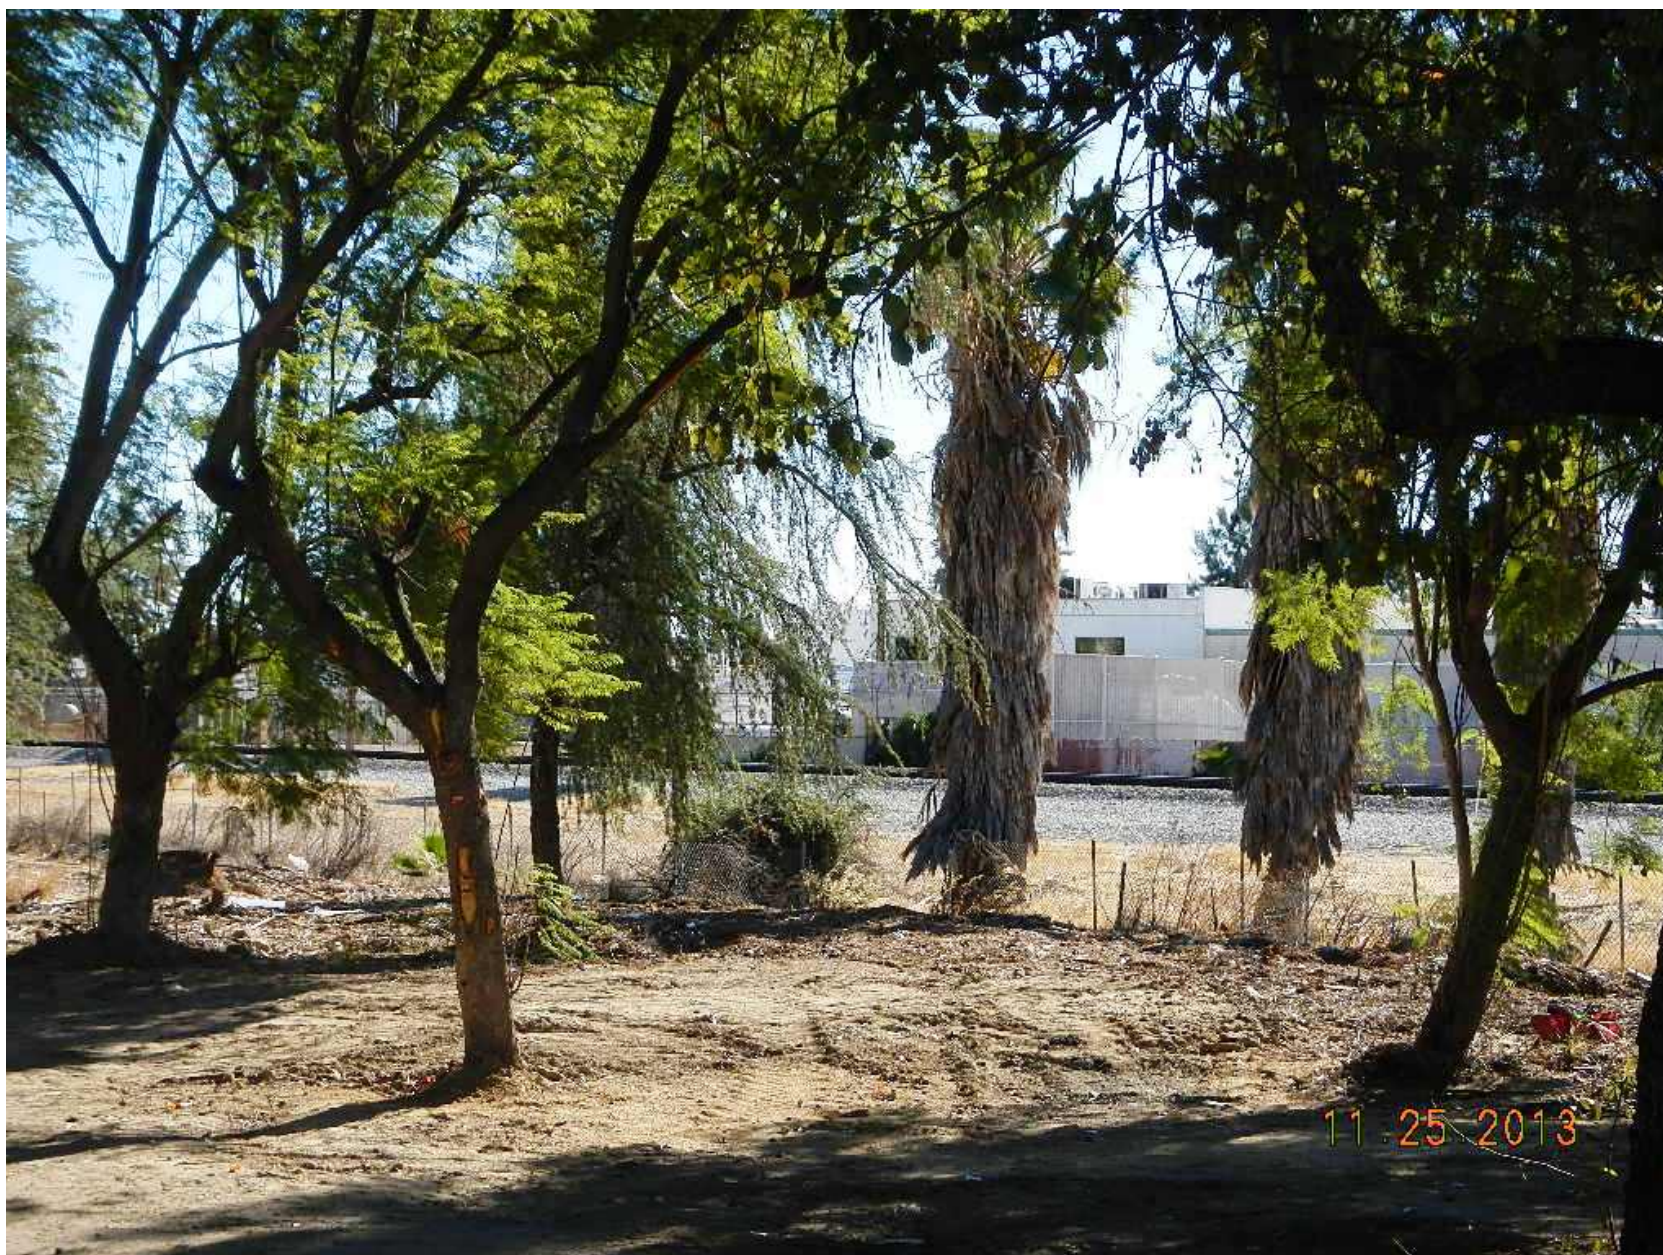
This area was graded and the equipment damaged tree trunks and limbs. Fill was left over the roots.

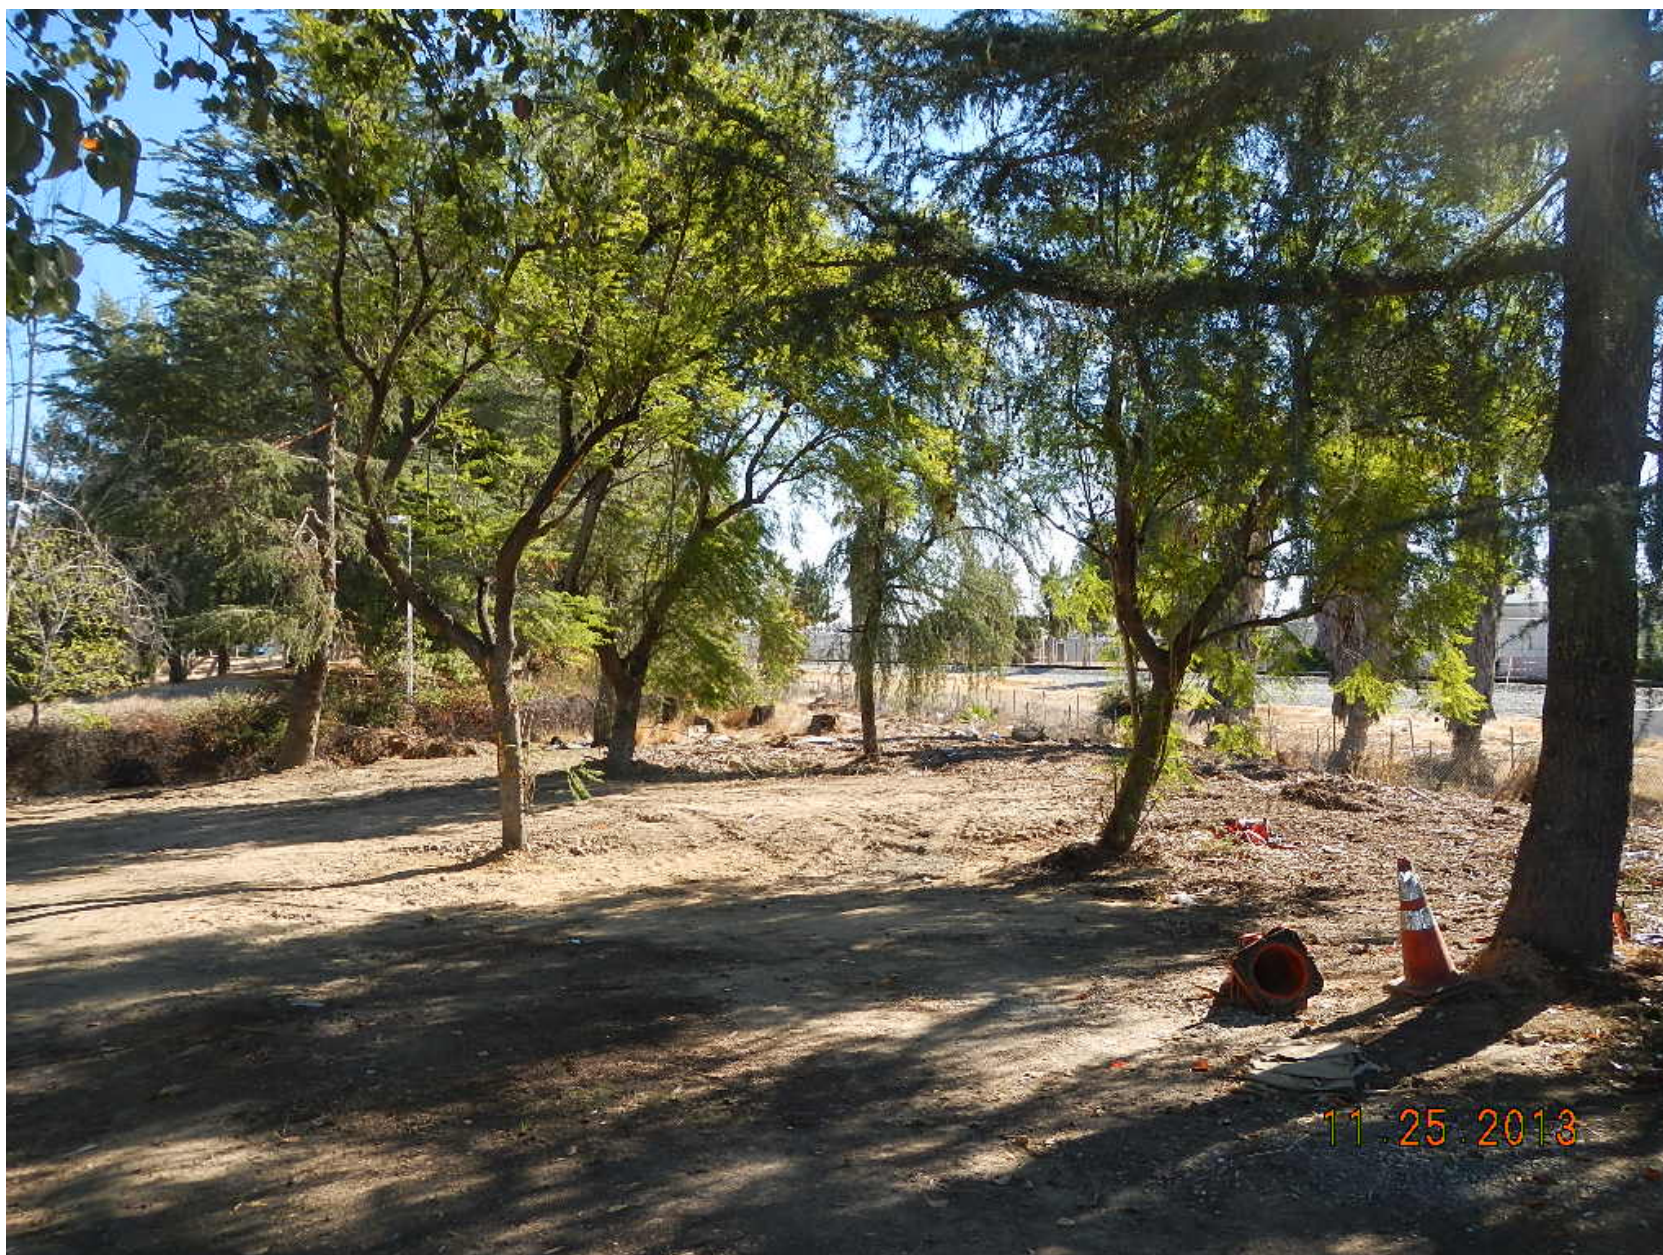
This fresh fill will soon begin to affect the health of these trees adversely.

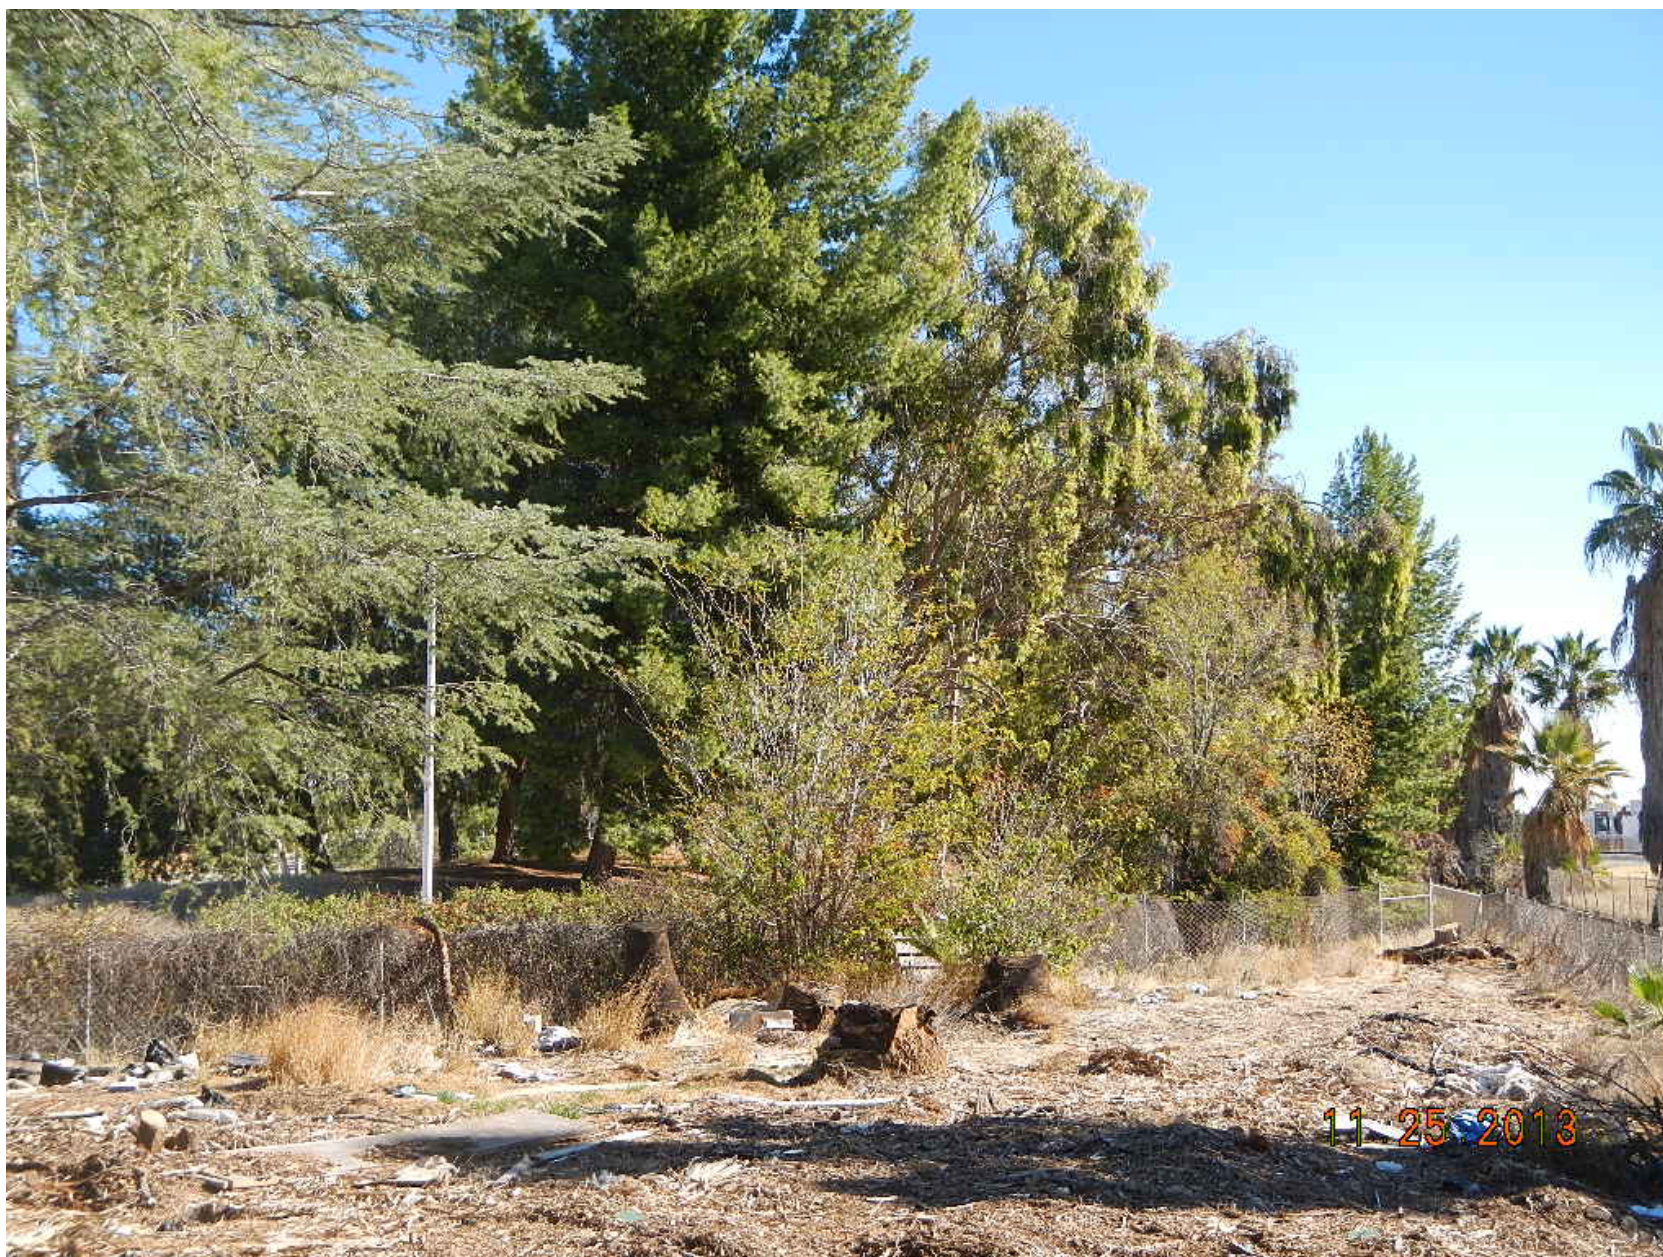
Note the burned stumps of Mexican fan palms just south of the channel.

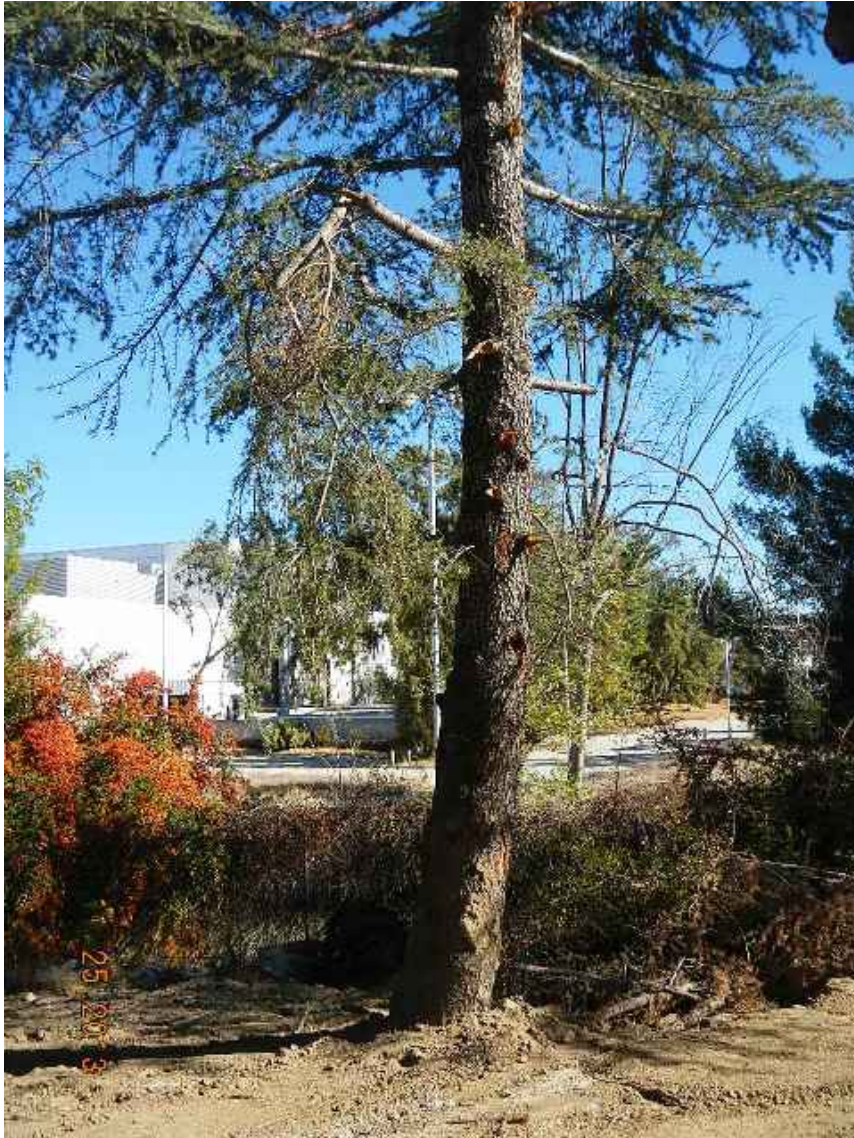
Note the recent damage to this deodar.
