Arborist Report

*200 Room Hotel
20401 Ventura Boulevard
Woodland Hills, California 91364*

February 28, 2017

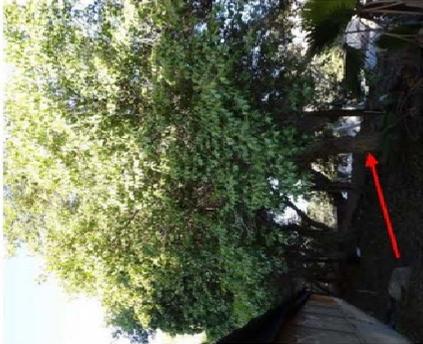
Tree #'s 180 through 184, 187, 188, 191 and 192 – These nine mature trees include three shiny xylosma, two evergreen pear trees, one Mexican fan palm, one California juniper (*Juniperus californica*) and two shamel ash. The trees are located near the northerly property line. The limits of excavation for the proposed hotel and parking structure would occur within their critical root zones, closer than five times diameter at

| Tree Number | Species | | dBH (inches) | Canopy (feet) | Height (feet) | Health | Appearance | Comments |
|---|---|---|---|---|---|---|---|---|
| 182 | <i>Xylosma congesta</i> | shiny xylosma | 13 | 22 | 30 | C- | C- | |

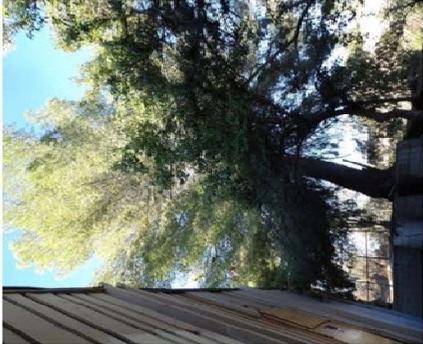
Tree #'s 185, 186 and 189 – These three mature trees include one Aleppo pine (*Pinus halepensis*), one Mexican fan palm (*Washingtonia robusta*) and one Chinese juniper (*Juniperus chinensis*). These trees are located near the northerly property line and are within the limits of grading for the proposed hotel and parking structure and would therefore need to be removed to construct the project as proposed.

| Tree Number | Species | | dBH (inches) | Canopy (feet) | Height (feet) | Health | Appearance | Comments |
|---|---|---|---|---|---|---|---|---|
| 185 | <i>Pinus halepensis</i> | Aleppo pine | 24 (est.) | 35 | 55 | C | B | Lean, bow |

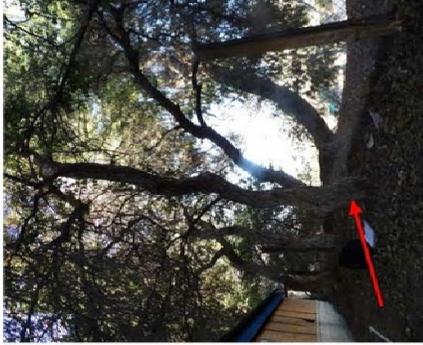
| Tree Number | Species | | dBH (inches) | Canopy (feet) | Height (feet) | Health | Appearance | Comments |
|---|---|---|---|---|---|---|---|---|
| 181 | <i>Xylosma congesta</i> | shiny xylosma | 11 @ 2.4' | 15 | 23 | D+ | D | Suppressed by pine |

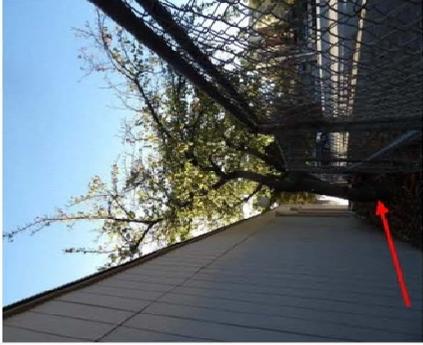
| Tree Number | Species | | dBH (inches) | Canopy (feet) | Height (feet) | Health | Appearance | Comments |
|---|---|---|---|---|---|---|---|---|
| 184 | <i>Pyrus kawakamii</i> | evergreen pear | 9 | 18 | 21 | C- | C- | Dieback |

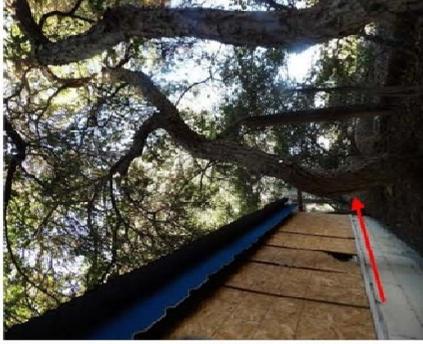
| Tree Number | Species | | dBH (inches) | Canopy (feet) | Height (feet) | Health | Appearance | Comments |
|---|---|---|---|---|---|---|---|---|
| 180 | <i>Xylosma congesta</i> | shiny xylosma | 10 | 18 | 25 | D+ | D | Suppressed by pine |

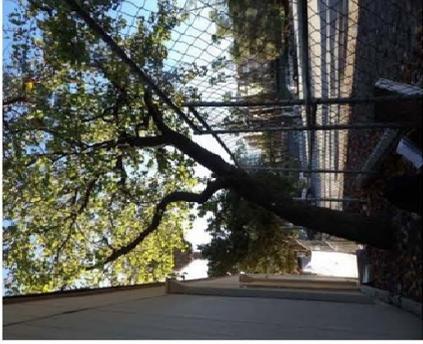
| Tree Number | Species | | dBH (inches) | Canopy (feet) | Height (feet) | Health | Appearance | Comments |
|---|---|---|---|---|---|---|---|---|
| 183 | <i>Pyrus kawakamii</i> | evergreen pear | 11 | 20 | 25 | C- | C- | Dieback |

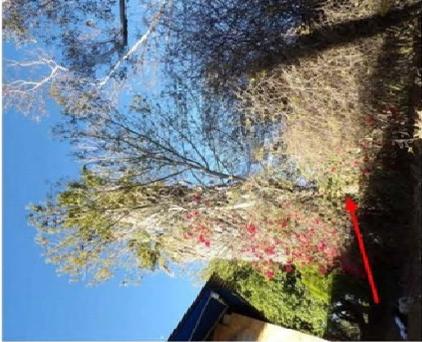
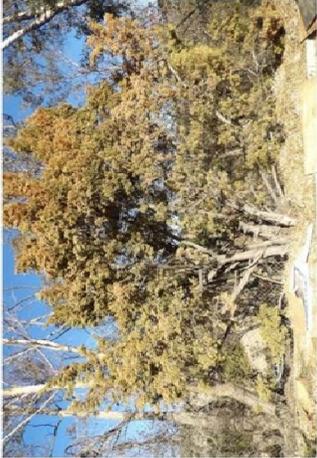
| | <p>Tree #188</p> |

| Tree Number | Species | | dBH (inches) | Canopy (feet) | Height (feet) | Health | Appearance | Comments |
|---|---|---|---|---|---|---|---|---|
| 188 | <i>Fraxinus uhdei</i> | evergreen ash | 11 | 30 | 45 | C | C | |

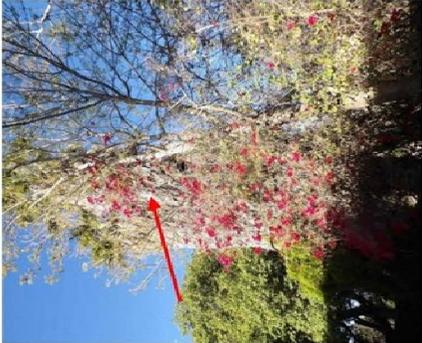
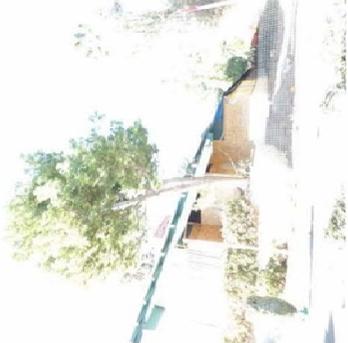
| | <p>Tree #190</p> |

Tree #'s 190, 194, 195 and 196 – These four mature trees include one Aleppo pine, two Canary Island pines (*Pinus canariensis*) and one Mexican fan palm. They are located within planters adjacent to the existing structure. The trees are within the footprint of the proposed hotel and parking structure and would therefore need to be removed to construct the project as proposed.

| Tree Number | Species | | dBH (inches) | Canopy (feet) | Height (feet) | Health | Appearance | Comments |
|---|---|---|---|---|---|---|---|---|
| 190 | <i>Pinus halepensis</i> | Aleppo pine | 15, 12 | 30 | 32 | B | B | 12-inch trunk embedding planter wall |

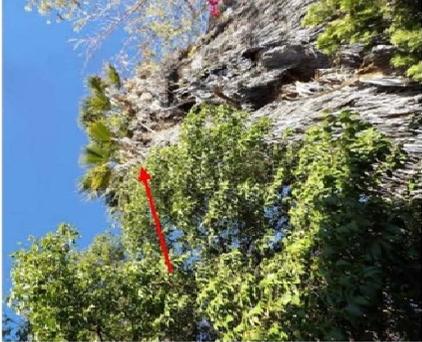
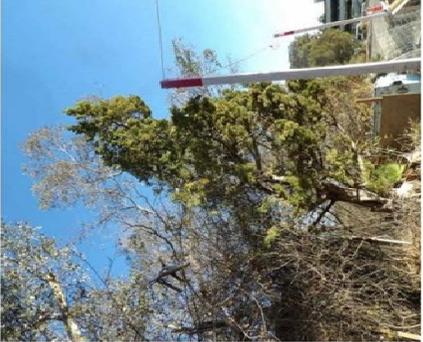
| | <p>Tree #189</p> |

| Tree Number | Species | | dBH (inches) | Canopy (feet) | Height (feet) | Health | Appearance | Comments |
|---|---|---|---|---|---|---|---|---|
| 189 | <i>Juniperus chinensis</i> | Chinese juniper | 12, 8 | 12 | 28 | C | C | Cavity at root crown, somewhat one-sided |

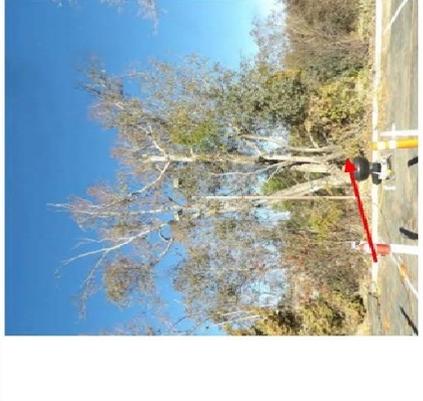
| Tree Number | Species | | dBH (inches) | Canopy (feet) | Height (feet) | Health | Appearance | Comments |
|---|---|---|---|---|---|---|---|---|
| 192 | <i>Fraxinus uhdei</i> | evergreen ash | 6, 6 | 10 | 28 | C- | D | Sparse, one trunk topped at five feet |

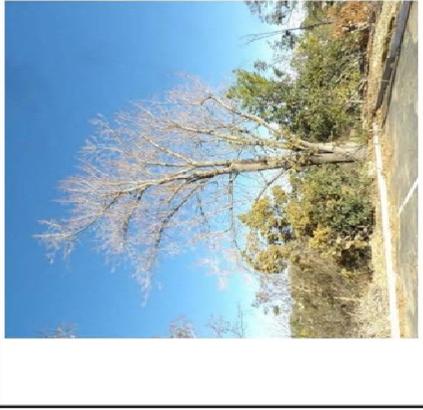
Tree #193 – This shamel ash is located within the northeasterly corner of the property. The tree is a poor specimen with severe included bark and would be removed to install the project landscaping as proposed.

| Tree Number | Species | | dBH (inches) | Canopy (feet) | Height (feet) | Health | Appearance | Comments |
|---|---|---|---|---|---|---|---|---|
| 193 | <i>Fraxinus uhdei</i> | evergreen ash | 9 (est.), 15 | 23 | 30 | C- | C- | Mostly out of leaf, tip burn on leaflets, included bark |

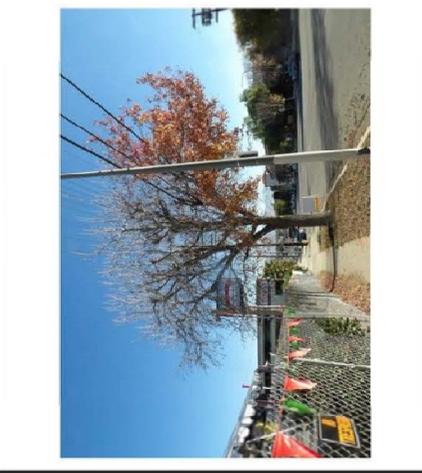
Tree #'s 197 through 199 – These three mature American sweetgums are street trees located adjacent to Ventura Boulevard. Construction of a new sidewalk and paving would occur throughout the trees' drip lines and construction of a city standard curb would occur within less than two feet of the trunks on their southerly sides. The trees would therefore need to be removed to construct the project as proposed.

| Tree Number | Species | | dBH (inches) | Canopy (feet) | Height (feet) | Health | Appearance | Comments |
|---|---|---|---|---|---|---|---|---|
| 197 | <i>Liquidambar styraciflua</i> | American sweetgum | 20 | 38 | 35 | C- | C- | Street tree, topped, under utility lines, raising sidewalk and curb |

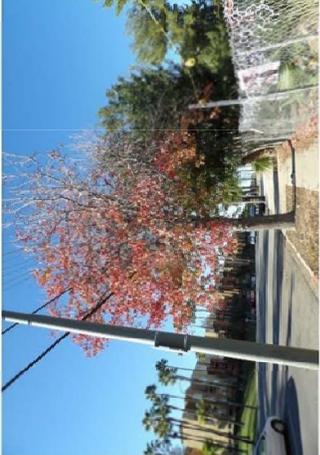
| | Tree #200 |

Tree #200 – This American sweetgum is a street tree located adjacent to Ventura Boulevard. The tree is within the footprint of the proposed westerly driveway and would therefore need to be removed to construct the project as proposed.

| Tree Number | Species | | dBH (inches) | Canopy (feet) | Height (feet) | Health | Appearance | Comments |
|---|---|---|---|---|---|---|---|---|
| 200 | <i>Liquidambar styraciflua</i> | American sweetgum | 19 @ 3.8' | 38 | 35 | C- | C- | Street tree, topped, under utility lines, raising sidewalk and curb |

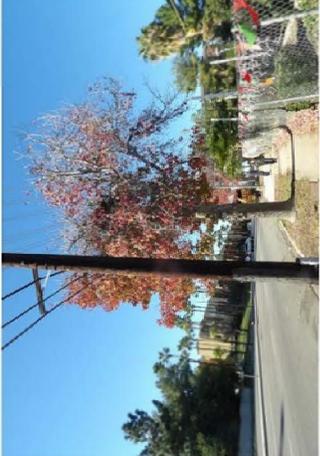
| | Tree #199 |

| Tree Number | Species | | dBH (inches) | Canopy (feet) | Height (feet) | Health | Appearance | Comments |
|---|---|---|---|---|---|---|---|---|
| 199 | <i>Liquidambar styraciflua</i> | American sweetgum | 21 | 35 | 35 | C- | C- | Street tree, topped, under utility lines, raising sidewalk and curb |

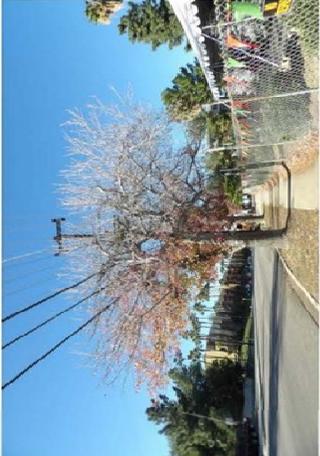
| | Tree #198 |

| Tree Number | Species | | dBH (inches) | Canopy (feet) | Height (feet) | Health | Appearance | Comments |
|---|---|---|---|---|---|---|---|---|
| 198 | <i>Liquidambar styraciflua</i> | American sweetgum | 24 @ 3.5' | 35 | 35 | C- | C- | Street tree, topped, under utility lines, raising sidewalk and curb |

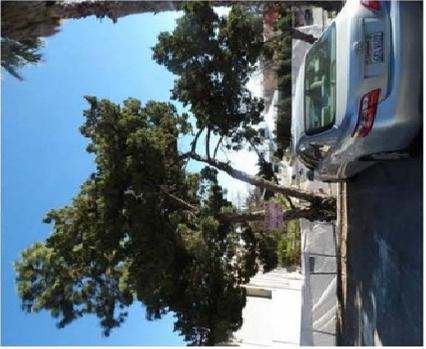
| | Tree #201 |

Tree #201 – This mature California juniper is located immediately east of the westerly property line, three feet from the limits of excavation for the proposed hotel and parking structure. The tree would therefore need to be removed to construct the project as proposed.

| Tree Number | Species | | dBH (inches) | Canopy (feet) | Height (feet) | Health | Appearance | Comments |
|---|---|---|---|---|---|---|---|---|
| 201 | <i>Juniperus chinensis</i> | Chinese juniper | 9, 9, 3 (est.) | 17 | 22 | C- | C- | |
