We are submitting our "Phase I Environmental Site Assessment, for 5525 West Sunset Boulevard, Los Angeles, California", SEG Report No. G-11-8697 prepared for Reliable Properties.

**PHASE I ENVIRONMENTAL SITE ASSESSMENT
5525 WEST SUNSET BOULEVARD
LOS ANGELES, CALIFORNIA**

SEG File No. 40437-1
SEG Report No. G-11-8697

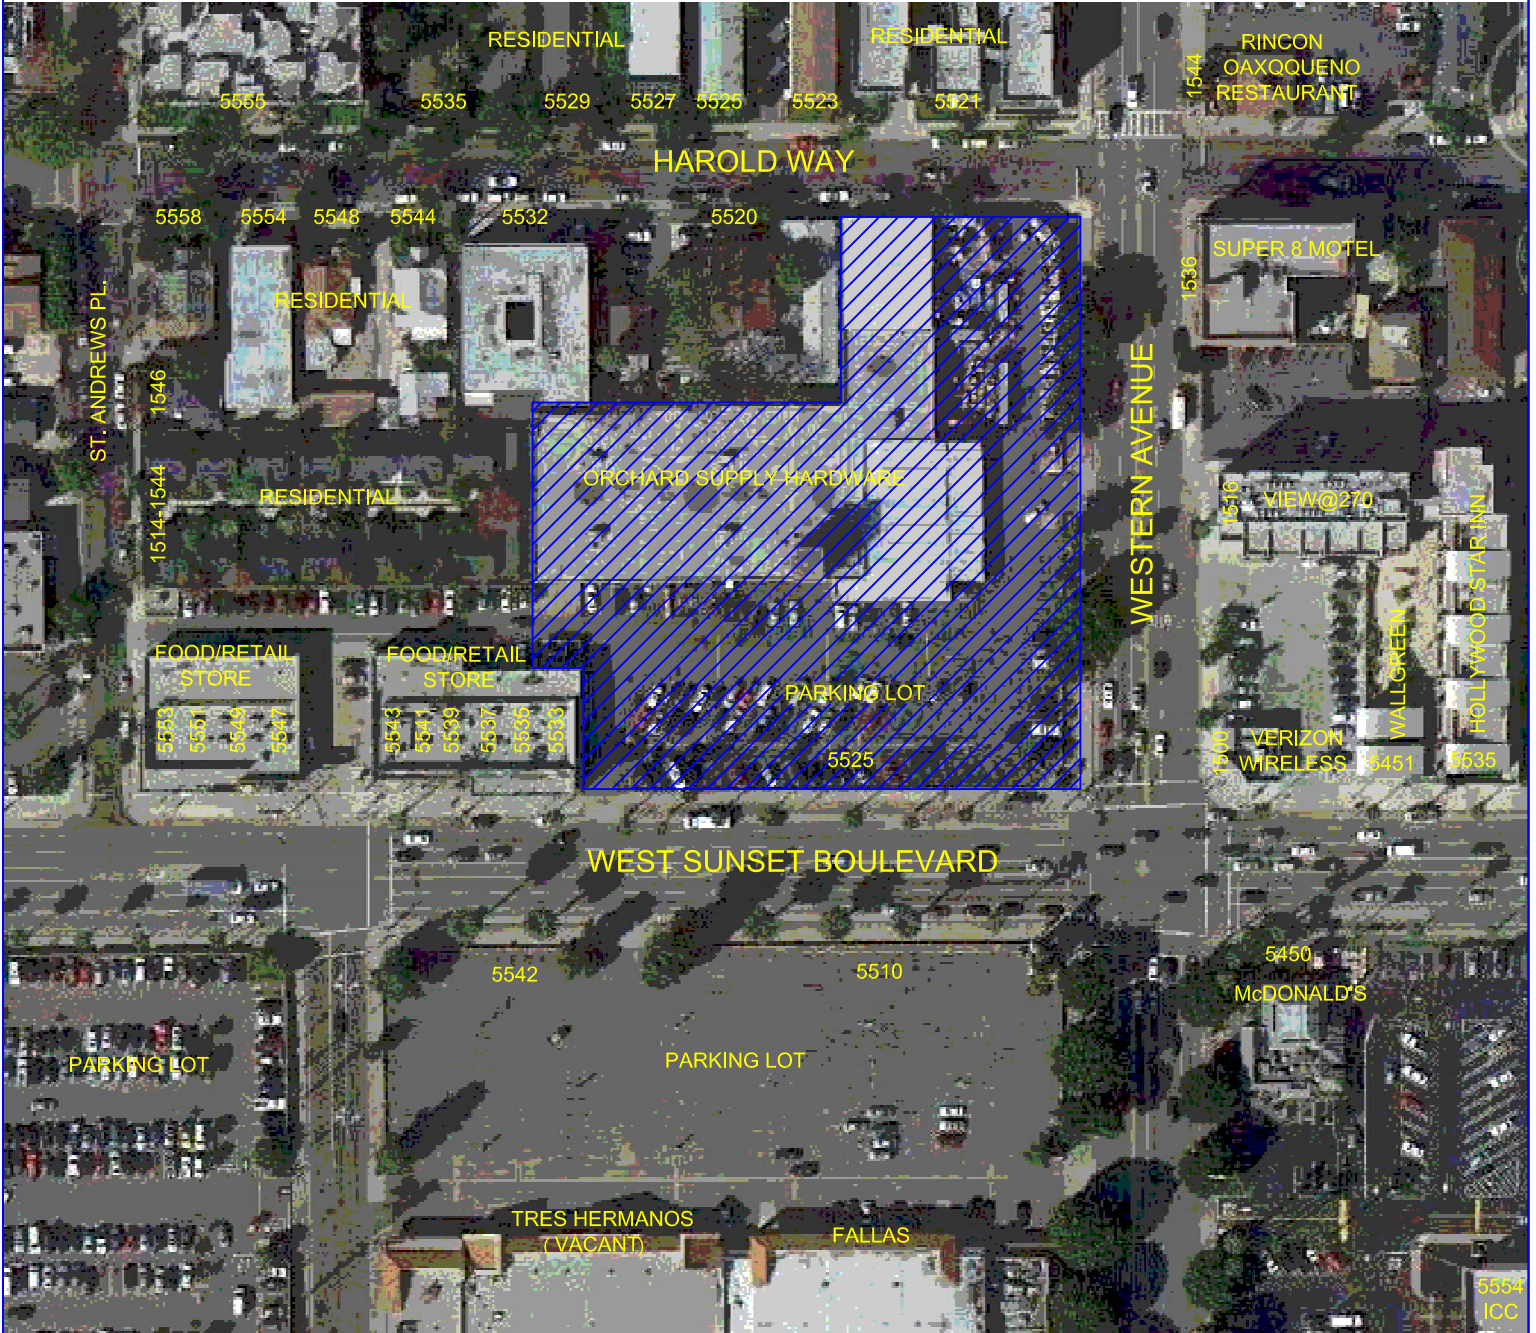
SITE SCHEMATIC

- 5533 W. SUNSET BLVD. - GAME STOP
- 5535 W. SUNSET BLVD. - SPRINT
- 5537 W. SUNSET BLVD. - SUBWAY
- 5539 W. SUNSET BLVD. - ONO HAWAIIAN BBQ
- 5541 W. SUNSET BLVD. - YOGURT LAND
- 5543 W. SUNSET BLVD. - PANDA EXPRESS

A reconnaissance of the site was performed by Ms. Ayesha Syeda and Mr. Eduardo Dela Cruz of Smith-Emery GeoServices (SEG) on November 11, 2011. The layout of the subject site and adjacent sites is shown on the Site Schematic, Plate No. 2. The layout of the subject site and items observed onsite is shown on the Subject Site Diagram, Plate No. 3. Photographs of the subject site are included as Plates No. 4A – 4C. The objective of the site reconnaissance is to obtain information indicating the likelihood of identifying recognized environmental conditions in connection with the property.

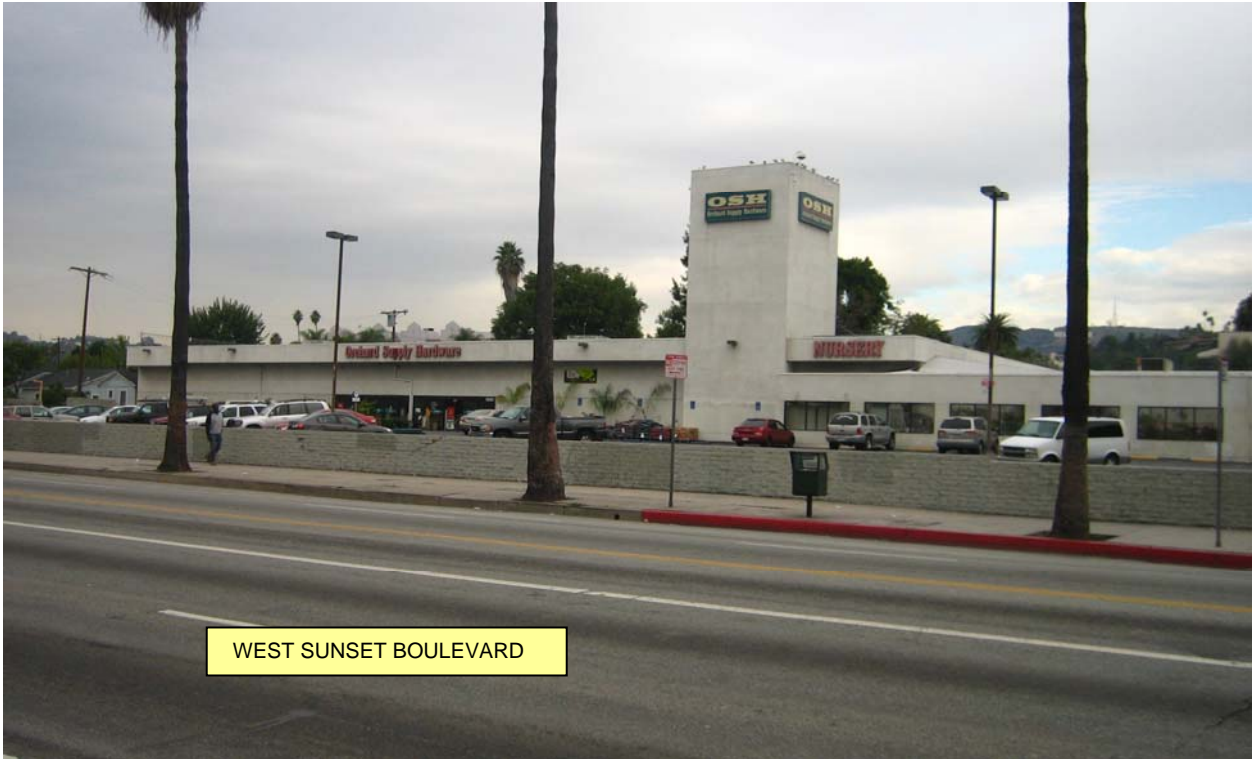
VIEW OF SUBJECT SITE FACING NORTH

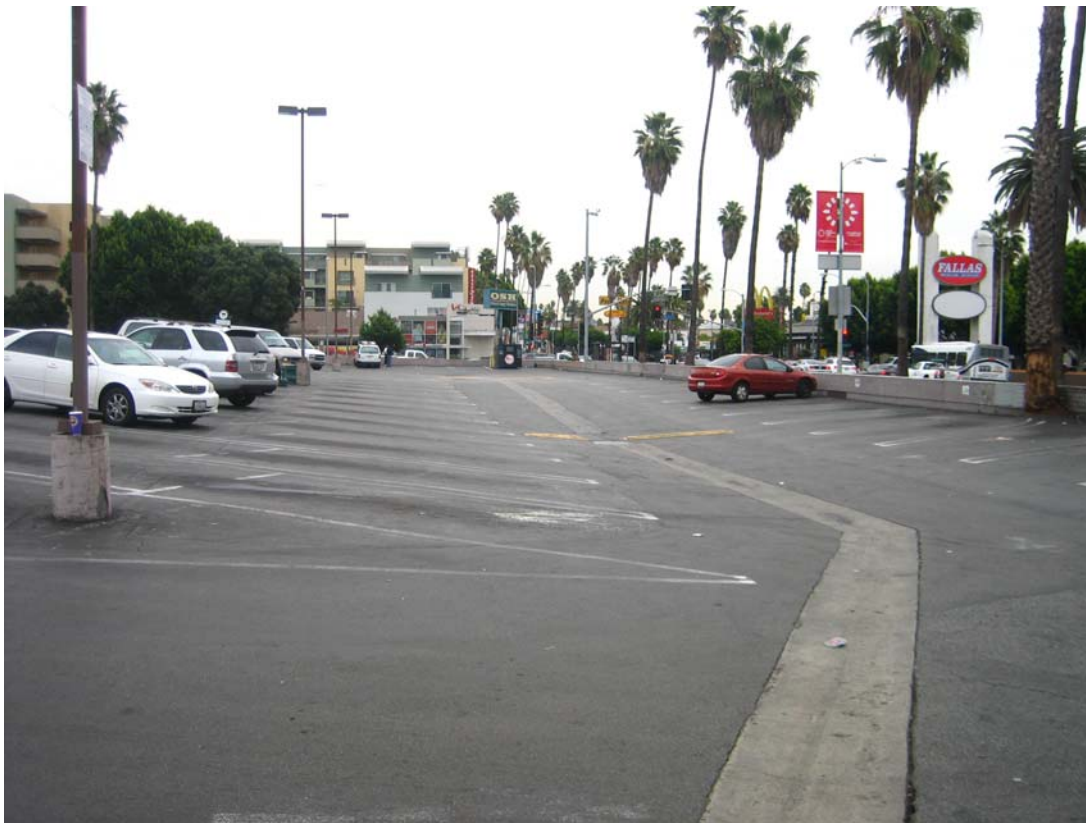
DWG BY: E.D.
PLATE NO.: 4A

VIEW OF PARKING LOT FACING EAST SIDE

The outside areas are asphalt paved and used for parking purposes. A fenced gardening center and the storage of large quantities of home building materials were observed on the east portion of the outside area. Our site observations are briefly summarized in the following table.

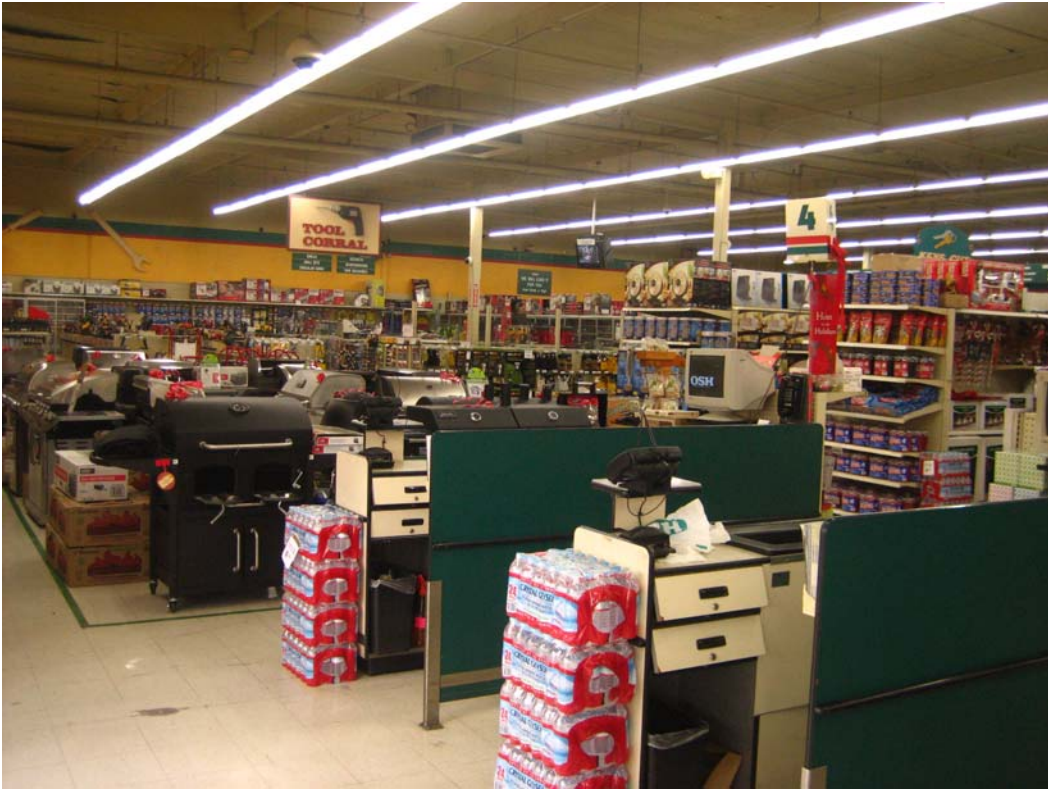
INSIDE VIEW OF CHECK OUT AREA

drywall partitions and ceilings, and open metal frame truss ceiling. The inside of the structure contains a check out area on the southern portion with the remainder of the structure used for retail items showcase and storage. A garden center and storage of building materials areas were observed adjacent to the east of the onsite structure. Access was not provided to all interior areas. SEG observed inside the structure posing as a regular customer that would have been shopping in the store.

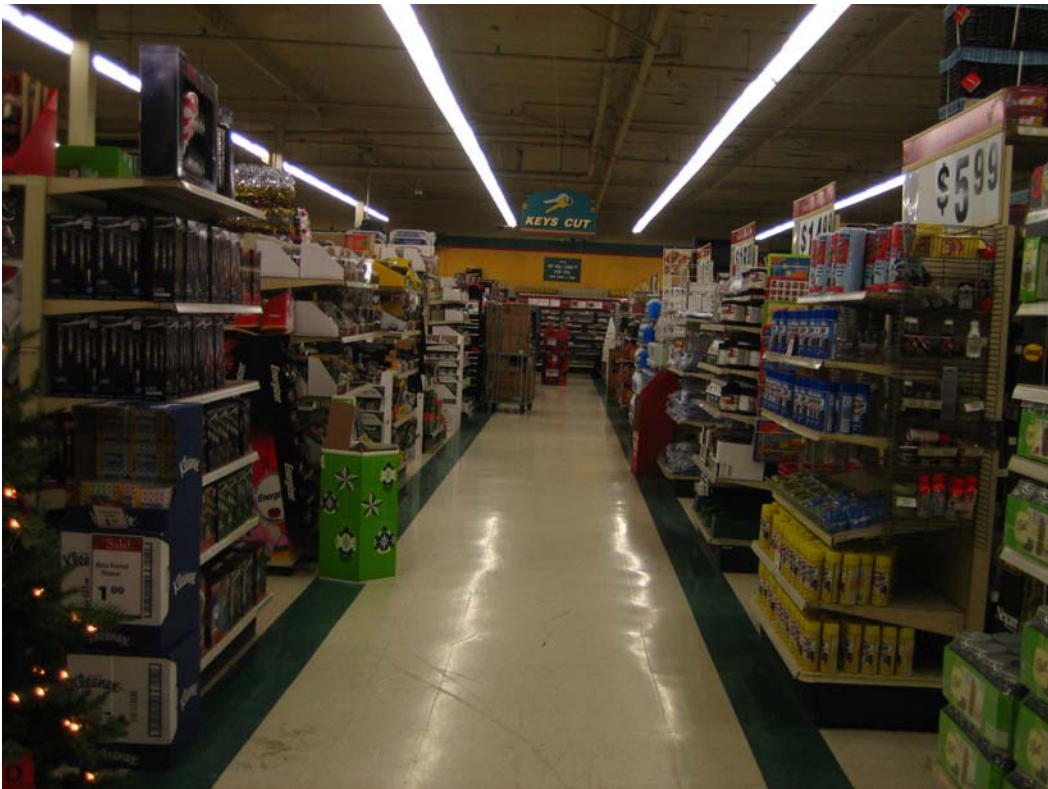
DWG BY: E.D.
PLATE NO.: 4B

INSIDE VIEW OF THE ONSITE STRUCTURE FACING EAST

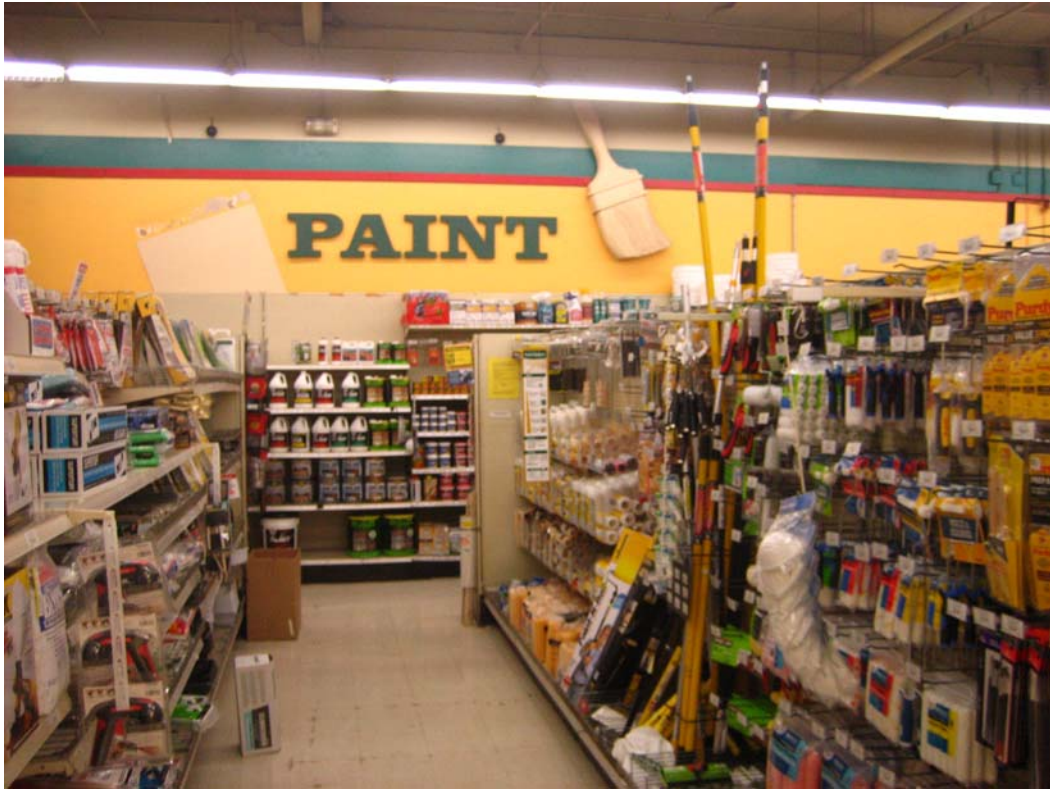
INSIDE VIEW OF PAINT SECTION

The operations conducted were mainly of retail sale of household and hardware items including, building materials, paints, tools, plumbing items, electrical items, and gardening materials. Minor amounts of paints and solvents in retail packaged quantities (5-gallons and less) are stored on shelves onsite. No significant cracking of the concrete floor was observed in the storage areas. HVAC system fueled by natural gas was observed onsite. Hydraulic trash compactor and hydraulic box bailer were also observed onsite. No signs of any leaks and/or staining in these areas.

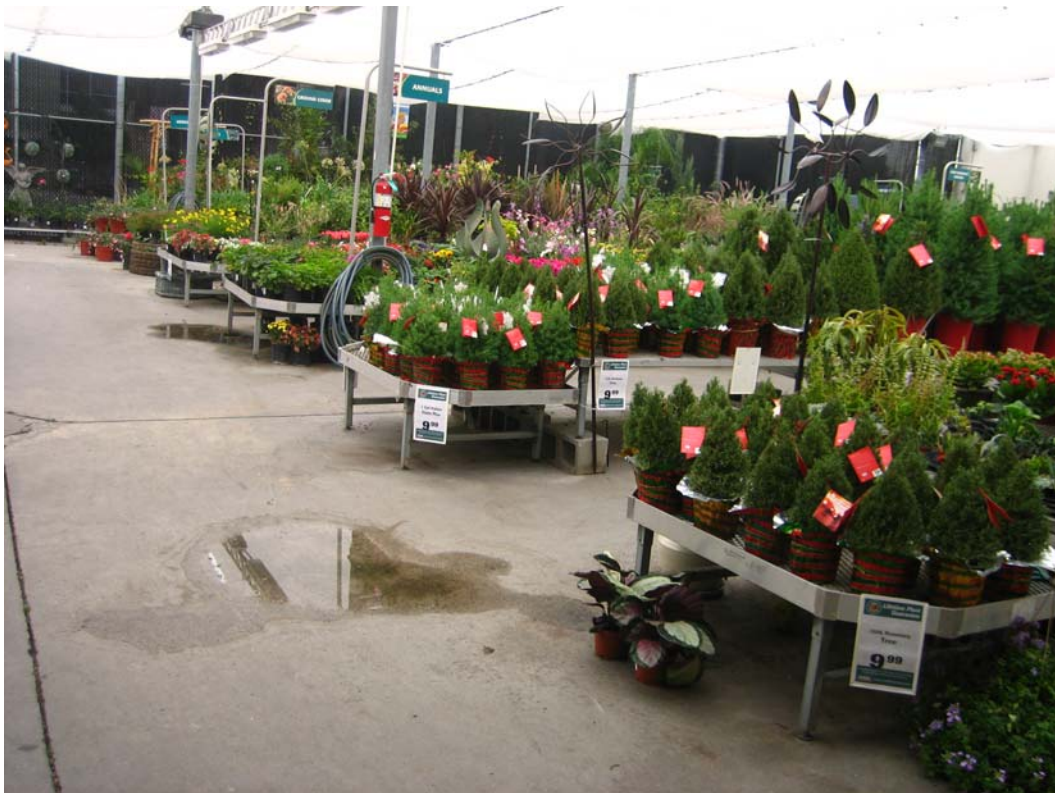
VIEW OF GARDEN SECTION ALONG THE
