**JARDINETTE APARTMENTS (HCM #390)**  
5128 West Marathon Street  
CHC-2017-2794-MAEX

## RECOMMENDATION REPORT

**PROJECT:** 5128 West Marathon Street  
Jardinette Apartments, Historic-Cultural Monument (HCM) #390

**REQUEST:** **APPROVAL OF EXEMPTION FROM LIMITATION OF ELIGIBILITY FOR HISTORICAL PROPERTY CONTRACT (MILLS ACT) APPLICATION**

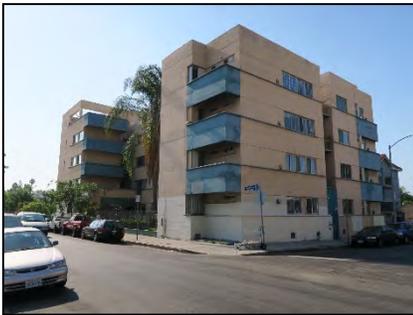
*Primary, west and north elevations,  
view southeast*

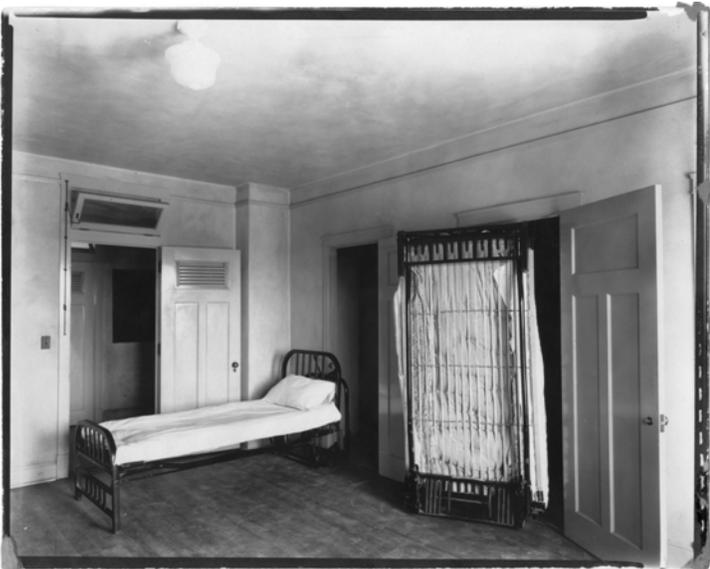
Figure 28. Ad for Murphy Bed

Figures 28 – 31, Murphy Beds. Figure 28, above left, a narrow single and a wider single Murphy bed, Kilian Hall bedroom, Concordia University, Texas, University of North Texas Libraries. Figure 29, above right, Neutra’s plan shows the 5’-4” width needed for a standard pivoting bed (the original configuration of the Murphy bed), Richard and Dion Neutra Papers, Coll. 1179, UCLA. Figure 30, left, an advertisement for Murphy beds (Sears kit house model “The Calumet,” showing the double-door, double bed, unit, seen in Jardinette Type 5 and some Type 6s (north side of building. Figure 31, lower left, a wider single Murphy bed door, Jardinette. Flat 107, Jardinette Apartments.

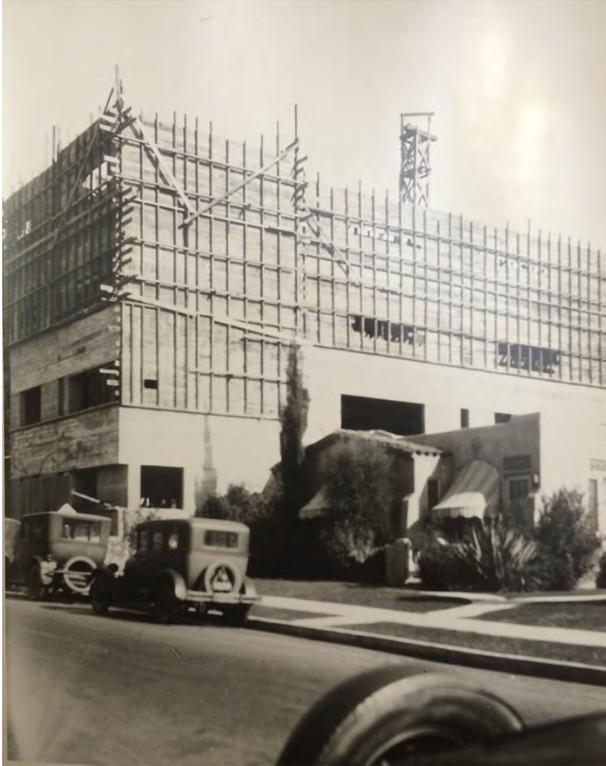
Figure 7. Jardinette Apartments, undated, photo probably by Richard Neutra, 1928. Richard and Dion Neutra Papers, Coll. 1179, Special Collections, UCLA. Framing for form boards, some concrete pored. Rear elevation. Camera facing NE.

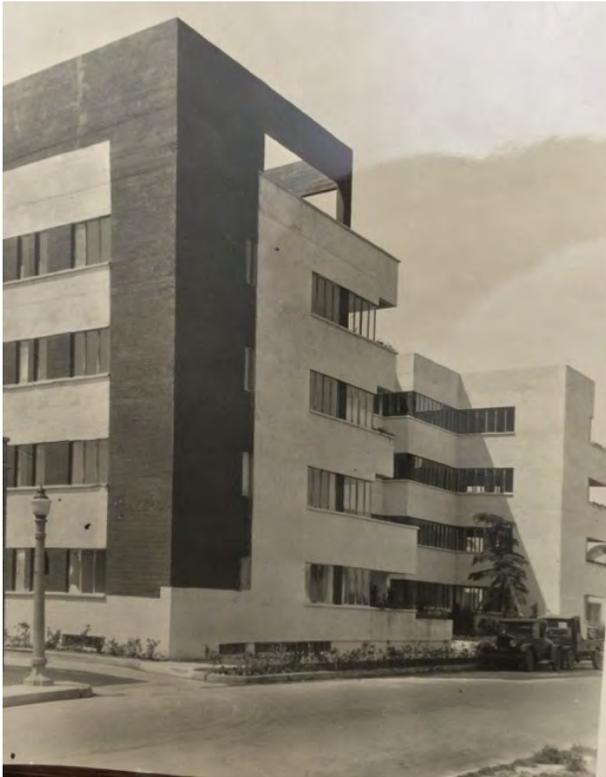
Figure 9. North, east elevations. NE corner. Undated, probably 1928. Camera looking southwest. Richard and Dion Neutra Papers, Coll. 1179, Special Collections, UCLA.

Historic Photo (Figure 9) North, east elevations NE corner. Undated, probably 1928. Camera looking southwest. Richard and Dion Neutra Papers, Coll. 1179, Special Collections, UCLA.

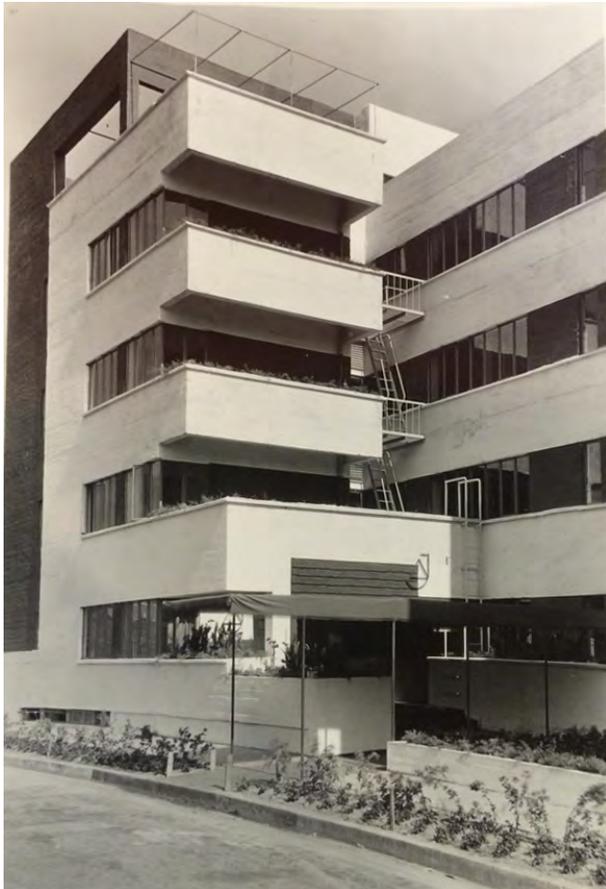
Figure 10. Jardinette Apartments, courtyard façade. Camera facing east. Photo by Luckhaus Studios. Richard and Dion Neutra Papers, Coll. 1179, Special Collections, UCLA.

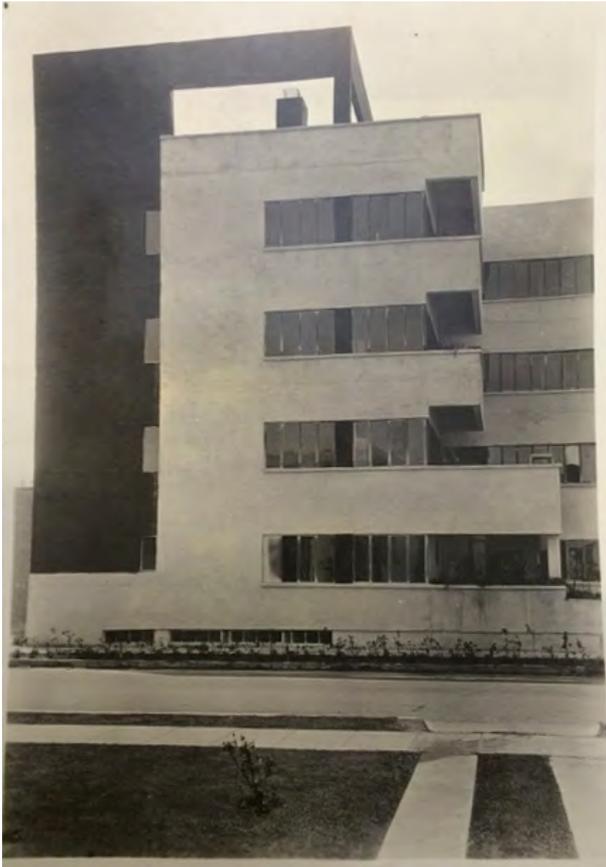
Figure 11. North elevation, east side. Camera facing south. Photo undated, probably 1928 Richard and Dion Neutra Papers, Coll. 1179, Special Collections, UCLA.

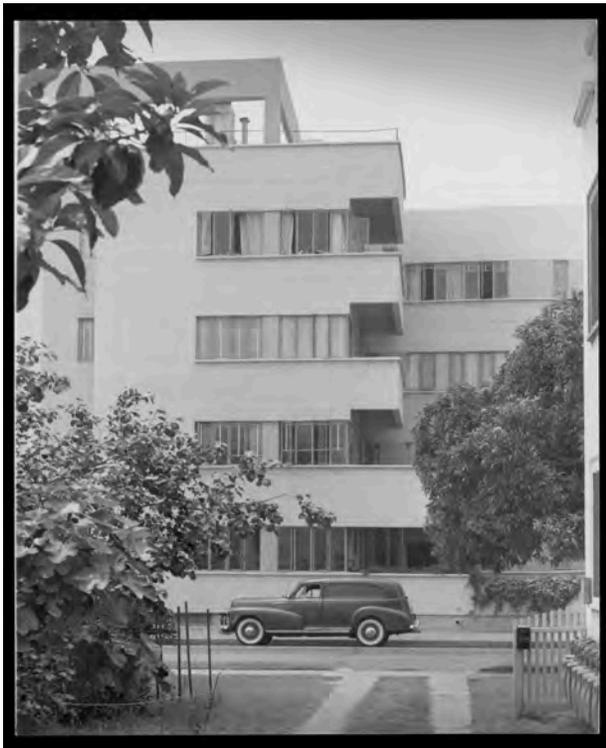
Figure 12. North elevation, east side. Camera facing south. Photo by Julius Shulman, 1950. © J. Paul Getty Trust. Getty Research Institute, Los Angeles (2004.R.10)

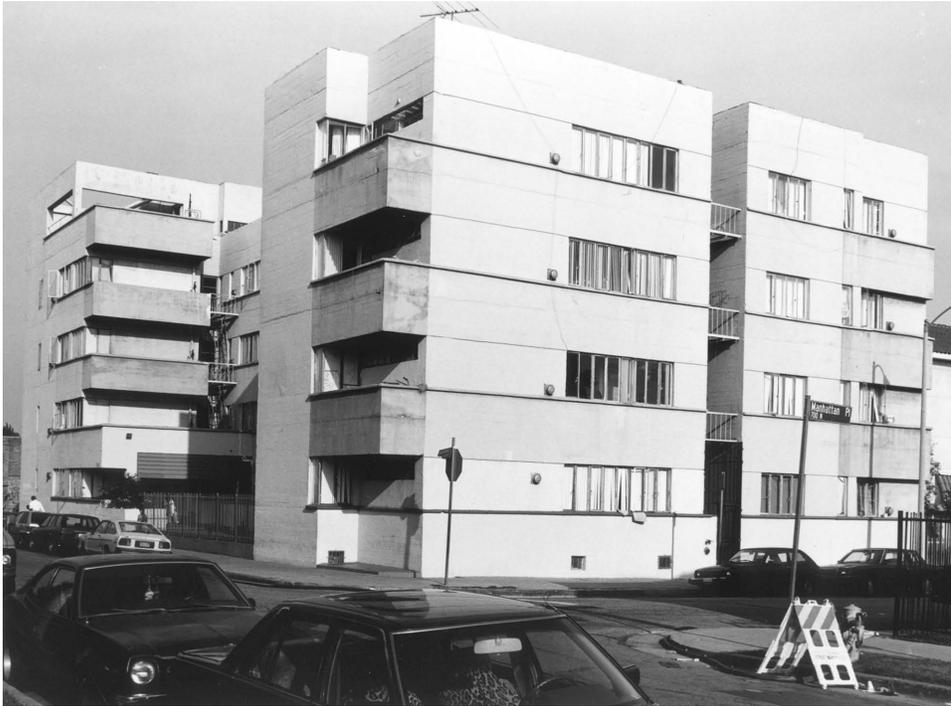
Figure 13. left. Jardinette Apartments, approximately 1970. West façade. Camera facing SE. Richard and Dion Neutra Papers, Coll. 1179, UCLA.

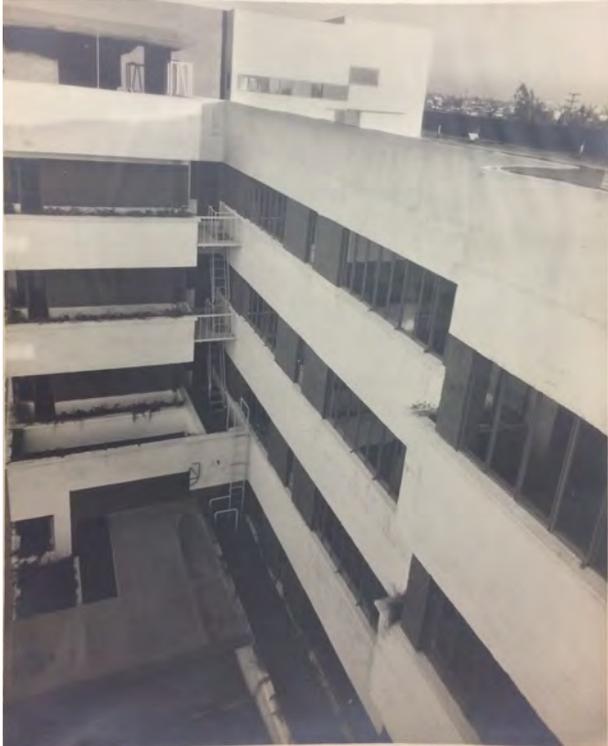
Figure 16. Courtyard elevation, NE corner. Undated, probably 1929. Camera looking E. Cal Poly Pomona, ENV-Special Collections. Willard D. Morgan presumed photographer; Morgan was the class photographer for the class Neutra and Schindler taught at the Academy of Modern Art, Jan. 29 – May 29, 1929. Later Morgan worked with Neutra as a designer/draftsman.

Historic photo (Figure 16) showing west side of rooftop service room and original roof canopy. Camera facing E. Cal Poly Pomona, ENV-Special Collections.

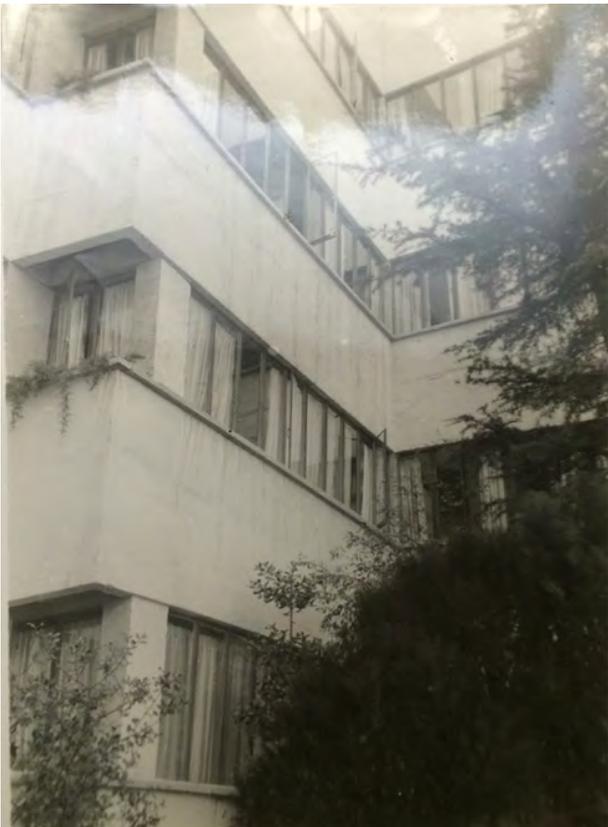
Figure 17. Courtyard elevation, camera looking southwest. Notes plants on east-facing projections that did not hold brackets for planters. Photo by Julius Shulman, 1950. © J. Paul Getty Trust. Getty Research Institute, Los Angeles (2004.R.10).

Historic Photo (Figure 17) Courtyard elevation, camera looking southwest. Notes plants on east-facing projections that did not hold brackets for planters. Photo by Julius Shulman, 1950. © J. Paul Getty Trust. Getty Research Institute, Los Angeles (2004. R. 10).

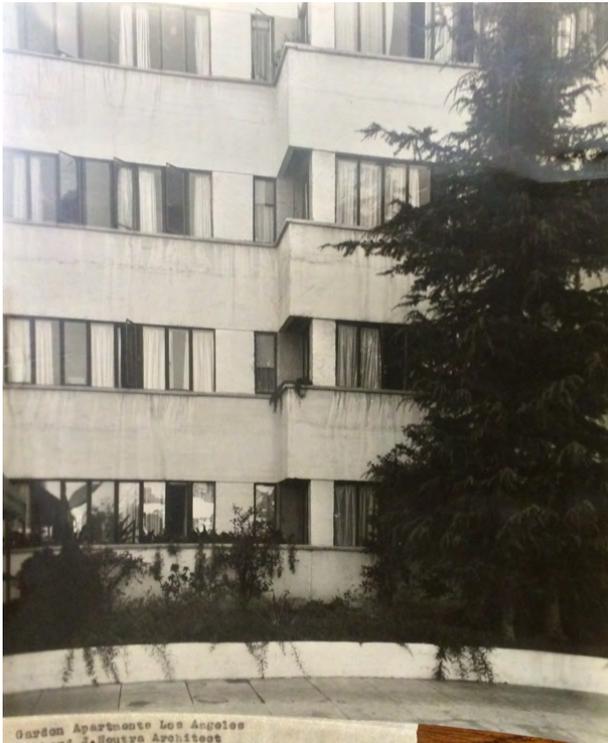
Figure 18. Landscaping at the Jardinette. This photo shows hanging vines and shrubs used for the ground plane, second floor "Type 5" Unit 208, and the rapidly-maturing conifer tree.

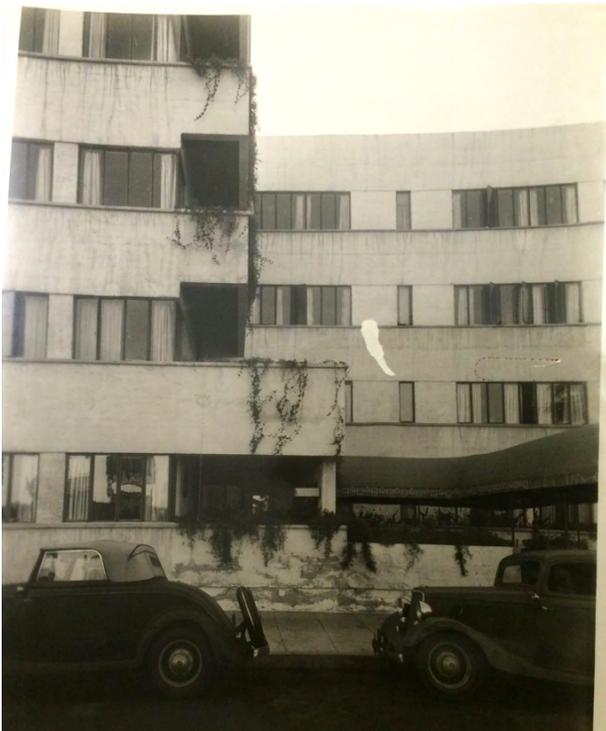
Figure 19. Landscaping at the Jardinette. This photo shows hanging vines on all four floors, North elevation, balconies facing west to courtyard. Richard and Dion Neutra Papers, UCLA. Notably, the car and roadster pictured are vintage 1933/1934, indicating that the very dark contrasting paint color used for the NE corner and the areas between the windows lasted only five years at most.

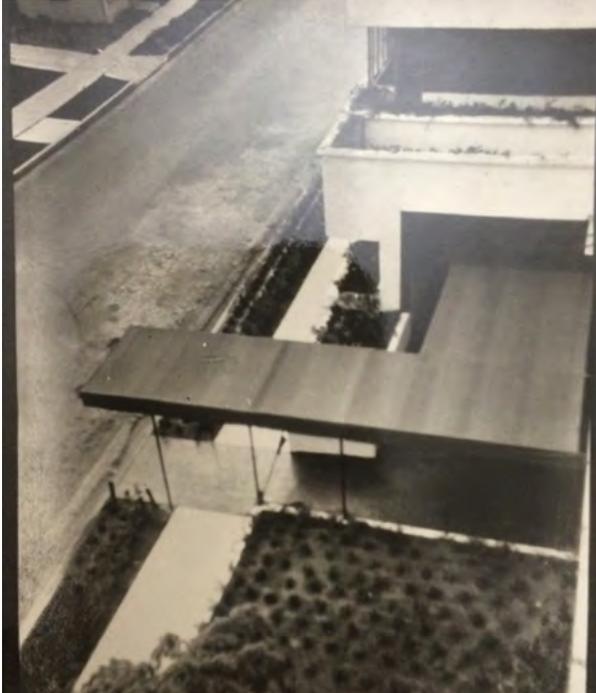
Figure 20. View of original awning from courtyard elevation roof. Note continuity of colored concrete to the curb and the variety of plantings on the balcony. Undated, unbylined. Richard and Dion Neutra Papers, Coll. 1179, UCLA.

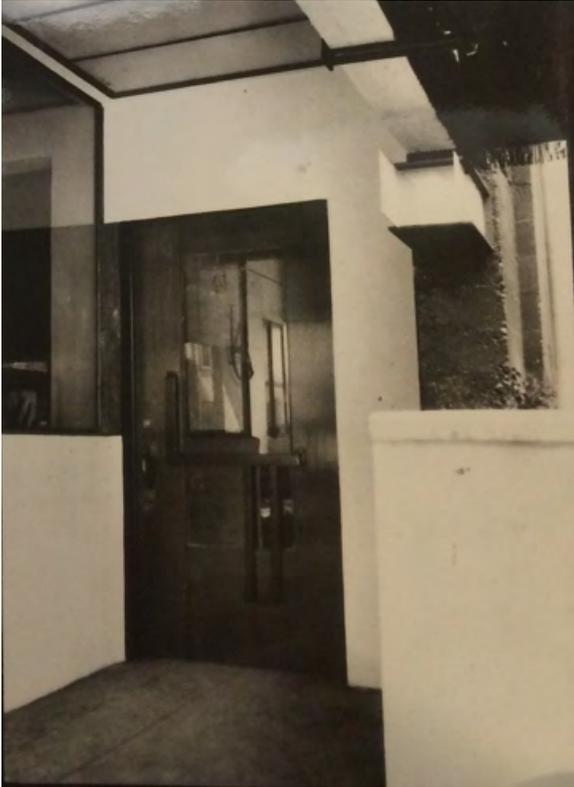
Figures 21, above, 22, below.

21, Exterior primary entrance. Note custom designed front door, three frosted overhead lights, and the large window to the manager's office. Richard and Dion Neutra Papers, Coll. 1179, UCLA.

Historic Photo (Figure 21), Exterior primary entrance. Note custom designed front door, three frosted overhead lights, and the large window to the manager's office. Richard and Dion Neutra Papers, Coll 1179, UCLA.

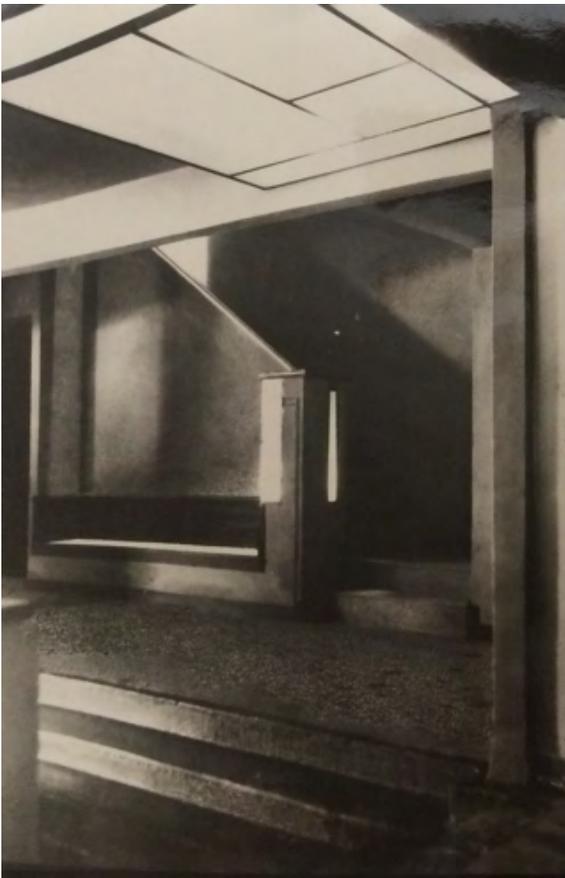
22, Interior lobby. Note bench with possible lighting illuminating the floating quality of the bench; the striking pattern of overhead lighting, and newel post lighting. Richard and Dion Neutra Papers, Coll. 1179, UCLA.

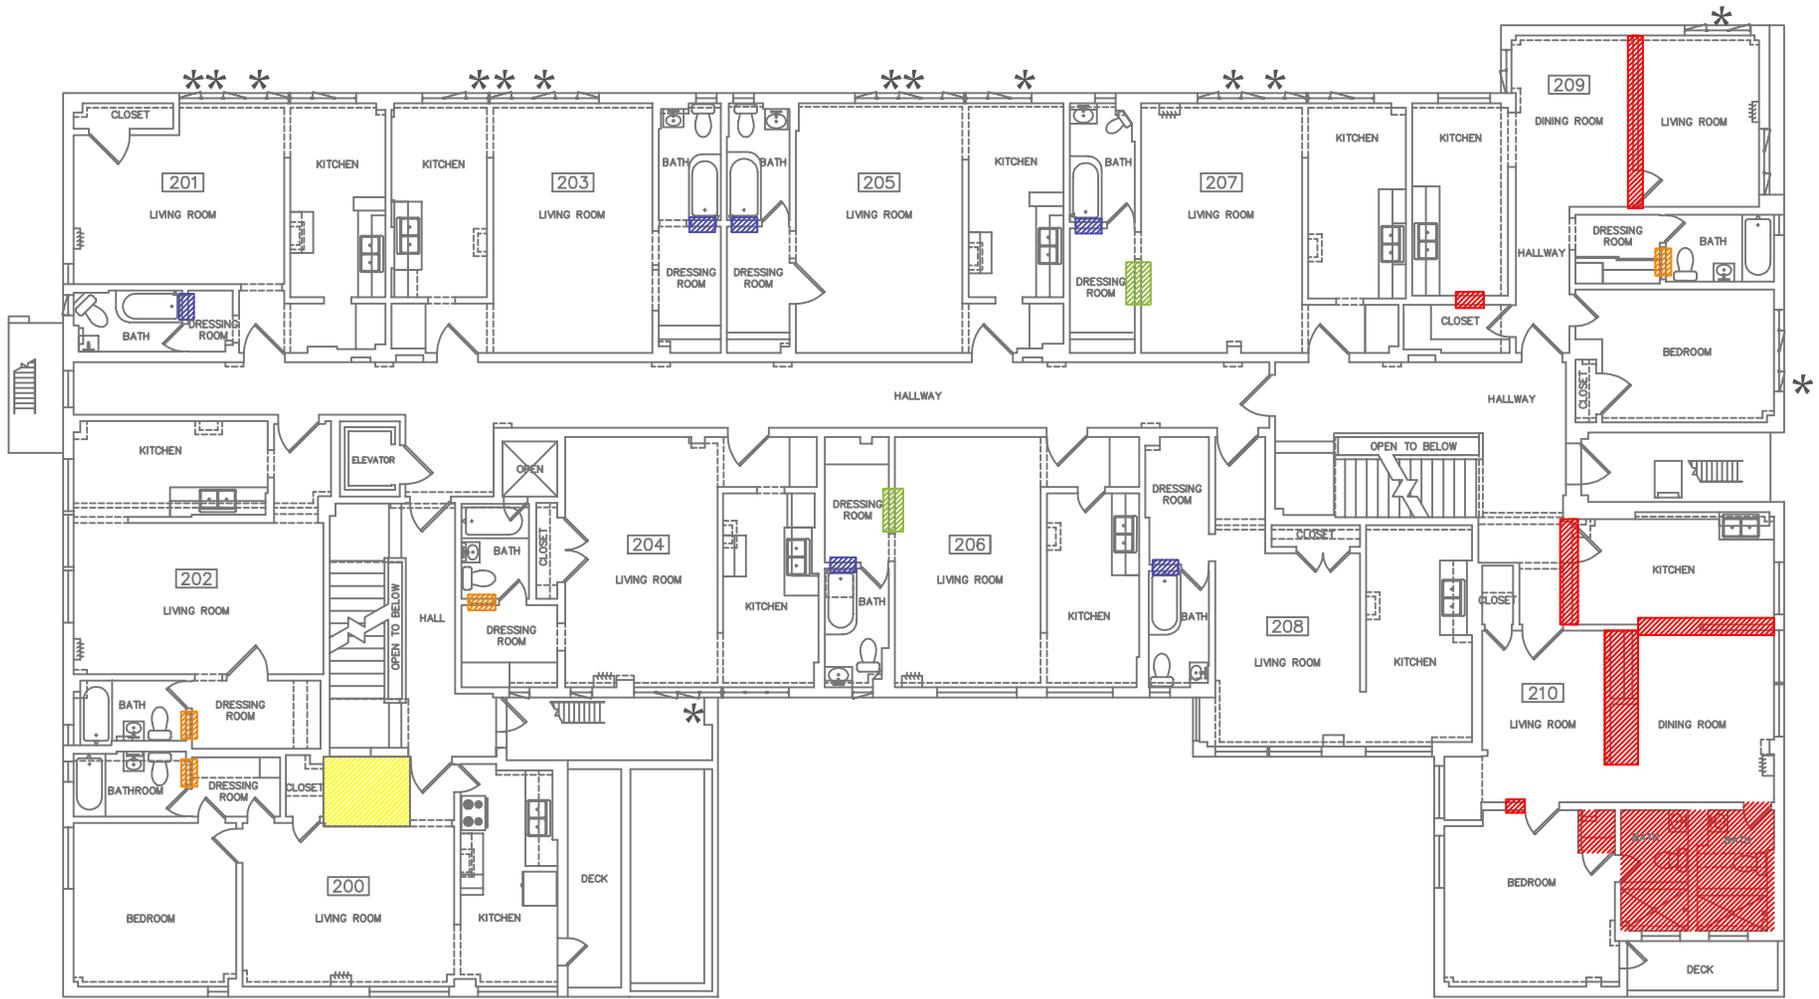
- NON-ORIGINAL WALLS OR DOORWAYS ENCASED
- ENCASED MURPHY BED OPENING
- BATHROOM SHELF INTACT
- NEUTRA DRAWING INDICATES DESIGN FOR LAUNDRY CHUTE OPENING TO STAIR AND INCINERATOR CHUTE
- BATHROOM SHELF ENCASED

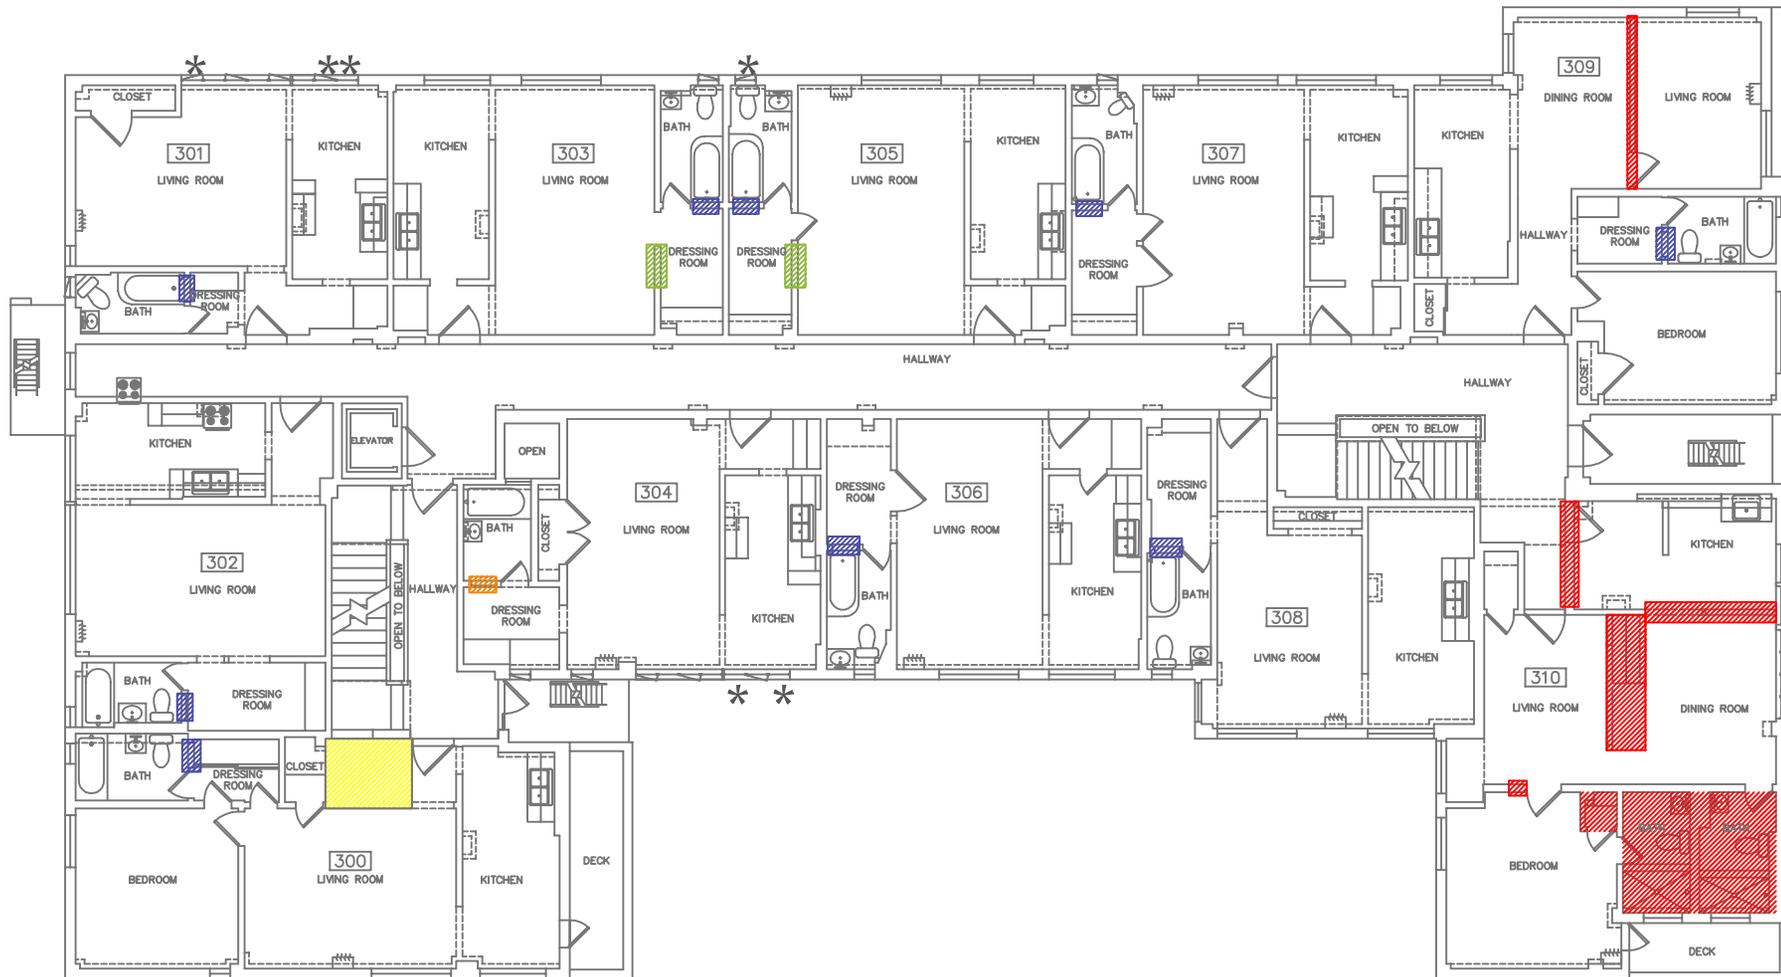
Floor Plans showing Spatial Alterations, a Primary Character-Defining Feature  
**FOURTH FLOOR**

\* ORIGINAL GLASS WINDOW

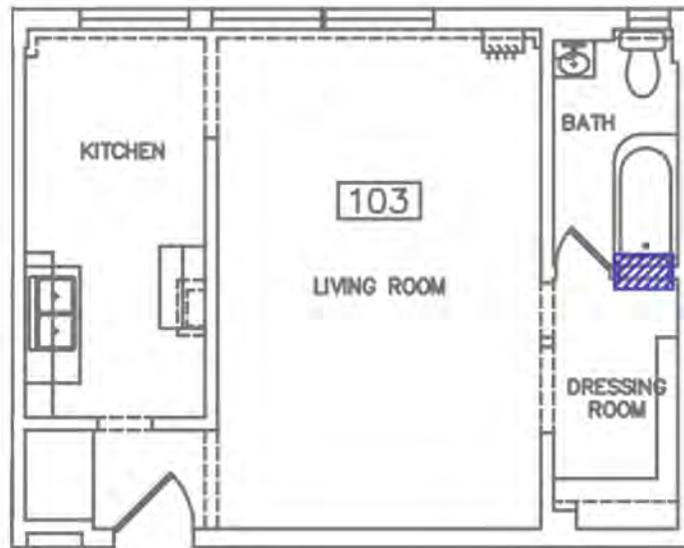
Square Feet: 426 sf

Ceiling Height: 9'-2"

Unit type 2 constitutes the most frequently employed studio apartment at the Jardinette. The apartment is located in the central building on the south side as 3 banked modular units from 1<sup>st</sup> floor to the 4<sup>th</sup> floor. Unit characteristics include a defined entry but at a slightly smaller scale than in unit type 1 but manages an effective use of an adjacent hall closet within the modest entry. The living room is flanked by the kitchen and dressing room/bathroom. The kitchen maintains access from both the entrance hall and living room. Continuous design vocabulary of banked casement windows between the kitchen and living room are employed. Notably, this unit type displays an extremely generous dressing room off the bathroom.

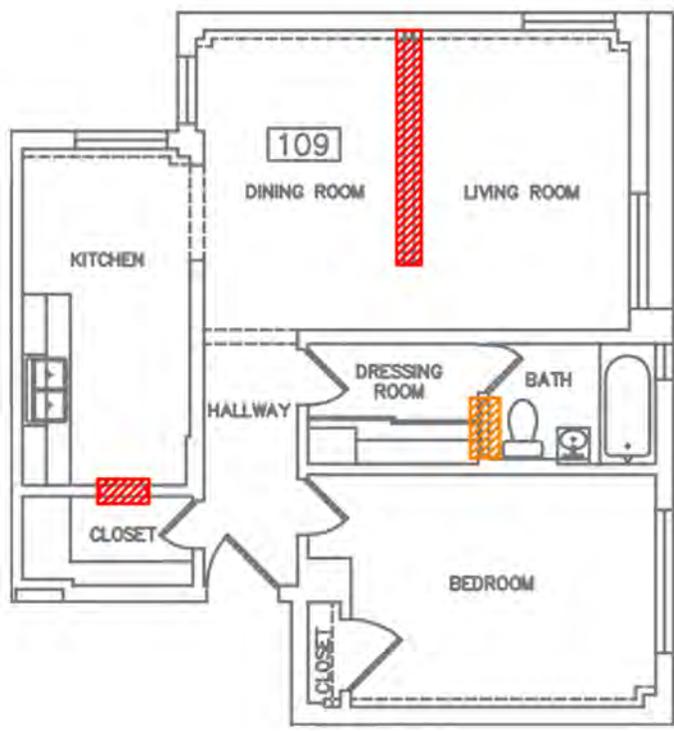
Square Feet: 605sf

Ceiling Height: 9'-2"

Located on the southwest corner of the building, unit type 3 has a generously defined entrance and hallway with adjacent hall closet. The bathroom/dressing room is centrally located between the living room and bedroom and all have accessed off the entrance hall. Notably, the kitchen has dual access between the hall closet and living room areas. Windows for this unit type display a unique theme in that the casement windows are placed in an off-set location on all walls with exception to the bedroom. The bathroom employs continuous design vocabulary of a large dressing room with an efficiently arranged bathroom.

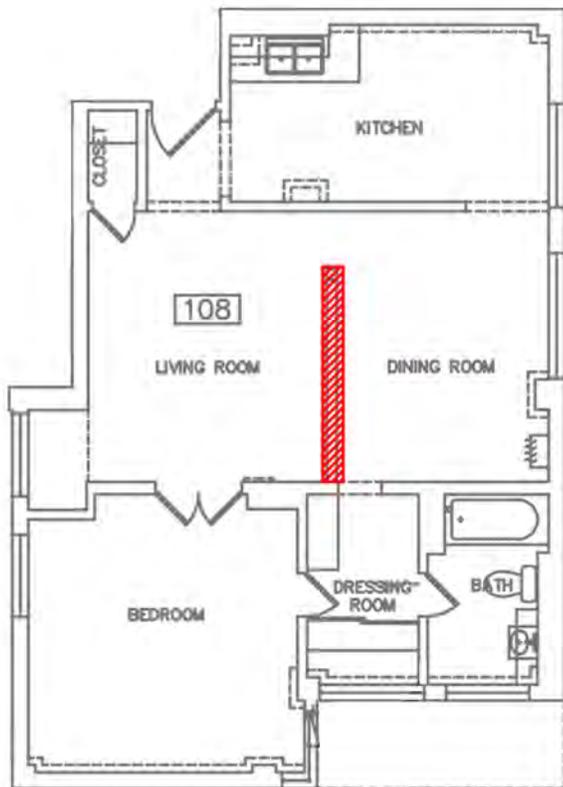
## Unit Type 4

Square Feet: 693

Ceiling Height: 9'-2"

Located on the northwest corner of the building, unit type 4 has a more modestly defined entry with a notably smaller hall closet space that is not located within the entry but rather is placed in the living room opposite the entry. However, as modest as this entry design is, it belies the fact that this is the largest and most elaborately appointed unit in the complex. The living room divides the space between the bedroom and kitchen. The kitchen maintains access from both the living room and entry. Notably, the bedroom doors off the living room were double French doors of divided lights. Dressing room and bathroom are generously proportioned and are accessed by both the living room and the bedroom. The bedroom notably has access to a covered exterior terrace facing north by northwest to Hollywood hills views and vistas on the upper floors.

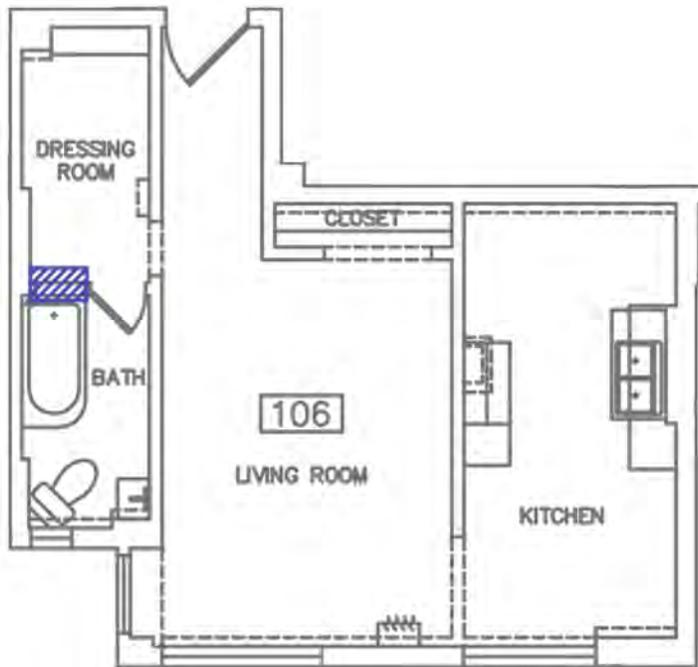
Square Feet: 405

Ceiling Height: 9'-2"

Located on the northern central/west location of the building, unit type 5 displays unique characteristics among other studio apartments in the Jardinette. A generously defined entry hall is prominently featured but there is no hall closet in this configuration. The dressing room and bathroom are generously proportioned and are accessed directly off the entry hall as it transitions into the living room space. The kitchen is accessed only through the living room. The living displays a unique eastern facing window providing views to the main entrance garden. The closet located in the living room was originally designed to include a “Murphy Bed.”

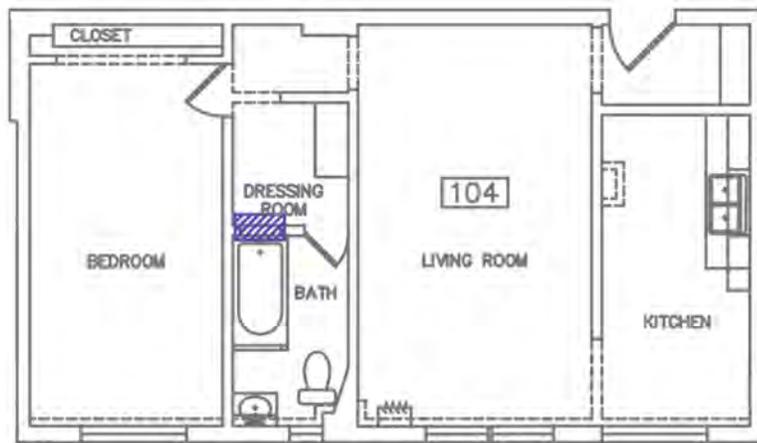
Square Feet:           574 (Apt. 104, 1 Bedroom)  
                              444 (Apts 204, 304, 404, Studios)  
                              410 (Apts. 206, 306, 406, Studios)

Ceiling Height:       9'-2"

Located in the center east section of the northern building, unit type 6 is unique because the room type varies. It has a one-bedroom unit (Apt. 104) and studio apartments on the 2<sup>nd</sup> through 4<sup>th</sup> floors (Apts, 204` has a defined entrance hall with an adjacent closet. Living room opens up to a continuous vocabulary of banded casement windows between the kitchen and living room itself. In a unique capacity, there's a small hall vestibule off the living room which accesses both the bedroom and dressing room. The dressing room, in turn, accesses the bathroom. The remaining unit type 6's on floors 2 through 4 are defined thusly:

Units 204 through 404 have a defined entry with adjacent hall closet. The living room is flanked by the kitchen and bathroom/dressing area. In this particular instance, the dressing area has casement window and the adjacent bathroom window opens to "light well."

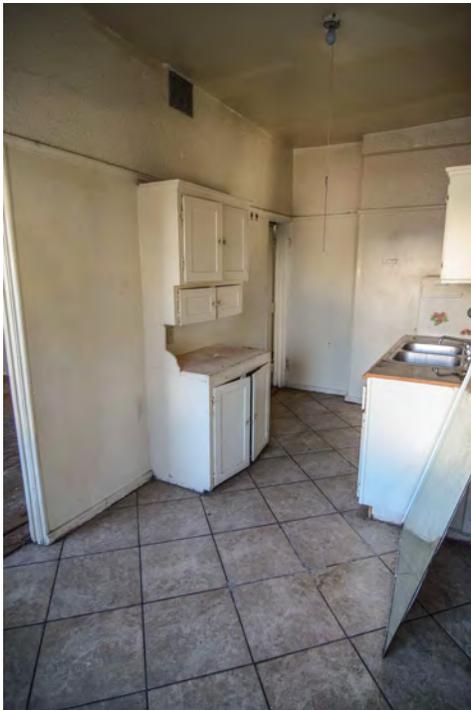
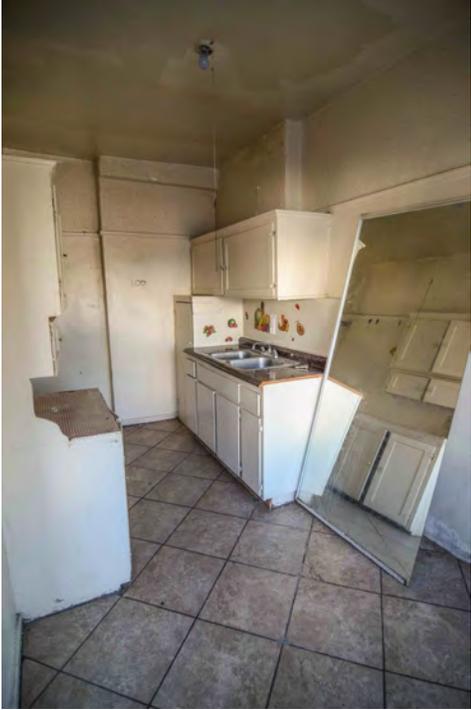
Unit Type: 8  
Condition Assessment  
Unit 100 Kitchen and Bathroom

PF Spatial layout	INTACT
PF Steel windows	see Window Inventory
PF Wall and door moldings	90% INTACT
PF Murphy bed door/opening	n/a
PF Texture above molding Only kitchen intact	35% INTACT
PF Wood doors	Five missing: . French doors to bedroom (wall partially enclosed) . Door to kitchen (opening intact) . Two doors demolished/encased to DR.
PF Painted kitchen cabinetry	50% INTACT
PF Wood closet casework (at entry closet or DR closet or both)	removed
PF Bathroom glass-backed shelving	INTACT
PF Bathtub	INTACT
SF Bathroom wall tile with liner	INTACT
SF Bathroom accessories, porcelain.	INTACT
SF Bathroom hex floor tile	removed or overlaid

. Kitchen

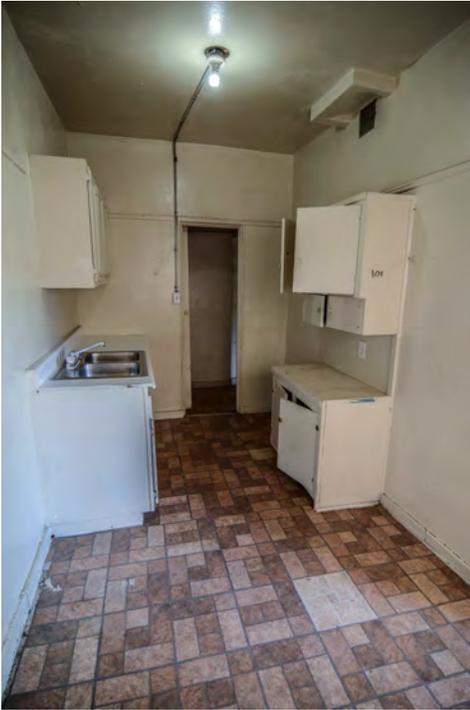
. Kitchen

PF Spatial layout	INTACT
PF Steel windows	see Window Inventory
PF Wall and door moldings	90% INTACT
PF Murphy bed door/opening	INTACT
PF Texture above molding LR intact; other areas hit and miss	65% INTACT
PF Wood doors	2 removed: Kit, DR
PF Bathroom glass-backed shelving	INTACT
PF Painted kitchen cabinetry	25% INTACT
PF Wood closet casework (at entry closet; in DR closet, or both)	removed
PF Bathtub	INTACT
SF Bathroom wall tile with liner	painted
SF Bathroom accessories, porcelain.	INTACT
SF Bathroom hex white floor tile	INTACT

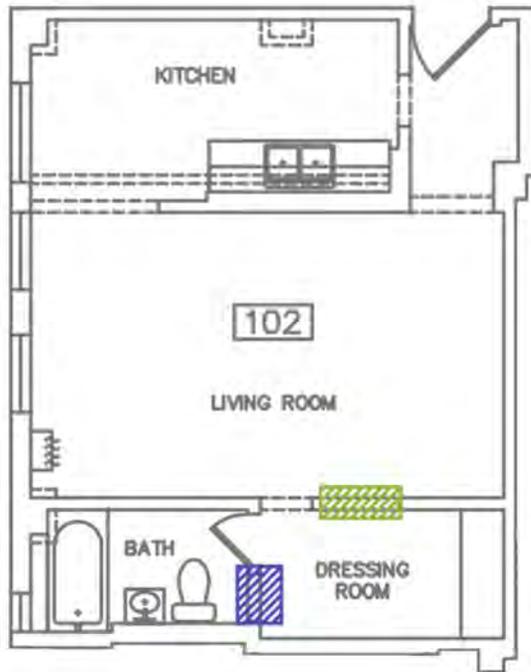
# Unit Type: 7 Condition Assessment Unit 102

PF Spatial layout	INTACT
PF Steel windows	see Window Inventory
PF Wall and door moldings	70% INTACT
PF Murphy bed door/opening	Removed
PF Texture above molding	90% INTACT
	LR intact; other areas hit and miss
PF Wood doors	2 removed: Kit, DR
PF Bathroom glass-backed shelving	Encased
PF Painted kitchen cabinetry	0% INTACT
PF Wood closet casework doors (at entry closet; in DR closet, or both)	Removed
PF Bathtub	INTACT
SF Bathroom wall tile with liner	painted
SF Bathroom accessories, porcelain.	n/a
SF Bathroom hex floor tile	INTACT

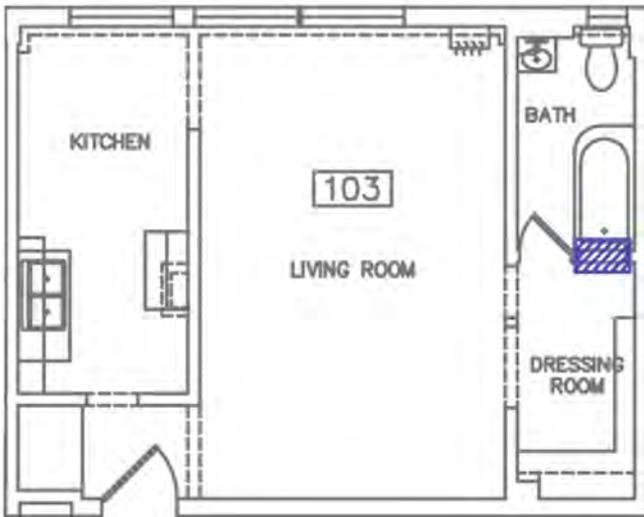
# Unit Type: 2 Condition Assessment Unit 103

**Note:** Bathroom interior (tile) wall severely bowing.

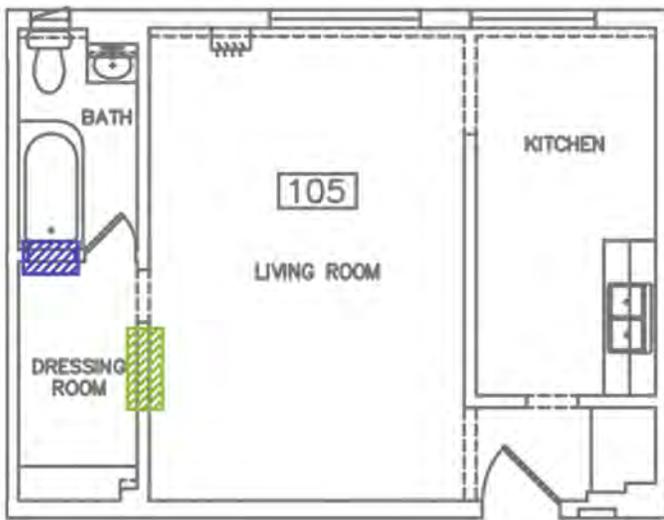
# Unit Type: 2 Condition Assessment Unit 105

PF Spatial layout	INTACT
PF Steel windows	see Window Inventory
PF Wall and door moldings	Removed
PF Murphy bed door/opening	Door and opening removed

PF Texture above molding	Removed
PF Wood doors	2 Removed: Kit, DR
PF Bathroom glass-backed shelving	Encased
PF Painted kitchen cabinetry	Removed
PF Wood closet casework (at entry closet; in DR closet, or both)	Removed

PF Bathtub	INTACT
SF Bathroom wall tile with liner	painted
SF Bathroom accessories, porcelain.	Removed
SF Bathroom hex floor tile	Removed or overlaid

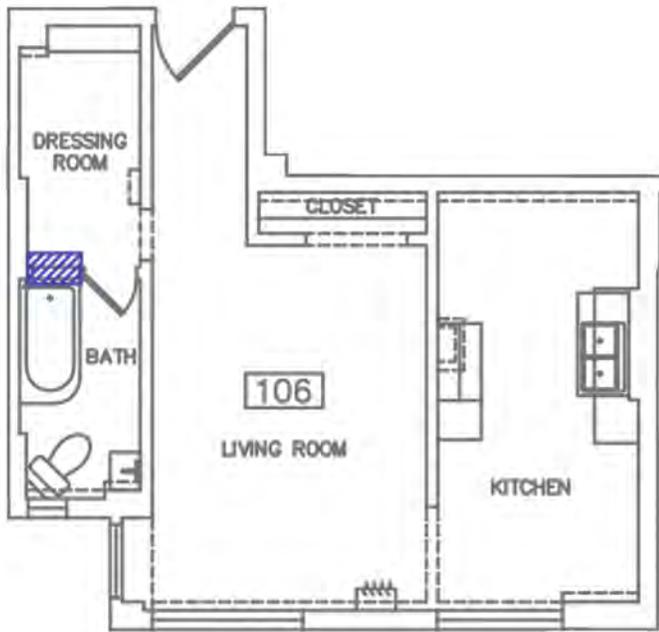
# Unit Type: 5 Condition Assessment Unit 106

**Note:** Bathroom interior (tile) wall bowing.

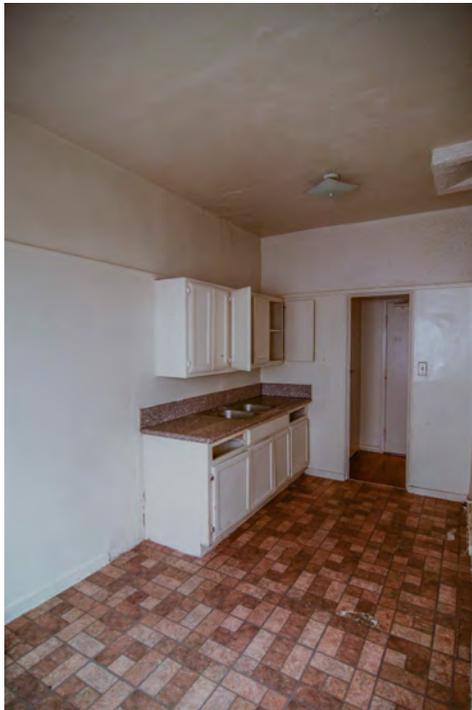
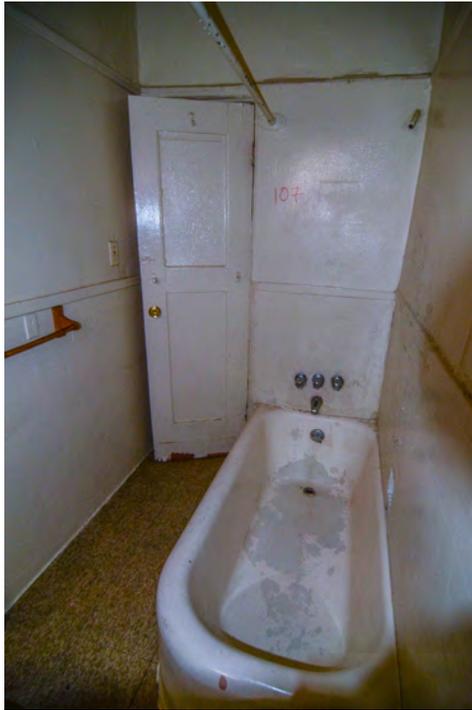
Unit Type: 2  
Condition Assessment  
Unit 107 Kitchen and Bathroom

. Kitchen

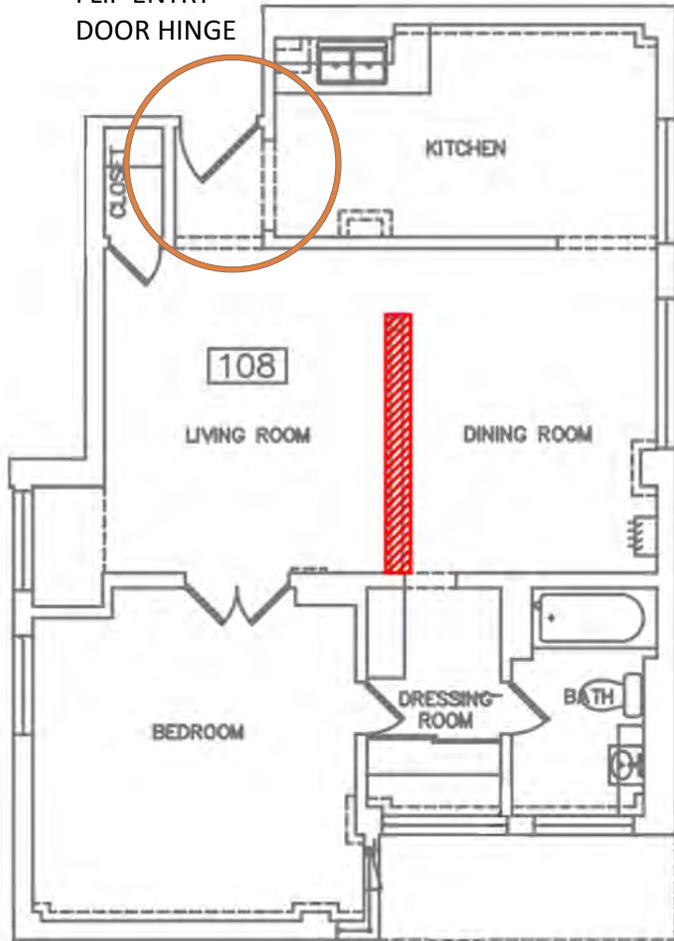
# Unit Type: 4 Condition Assessment Unit 108

FLIP ENTRY  
DOOR HINGE

**NOTE: ENTRY DOOR HINGED WRONG SIDE.**

PF Spatial layout	DEMOLISHED
PF Steel windows	see Window Inventory
PF Wall and door moldings	50% INTACT
PF Murphy bed door/opening	n/a
PF Texture above molding	Removed
PF Wood doors	Kit door gone, door to DR gone
PF Bathroom glass-backed shelving	Encased
PF Painted kitchen cabinetry	Removed
PF Wood closet casework doors (at entry; in DR, or both)	Removed (DR area)
PF Bathtub	INTACT
SF Bathroom wall tile with liner	painted
SF Bathroom accessories, porcelain.	Removed
SF Bathroom hex floor tile	Removed or overlaid

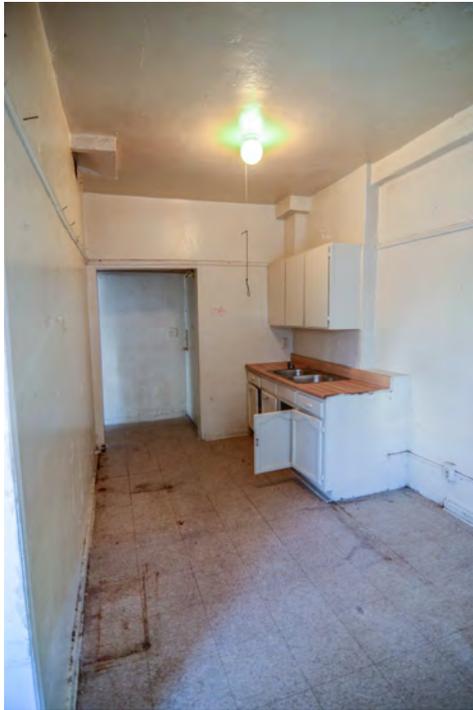
Unit Type: 4  
Condition Assessment  
Unit 108 Kitchen and Bathroom

. Kitchen

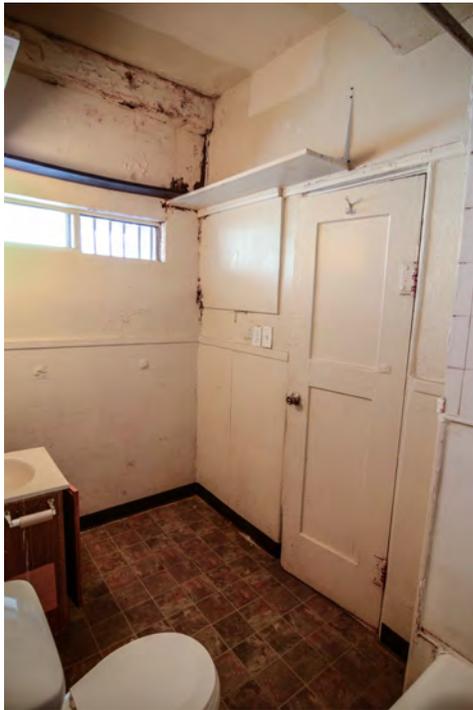
. Bathroom

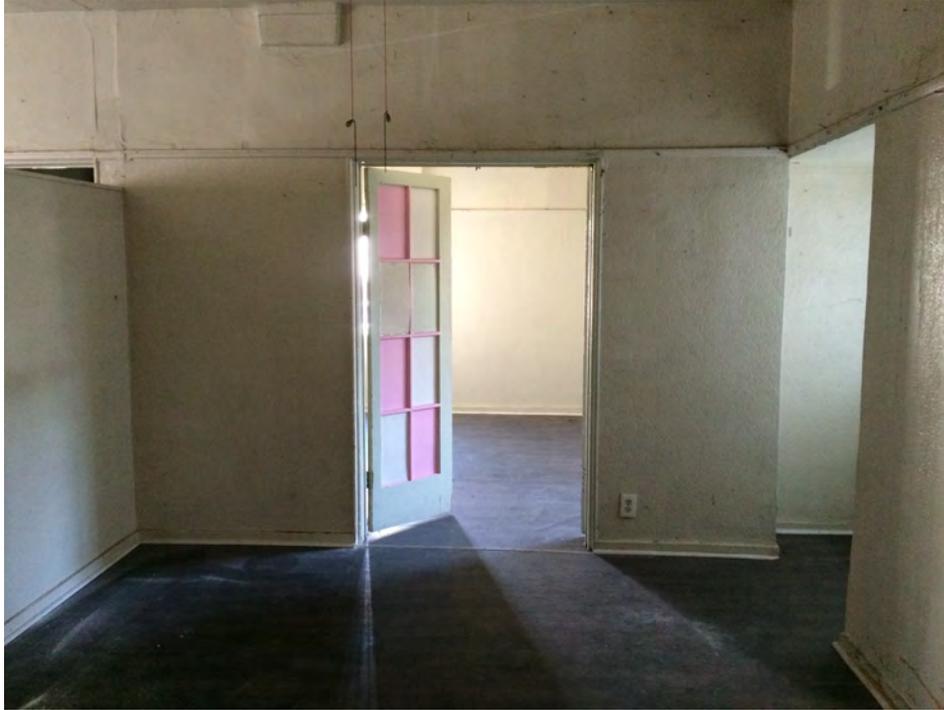
Unit Type: 4  
Condition Assessment  
Unit 108 Living Spaces

. Living Room

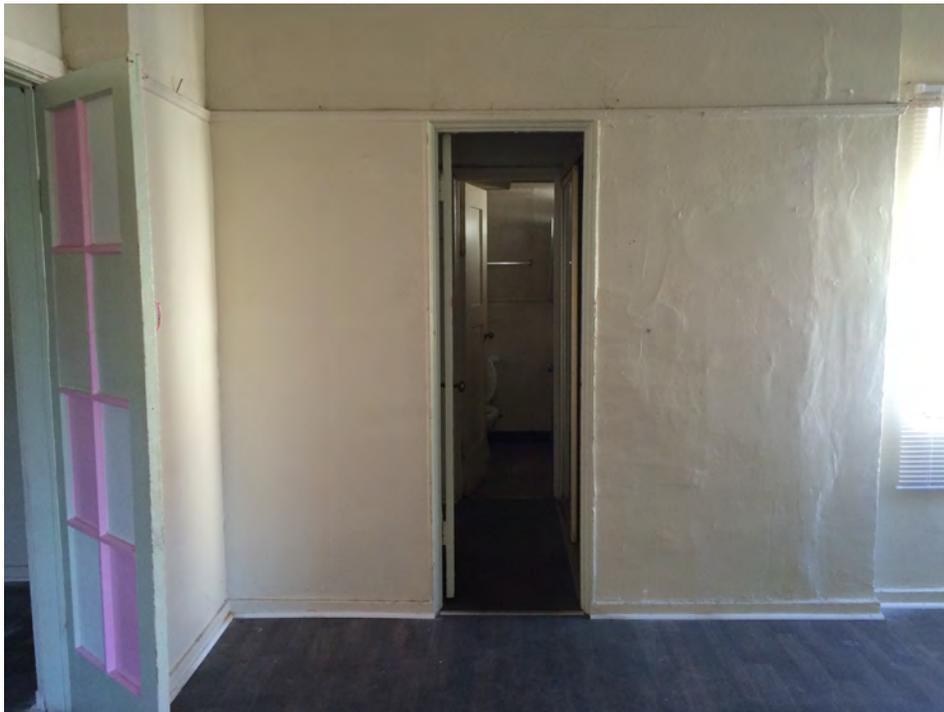
. Bedroom

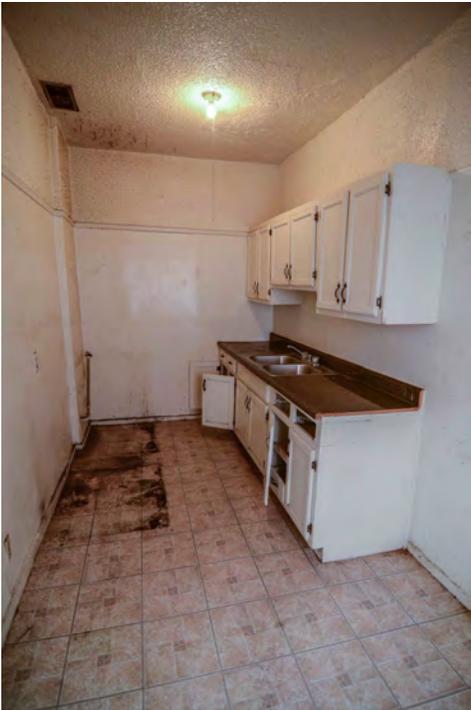
Unit Type: 3  
Condition Assessment  
Unit 109 Kitchen and Bathroom

PF Spatial layout	Altered
PF Steel windows	see Window Inventory
PF Wall and door moldings	80% INTACT
PF Murphy bed door/opening	INTACT
PF Texture above molding	Removed
PF Wood doors	3 doors missing including encased kitchen door
PF Bathroom glass-backed shelving	INTACT
PF Painted kitchen cabinetry	Removed
PF Wood closet casework doors (at entry; in DR, or both)	Removed
PF Bathtub	INTACT
SF Bathroom wall tile with liner	painted
SF Bathroom accessories, porcelain.	Removed
SF Bathroom hex floor tile	Removed or overlaid

. Kitchen

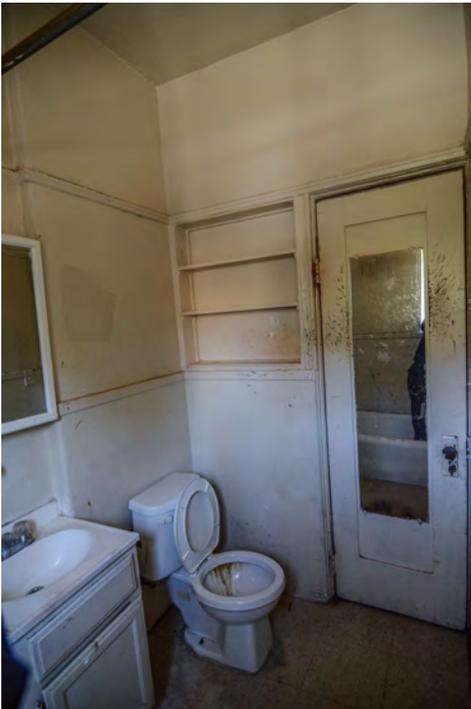
. Bathroom
