**JARDINETTE APARTMENTS (HCM #390)**  
5128 West Marathon Street  
CHC-2017-2794-MAEX

## RECOMMENDATION REPORT

**PROJECT:** 5128 West Marathon Street  
Jardinette Apartments, Historic-Cultural Monument (HCM) #390

**REQUEST:** **APPROVAL OF EXEMPTION FROM LIMITATION OF ELIGIBILITY FOR HISTORICAL PROPERTY CONTRACT (MILLS ACT) APPLICATION**

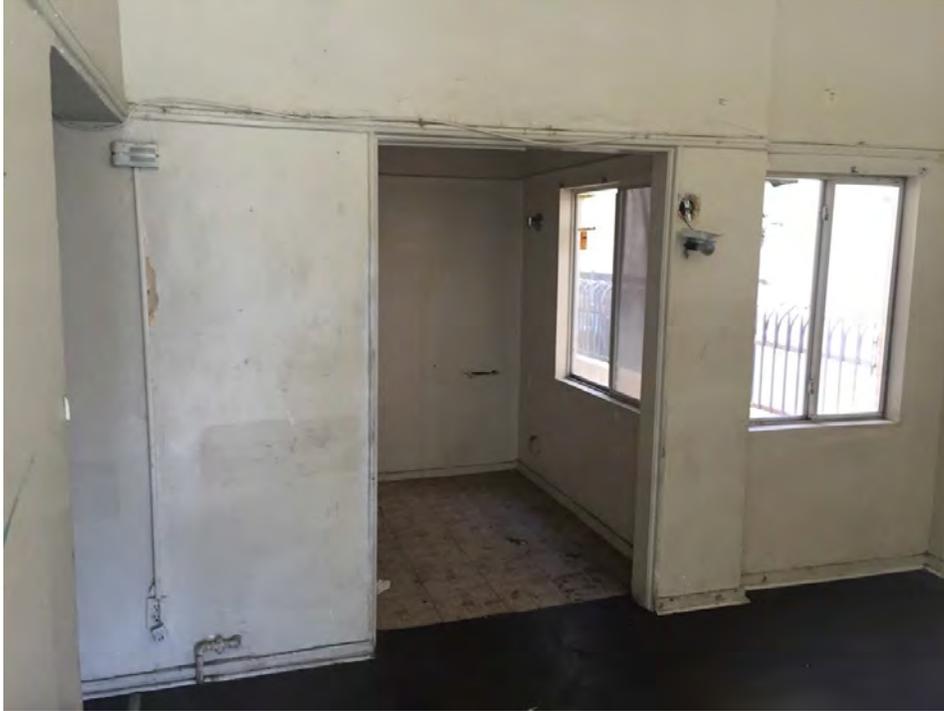
Unit Type: 3  
Condition Assessment  
Unit 109 Living Spaces

. Living Room

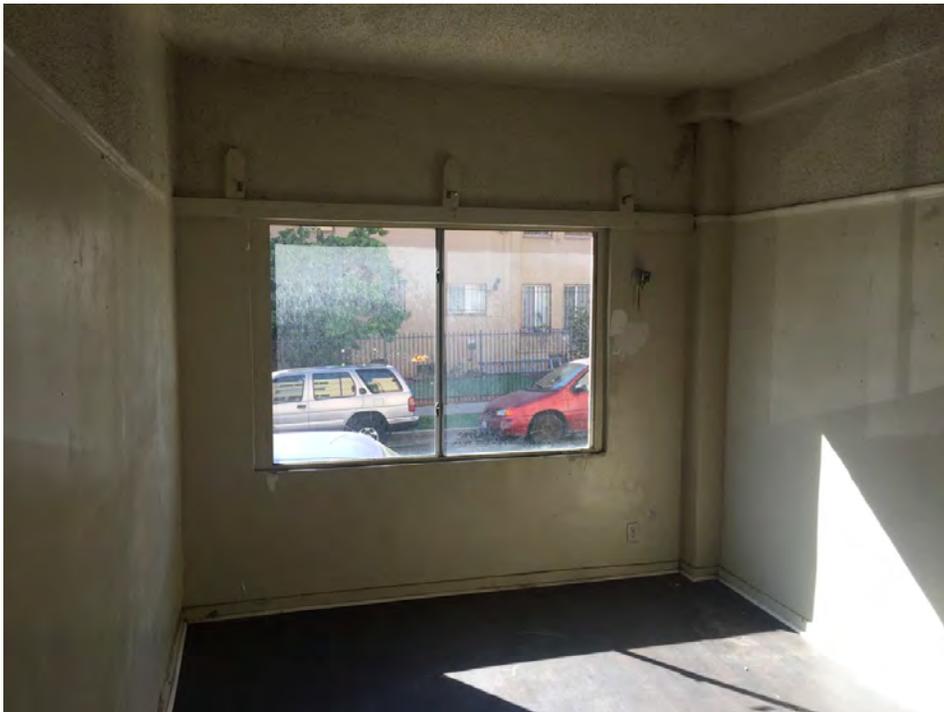
. Bedroom

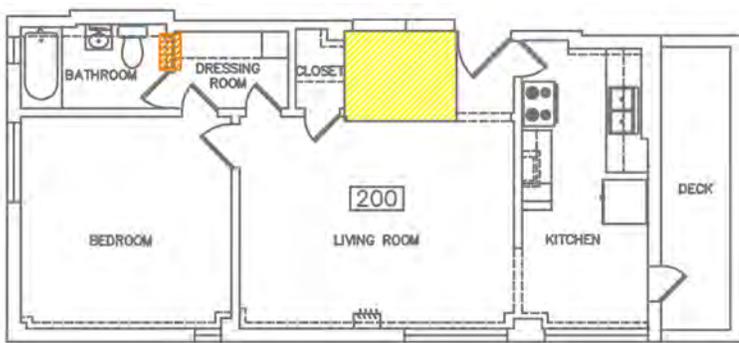
# Unit Type: 8 Condition Assessment Unit 200

SF Bathroom accessories, porcelain INTACT

SF Bathroom hex floor tile INTACT

- NON-ORIGINAL WALLS OR DOORWAYS ENCASED
- BATHROOM SHELF INTACT
- BATHROOM SHELF ENCASED
- ENCASED MURPHY BED OPENING
- NEUTRA DRAWING INDICATES DESIGN FOR LAUNDRY CHUTE OPENING TO STAIR AND INCINERATOR CHUTE
- \* ORIGINAL GLASS WINDOW

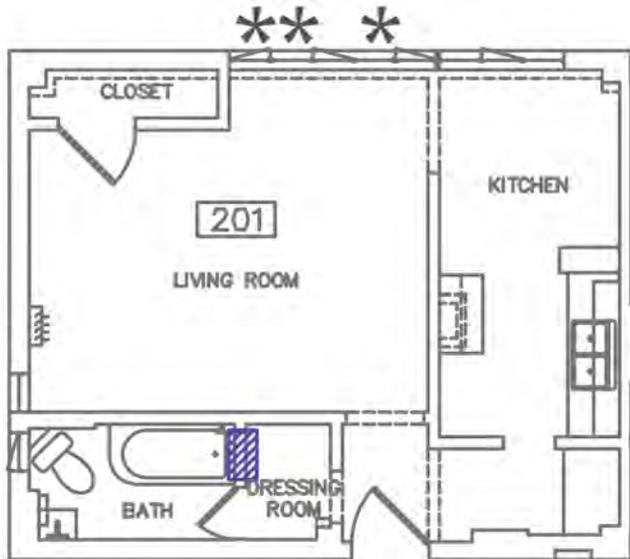
# Unit Type: 1 Condition Assessment Unit 201

PF Spatial layout	INTACT
PF Steel windows	see Window Inventory
PF Wall and door moldings	90% INTACT
PF Murphy bed door/opening	INTACT
PF Texture above molding	removed
PF Wood doors at bathroom	2 removed: Kit, DR INTACT
PF Bathroom glass-backed shelving	encased
PF Painted kitchen cabinetry	65% INTACT
PF Wood closet casework at entry	INTACT
at DR closet	removed
PF Bathtub	INTACT
SF Bathroom wall tile with liner	75% INTACT
SF Bathroom accessories, porcelain.	broken
SF Bathroom hex white floor tile	overlayed/removed

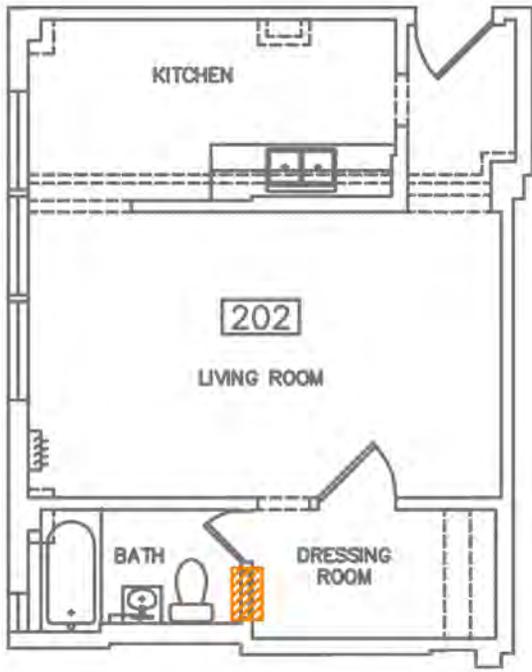
# Unit Type: 7 Condition Assessment Unit 202

PF Spatial layout	INTACT
PF Steel windows	see Window Inventory
PF Wall and door moldings	INTACT
PF Murphy bed door/opening	INTACT
PF Texture above molding	removed
PF Wood doors	2 removed: Kit, DR
Bathroom door	INTACT
PF Bathroom glass-backed shelving	INTACT
PF Painted kitchen cabinetry	45% INTACT
PF Wood closet casework doors (at entry; in DR, or both)	removed
PF Bath tub	90% INTACT
SF Bathroom wall tile with liner	INTACT
SF Bathroom accessories, porcelain.	n/a
SF Bathroom hex white floor tile	overlayed/removed

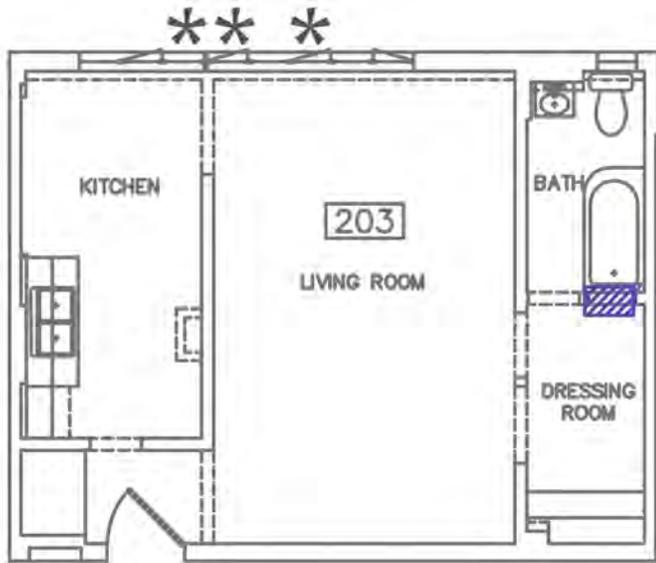
# Unit Type: 2 Condition Assessment Unit 203

PF Spatial layout	INTACT
PF Steel windows	see Window Inventory
PF Wall and door moldings	75% INTACT
PF Murphy bed door/opening	Opening INTACT door removed
PF Texture above molding	kitchen INTACT all else removed
PF Wood doors	2 removed: Kit, DR
PF Bathroom glass-backed shelving	Encased
PF Painted kitchen cabinetry	removed
PF Wood closet casework at entry closet in DR closet	INTACT removed
PF Bathtub	INTACT
SF Bathroom wall tile with liner	painted
SF Bathroom accessories, porcelain. Original Medicine Cabinet	n/a INTACT
SF Bathroom hex floor tile	removed or overlaid

**Note:** Bathroom interior (tile) wall severely bowing.

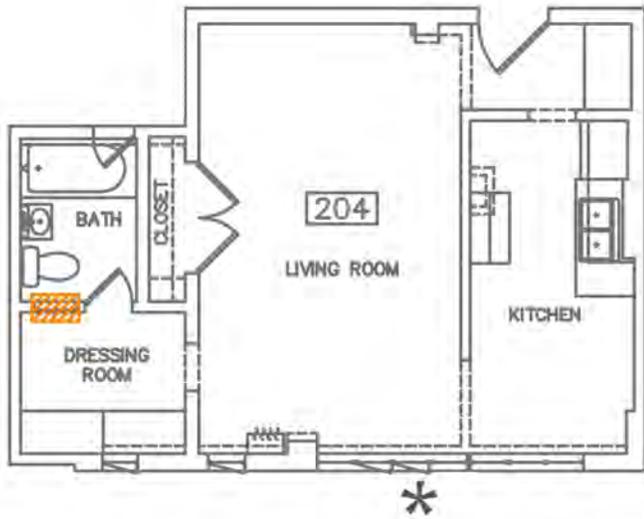
# Unit Type: 6 Condition Assessment Unit 204

PF Spatial layout	INTACT
PF Steel windows	see Window Inventory
PF Wall and door moldings	60% INTACT
PF Murphy bed door/opening	INTACT
PF Texture above molding	removed
PF Wood doors	2 removed: Kit, DR.
Bathroom door	INTACT
PF Bathroom glass-backed shelving	encased
PF Painted kitchen cabinetry	90% INTACT
PF Wood closet casework at entry closet	removed
in DR closet	INTACT
PF Bathtub	INTACT
SF Bathroom wall tile with liner	50% INTACT
SF Bathroom accessories, porcelain.	INTACT
SF Bathroom hex floor tile	Removed or overlaid

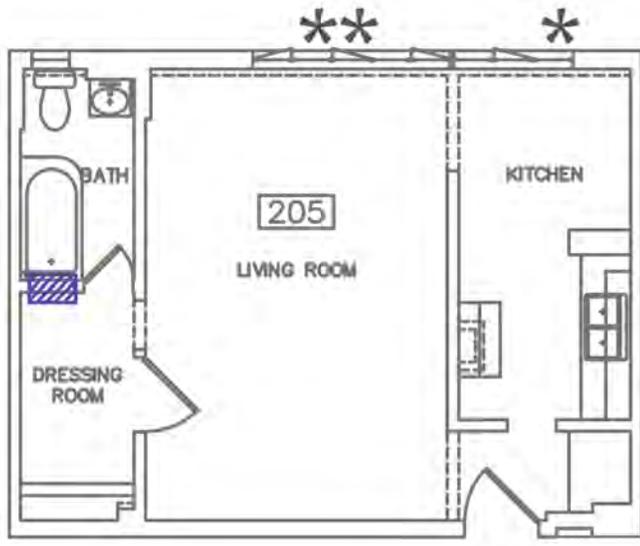
# Unit Type: 2 Condition Assessment Unit 205

PF Spatial layout	INTACT
PF Steel windows	see Window Inventory
PF Wall and door moldings	INTACT
PF Murphy bed door/opening	INTACT
PF Texture above molding	Removed
PF Wood doors	2 Removed: Kit, DR
PF Bathroom glass-backed shelving	Encased
PF Painted kitchen cabinetry	50% INTACT
PF Wood closet casework at entry closet in DR closet, or both)	INTACT Removed
PF Bathtub	INTACT
SF Bathroom wall tile with liner	painted
SF Bathroom accessories, porcelain.	65% INTACT
SF Bathroom hex floor tile	Removed or overlaid

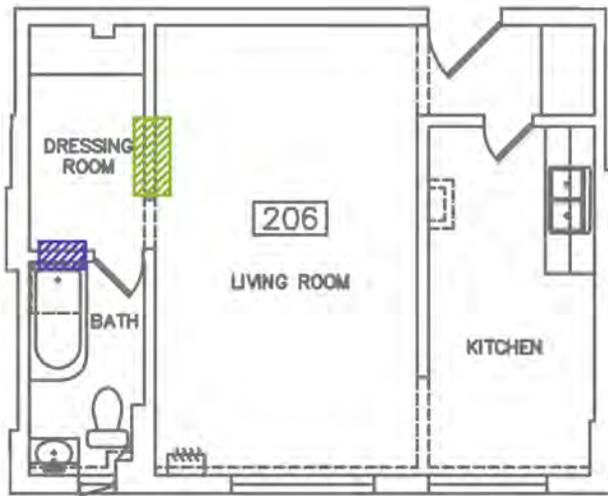
# Unit Type: 6 Condition Assessment Unit 206

**Note:** Bathroom interior (tile) wall bowing.

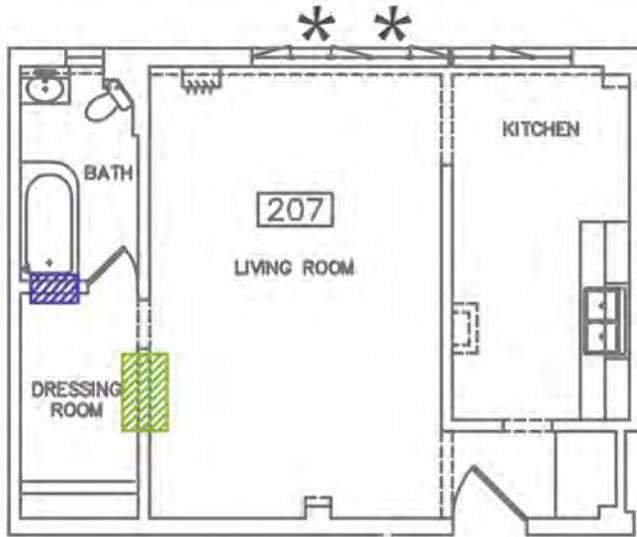
# Unit Type: 2 Condition Assessment Unit 207

PF Spatial layout	INTACT
PF Steel windows	see Window Inventory
PF Wall and door moldings	90% INTACT
PF Murphy bed door/opening	door removed, opening walled-in, molding removed
PF Texture above molding	removed
PF Wood doors	removed
Kitchen	altered (width increased)
DR	INTACT
Bathroom	encased
PF Bathroom glass-backed shelving	removed
PF Painted kitchen cabinetry	INTACT
PF Wood closet casework at entry	removed
in DR,	INTACT
PF Bathtub	painted (50%)
SF Bathroom wall tile with liner	INTACT
SF Bathroom accessories, porcelain.	removed or overlaid
SF Bathroom hex floor tile

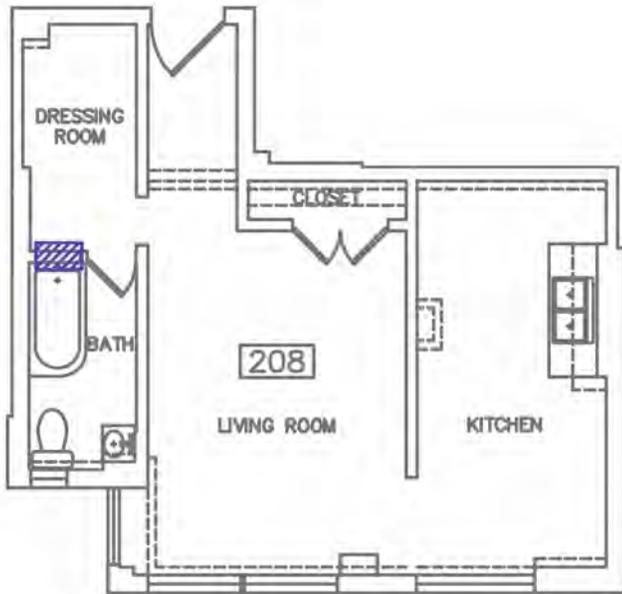
# Unit Type: 5 Condition Assessment Unit 208

PF Spatial layout	INTACT
PF Steel windows	see Window Inventory
PF Wall and door moldings	40% INTACT
PF Murphy bed door/opening	doors removed
PF Texture above molding	tbd
PF Wood doors	
DR	removed
Bathroom	INTACT
PF Bathroom glass-backed shelving	encased
PF Painted kitchen cabinetry	removed
PF Wood closet casework at entry:	Unit design does not have entry closet
DR closet	removed partially
PF Bathtub	INTACT
SF Bathroom wall tile with liner	INTACT
SF Bathroom accessories, porcelain.	removed
SF Bathroom hex floor tile	removed or overlaid

**Note:** Bathroom interior (tile) wall bowing.

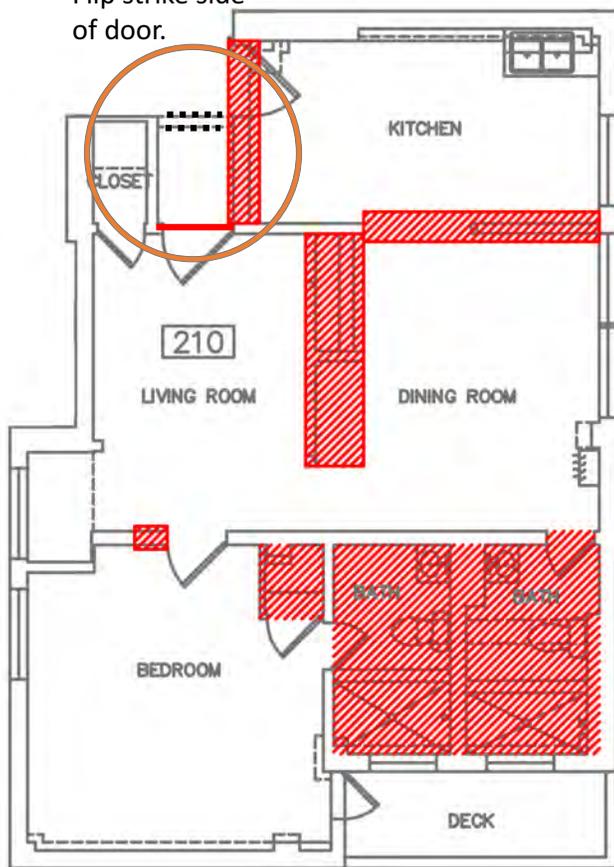
# Unit Type: 4 Condition Assessment Unit 210

Note original location, door, per Unit 108 . Flip strike side of door.

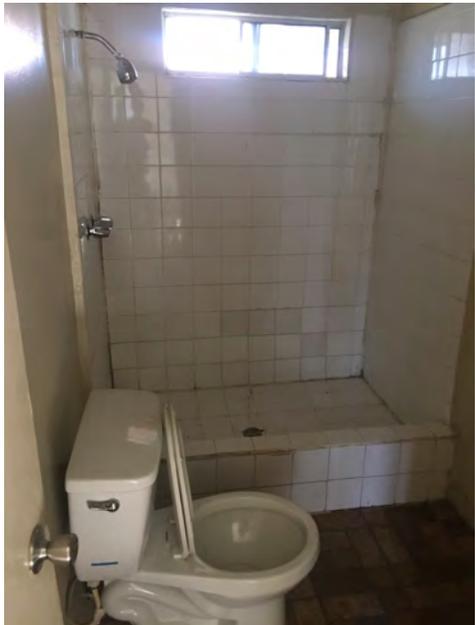
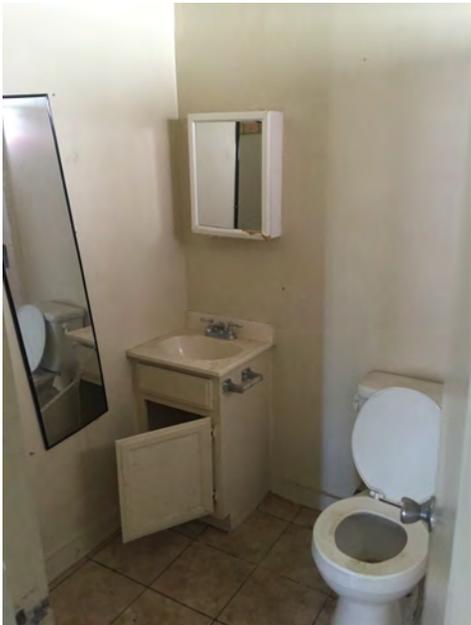
. Bathroom

**Note:** ALL ORIGINAL DRESSING ROOM/BATHROOM FEATURES HAVE BEEN SUBSTANTIALLY ALTERED OR DEMOLISHED.

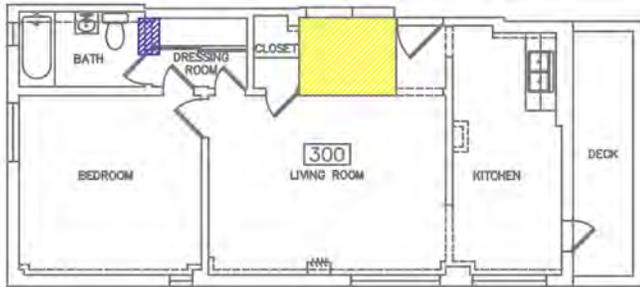
# Unit Type: 8 Condition Assessment Unit 300

PF Spatial layout	INTACT
PF Steel windows	see Window Inventory
PF Wall and door moldings	90% INTACT
PF Murphy bed door/opening	n/a
PF Texture above molding	Removed
PF Wood doors	Intact except for removed south kit door
PF Bathroom glass-backed shelving	ENCASED
PF Painted kitchen cabinetry	REMOVED
PF Wood closet casework (at entry closet, in DR closet, or both)	DR closet area altered, all 4 doors missing; long deep thin closet + door INTACT
PF Bathtub	INTACT
SF Bathroom wall tile with liner	Two walls intact, bath shower area new later incompatible tile
SF Bathroom accessories, porcelain.	3 INTACT
SF Bathroom hex white floor tile	REMOVED or overlaid

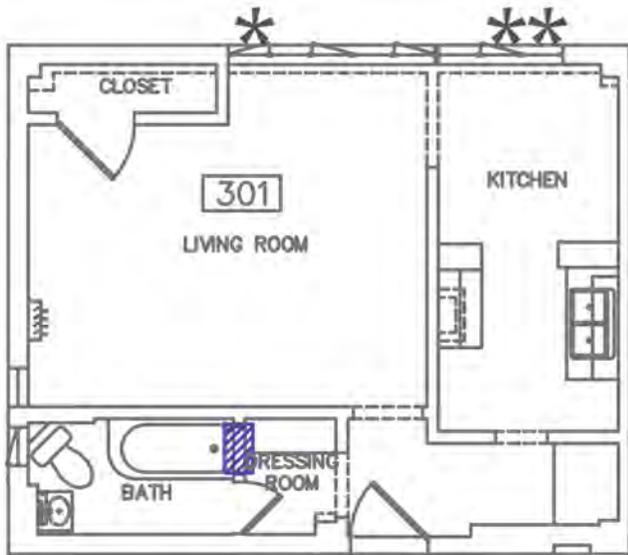
# Unit Type: 1 Condition Assessment Unit 301

PF Spatial layout	INTACT
PF Steel windows	see Window Inventory
PF Wall and door moldings	INTACT
PF Murphy bed door/opening	INTACT, knob removed
PF Texture above molding	Removed
PF Wood doors	2 missing (kit, DR)
PF Bathroom glass-backed shelving	ENCASED
PF Painted kitchen cabinetry	90% INTACT, excellent
PF Wood closet casework (at entry closet; in DR closet or both)	Entry doors, casework, hardware, hinges INTACT. DR closet altered: doors missing
PF Bathtub	INTACT
SF Bathroom wall tile with liner	INTACT, painted
SF Bathroom accessories, porcelain.	all INTACT
SF Bathroom hex white floor tile	REMOVED or overlaid

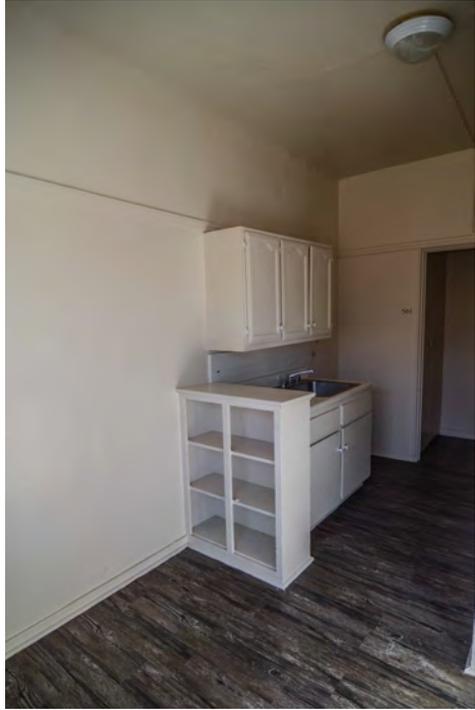
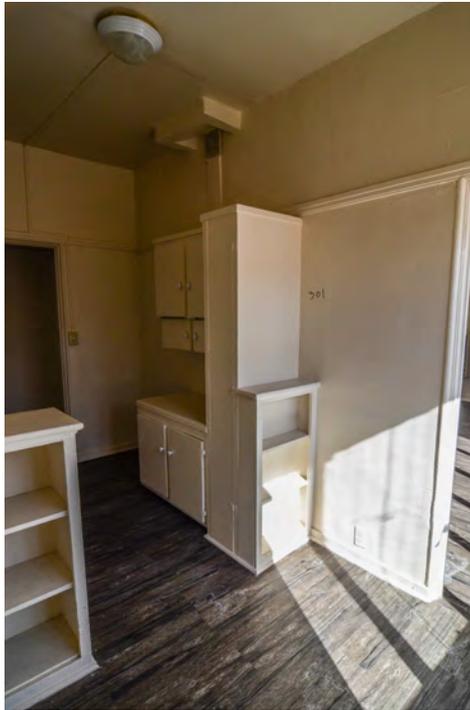
. Kitchen

**NOTE: Note black tile liner, white subway tile in kitchen.**

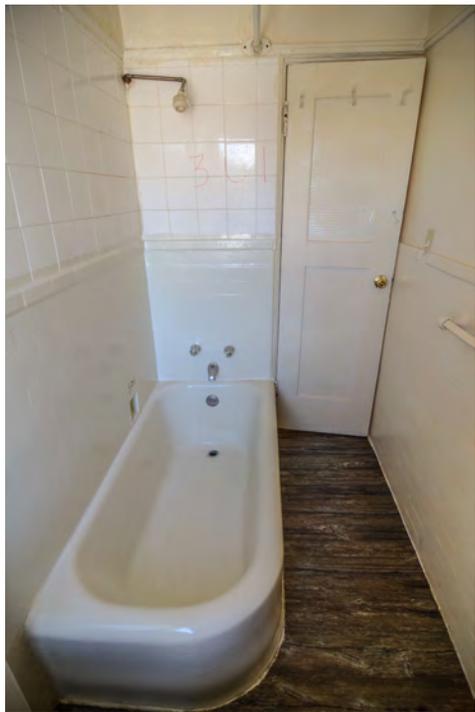
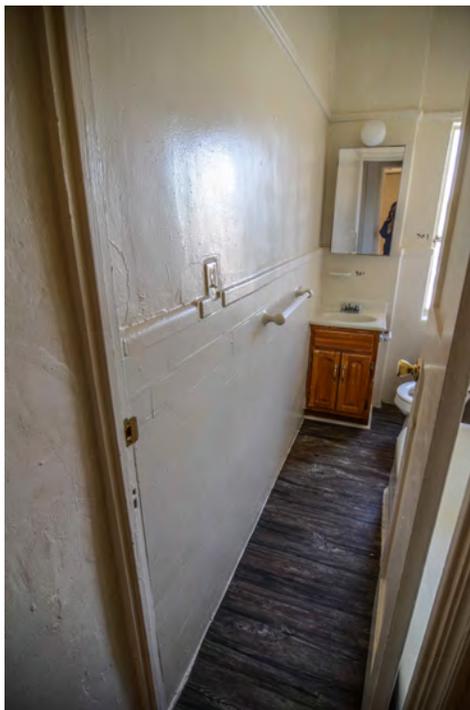
. Bathroom

Black liner tile embellishing  
subway field tile

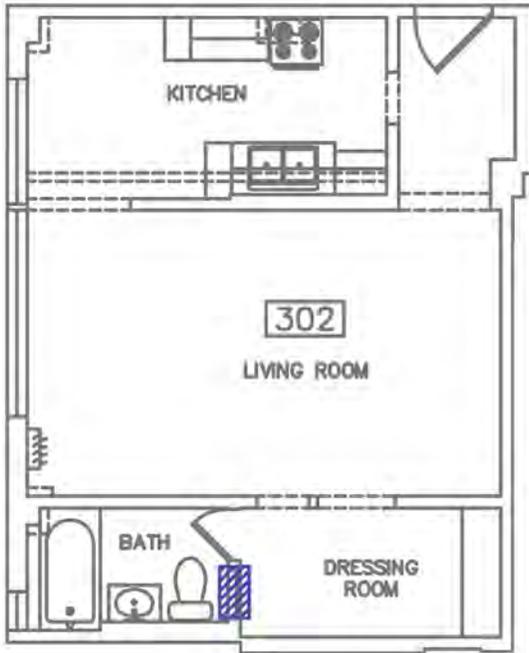
# Unit Type: 7 Condition Assessment Unit 302

PF Spatial Layout	INTACT
PF Steel windows	see Window Inventory
PF Wall and door moldings	INTACT
PF Murphy bed door/opening	INTACT, knob removed
PF Texture above molding	Apparently intact
PF Wood doors	2 missing (kit, DR)
PF Bathroom glass-backed shelving	ENCASED
PF Painted kitchen cabinetry	INTACT, excellent
PF Wood closet casework doors (at entry; in DR, or both)	DR – 1 tall door missing; no hall closet per design
PF Bathtub	INTACT
SF Bathroom wall tile with liner	INTACT, painted
SF Bathroom accessories, porcelain.	all INTACT
SF Bathroom hex white floor tile	REMOVED or overlaid

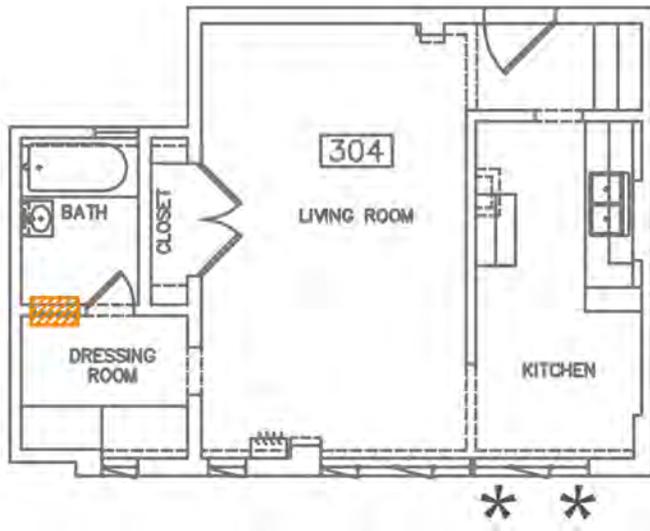
# Unit Type: 6 Condition Assessment Unit 304

PF Spatial layout	INTACT
PF Steel windows	see Window Inventory
PF Wall and door moldings	95% INTACT
PF Murphy bed door/opening	INTACT including hardware, knobs
PF Texture above molding	INTACT in LR only.
PF Wood doors	2 missing (kit, DR)
PF Bathroom glass-backed shelving	Intact on bathroom side, glass may be painted.
PF Painted kitchen cabinetry	50% INTACT, <b>note retention of doors to china cabinet</b>
PF Wood closet casework doors (at entry; in DR, or both)	Entry – int. altered, doors and frame missing. DR – low storage chest; upper and lower doors and some casework missing. SEE UNIT 204, INTACT
PF Bathtub	INTACT
SF Bathroom wall tile with liner	Painted
SF Bathroom accessories, porcelain.	Removed
SF Bathroom hex white floor tile	REMOVED or overlaid

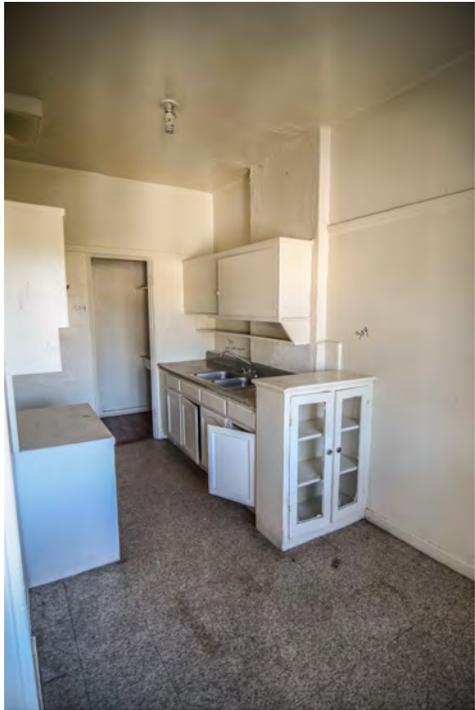
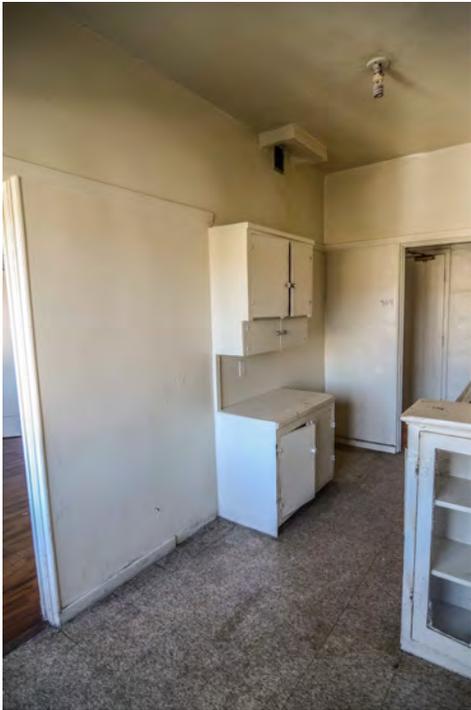
. Kitchen

**NOTE:** Only extant china cabinet with original doors

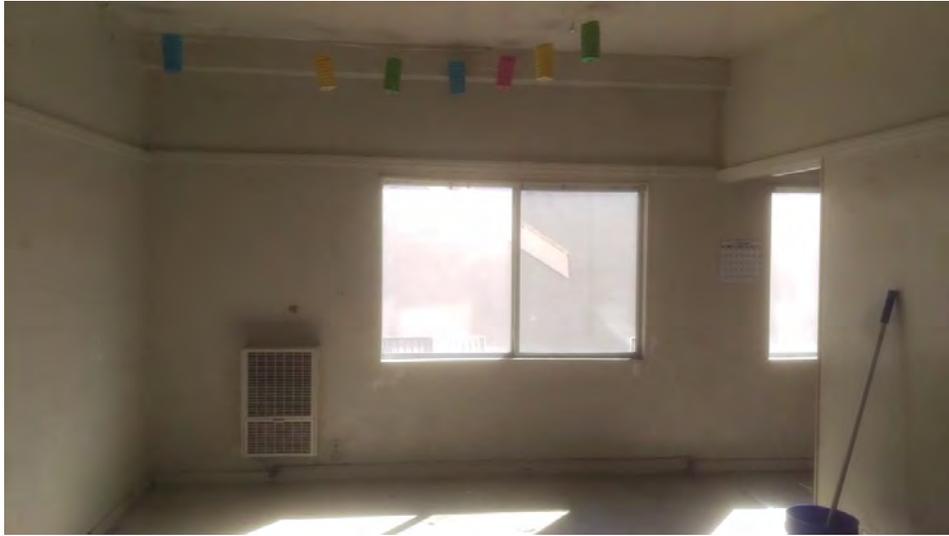
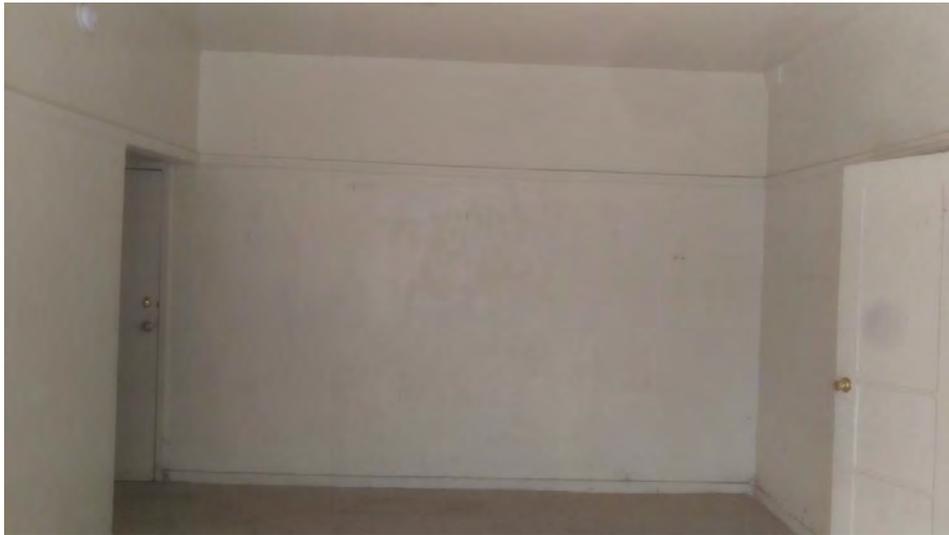
. Living Room

Unit Type: 2  
Condition Assessment  
Unit 305 Living Spaces

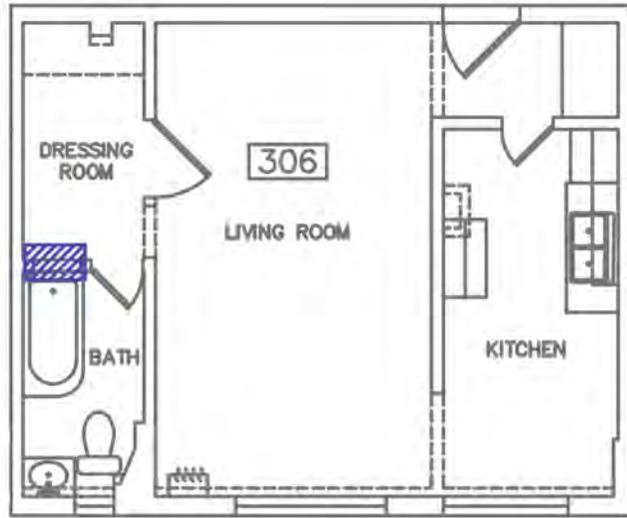
# Unit Type: 6 Condition Assessment Unit 306

PF Spatial Layout	INTACT
PF Steel windows	see Window Inventory
PF Wall and door moldings	INTACT
PF Murphy bed door/opening	INTACT, no knob. May be painted shut.
PF Texture above molding	Present and patched on LR walls, only.
PF Wood doors	2 missing (kit, DR)
PF Bathroom glass-backed shelving	ENCASED
PF Painted kitchen cabinetry	70% INTACT, excellent Rare example of extant door, icebox.
PF Wood closet casework (at entry closet; in DR closet, or both)	DR – upper two small doors intact, lower 2 tall doors missing. Hallway doors missing.
PF Bathtub	INTACT
SF Bathroom wall tile with liner	INTACT, painted
SF Bathroom accessories, porcelain.	Removed
SF Bathroom hex white floor tile	REMOVED or overlaid

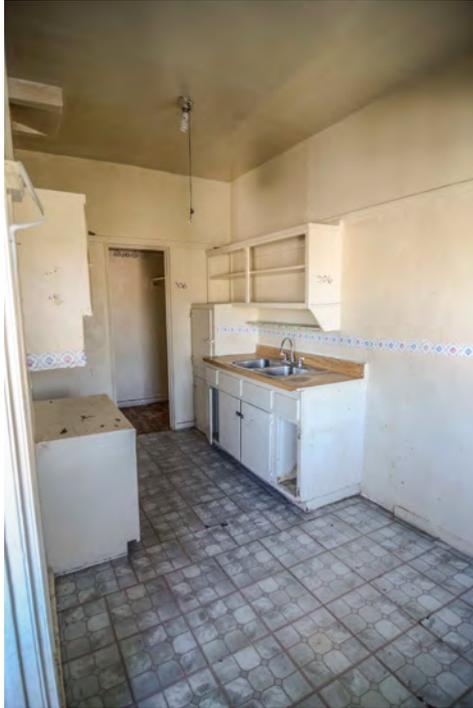
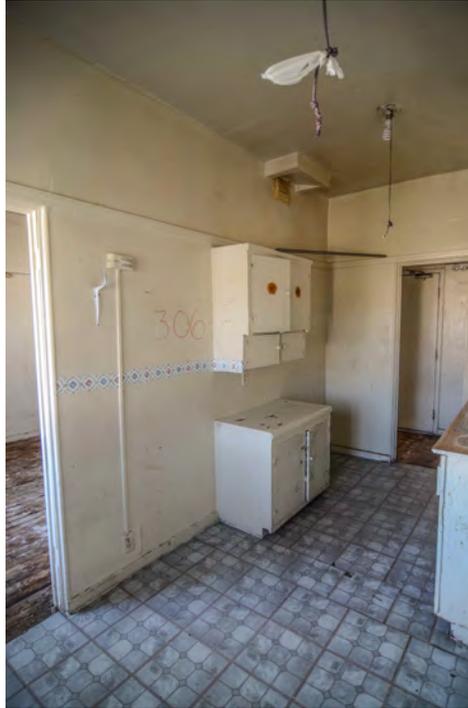
## . Kitchen

Rare example of extant door to the ice box (some conflicting evidence on whether a small refrigerator was ever installed per design development drawings).

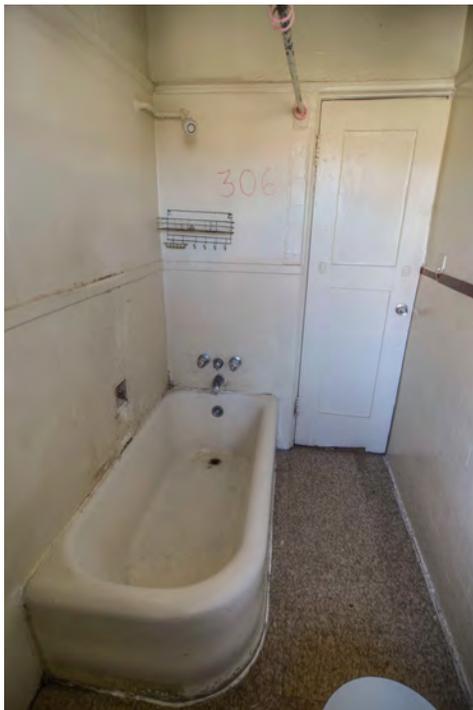
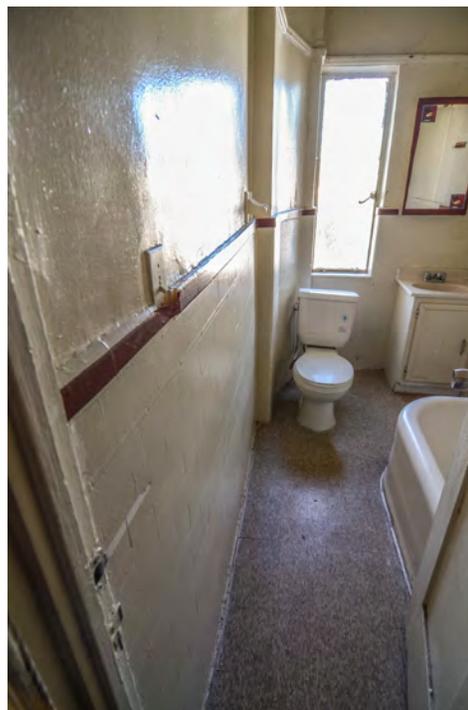
## . Bathroom

# Unit Type: 6 Condition Assessment Unit 306 Kitchen and Bathroom

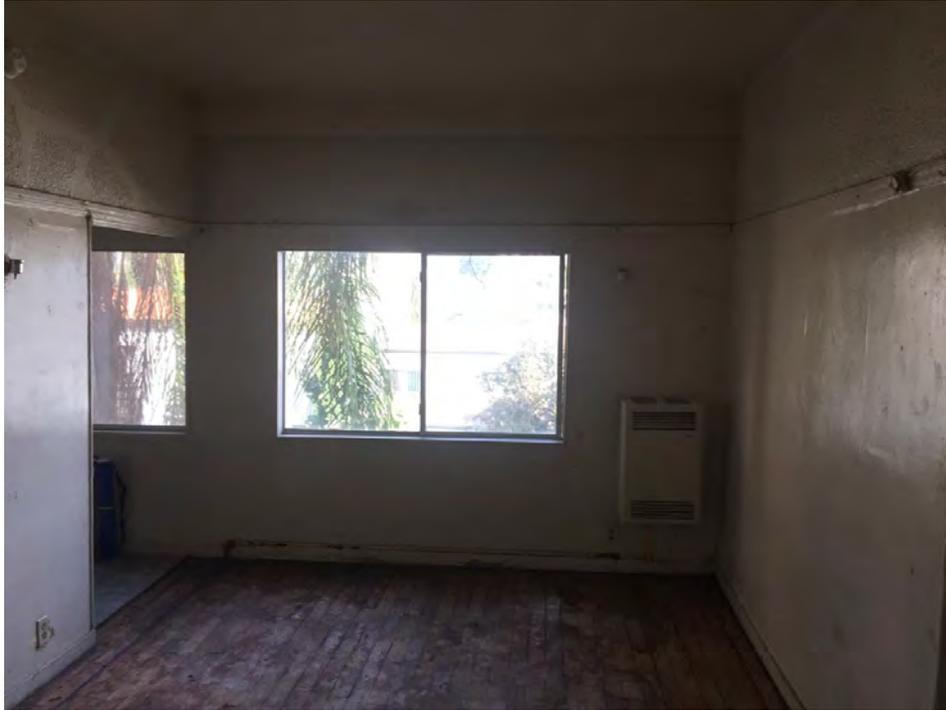
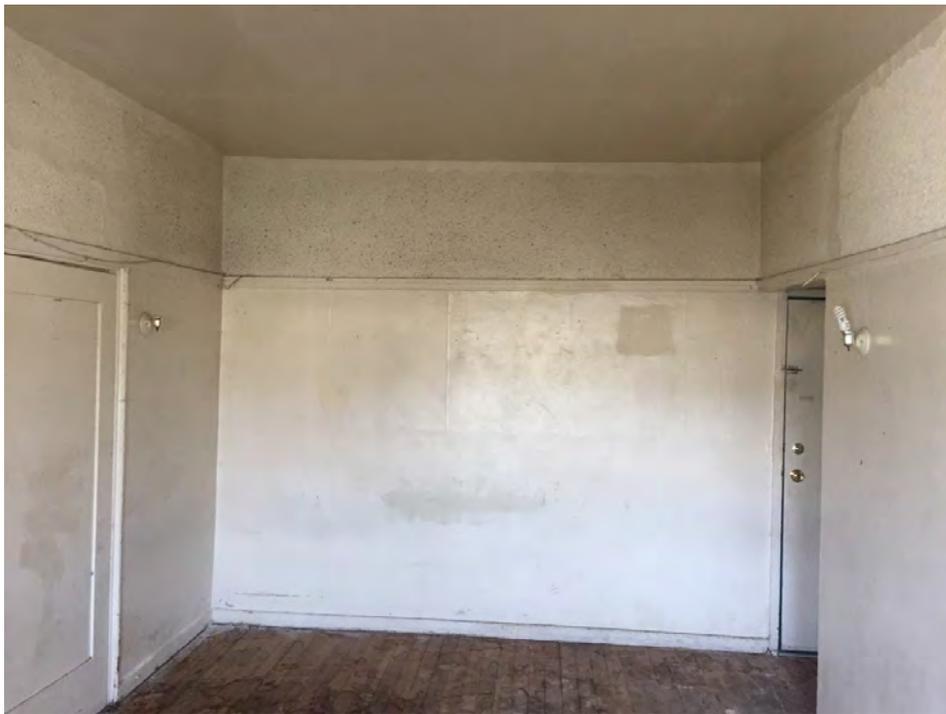
. Living Room

Unit Type: 6  
Condition Assessment  
Unit 306 Living Spaces

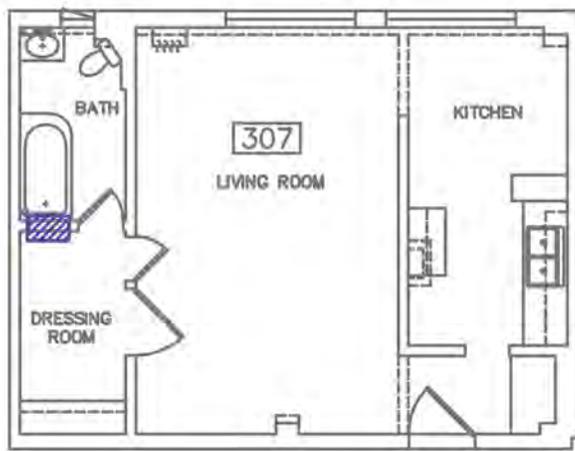
# Unit Type: 2 Condition Assessment Unit 307

PF Spatial layout	INTACT
PF Steel windows	see Window Inventory
PF Wall and door moldings	INTACT
PF Murphy bed door/opening	opening extant, door replaced by incompatible door

PF Texture above molding	Removed
PF Wood doors	1 Removed: Kit. Intact BA and DR doors have original hardware
PF Bathroom glass-backed shelving	Encased
PF Painted kitchen cabinetry	35-40% intact (2 components - Lovell unit, china cabinet)
PF Wood closet casework (at entry closet; in DR area, or both)	Entry closet doors INTACT DR full height cabinet (w 4 doors) missing,
PF Bathtub	INTACT
SF Bathroom wall tile with liner	painted
SF Bathroom accessories, porcelain.	Soap dish intact, 1/2 towel rack
SF Bathroom hex floor tile	Removed or overlaid

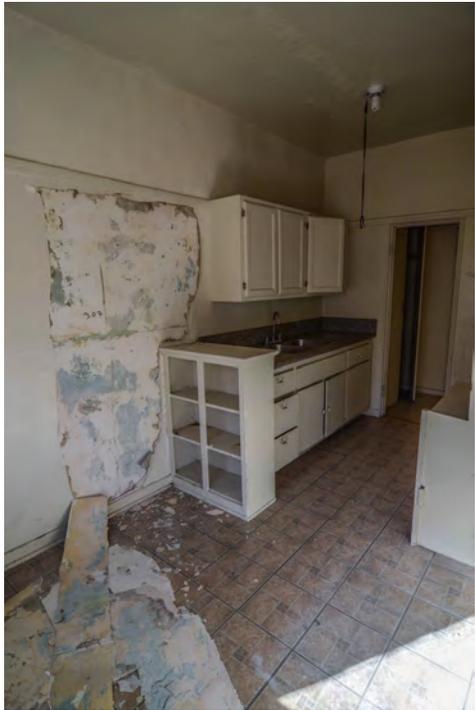
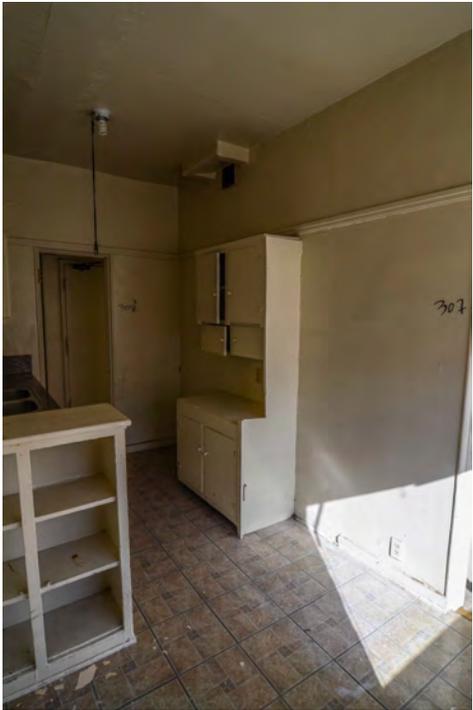
. Kitchen

Unit Type: 2  
Condition Assessment  
Unit 307 Kitchen and Bathroom

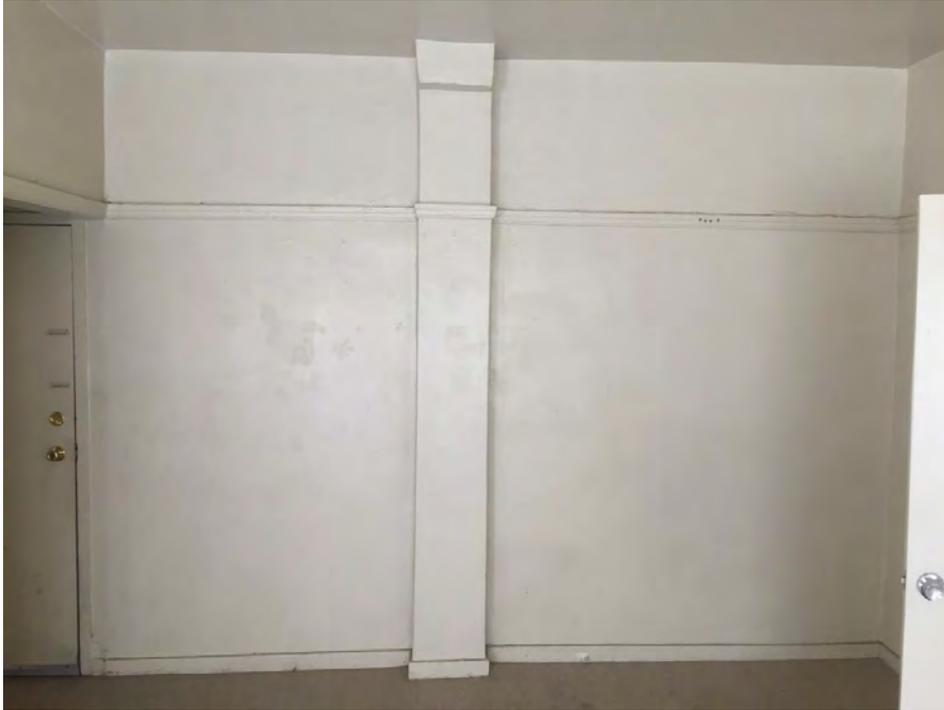
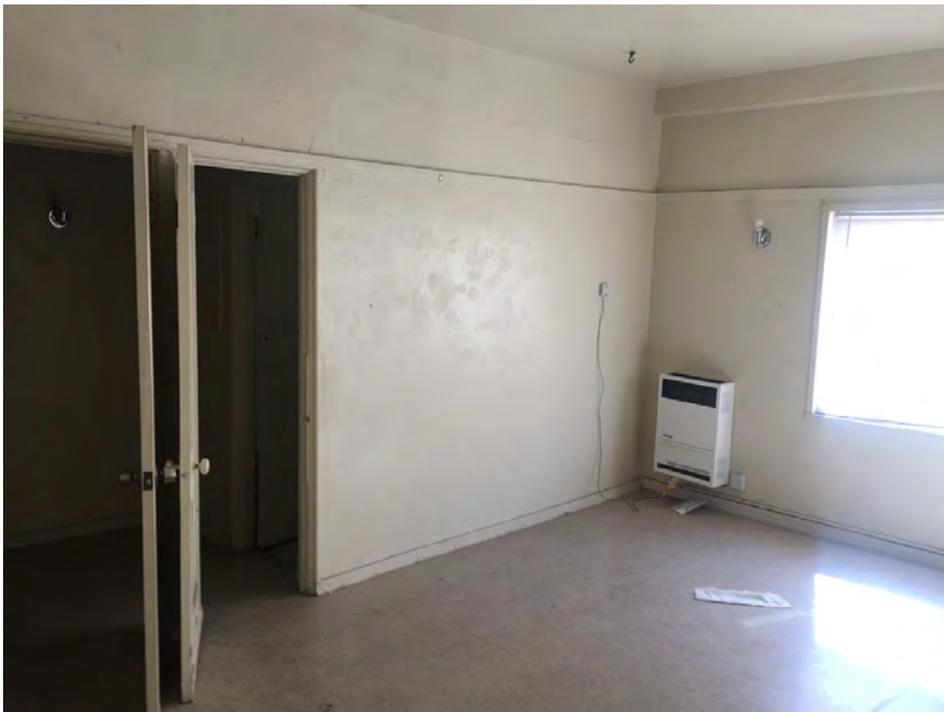
. Living Room

Unit Type: 2  
Condition Assessment  
Unit 307 Living Spaces

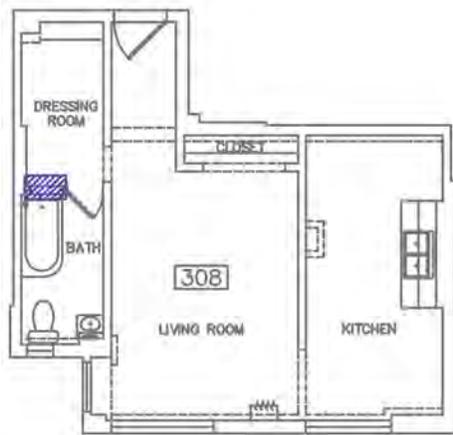
# Unit Type: 5 Condition Assessment Unit 308

PF Wood doors DR area door missing

PF Wood closet casework (at entry closet; in DR area, or both) DR – casework intact. Upper 2 small doors intact, 2 tall doors missing. No entry closet in this unit plan.

SF Bathroom accessories, porcelain. Soap dish intact.

SF Bathroom hex floor tile Removed or overlaid

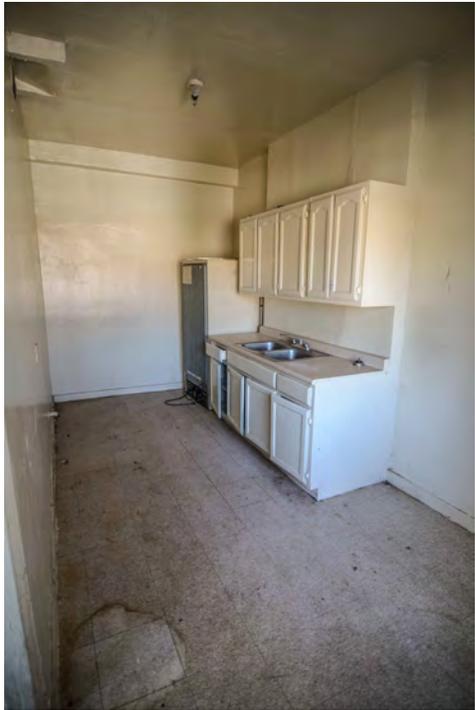
. Kitchen

Unit Type: 5  
Condition Assessment  
Unit 308 Kitchen and Bathroom

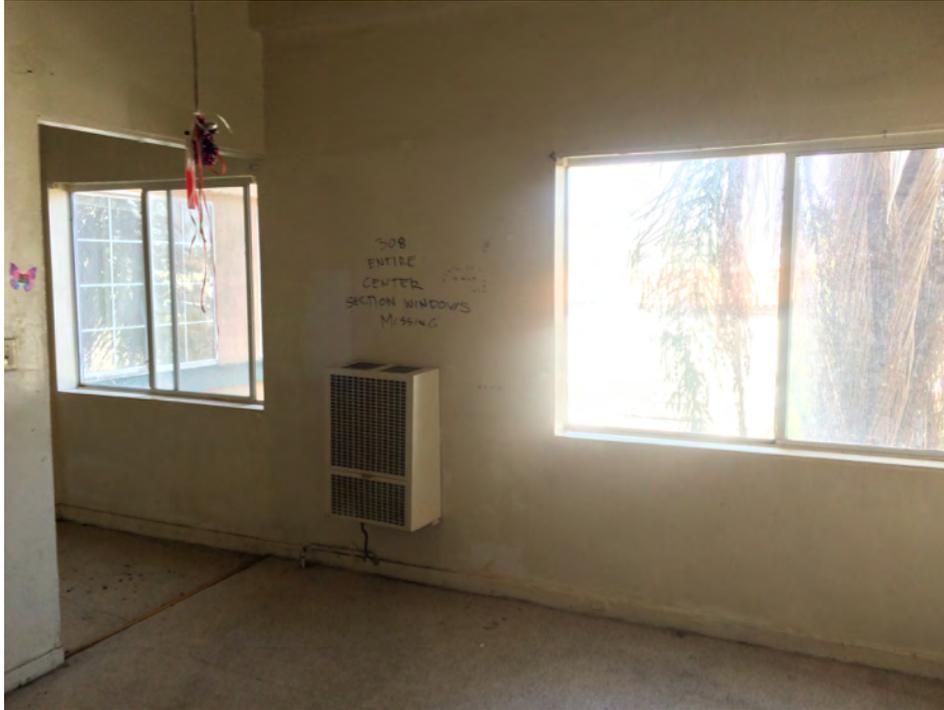
. Living Room

Unit Type: 5  
Condition Assessment  
Unit 308 Living Spaces

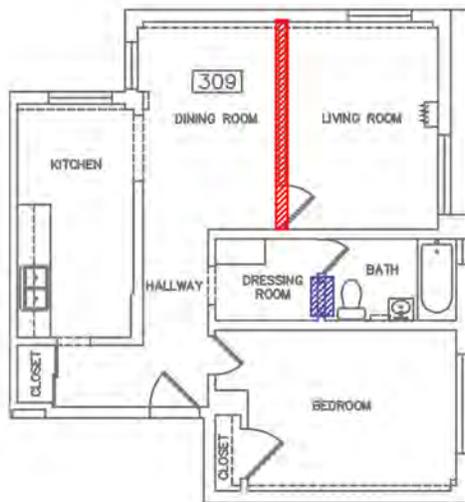
# Unit Type: 3 Condition Assessment Unit 309

PF Spatial layout	Dividing wall in LR
PF Steel windows	see Window Inventory
PF Wall and door moldings	Removed
PF Murphy bed door/opening	INTACT, including hardware and knob.
PF Texture above molding	Removed
PF Wood doors	Kit and DR doors missing
PF Bathroom glass-backed shelving	Encased
PF Painted kitchen cabinetry	All removed.
PF Wood closet casework (at entry closet; in DR area, or both)	Entry closet doors removed DR closet casework and four doors (2 small, 2 tall) INTACT
PF Bathtub	INTACT
SF Bathroom wall tile with liner	painted
SF Bathroom accessories, porcelain.	Towel rack, tissue holder intact
SF Bathroom hex floor tile	Removed or overlaid

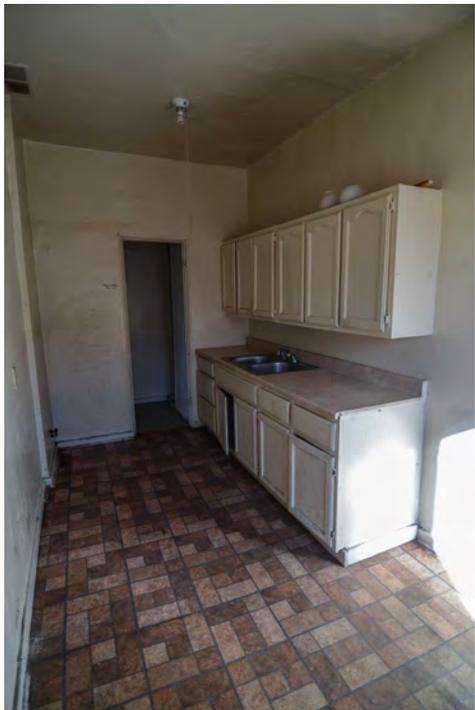
. Kitchen

Unit Type: 3  
Condition Assessment  
Unit 309 Kitchen and Bathroom

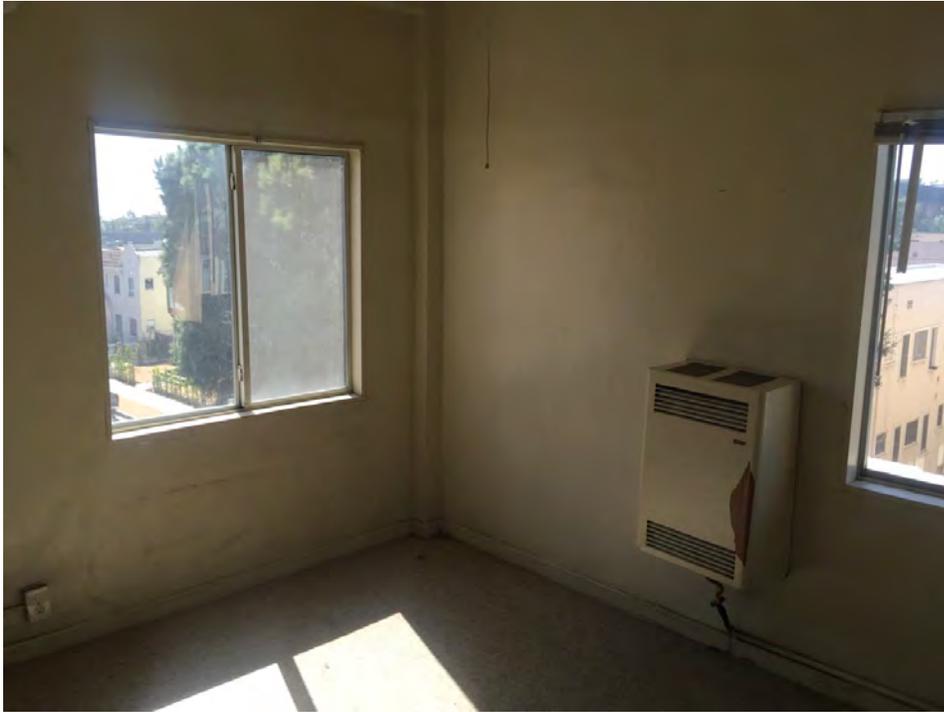
. Living Room

Unit Type: 3  
Condition Assessment  
Unit 309 Living Spaces

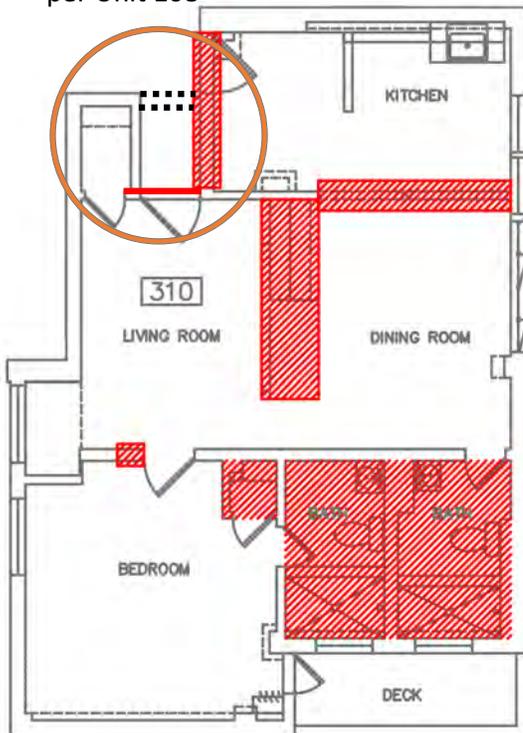
# Unit Type: 4 Condition Assessment Unit 310

Note original location, door, per Unit 108

PF Spatial layout	Eradicated – See Note, left.
PF Steel windows	see Window Inventory
PF Wall and door moldings	Removed
PF Murphy bed door/opening	n/a
PF Texture above molding	Removed
PF Wood doors	All are missing except for entry closet door
PF Bathroom glass-backed shelving	Encased, although not clear that it originally existed. Careful disassembly, Unit 109, may shed on this.
PF Painted kitchen cabinetry	All removed.
PF Wood closet casework (at entry closet; in DR area, or both)	DR area removed. Entry closet door (standard 24" door) intact per above.
PF Bathtub	Removed
SF Bathroom wall tile with liner	Removed
SF Bathroom accessories, porcelain.	Removed
SF Bathroom hex floor tile	Removed or overlaid

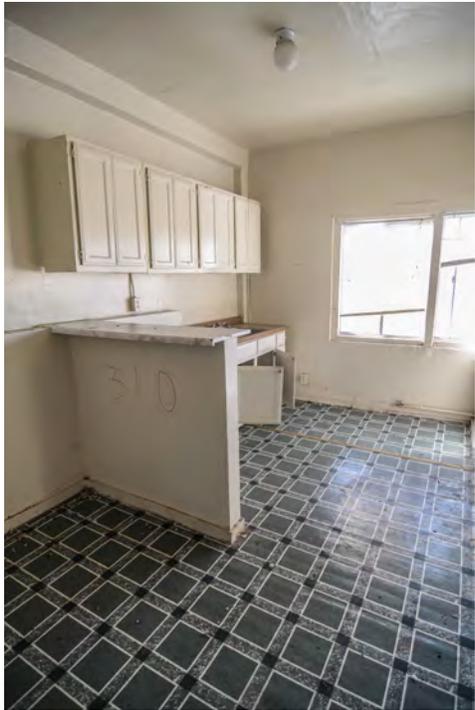
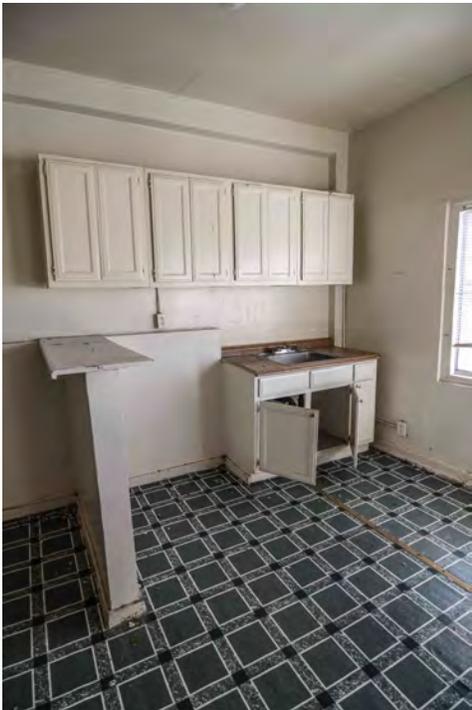
. Kitchen

Unit Type: 4  
Condition Assessment  
Unit 310 Kitchen and Bathroom

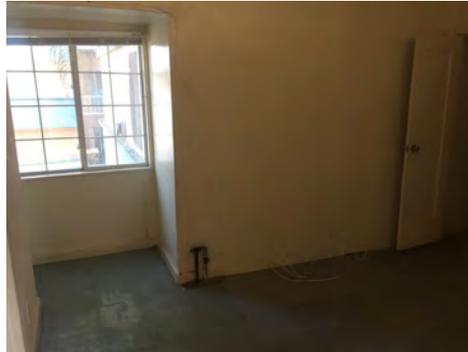
. Living Room

Unit Type: 4  
Condition Assessment  
Unit 310 Living Spaces

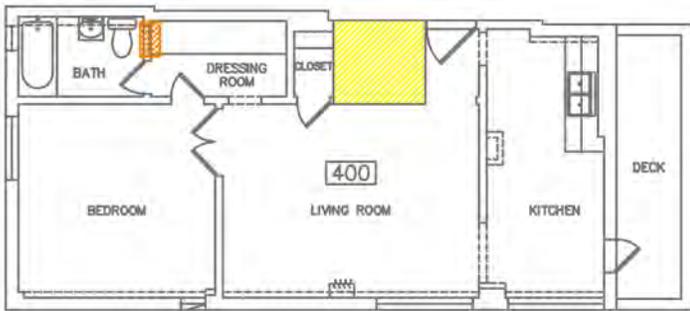
# Unit Type: 8 Condition Assessment Unit 400

PF Spatial layout	INTACT
PF Steel windows and balcony door	see Window Inventory
PF Wall and door moldings	Approx. 60% INTACT: extant in LR, DR, partly in BA. Removed in Kit.
PF Murphy bed door/opening	n/a
PF Texture above molding	Removed
PF Wood doors	2 missing (kit, DR) French doors to bdrm intact; one (S) may be later replacement. N leaf original
PF Bathroom glass-backed shelving	INTACT
PF Painted kitchen cabinetry	Removed
PF Wood closet casework (at entry closet; in DR closet, or both)	DR INTACT (2 tall doors, 2 upper small doors.) Long deep thin hall closet INTACT
PF Bathtub	INTACT
SF Bathroom wall tile with liner	90% INTACT, excellent cond., high degree integrity.
SF Bathroom accessories, porcelain.	INTACT
SF Bathroom hex white floor tile	INTACT

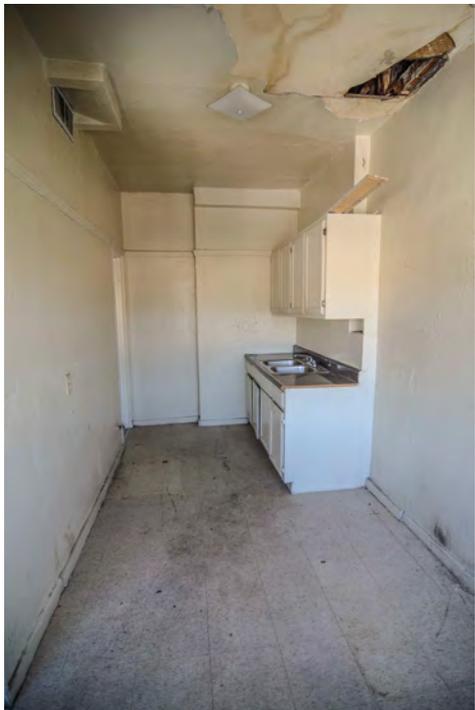
. Kitchen

Unit Type: 8  
Condition Assessment  
Unit 400 Kitchen and Bathroom
