**JARDINETTE APARTMENTS (HCM #390)**  
5128 West Marathon Street  
CHC-2017-2794-MAEX

## RECOMMENDATION REPORT

**PROJECT:** 5128 West Marathon Street  
Jardinette Apartments, Historic-Cultural Monument (HCM) #390

**REQUEST:** **APPROVAL OF EXEMPTION FROM LIMITATION OF ELIGIBILITY FOR HISTORICAL PROPERTY CONTRACT (MILLS ACT) APPLICATION**

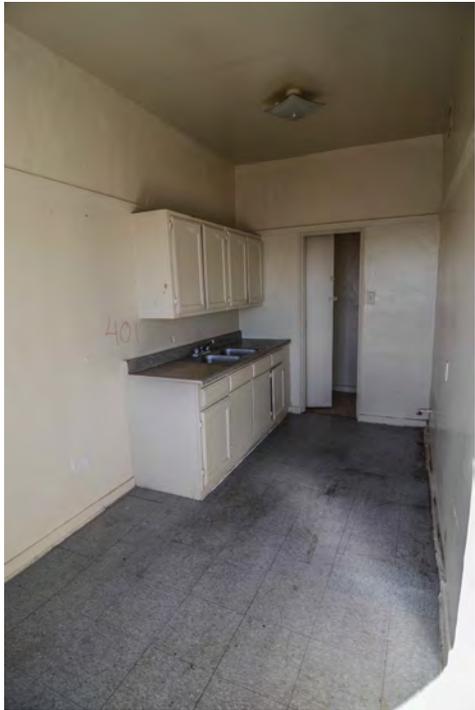
. Kitchen

PF Spatial layout	INTACT
PF Steel windows and balcony door	see Window Inventory
PF Wall and door moldings	INTACT
PF Murphy bed door/opening	INTACT, including hinges.
PF Texture above molding	Removed, replaced with incompatible texture
PF Wood doors	2 missing (kit, DR) BA has original door knob
PF Bathroom glass-backed shelving	Encased or Removed.
PF Painted kitchen cabinetry	Removed
PF Wood closet casework (at entry closet; in DR closet, or both)	DR doors missing (4) Entry closet INTACT? (asymmetrical door layout)
PF Bathtub	INTACT
SF Bathroom wall tile with liner	Extant, painted.
SF Bathroom accessories, porcelain.	n/a; tissue dispenser extant
SF Bathroom hex white floor tile	Removed or overlaid

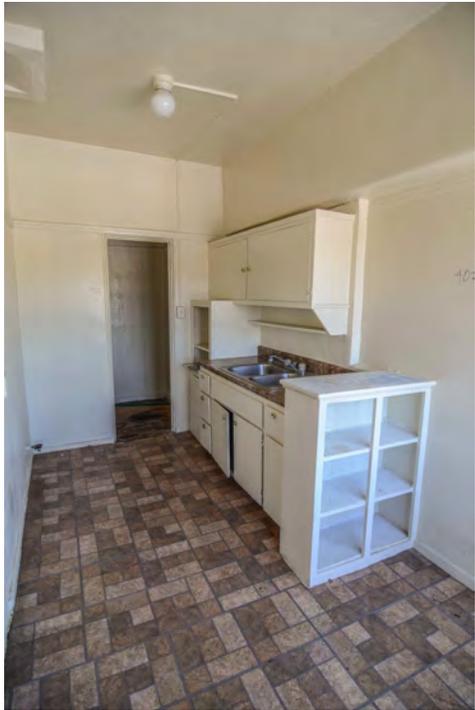
. Kitchen

PF Spatial layout	INTACT
PF Steel windows and balcony door	see Window Inventory
PF Wall and door moldings	80% INTACT
PF Murphy bed door/opening	INTACT
PF Texture above molding	Removed
PF Wood doors	2 missing (kit, DR)
PF Bathroom glass-backed shelving	INTACT, painted, shelves missing.
PF Painted kitchen cabinetry	35% INTACT (2 components present)
PF Wood closet casework (at entry closet; in DR closet, or both)	While DR closet area is altered, VERY IMPT in original configuration. no hall closet per design
PF Bathtub	INTACT
SF Bathroom wall tile with liner	INTACT
SF Bathroom accessories, porcelain.	Soap dispenser, tissue dispenser extant
SF Bathroom hex white floor tile	INTACT
<b>NOTE: Some linoleum with brown linear texture bordering LR may be original.</b>

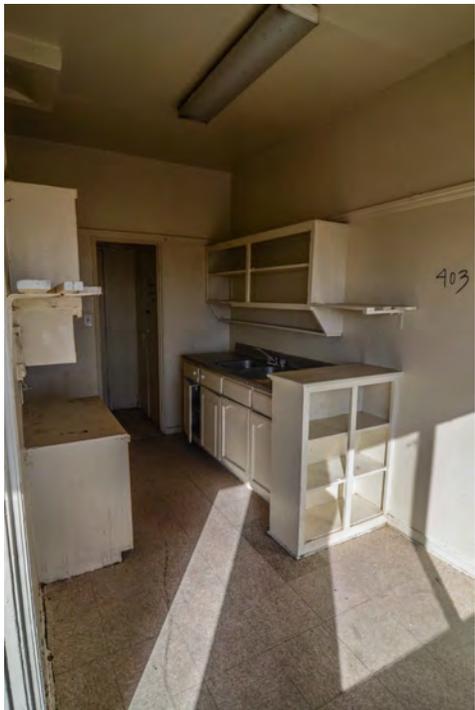
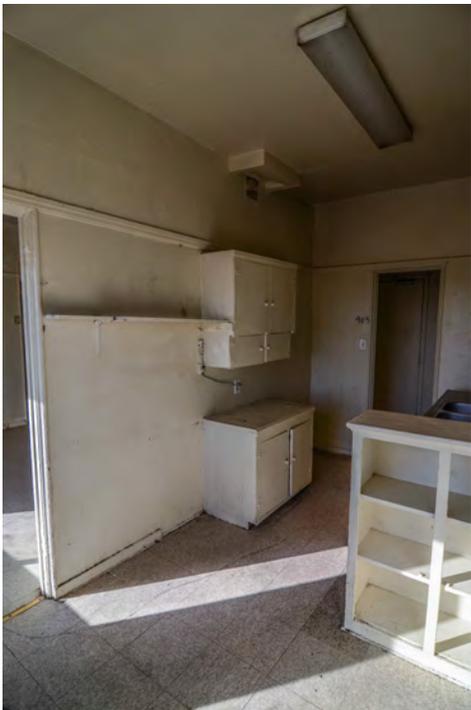
. Kitchen

PF Spatial layout	INTACT
PF Steel windows and balcony door	see Window Inventory
PF Wall and door moldings	Some extant, 80% altered
PF Murphy bed door/opening	Murphy door gone, opening INTACT
PF Texture above molding	Removed; patched texture poorly executed.
PF Wood doors	2 missing (kit, DR)
PF Bathroom glass-backed shelving	Encased or Removed.
PF Painted kitchen cabinetry	Approx 60% intact
PF Wood closet casework (at entry closet; in DR closet, or both)	DR altered, 4 doors missing. DR shelving not original. Hall closet INTACT, including hinges.
PF Bathtub	INTACT
SF Bathroom wall tile with liner	INTACT. Shower surround tile not original.
SF Bathroom accessories, porcelain.	Removed
SF Bathroom hex white floor tile	Removed or overlaid

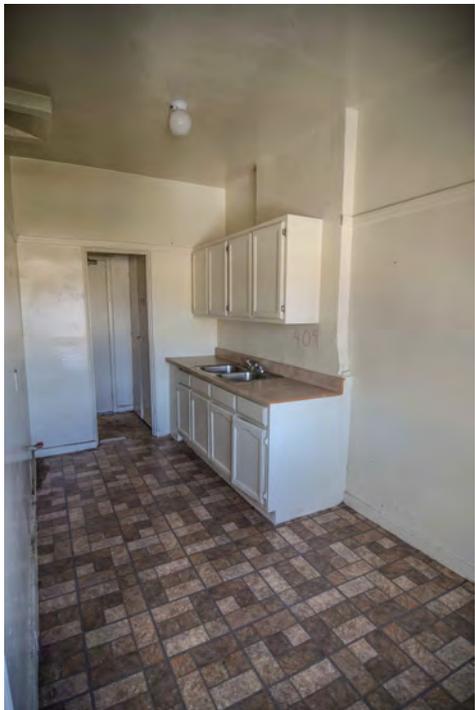
. Kitchen

PF Spatial layout	INTACT
PF Steel windows and balcony door	see Window Inventory
PF Wall and door moldings	INTACT
PF Murphy bed door/opening	Opening/molding INTACT no door
PF Texture above molding	Removed
PF Wood doors	2 missing (kit, DR)
PF Bathroom glass-backed shelving	INTACT w shelving .
PF Painted kitchen cabinetry	Removed
PF Wood closet casework (at entry closet; in DR closet, or both)	DR Altered; largely gone s Hall closet INTACT
PF Bathtub	INTACT
SF Bathroom wall tile with liner	Extant, painted.
SF Bathroom accessories, porcelain.	n/a; tissue dispenser extant
SF Bathroom hex white floor tile	INTACT

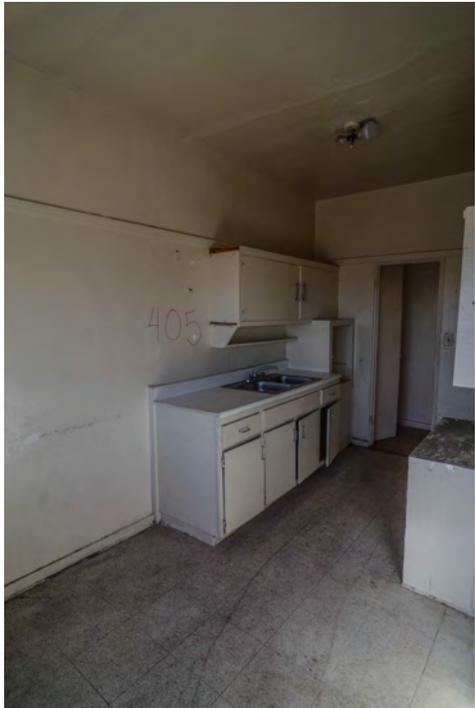
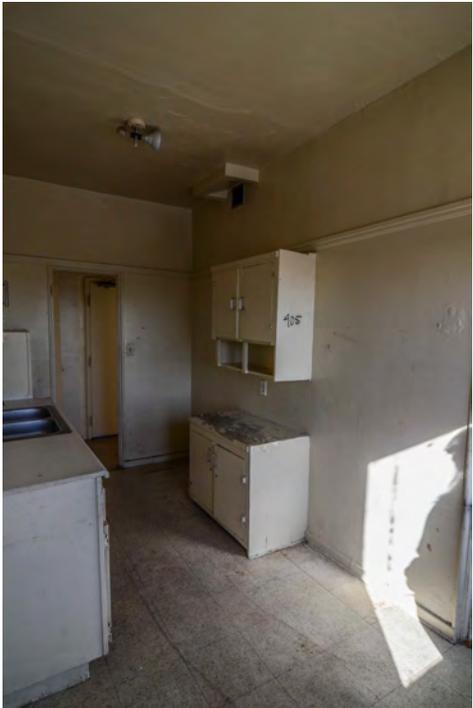
. Kitchen

<p>PF Bathroom glass-backed shelving</p> <p>PF Painted kitchen cabinetry</p> <p>PF Wood closet casework (at entry closet; in DR closet, or both)</p> <p>PF Bathtub</p> <p>SF Bathroom wall tile with liner</p> <p>SF Bathroom accessories, porcelain.</p> <p>SF Bathroom hex white floor tile</p>	<p>Encased or Removed.</p> <p>Approx 60% intact; 4 components intact</p> <p>DR casework and doors missing Hall closet INTACT</p> <p>INTACT</p> <p>Extant, painted.</p> <p>n/a; tissue dispenser extant</p> <p>Removed or overlaid</p>
---------------------------------------------------------------------------------------------------------------------------------------------------------------------------------------------------------------------------------------------------------------------------------------------------	-------------------------------------------------------------------------------------------------------------------------------------------------------------------------------------------------------------------------------------------

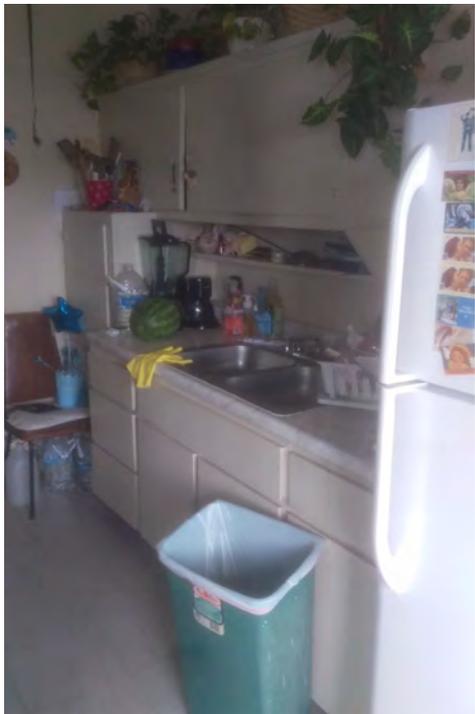
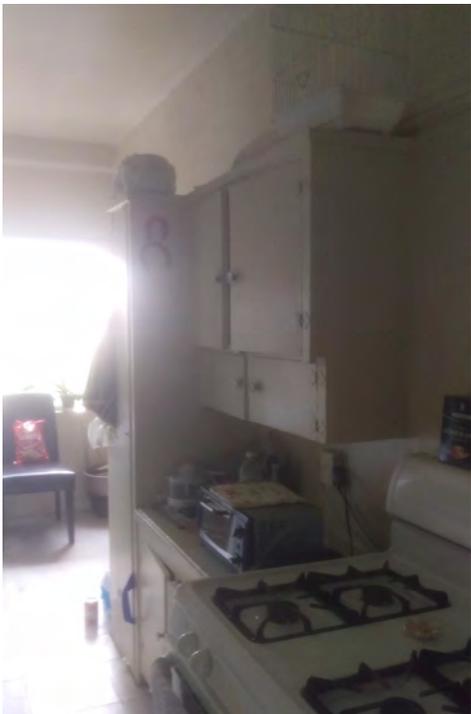
. Kitchen

PF Spatial layout	INTACT
PF Steel windows and balcony door	see Window Inventory
PF Wall and door moldings	INTACT
PF Murphy bed door/opening	INTACT. May be painted shut.
PF Texture above molding	Removed
PF Wood doors	2 missing (kit, DR) BA has original door knob
PF Bathroom glass-backed shelving	INTACT
PF Painted kitchen cabinetry	80% INTACT
PF Wood closet casework (at entry closet; in DR closet, or both)	DR casework largely intact; two tall doors missing Hall closet doors REMOVED
PF Bathtub	INTACT
SF Bathroom wall tile with liner	INTACT
SF Bathroom accessories, porcelain. one soap dispenser	At least 3 of the 4 INTACT,
SF Bathroom hex white floor tile	Removed or overlaid

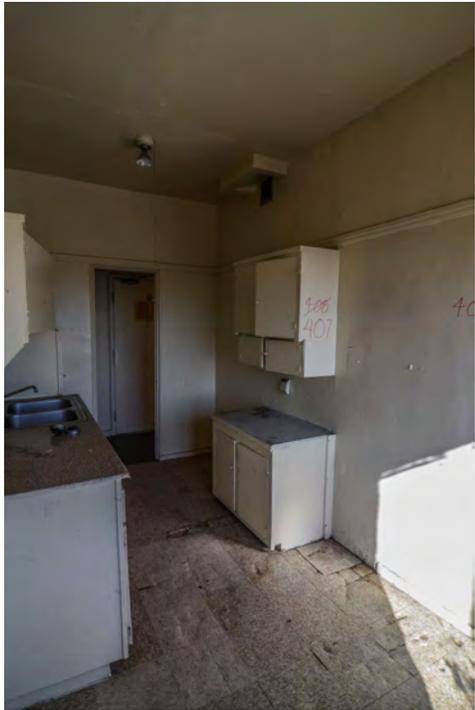
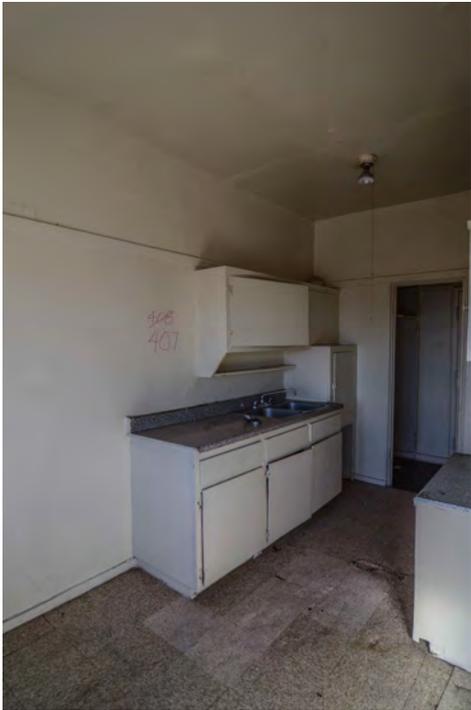
PF Spatial layout	INTACT
PF Steel windows and balcony door	see Window Inventory
PF Wall and door moldings	INTACT
PF Murphy bed door/opening	INTACT, including ball-pin hinges.
PF Texture above molding	Removed
PF Wood doors	2 missing (kit, DR)
PF Bathroom glass-backed shelving	Encased or Removed.
PF Painted kitchen cabinetry	Approx 50 - 55% intact
PF Wood closet casework (at entry closet; in DR closet, or both)	DR doors missing Hall closet doors and hardware missing
PF Bathtub	INTACT
SF Bathroom wall tile with liner	Extant, painted.
SF Bathroom accessories, porcelain.	n/a; tissue dispenser extant
SF Bathroom hex white floor tile	Removed or overlaid
<b>NOTE: Original medicine cabinet</b> , east wall BA, one of 3 or 4 remaining. See also Unit 409.

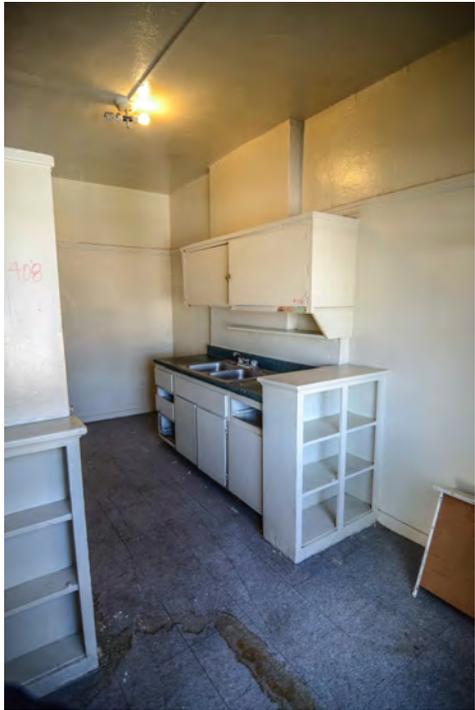
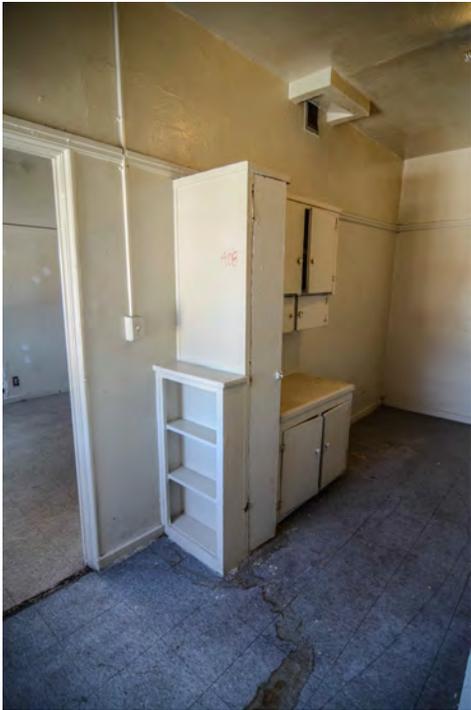
PF Spatial layout	INTACT
PF Steel windows and balcony door	see Window Inventory
PF Wall and door moldings	INTACT
PF Murphy bed door/opening	INTACT, including hinges.
PF Texture above molding	Removed
PF Wood doors	1 missing (DR)
PF Bathroom glass-backed shelving	INTACT
PF Painted kitchen cabinetry	90% INTACT. Model kit.
PF Wood closet casework (at entry closet; in DR closet, or both)	DR altered; casework partially retained, upper 2 small doors extant, tall doors missing. No hall closet.
PF Bathtub	INTACT
SF Bathroom wall tile with liner	Extant, painted.
SF Bathroom accessories, porcelain.	Towel rack and tissue dispenser extant
SF Bathroom hex white floor tile	Removed or overlaid

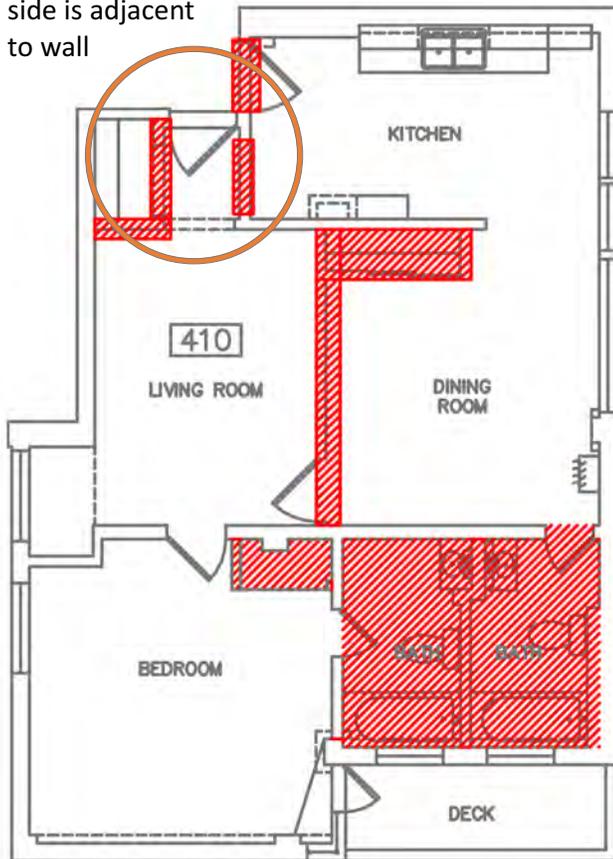
# Unit Type: 4 Condition Assessment Unit 410

FLIP ENTRY  
DOOR so strike  
side is adjacent  
to wall

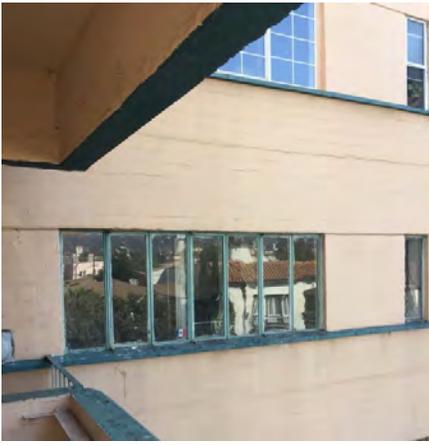
Figure 26. Bands of horizontally oriented form board concrete contrasting with non-oriented “Conc. Tex.” between windows

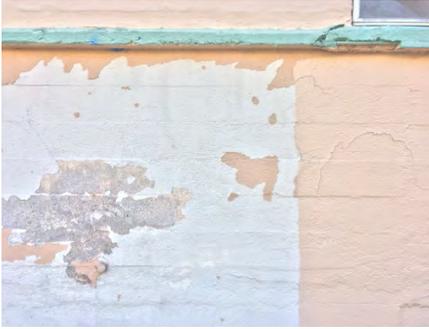
Figure 27. Paint/coating deterioration, west elevation.

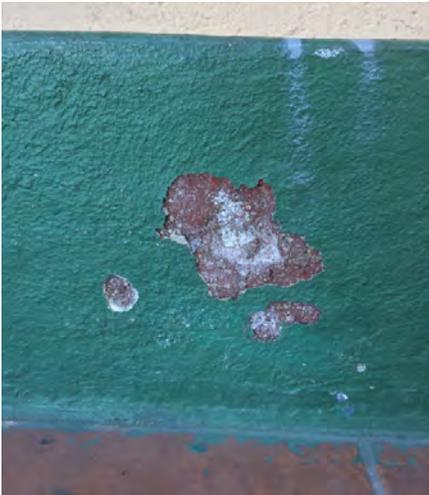
Figure 28. Original red-stained concrete, entrance bench portico, and terrace

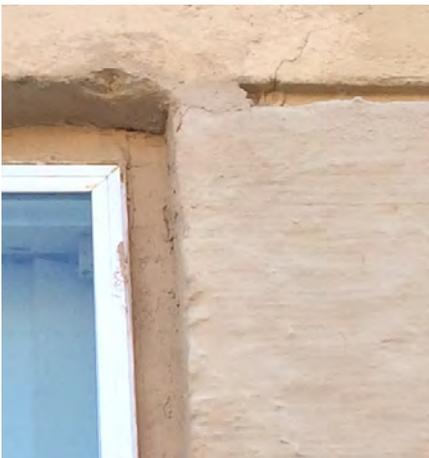
Figure 29. Inappropriate infill patching reveal, west elevation.

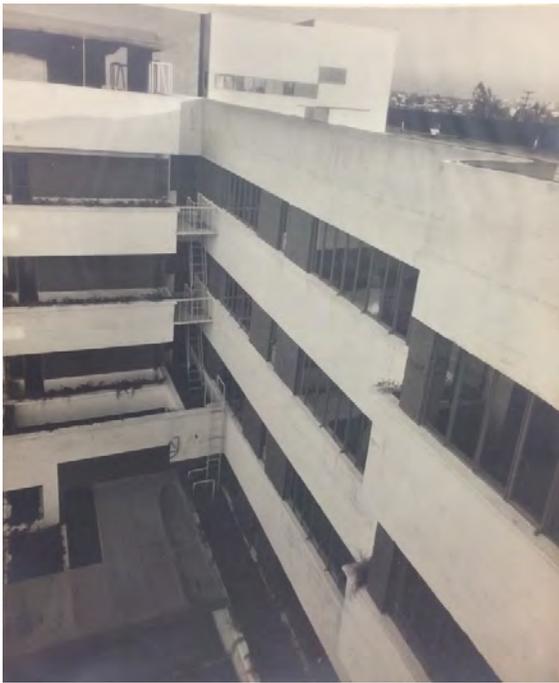
Historic photo (Figure 16) showing west side of rooftop service room and original roof canopy. Camera facing E. Cal Poly Pomona, ENV-Special Collections.

5. Consider replicating identical or installing compatible rooftop canopy per historic photo, top left. There appears to be a wall in this photo behind the awning although there is no physical evidence of such a wall. The Jardinette archives at UCLA do not include a roof plan.

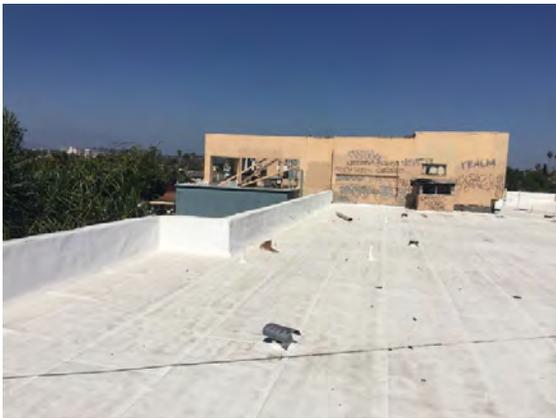
Figure 30. Camera facing E toward rooftop service volume and parapet.

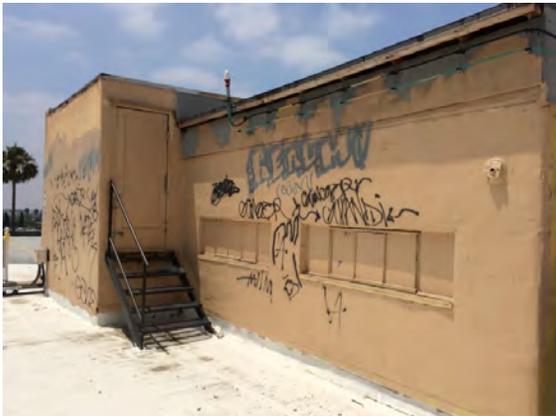
Figure 31. Camera facing SW. East side of rooftop volume with hopper/fixed windows.

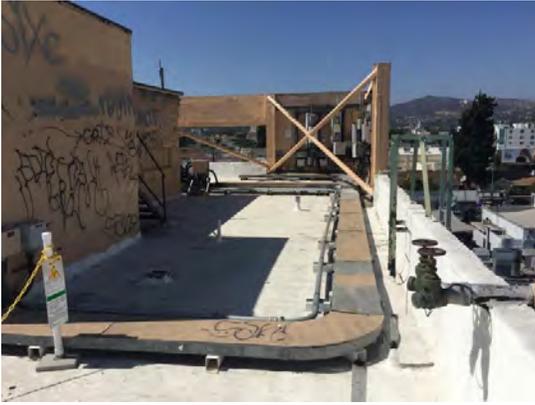
Figure 32. East side of building east side rooftop service room. Camera facing N.

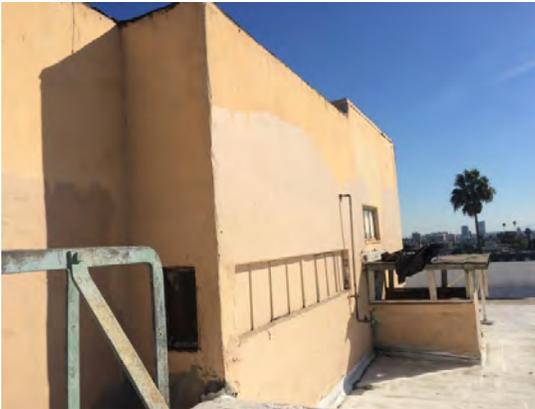
Figure 33. East side of building west side of rooftop service room. Camera facing S.

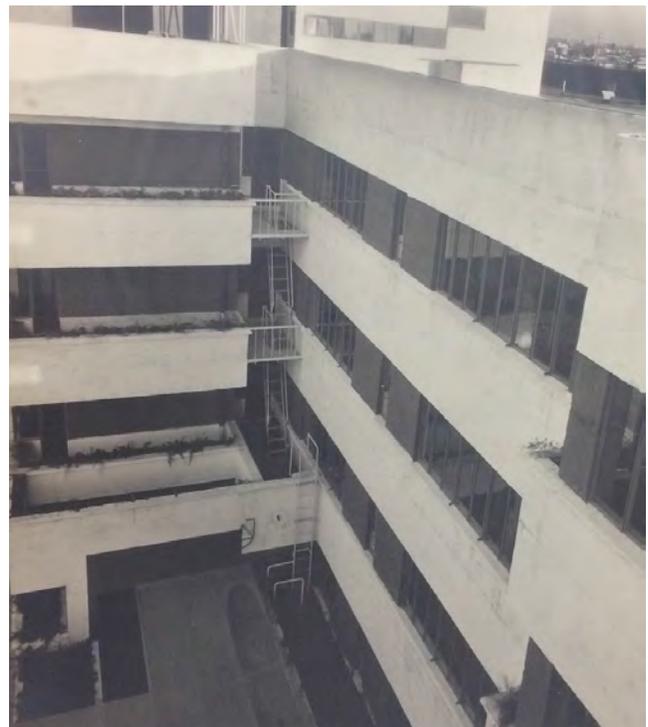
1. The only incompatible element here is the long wooden box that contains the lowest leg of the courtyard fire escape; see photo bottom left. This hides an important character-defining feature, which is the series of incised lines in the elevated concrete wall above the entry portico. This vertically oriented box interrupts the important horizontal continuity, seen in photo below right. If possible, remove this wooden construction to restore original condition.
2. Evaluate connections between steel fire escape and concrete walls, reinforce if necessary.
3. Rehabilitate steel framing with protocols for "Steel Casement Windows" above.

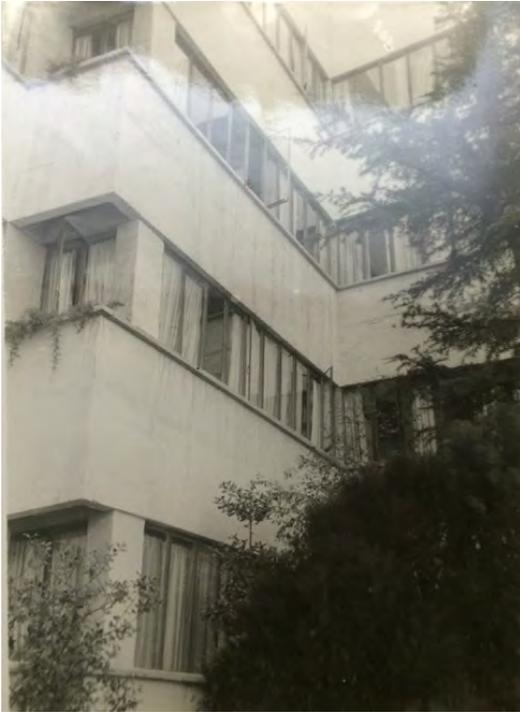
**Existing Condition:** *The current plantings are incompatible with original plantings seen in historic photographs. The present plantings and palm tree are in poor condition, as are soil conditions. There appears to be no sprinkler system.*

Historic Photo (Figure 17) Courtyard elevation, camera looking southwest. Notes plants on east-facing projections that did not hold brackets for planters. Photo by Julius Shulman, 1950. © J. Paul Getty Trust. Getty Research Institute, Los Angeles (2004. R. 10).

1. Remove all existing plantings; none are original or compatible.
2. Assess efficacy of waterproofing, concrete planter walls, and, if adjacent, water intrusion from planters to the foundation and basement.

6. Because there are no specifications regarding landscape, some leeway is acceptable. To retain the original design intent and Neutra's typical practices, hardy plantings that are easy to maintain would be appropriate. Re-greening the balconies is an important part of the rehabilitation.

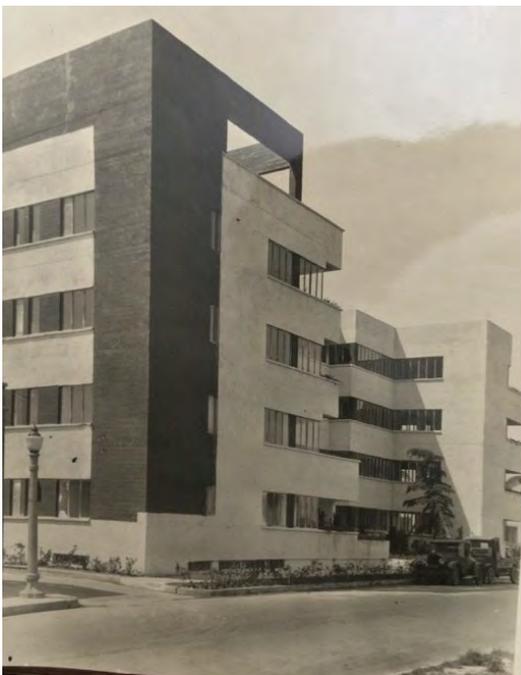
Historic Photo (Figure 9) North, east elevations NE corner. Undated, probably 1928. Camera looking southwest. Richard and Dion Neutra Papers, Coll. 1179, Special Collections, UCLA.

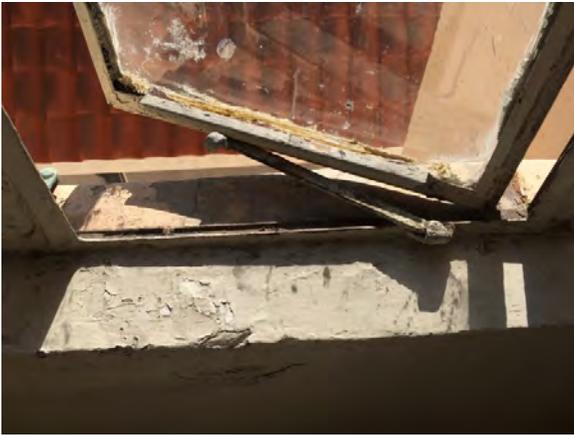
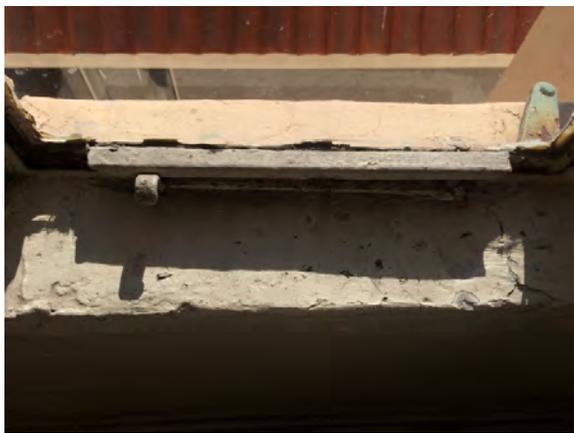
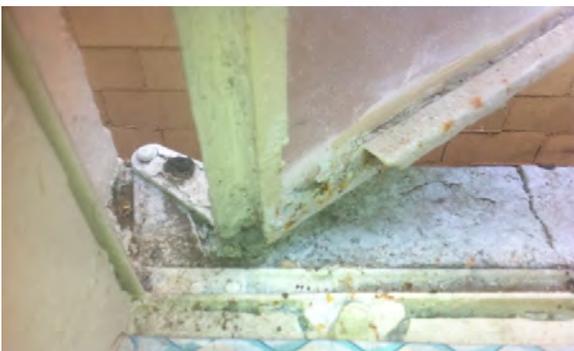
Figures 37 – 39, Steel casement window hardware details

**NOTE:** For **EXISTING** windows with original glass, exercise great care as the original glass can be quite fragile. If existing putty is not deteriorated, leave in place and patch carefully.

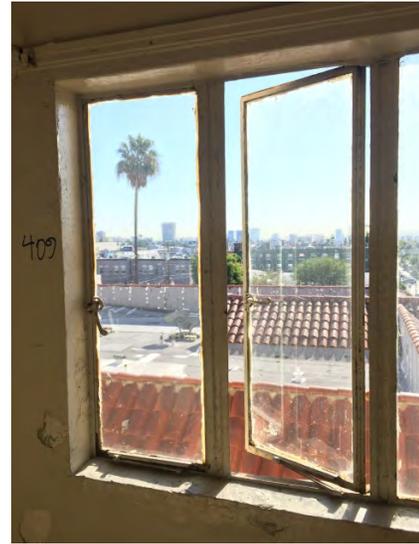
Figure 40. Steel casement window

**Existing Condition:** Overall, very deteriorated, reflecting long-term lack of maintenance. About one third of the windows are intact, but are rusted, overpainted, and the work sloppily executed. All other windows were demolished, covered up, or the glass replaced with plywood. See 6.3, Window Inventory.

1. For **EXISTING** windows with non-original glass (to be replaced), remove glass and putty.
2. With wire brushes, pads and steel wool, remove what is “loose and flaky” lead paint, making sure to obtain a fairly even surface. If needed strip windows with professional-grade stripper (such as MasterStrip) and steel wool and/or red oxide (automotive-grade) sandpaper. Whatever the approach, rinse and dry thoroughly so that no film or slick surfaces remain.
3. Stabilize surface for painting with Ospho 605 or “Rust Reformer” by Rustoleum or sim.; two treatments may be required. Wipe down with damp rag and dry. Bondo as necessary if corrosion is severe.
4. Replace any missing screws or hardware that secures frame to concrete.
5. Prime with quality metal primer.
6. Reglaze.
7. Reputty using CRL Gray Metal Sash Putty.
8. Prime putty.
9. Paint with quality paint compatible with primer.

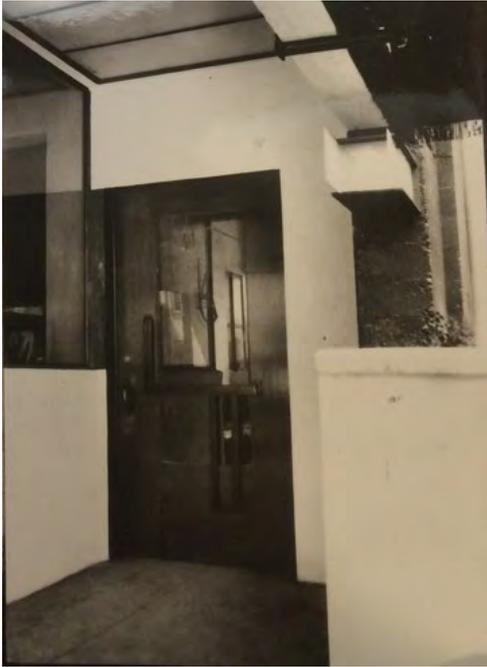
Historic Photo (Figure 21), Exterior primary entrance. Note custom designed front door, three frosted overhead lights, and the large window to the manager's office. Richard and Dion Neutra Papers, Coll 1179, UCLA.

1. Using archival drawings (UCLA) and photo left, as possible, replicate primary entry door.
2. Carefully disassemble staircase enclosure and mailbox area, where archival photograph indicates a recessed wood bench and possible vertical light fixture in wood newel post. If any part of these elements still exists, it may be possible to repair and restore, or inform a replica.

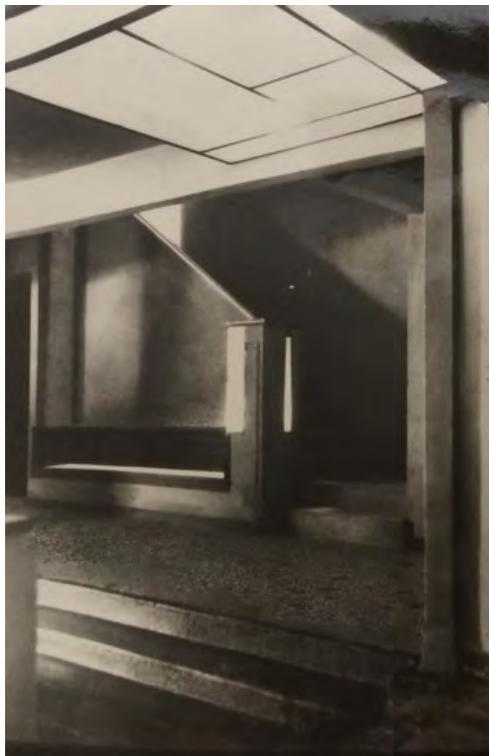
Historic Photo (Figure 22), Interior lobby. Note bench with possible lighting illuminating the floating quality of the bench; the striking pattern of overhead lighting and newel post lighting. Richard and Dion Neutra Papers, Coll 1179, UCLA.

**Existing Condition:** *As noted in the Description, the Lobby originally was a striking composition combining Modern, Art Moderne, and Japanese decorative motifs. Except for overall spatial layout, it has been demolished. There is little evidence as to original condition apart from few archival drawing(s) and the sole available photographs shown at left.*

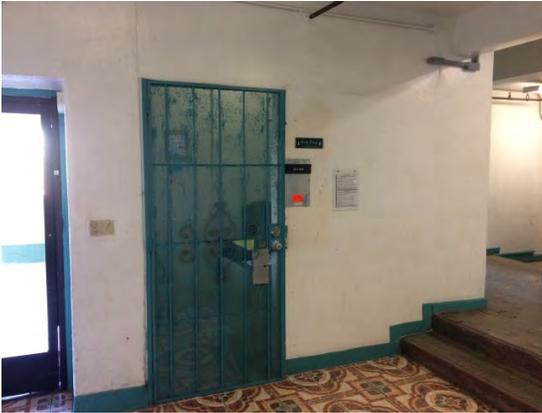
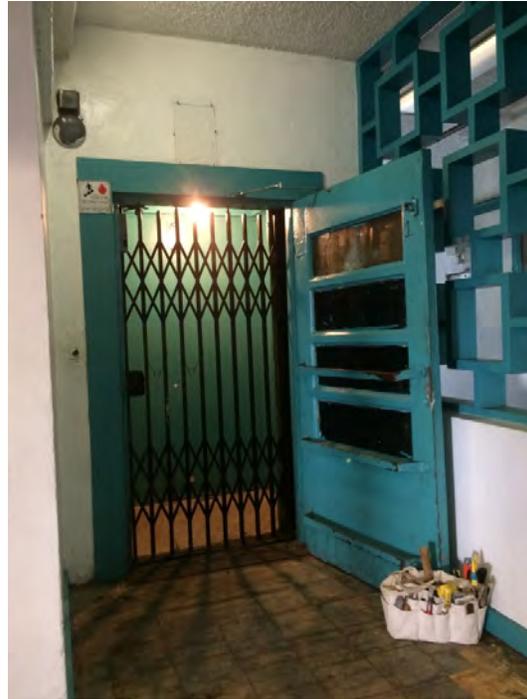
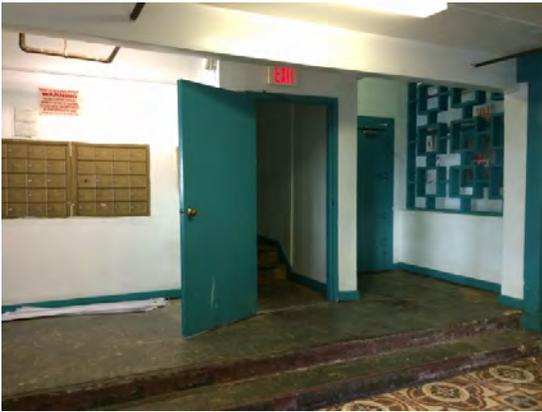
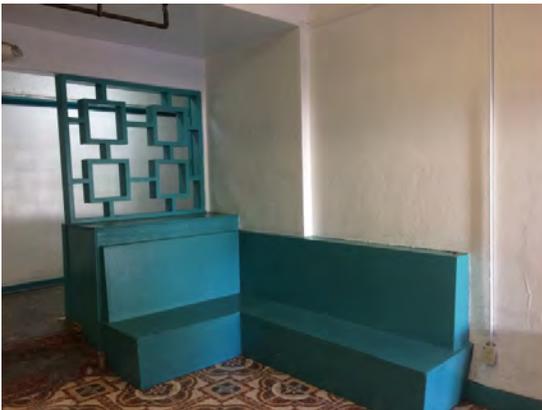
Figures 43 - 46, Lobby: Above left, north elev. Above right, east elev. with elevator. Middle left, East elev. Below left, SW corner, lobby.

1. Perform regular testing and maintenance, as required by City.
2. Install a 1.5” diameter handrail at the rear of the elevator.
3. Its woodwork needs patching with wood Bondo or Abitron prior to prepping and painting.

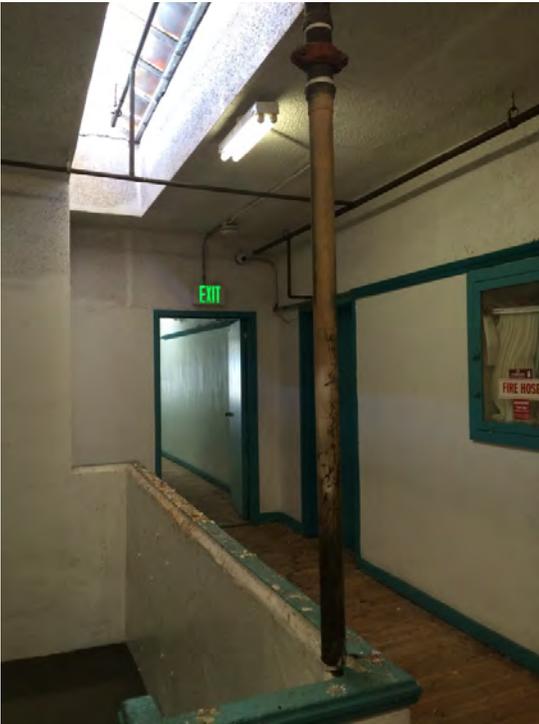
Figure 47. Fourth floor, top of stairs and hallway view with skylight above for natural lighting conditions

**Existing Condition:** *All the hallways and staircases are virtually identical and are in fair condition. The east end of the east-west main hallway is occupied by a large double-hung window, while the west end leads to others units and the west fire escape. The east end of the north-south hallway leads to unit and the courtyard fire escape. Existing repairs to the rough-cast stucco above the upper wood molding which is largely original and intact, are crude. No original flooring survives. All of the doors to the units are fire doors probably installed in the 1970s or 1980s and will be retained. Notably, the design ensures that no unit's front door opens directly across from another's.*

1. Repair extensive damage, dry rot and termite infestations, subfloors.
2. Evaluate existing sprinkler system according to the CHBC. No record was obtained regarding the date of installation.
3. Restore missing pieces of angled molding separating upper heavily textured "dash" texture from smooth plaster finish below.
4. Patch, repair existing upper and lower textures to match original.
5. Budget permitting perform analysis to determine original color of paint; repaint an identical or similar color. While paint color is not a character-defining feature, the colors should be appropriate to Neutra's use of interior paint colors in the period of significance.
6. Archival drawings indicate carpet was used for the hallways but there is no physical evidence to indicate that was installed.
7. Carpet, cork, or linoleum is acceptable.

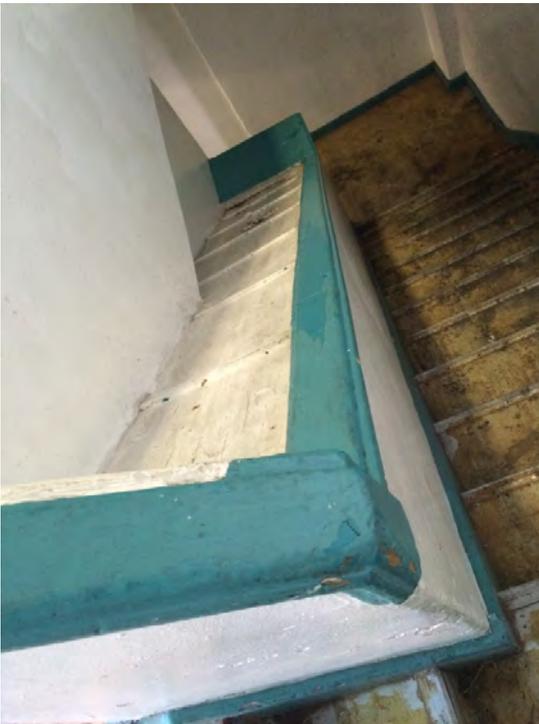
Figure 48. Handrail detail

**Existing Condition:** *Two wood-framed, plaster-clad staircases serve the building. Oriented north-south, the east staircase is the primary stair leading from the lobby. The west staircase is oriented east-west. Both have identical distinctive carved wood handrails. Both are illuminated by operable skylights to daylight the stairs. The skylights have been painted over.*

1. Remove paint from skylights to restore daylight illumination as designed. Refurbish as necessary to restore operability.
2. Remove remnants of previous finish on stairs, evaluate for damage, and repair wood sub strate.
3. Reinstall new non-slip compatible finish such as linoleum.
4. Clean and repaint wood handrail; full stripping is not recommended.

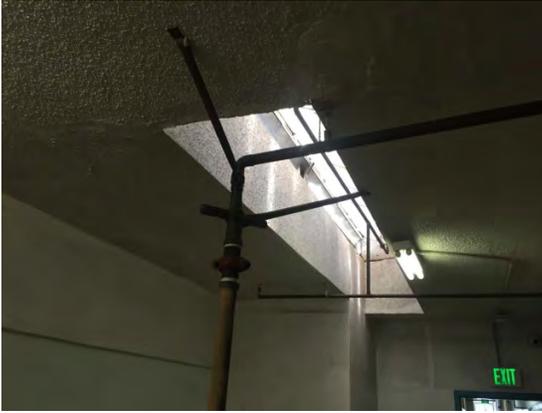
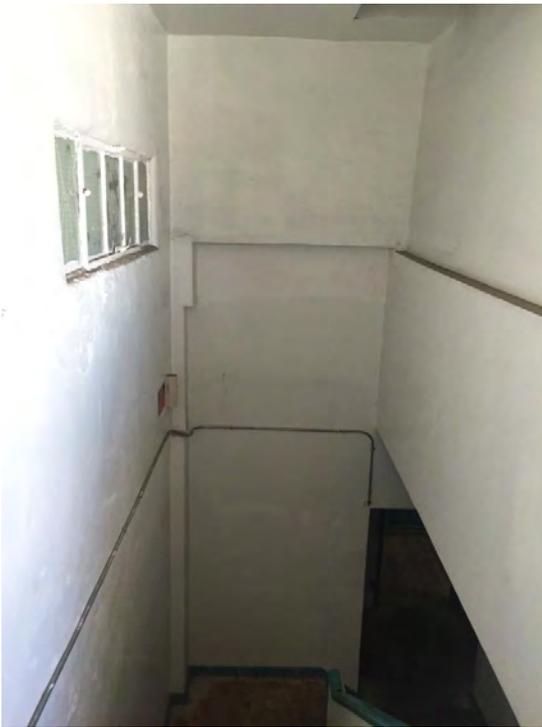
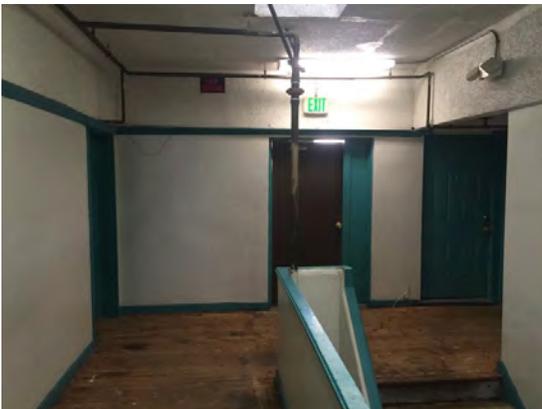
Figures 49 – 51, Views of Skylights, stair runs, and "gap" space for vertical shaft of daylight. West stairs, top and bottom. East stairs, middle.

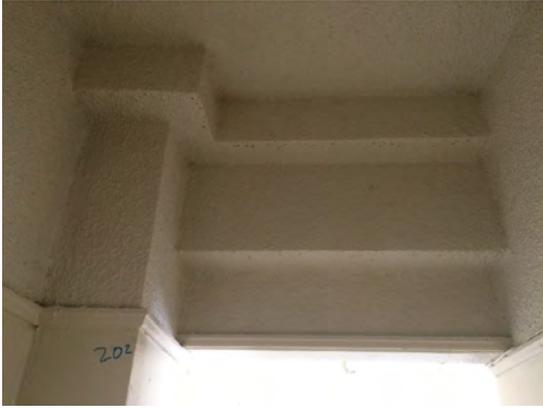
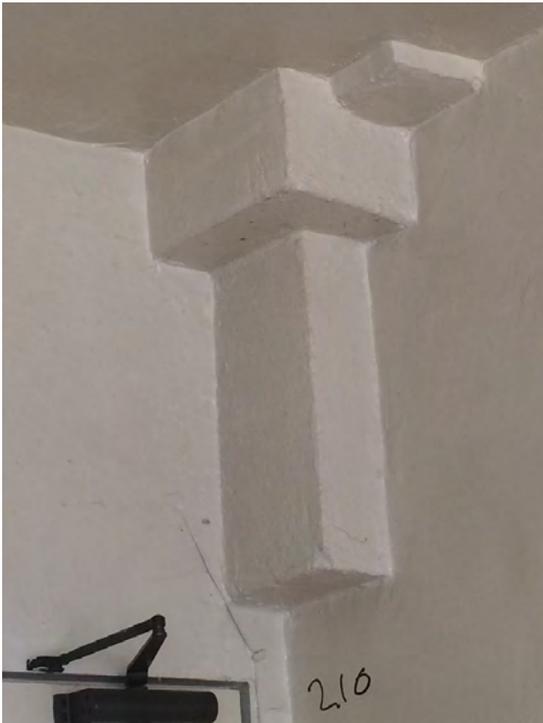
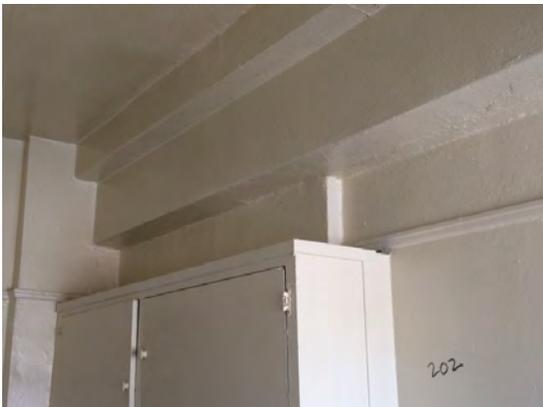
Figures 52 – 54, Details, concrete structure

**Existing Condition:** *Throughout the building there are many instances of what appears to be eccentric expressions of a complex system of reinforced concrete construction. Some of these truncated projections served as ledgers for the pour of the next higher floor. Given early Modernism's public tenet of "rationalized" systems, these idiosyncratic expressions of early experiments with working with reinforced concrete are singular and highly unusual, and thus important character defining features conveying the period of significance.*

1. Before any intervention into walls or ceilings, review the potential impact on these each of these unique character-defining features with Architect or Preservation Consultant. Minimize impact and restore as is possible and feasible.

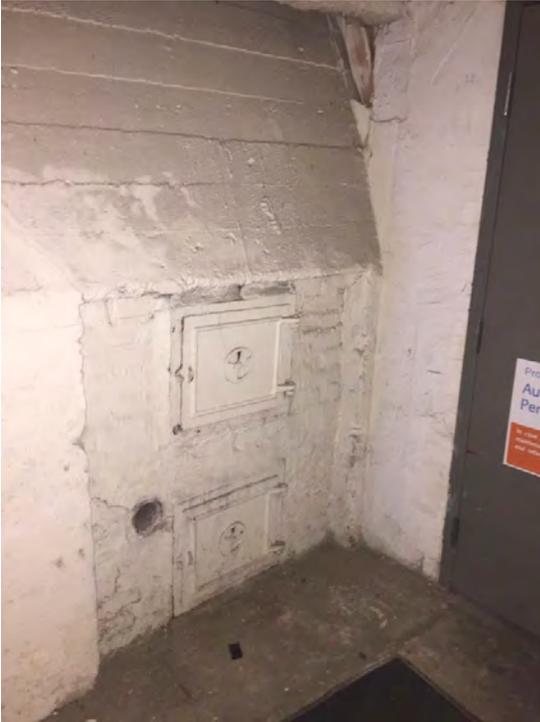
Figure 55. Incinerator on East side of basement

**Existing Condition:** *The basement is located on the east side of the building, and houses water heaters, the furnace, storage areas, and the old incinerator. While overall the basement appears to be in sound condition, evidence of water infiltration and subsequent damage to floors and walls is present on the southeast quadrant of the building, where the usable basement laundry, storage, plumbing and heating rooms and equipment are located.*

1. While there is no architectural significance to the basement *per se*, to conform to windows above the ground plane, the high basement windows should be rehabilitated according to the protocols established above for “Steel Casement Windows.”
2. Check concrete walls for water-intrusion and deterioration; repair as necessary.
3. Replace pipes as necessary; consider flexible PEX as alternate to copper.
4. Repair apparent leaks in bathroom on east side of basement

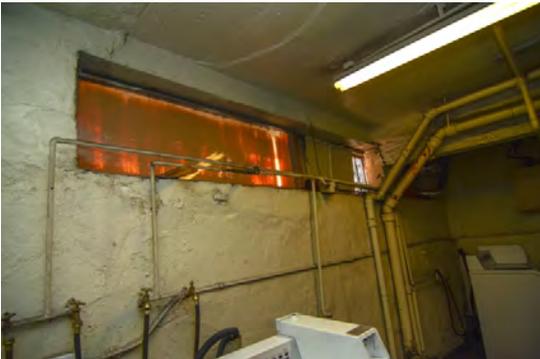
Figure 56. Basement showing windows on East side of building. Note similarity to those in mechanical service volume on roof.

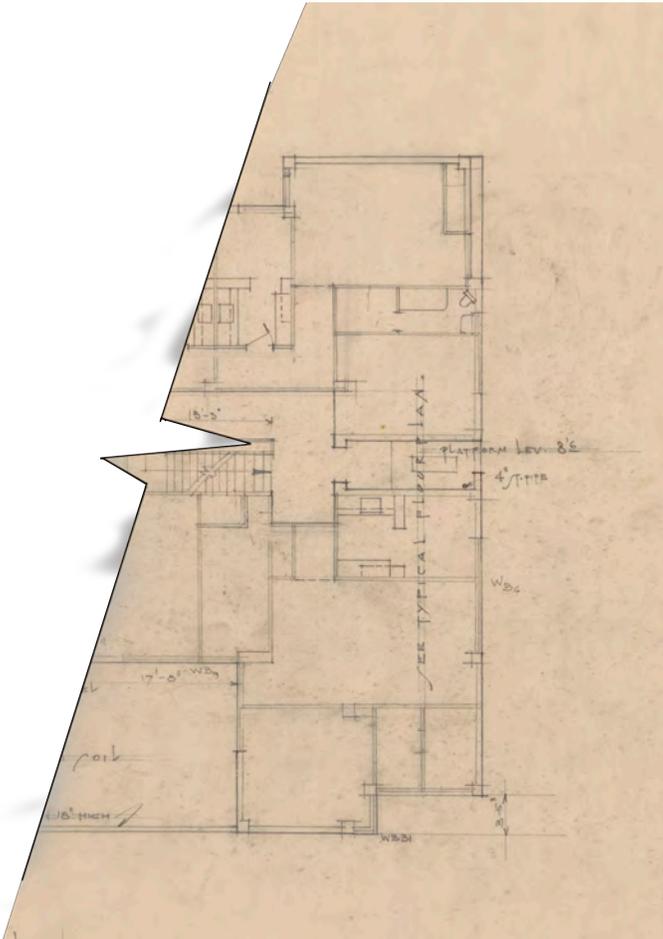
Figure 59. Clip of Original Floor Plan (schematic sketch) showing units on west side of the building.

1. Specific treatments for the Murphy bed openings, kitchen, and bathrooms are included later in this section.
2. For the location of full height non-original walls to be removed in order to reinstate original spatial relationships, see Section 6, Spatial Alterations. These walls are shown in red. After careful disassembly of these full-height non-original walls, reinstate original moldings and baseboards.

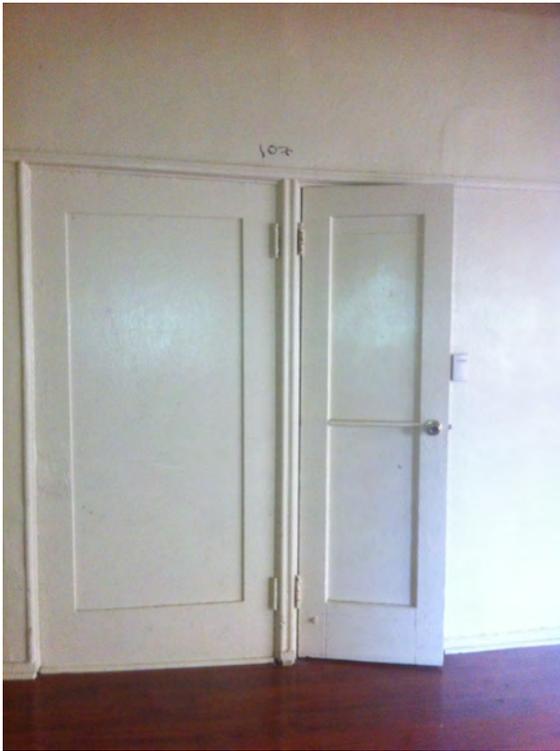
Figure 66, intact Murphy Bed door and original ball-pint molding, Unit 107.

3. If door and opening painted shut, repair so that door is operable.
4. If later incompatible door installed, replace with alternatives above.
5. It is preferred that the hinges for the Murphy Bed not be removed. However, if there are some portions of A hinge that might prove hazardous or a daily irritant, remove those portions.

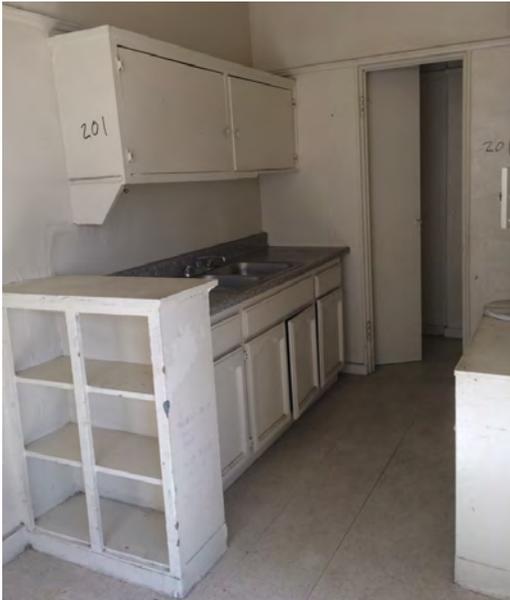
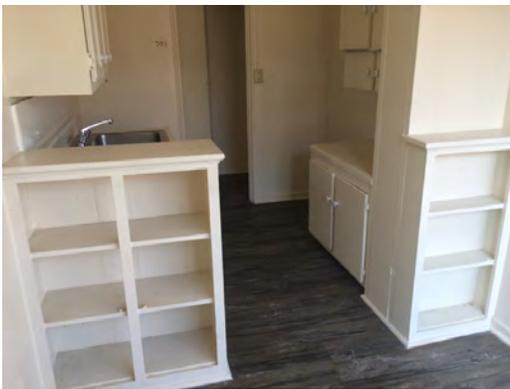
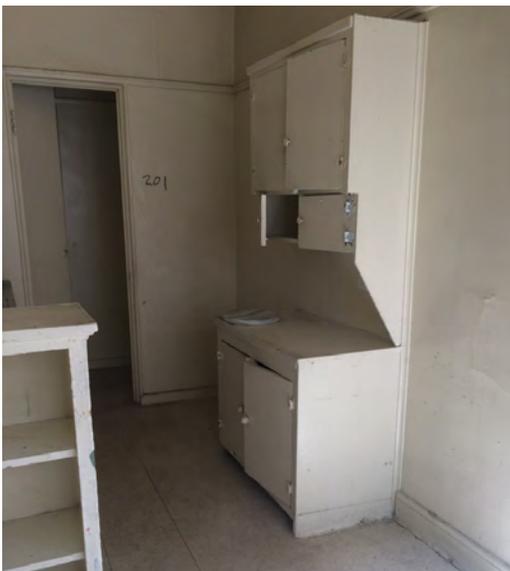
Figures 67 - 69, views of kitchen and original cabinetry, Unit 201. The only non-original portion of the kitchen is the sink-base cabinetry, 24" deep rather than the original 20"-depth of the historic sink counter and cabinetry.

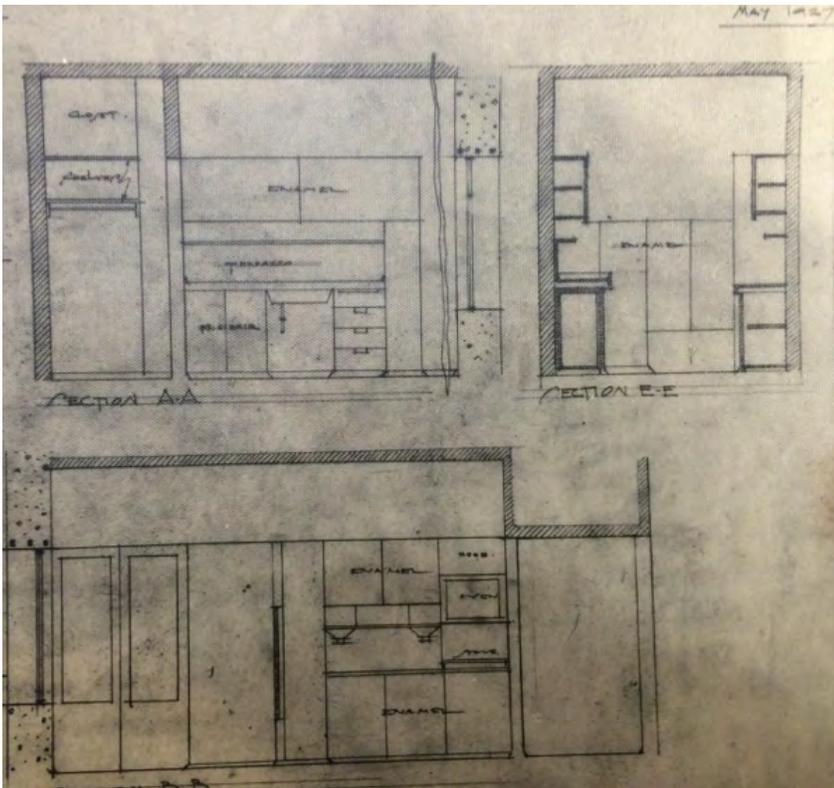
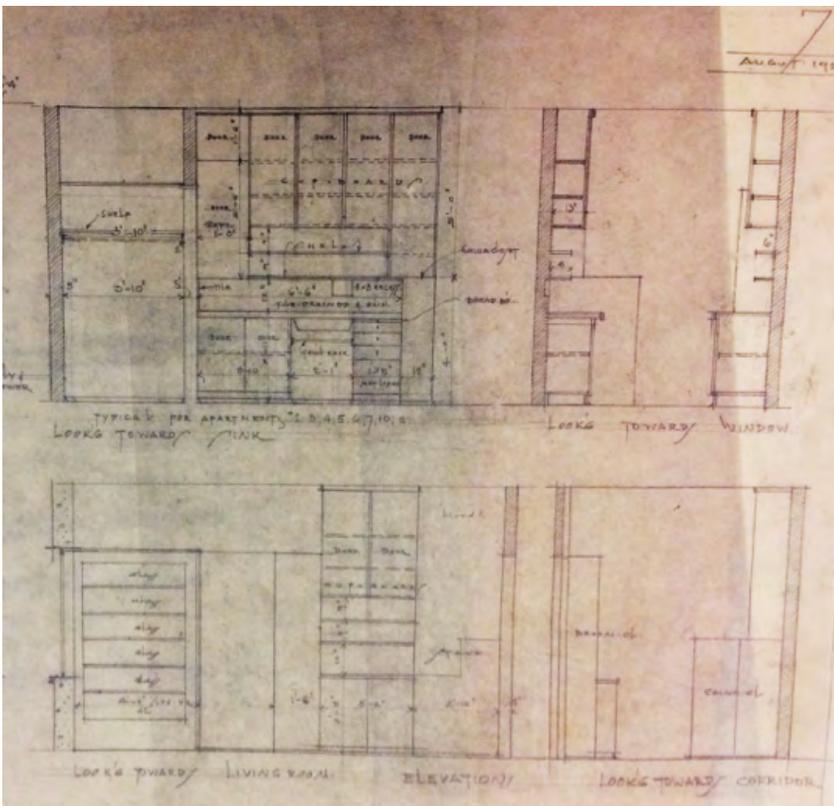
Kitchen elevations, UCLA, Folder 1134.  
Figure 70, above – May 1927  
Figure 71, lower – August 1927

**Existing Condition:** *While some components have been removed, the remaining components have largely been retained although most are in poor to fair condition.*
