**JARDINETTE APARTMENTS (HCM #390)**  
5128 West Marathon Street  
CHC-2017-2794-MAEX

## RECOMMENDATION REPORT

**PROJECT:** 5128 West Marathon Street  
Jardinette Apartments, Historic-Cultural Monument (HCM) #390

**REQUEST:** **APPROVAL OF EXEMPTION FROM LIMITATION OF ELIGIBILITY FOR HISTORICAL PROPERTY CONTRACT (MILLS ACT) APPLICATION**

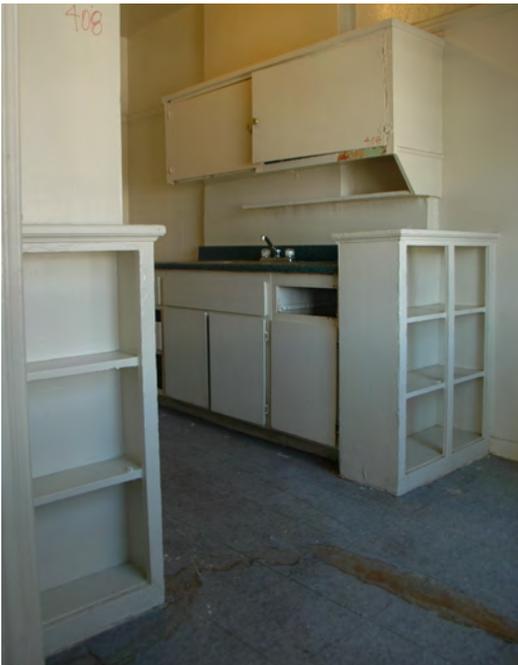
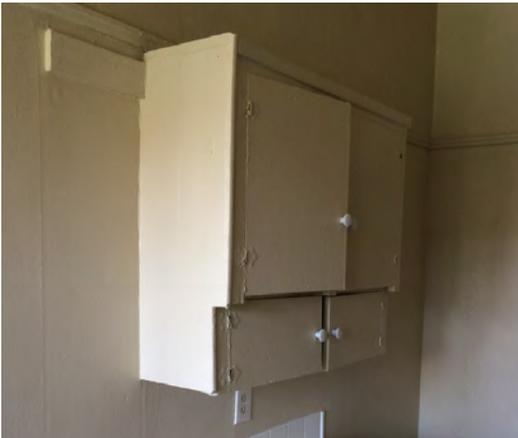
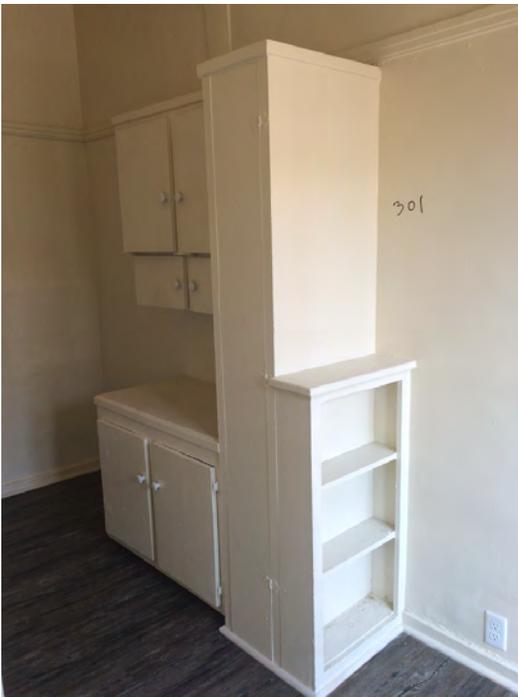
Figures 72 – 74. More view of kitchen and original cabinetry, Fig. 72, top, Unit 408 especially intact; the shelving below the the upper cabinets shows how architect/builder adapted standard detail to the complex structure. Fig. 72 also shows typical inclusion of the non-original sink base cabinetry; no original sink base remains. Fig. 74, bottom, Unit 301. Fig. 73, middle, shows the typical recessed upper cabinetry, extant in many units.

**2. Less Preferred Alternative:** For units with 75 percent intact kitchens, and depending on plumbing and construction needs as walls are opened, add replicas of missing components (except for ice chest cabinet, per above.) As a goal, for remaining units, replace all kitchen cabinetry with replicas or contemporary versions of cabinetry that are compatible with and recall the original. This goal applies to nine units 75 percent intact or higher: Units 106, 200, 204, 301, 302, 303, 305, 406, 408. If this goal is not "technologically and economically feasible," at least one unit per floor and, if possible, reflecting a different Type of the 8 Unit Types, should be maintained with as much original historic fabric as possible and installing replicas of missing or altered cabinets. New fixtures and finishes shall be those in use during the Period of Significance and shall reflect Neutra's typical use of standard, robust, simple items.

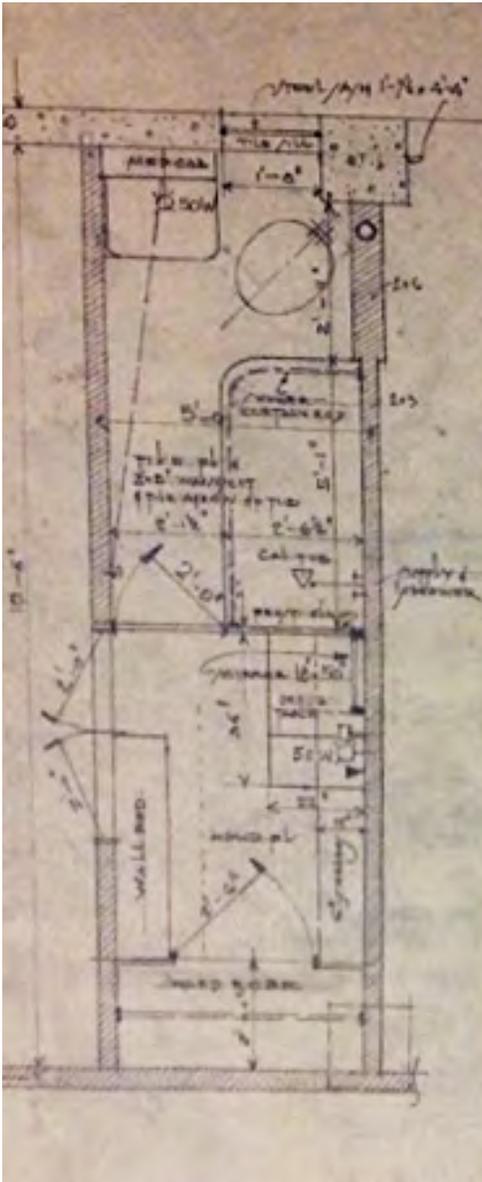
Figures 75, 76, plans and section/elevation, typical bathroom and dressing area, DR. UCLA, Coll. 1179. Fig. 75, top, plans for bathroom and DR. Fig. 76, below, shows wall mounted sink attached to exterior wall, line of tile wainscoting, medicine cabinet in bathroom; in DR, cabinet with inset mirror, upper storage and rack (pole.)

7. Original lavatory was wall hung on exterior wall. Install similar or with base cabinet.

8. Strip original bathtub of paint and (failed) artificial porcelain coating. Remove rust as possible.

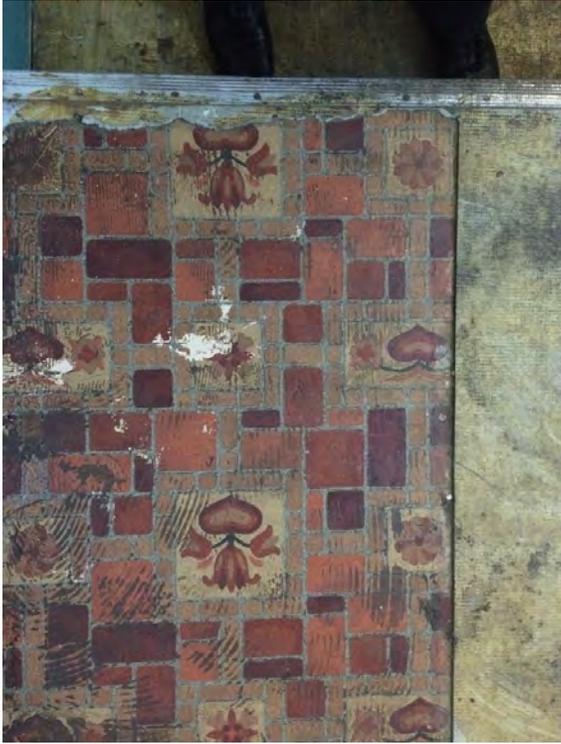
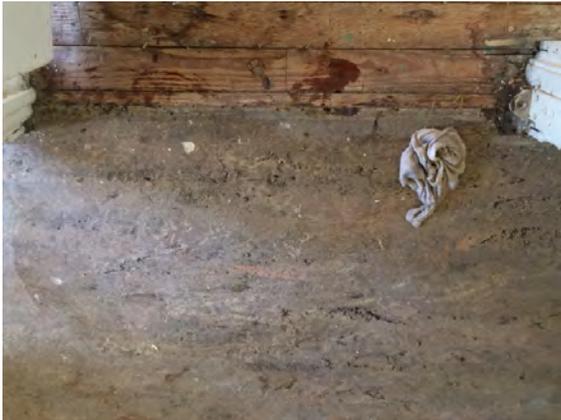
**Existing Condition:** *Except for remnants of linoleum here and there no original flooring has survived. Archival drawings indicate that carpet was specified for the main living space, bedroom, and for the dinette area. Linoleum was indicated for the kitchen proper; text was illegible for determining whether carpet or linoleum for the DR, the Dressing Room. It is not known, however, whether carpet was installed per the drawings; it may be that the entire kitchen area had linoleum.*

*Several variations of linoleum, seen left, that could be original were discovered. Notably, in two units (101, manager's unit, and 301) there appears to be a band of linoleum with a wood-grain appearance that surrounds a field, or "carpet," of patterned linoleum.*

Figures 77 – 79, left. Versions of linoleum found in public areas and in units. Fig. 77, top left, shows linoleum on second floor landing, east stair. Fig. 78, middle left, shows linoleum in dressing room/ While very similar to a contemporary product Forbo Real Series, this linoleum is quite aged. Figure 79, bottom left, shows pattern in Units 100, 402.

1. As economically and technically feasible, perform additional discovery of flooring layers to confirm that previously discovered remnants are original; there should be some repetition of linoleum throughout building.
2. Assuming previously discovered remnants, pictured here, new linoleum choices should recall these patterns and colors from the Period of Significance.

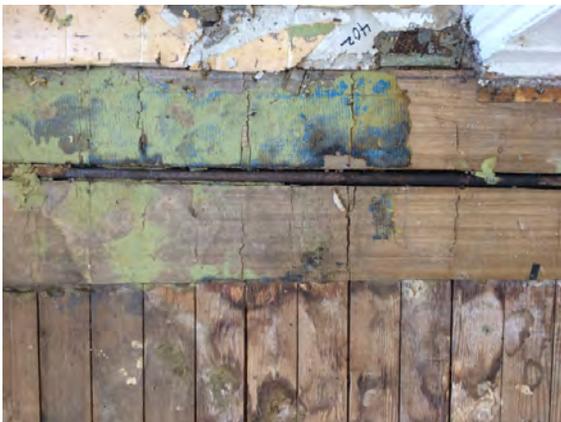
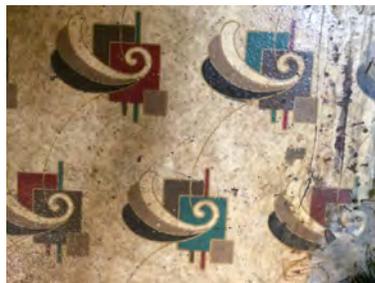
Figures 80, 81. Figure 80, top, closeup of Figure 78. Figure 81, below, linoleum in a unit lobby.

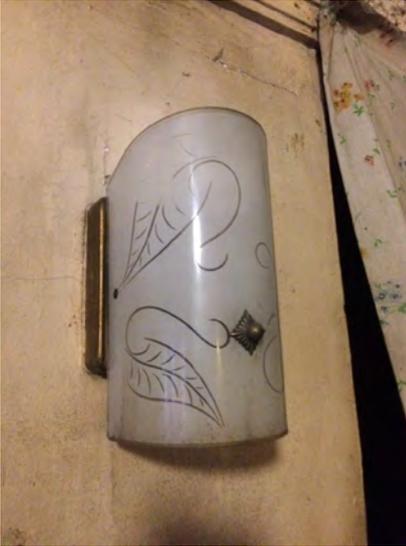
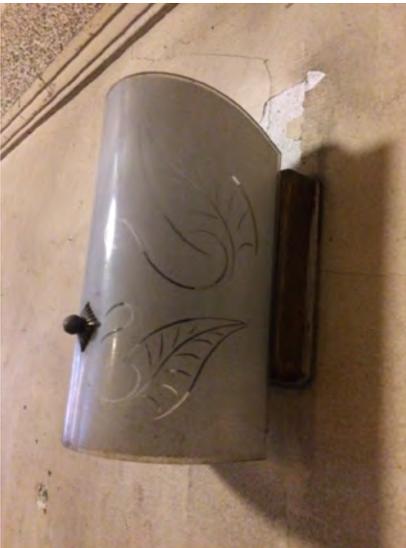
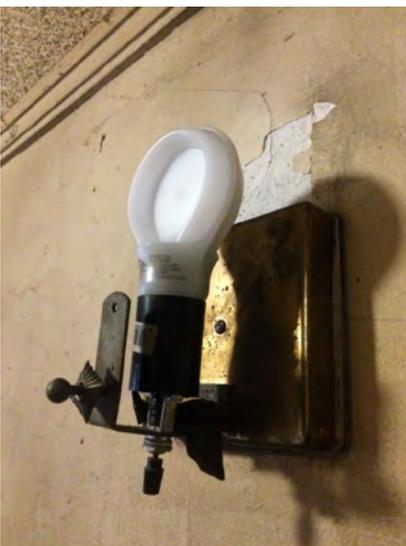
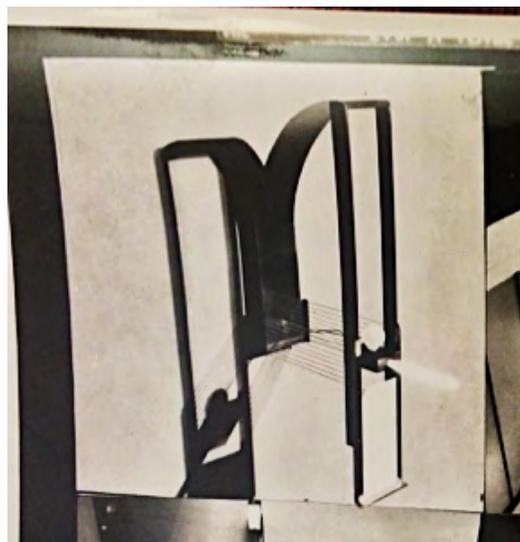
Figures 82 – 84, left. Figure 82, top left, and Figure 83, middle left, show possibly original cover for wall sconce, Unit 302. Figure 84, bottom left, shows fixture without cover. Figure 85, below, shows Neutra-designed light fixture design that possibly is related to the Jardinette, but there is no other documentation to support that, other than that this image was included on a 1928 photographic sheet with other built conditions at the Jardinette Apartments.

**Existing Condition:** *Virtually all original lighting has been removed with no remaining fixture pieces to witness original locations. As was noted in the Electrical Section of 7.1 Recommended Treatments, there is one historic photo of a wall sconce, pictured below, but there is no proof that this was ever employed at the Jardinette. Unit 302 does retain what appears to be original fixtures; the figured glass covers may be original but bear no relation to lighting designed by Neutra or Schindler. Rather, these curvaceous covers may have been chosen by the developer or installed after the architects and the developer were no longer involved in the project.*

1. Review existing wall locations for sconces present in Unit 302 to inform choices for new fixture locations. If not technically or economically feasible, located new fixtures where appropriate to contemporary needs.
2. Choose lighting that is within the Period of Significance and that is compatible with Neutra and Schindler's lighting designs and choices in the 1920s and '30s.
