**OCCIDENTAL COLLEGE, SWAN HALL
REHABILITATION AND ADDITION
Historic Resource Impact Assessment**

September 20, 2010

**Kaplan Chen Kaplan
2526 Eighteenth Street
Santa Monica, CA 90405**

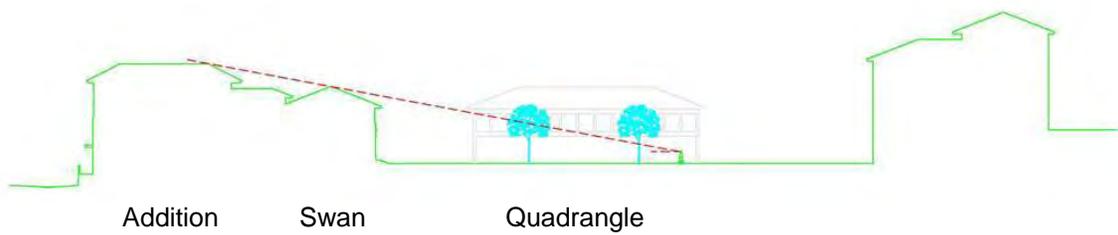
Section showing line of sight over Swan Hall to new addition.

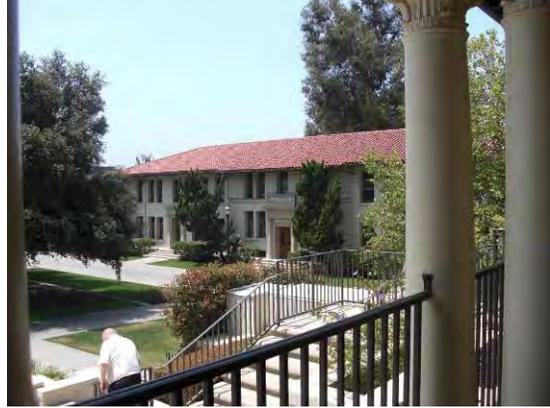
View from northeast. Lg. tree to be removed. New bldg to be visible above

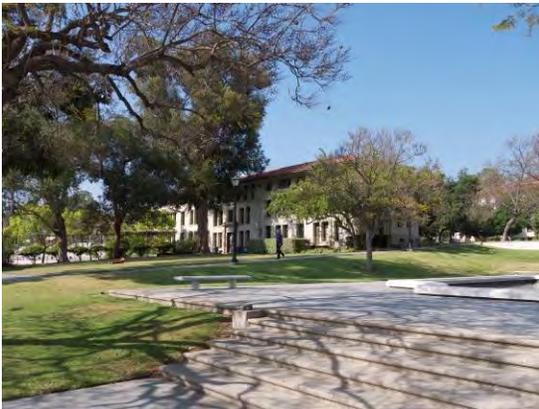
Views of Swan Hall from southwest. The addition is proposed on the west (left).

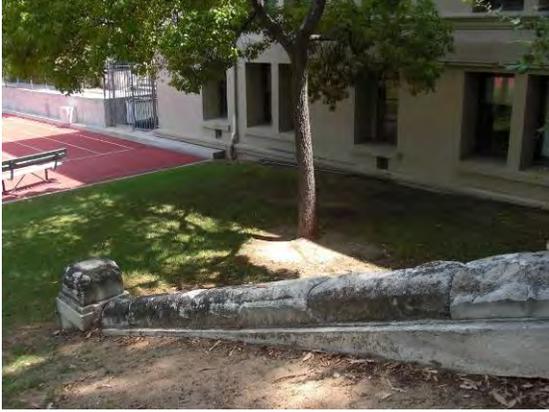
View of basement at NW and orig. stair

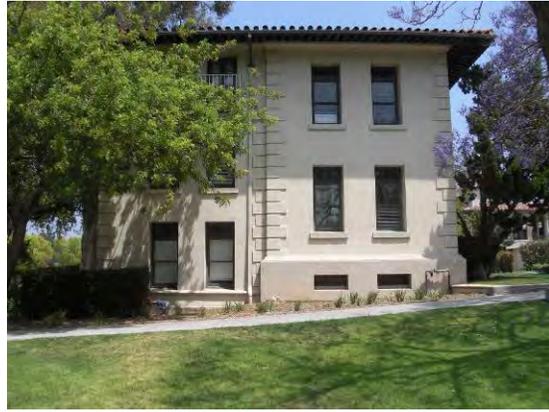
South end elevation indicating stepping of interior floor levels.

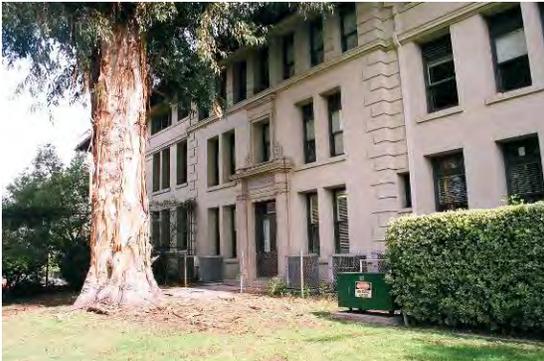
West façade with central entry portal.

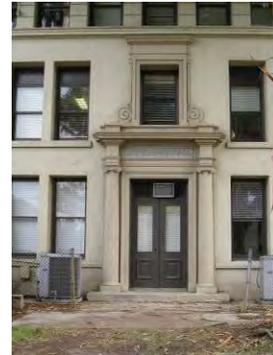
West façade at central bay and entry. The trees on the west would be removed for the addition

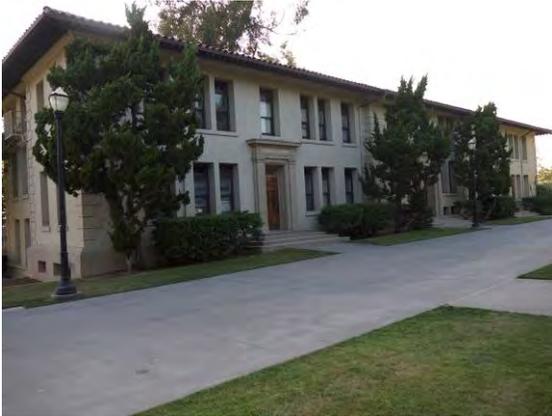
View of east elevation from southeast
The stepped floors show on the south.

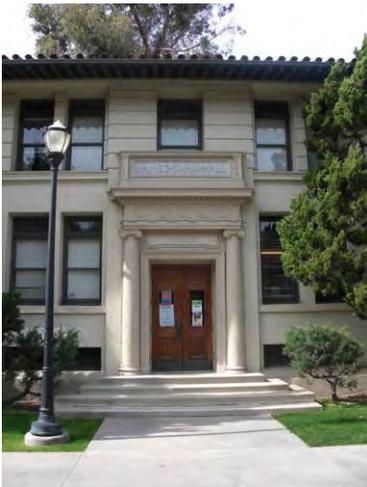
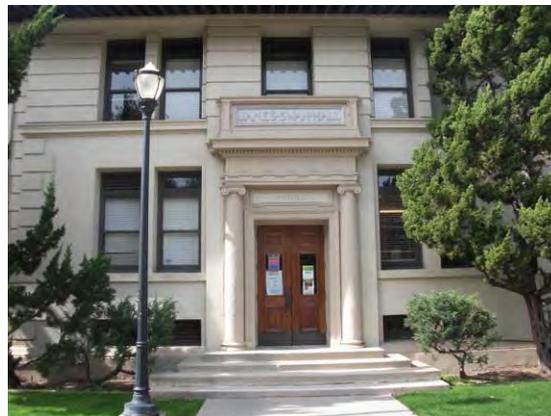
Central entry on east with double doors and decorative surround.

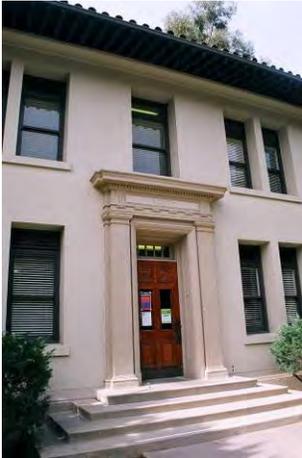
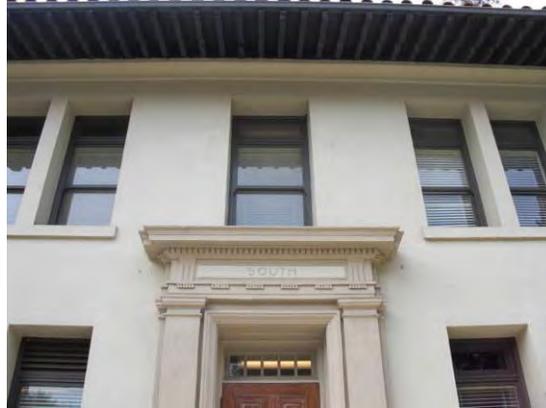
Flanking entries on east elevation with single door and decorative surround.

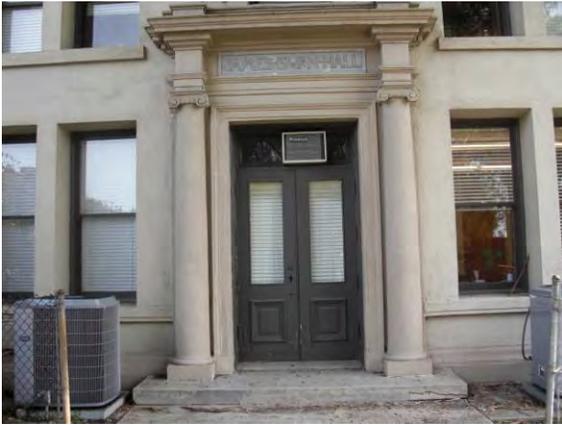
Entry on west with double doors and decorative surround.

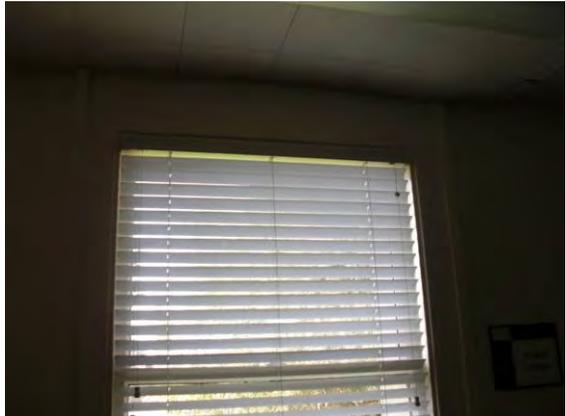
Window interior detail at ceiling.

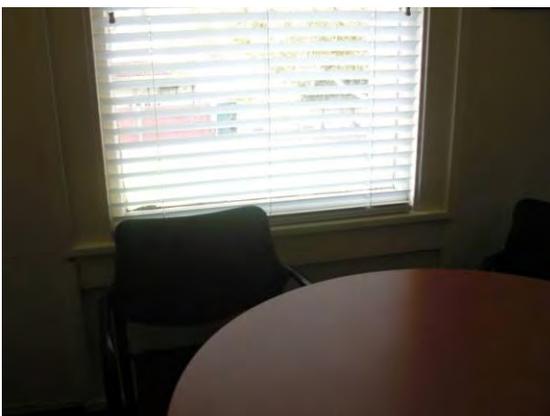
Window interior sill detail.

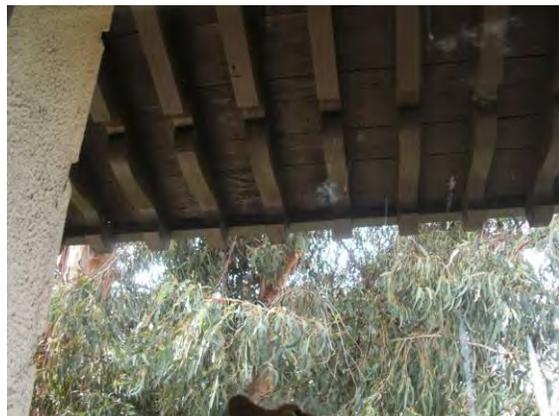
Roof eave detail with shaped rafters.

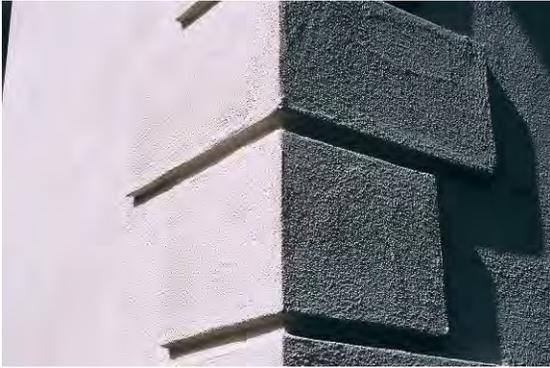
Exterior detail at corner plaster quoins

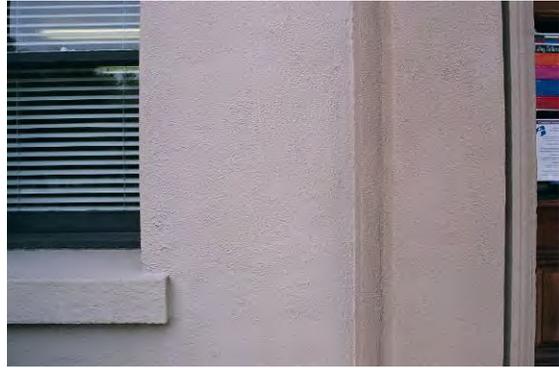
Exterior detail at window opening

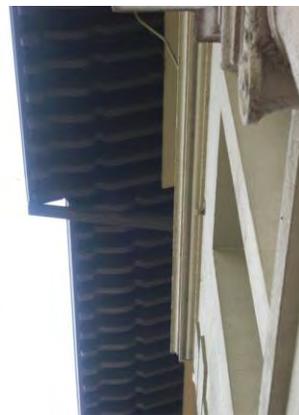
Roof eave and plaster detail

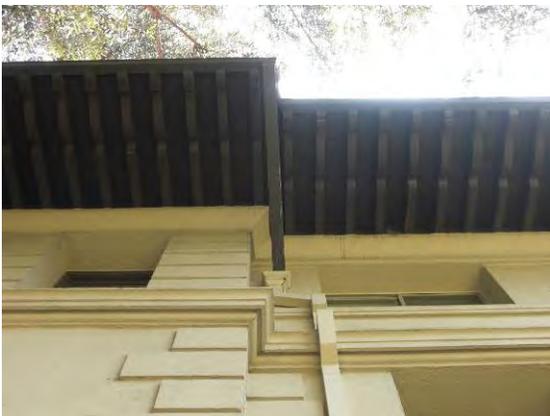
Offset at tripartite division on west where new building to connect.

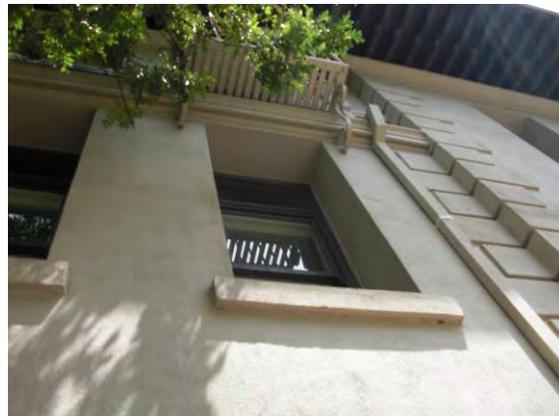
Original window sills, quoins and metal balconies

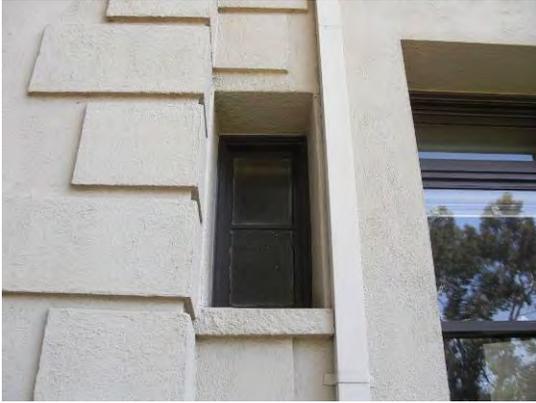
Original window on west is not included in replication

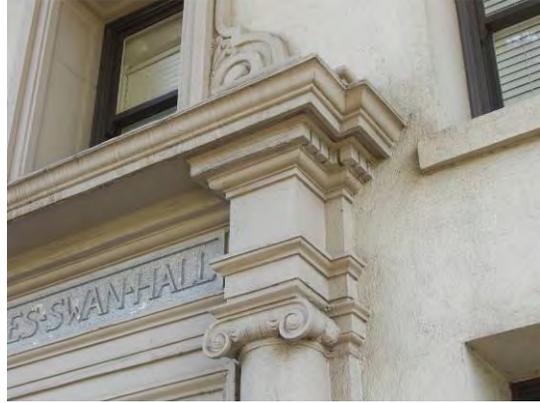
Original entry with multiple levels of detail

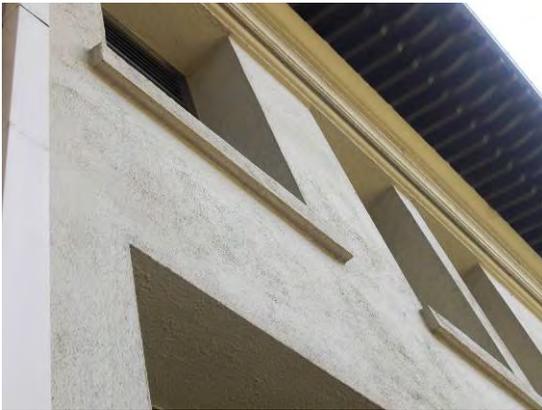
Typical sills and other details. Each location is built slightly differently.

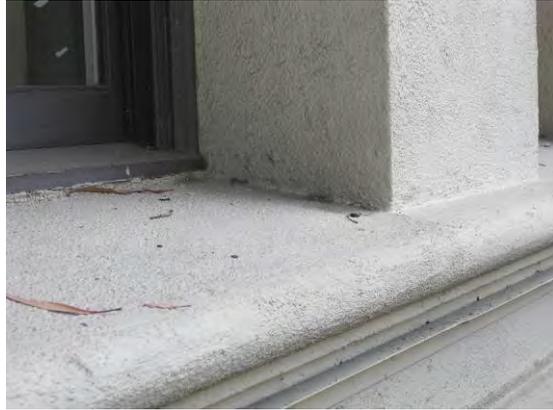
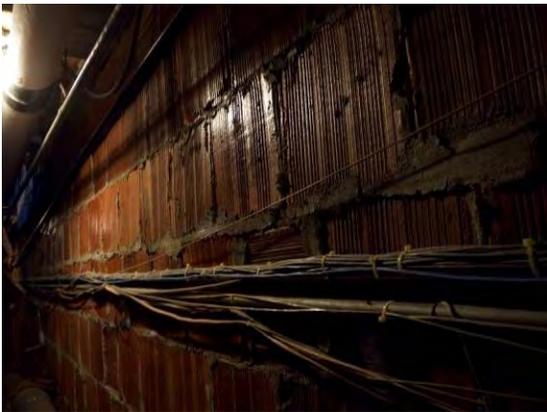
View inside HCT wall

advance in the fireproofing of buildings and was used extensively at the time. The clay tile behind the plaster façade returns back at the deep window recesses and then connects with hollow clay tile on the interior side creating a deep box-like exterior wall with an airspace inside. Construction with hollow clay tile finished with plaster was common for Myron Hunt's buildings and similar to the Ambassador Hotel except for the use of the double wall in Swan Hall where the returns for the windows may provide added strength to the assembly. The plaster finish (except in areas of repair following the Northridge earthquake at the building ends), while possibly covered with a heavy paint or coating is of original cement plaster construction including typical heavier finish coat. Most of the decorative façade features are finished with plaster. Plaster at the time was a 2-coat process with a thicker finish coat (3/8" +/-) that allowed more workability and shaping than modern 3-coat plaster.

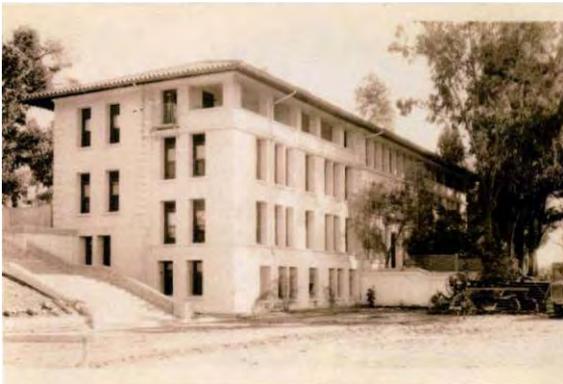
View from northwest showing stepped floors and sleeping porches

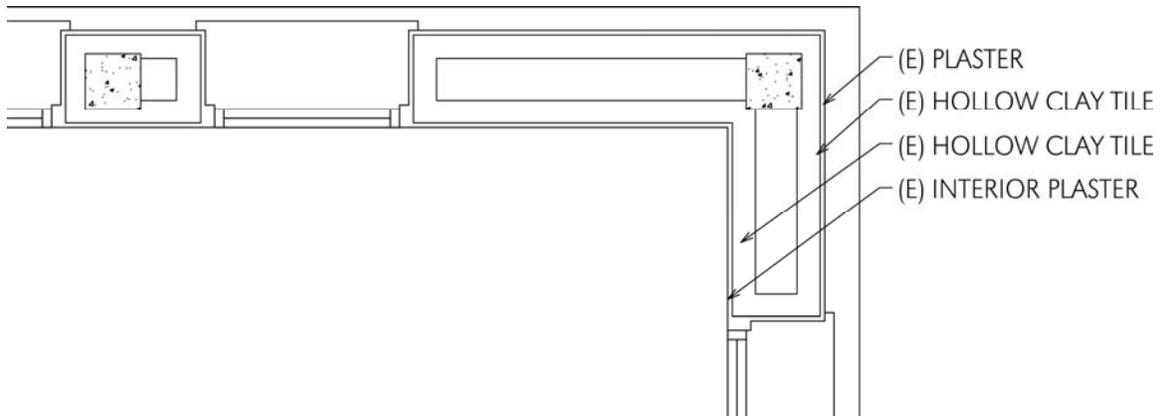
A. The above drawing is a plan of a corner of Swan Hall and indicates the various layers of the original wall construction. The exterior wall is constructed of hollow clay tile blocks with an exterior plaster finish. The interior side is also constructed of hollow clay tile with plaster finish. The exterior and interior walls are separated and joined at the ends by the windows, creating the apparent depth of the exterior façade and leaving an air space/void between the exterior and interior walls.

The drawings below are detail drawings of a corner of Swan Hall and show (A.) the original configuration, B. the proposed project assembly and (C.) the preservation alternative.

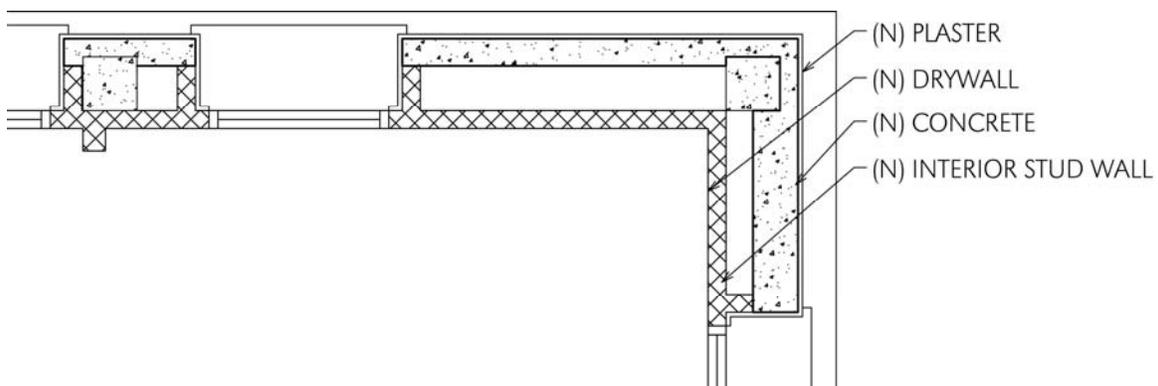
B. This drawing indicates the wall assembly under the proposed scheme. Only the columns (and perimeter beams above and below) would remain in place. The new exterior plaster would be applied directly to new poured-in-place concrete. The interior wall would be made with metal studs and finished drywall. The window sash and window frames are to be removed, refurbished and reinstalled.

- Renovation of Swan Hall's structural system and reconstruction of the exterior. The proposed treatment of the existing Swan Hall is removal of all exterior facades and interior floors. The existing windows (frame and sash) and doors are proposed to be removed and salvaged for repair and reuse. The roof tile is also proposed for removal, salvage and reinstallation. This approach is being undertaken as a less expensive construction project than a project that would retain the original exterior.

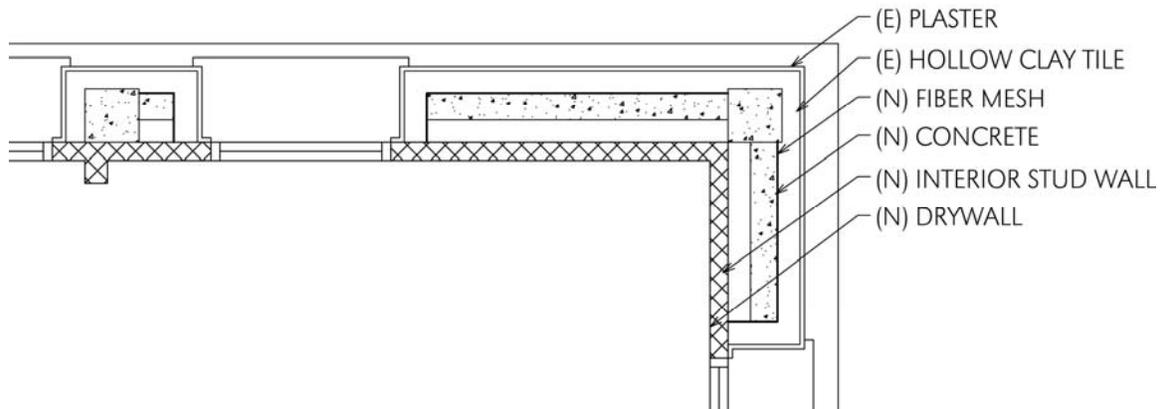
C. This drawing indicates the wall assembly following structural strengthening under the preservation scheme. The existing exterior plaster and hollow clay tile construction would remain in place. A fiber adhesive mesh would be applied to the back of the hollow clay tile with projecting anchors that would be cast into the new shear wall built behind the hollow clay tile either as shotcrete or cast-in-place concrete. The interior hollow clay tile wall would be removed to perform this work and the reconstructed interior wall would be similar to the proposed project built with metal frame studs and finished drywall. The window frames may refurbished in place and window sash removed as needed, refurbished and reinstalled.
