SUNSHINE CANYON LANDFILL

Subject: Report to the Joint Sunshine Canyon Landfill Technical Advisory Committee
Meeting Date June 4, 2014

RE: Post-Storm Cleanup and Repairs, Cell CC-3A, Part 2 Area

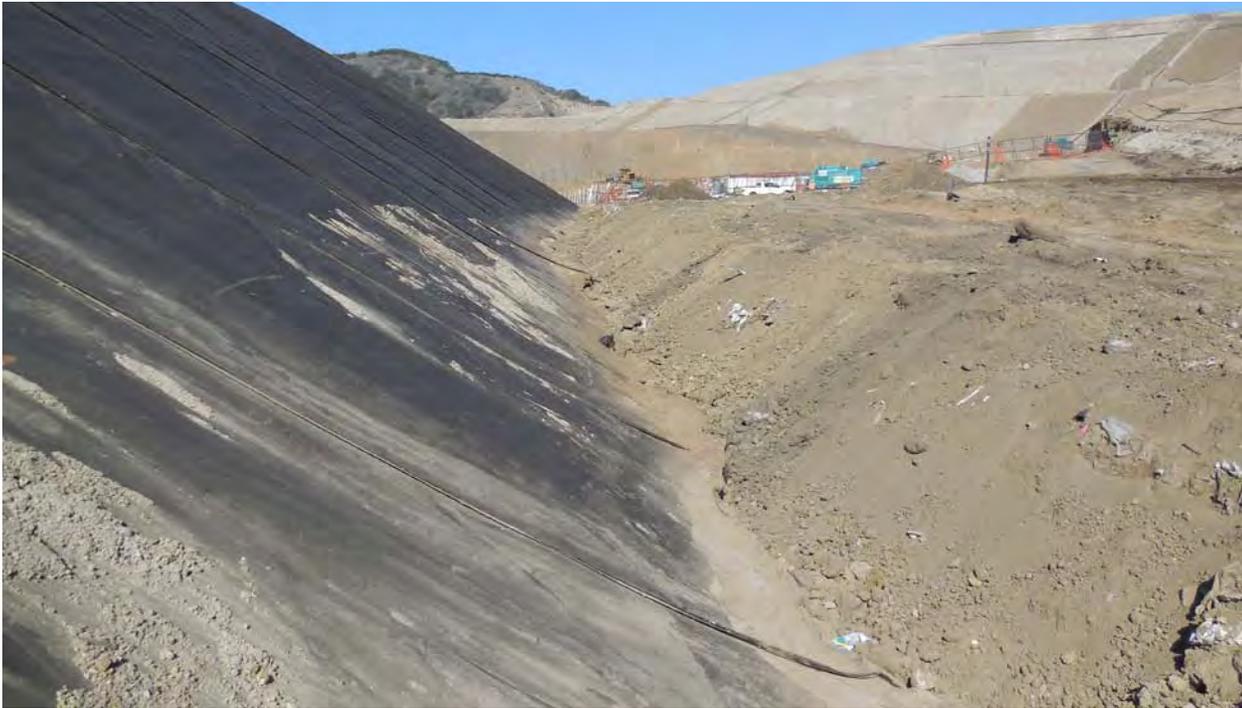
Photo 1 - The area was covered with daily cover soil prior to the cleanup and repair work.

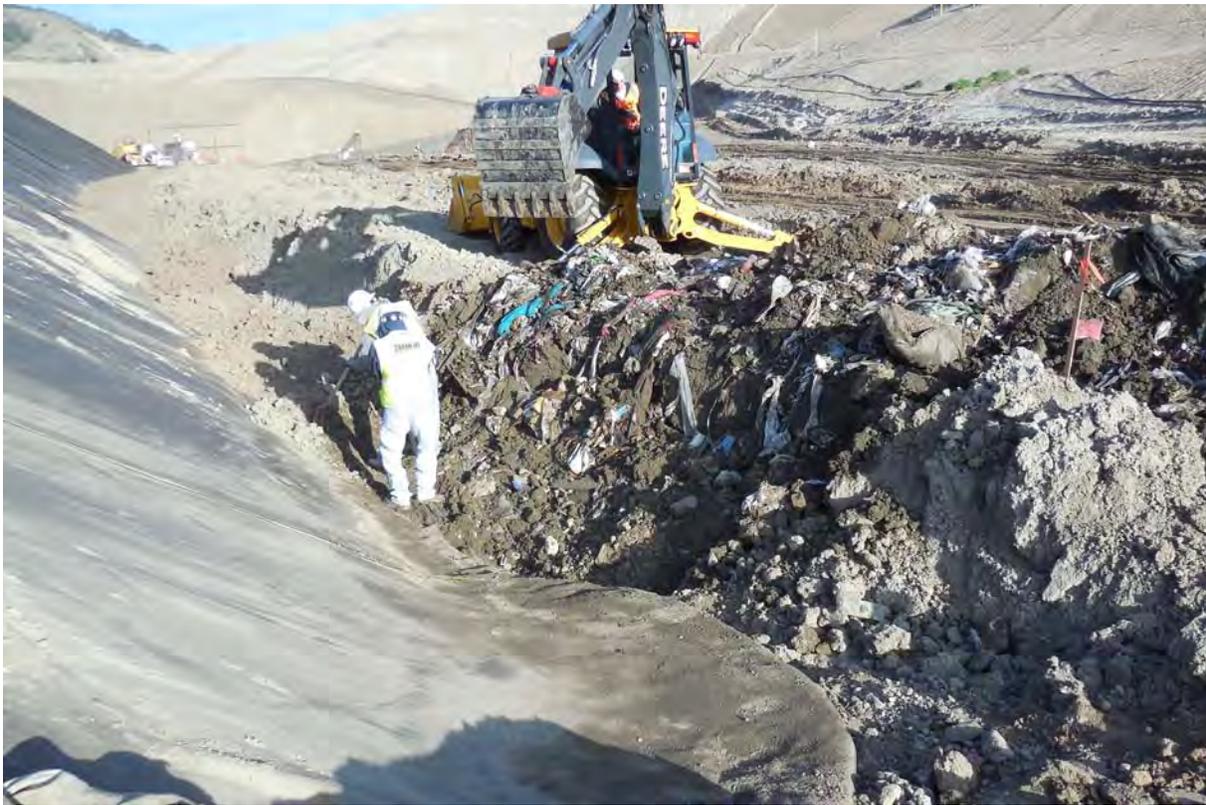
Photo 2 - Refuse and protective cover soil were removed from the affected area.

In order to expose areas of displaced protective soil and geotextile, the contractor first removed refuse and protective soil from the affected area. This work was performed under our observation using a backhoe. We confirmed that the work was done without damage to the liner in the area.

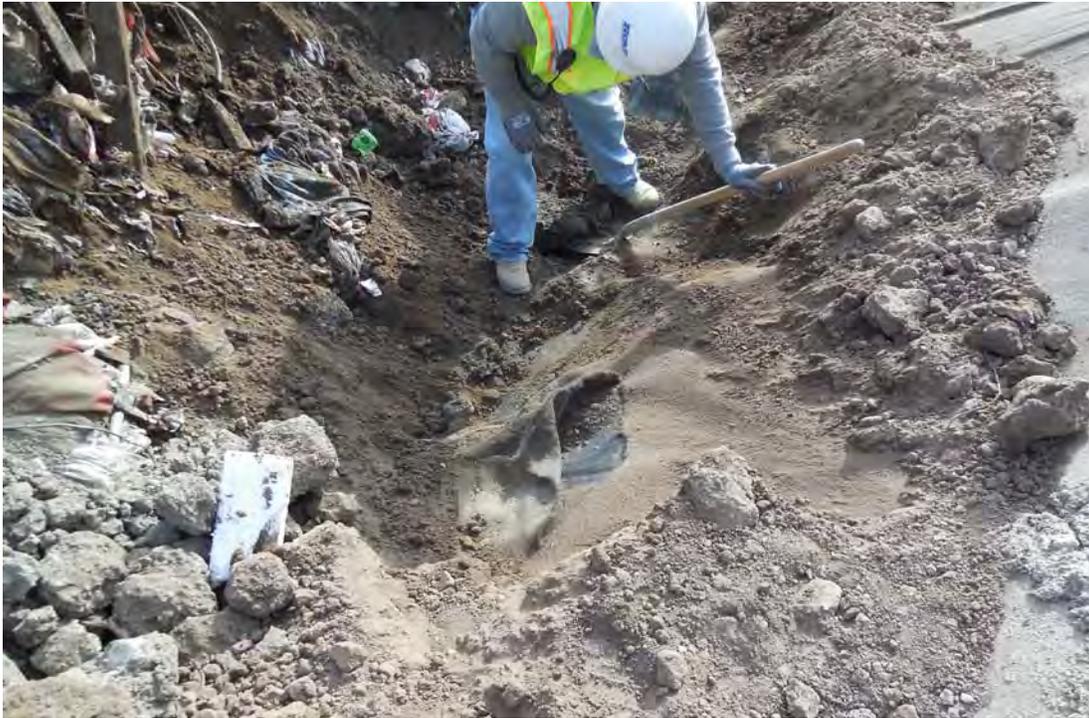
Prior to starting the cleanup work, we inspected the area and observed that some protective soil placed over the liner system prior to refuse filling was displaced by storm water near the south end of Cell CC-3A Part 2 (just north of the scalehouse area). Inspection also showed that in some areas the protective geotextile directly below the displaced protective soil was damaged, allowing fine-grained soils to be deposited between the 80-mil HDPE geomembrane liner and the geotextile.

Photo 3 - Some damage was observed to geotextile below the displaced protective soil.

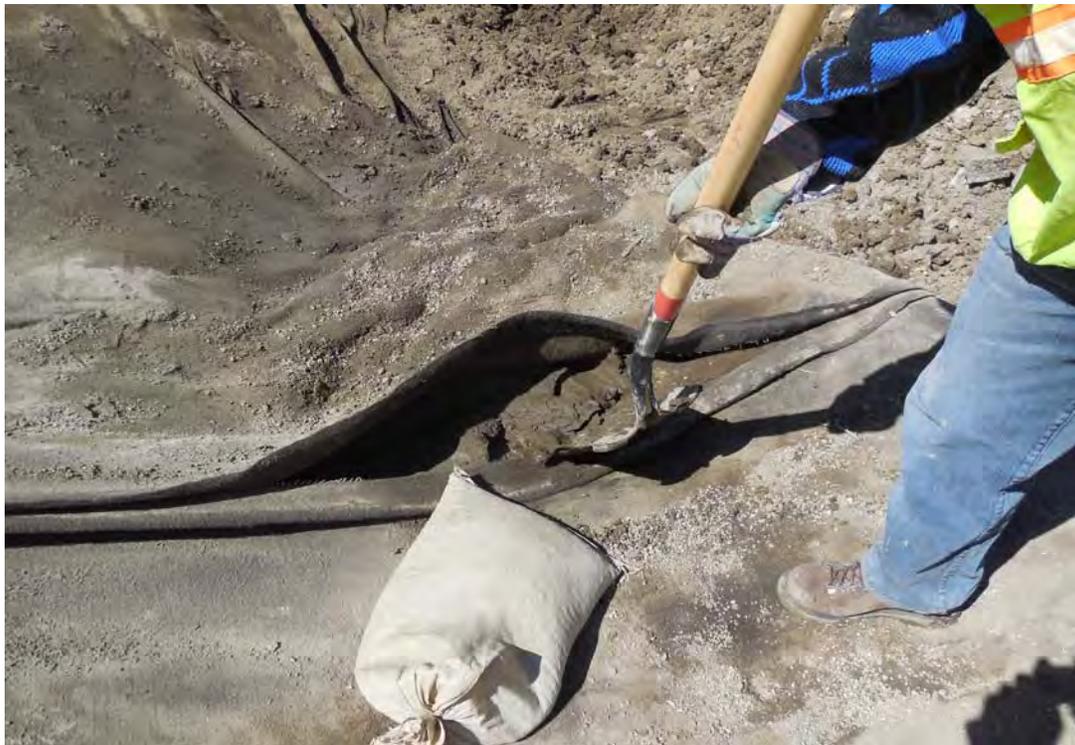
Photo 4 - Fine-grained soils were observed under the geotextile.

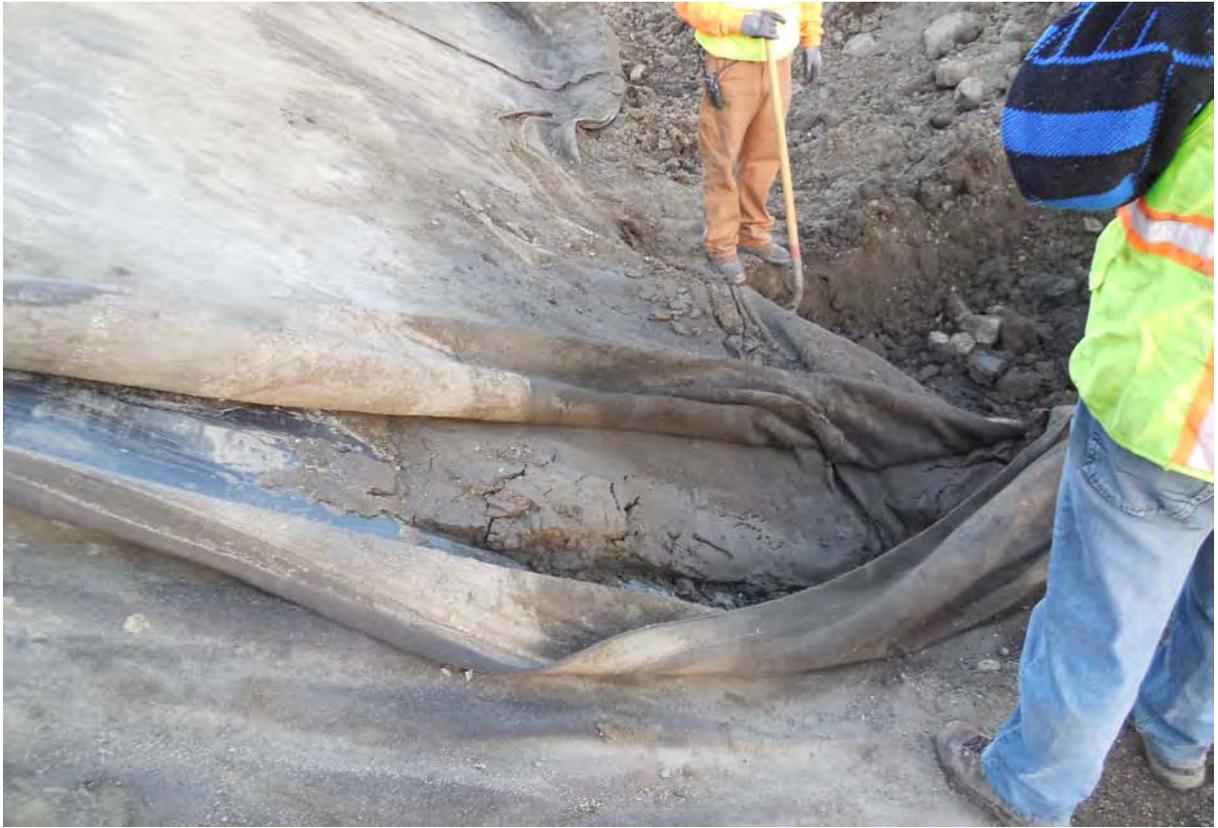
Photo 5 - Fine-grained soils were observed under the geotextile.

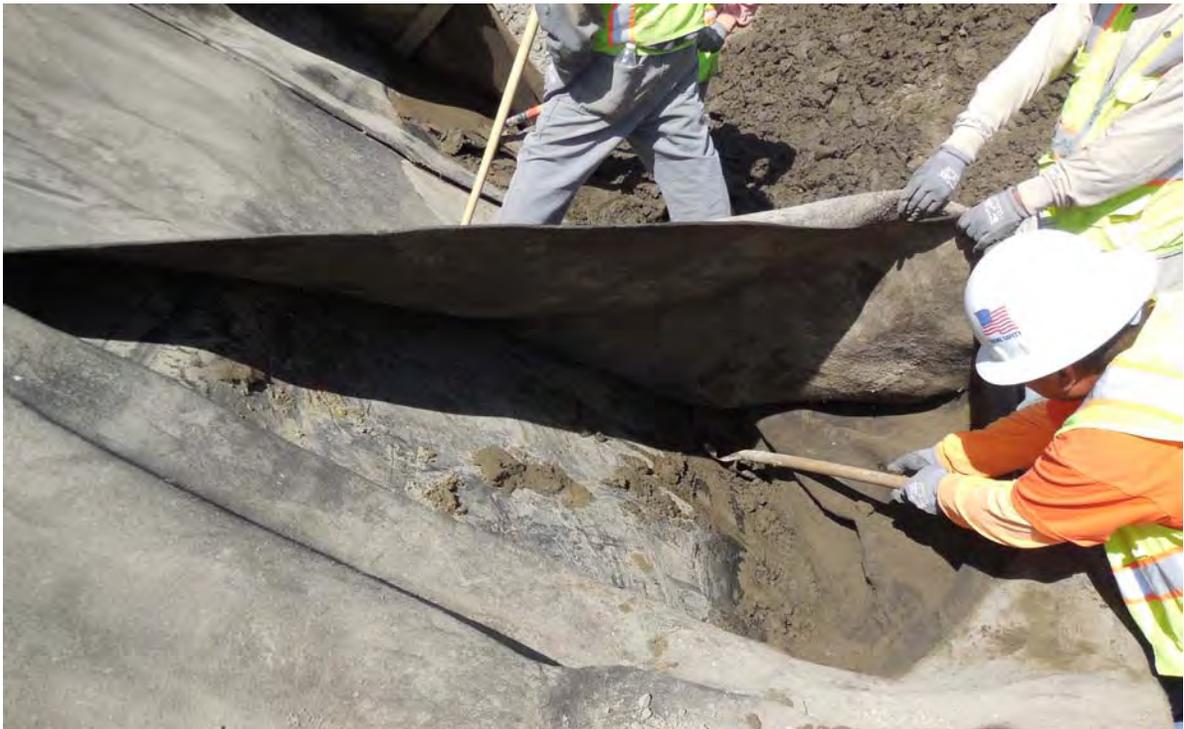
Photo 6 - Fine-grained soils were removed.

After the affected area was exposed, the contractor pulled back the geotextile and removed the fine-grained soils under the geotextile. After the liner surface was cleaned, we inspected the liner and confirmed that the liner was undamaged. Any damaged geotextile was then replaced or repaired by sewing torn pieces and patches as needed. We confirmed that the repaired geotextile is sound and in conformance with original installation requirements.

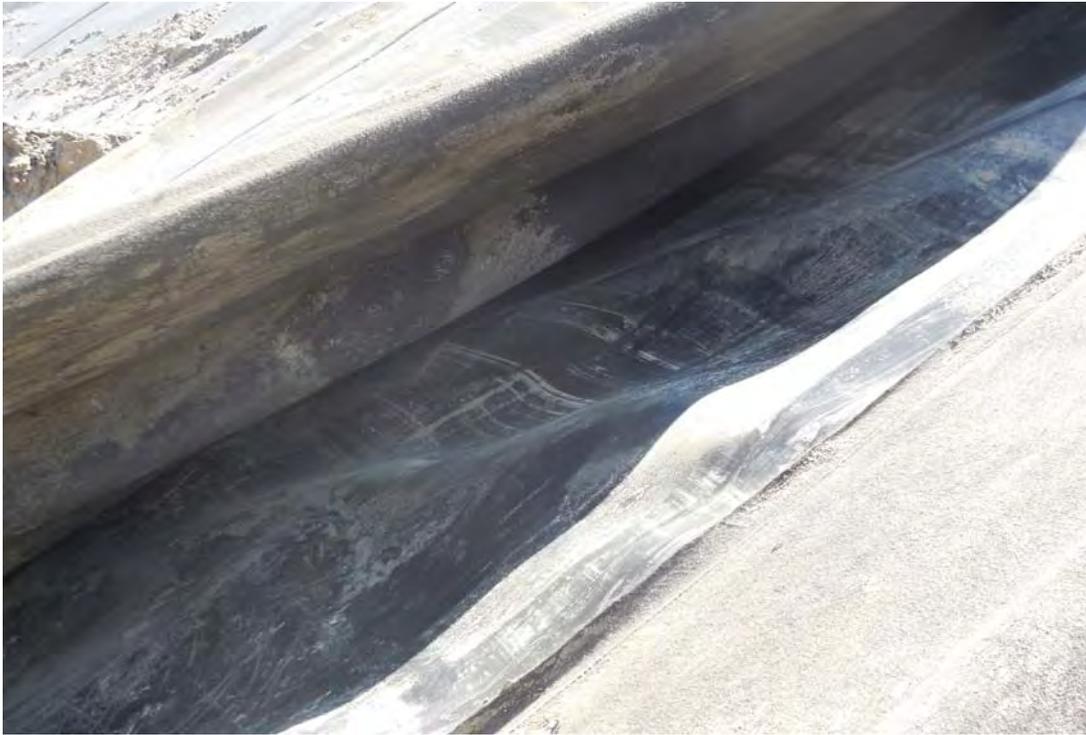
Photo 7 - The liner surface was inspected to confirm that the liner was undamaged.

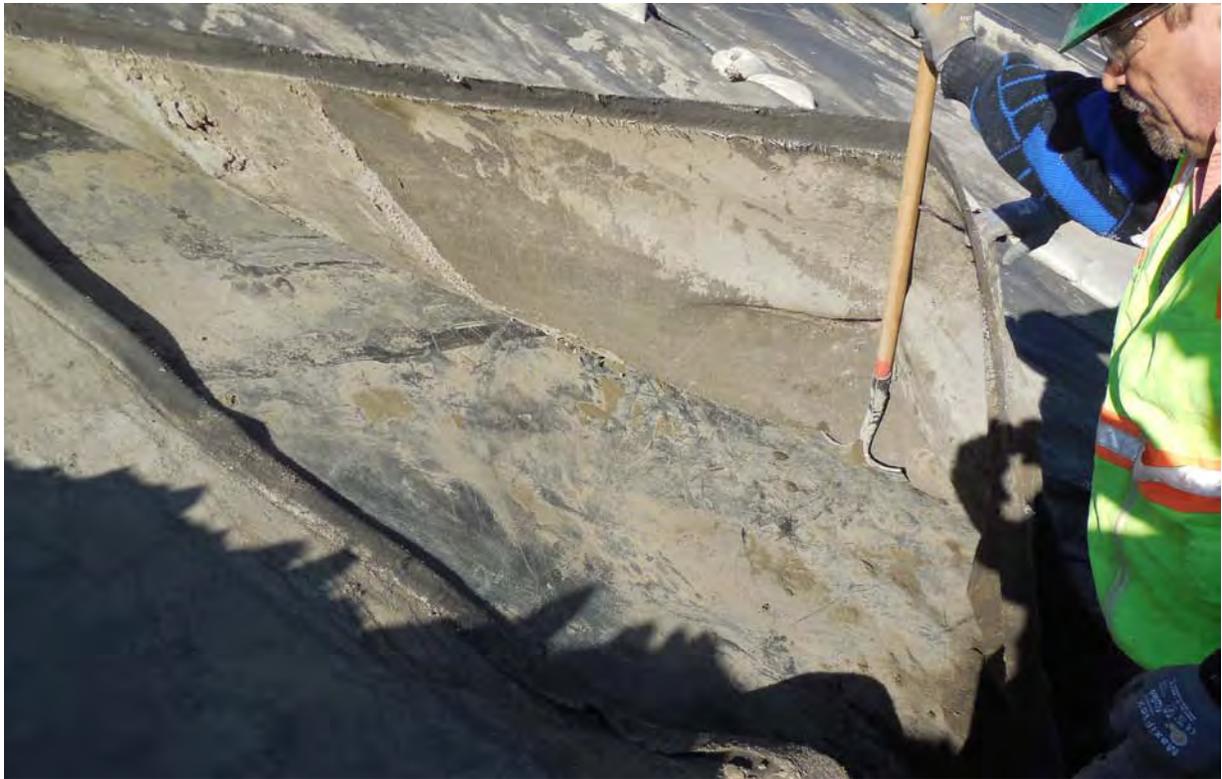
Photo 8 - The liner surface was inspected to confirm that the liner was undamaged.

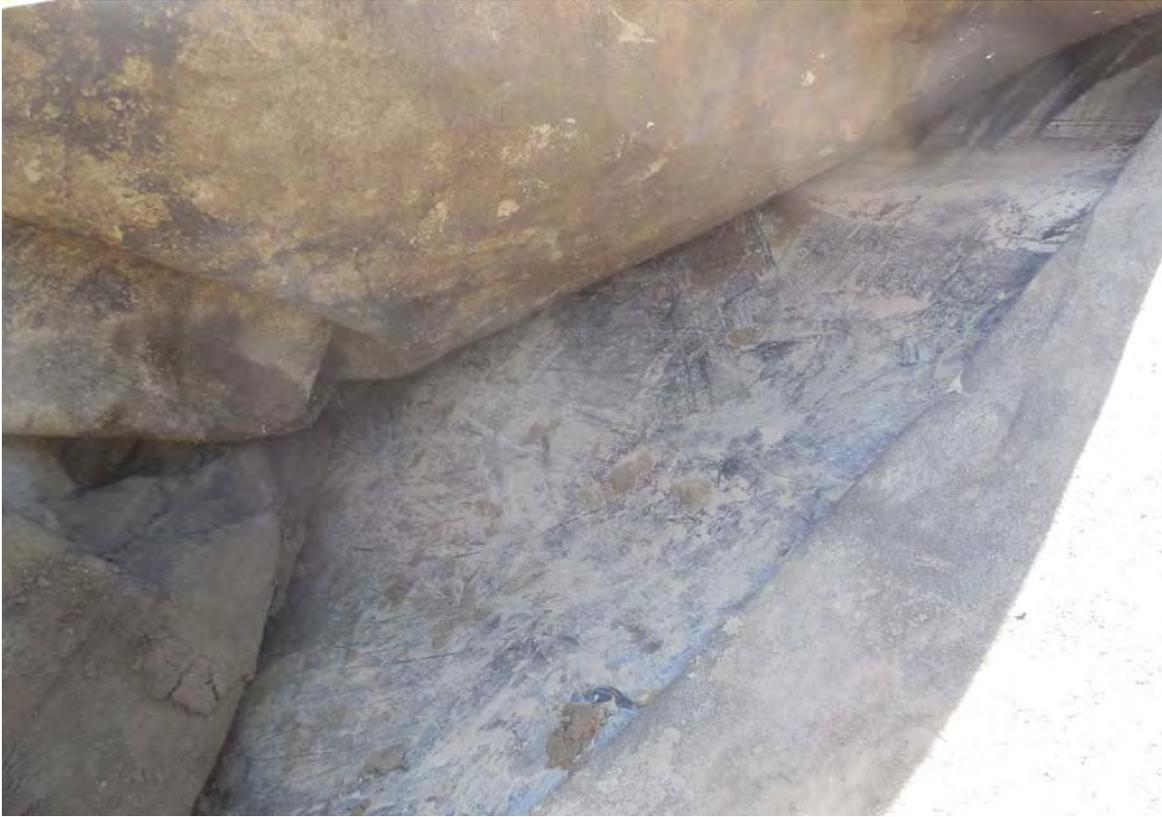
Photo 9 - The liner surface was inspected to confirm that the liner was undamaged.

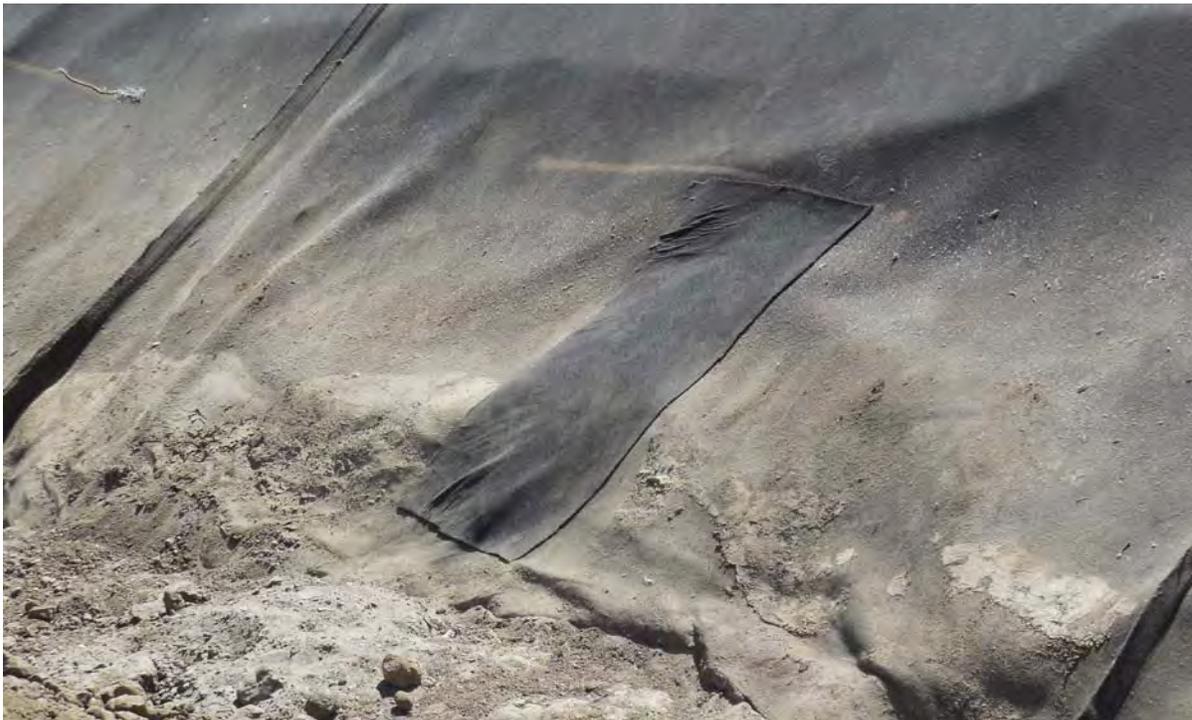
Photo 10 - The geotextile was repaired.

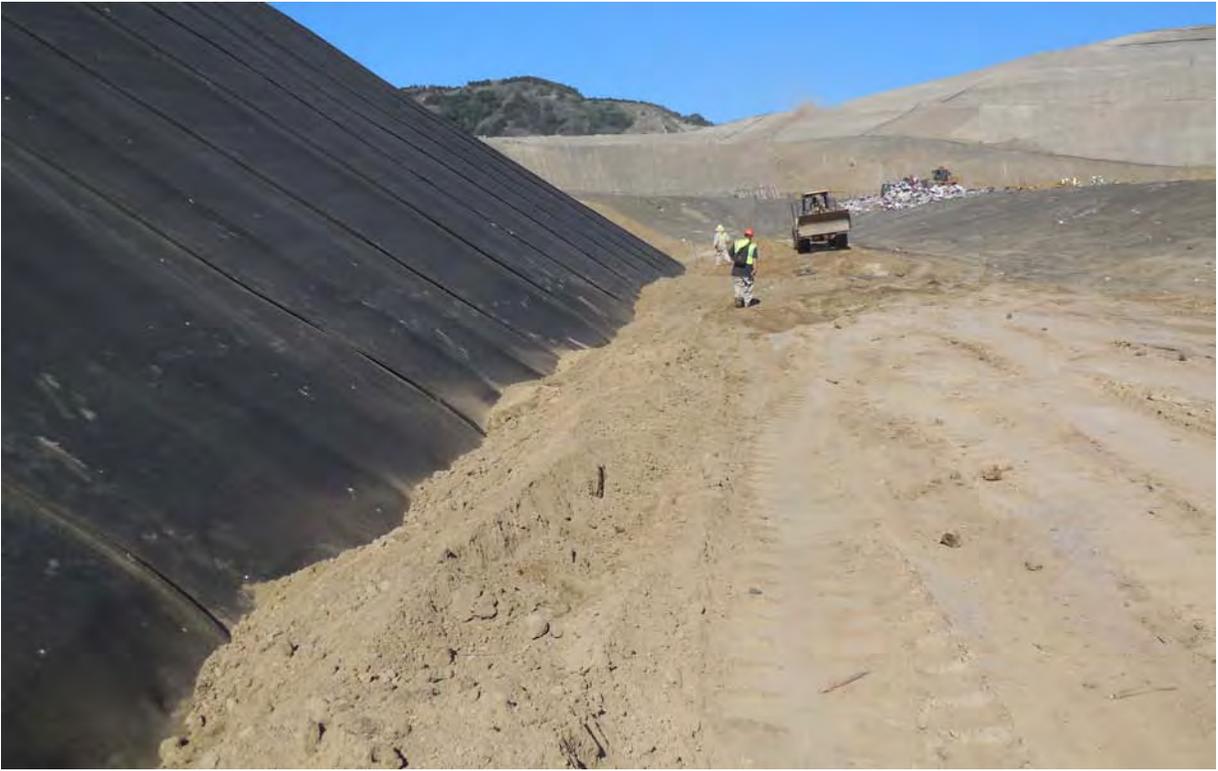
Photo 11 - The protective soil was replaced.

After all cleaning and repairs were complete, we verbally reported our findings to staff of the Regional Water Quality Board, and then the contractor installed new protective soil in conformance with original construction requirements. Cover soil placement was completed under our supervision on March 17, 2014.

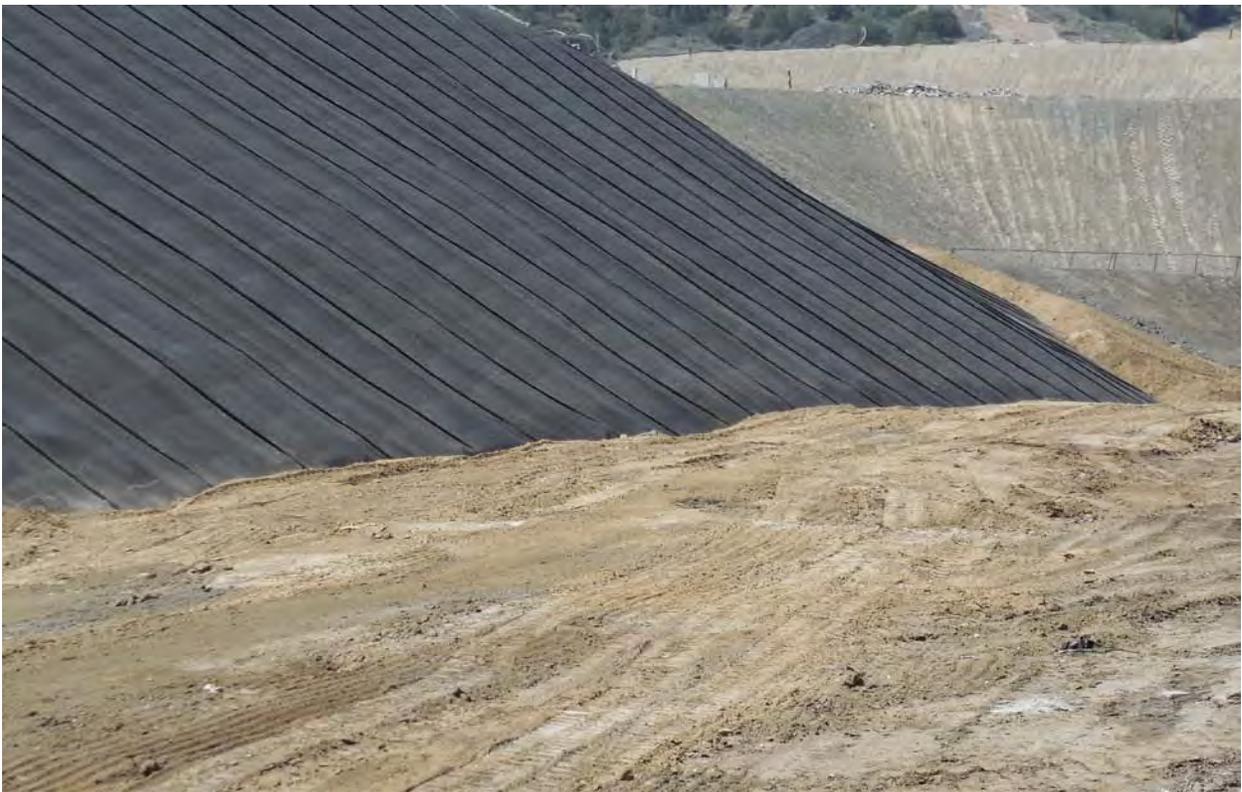
Photo 12 - The protective soil was replaced.

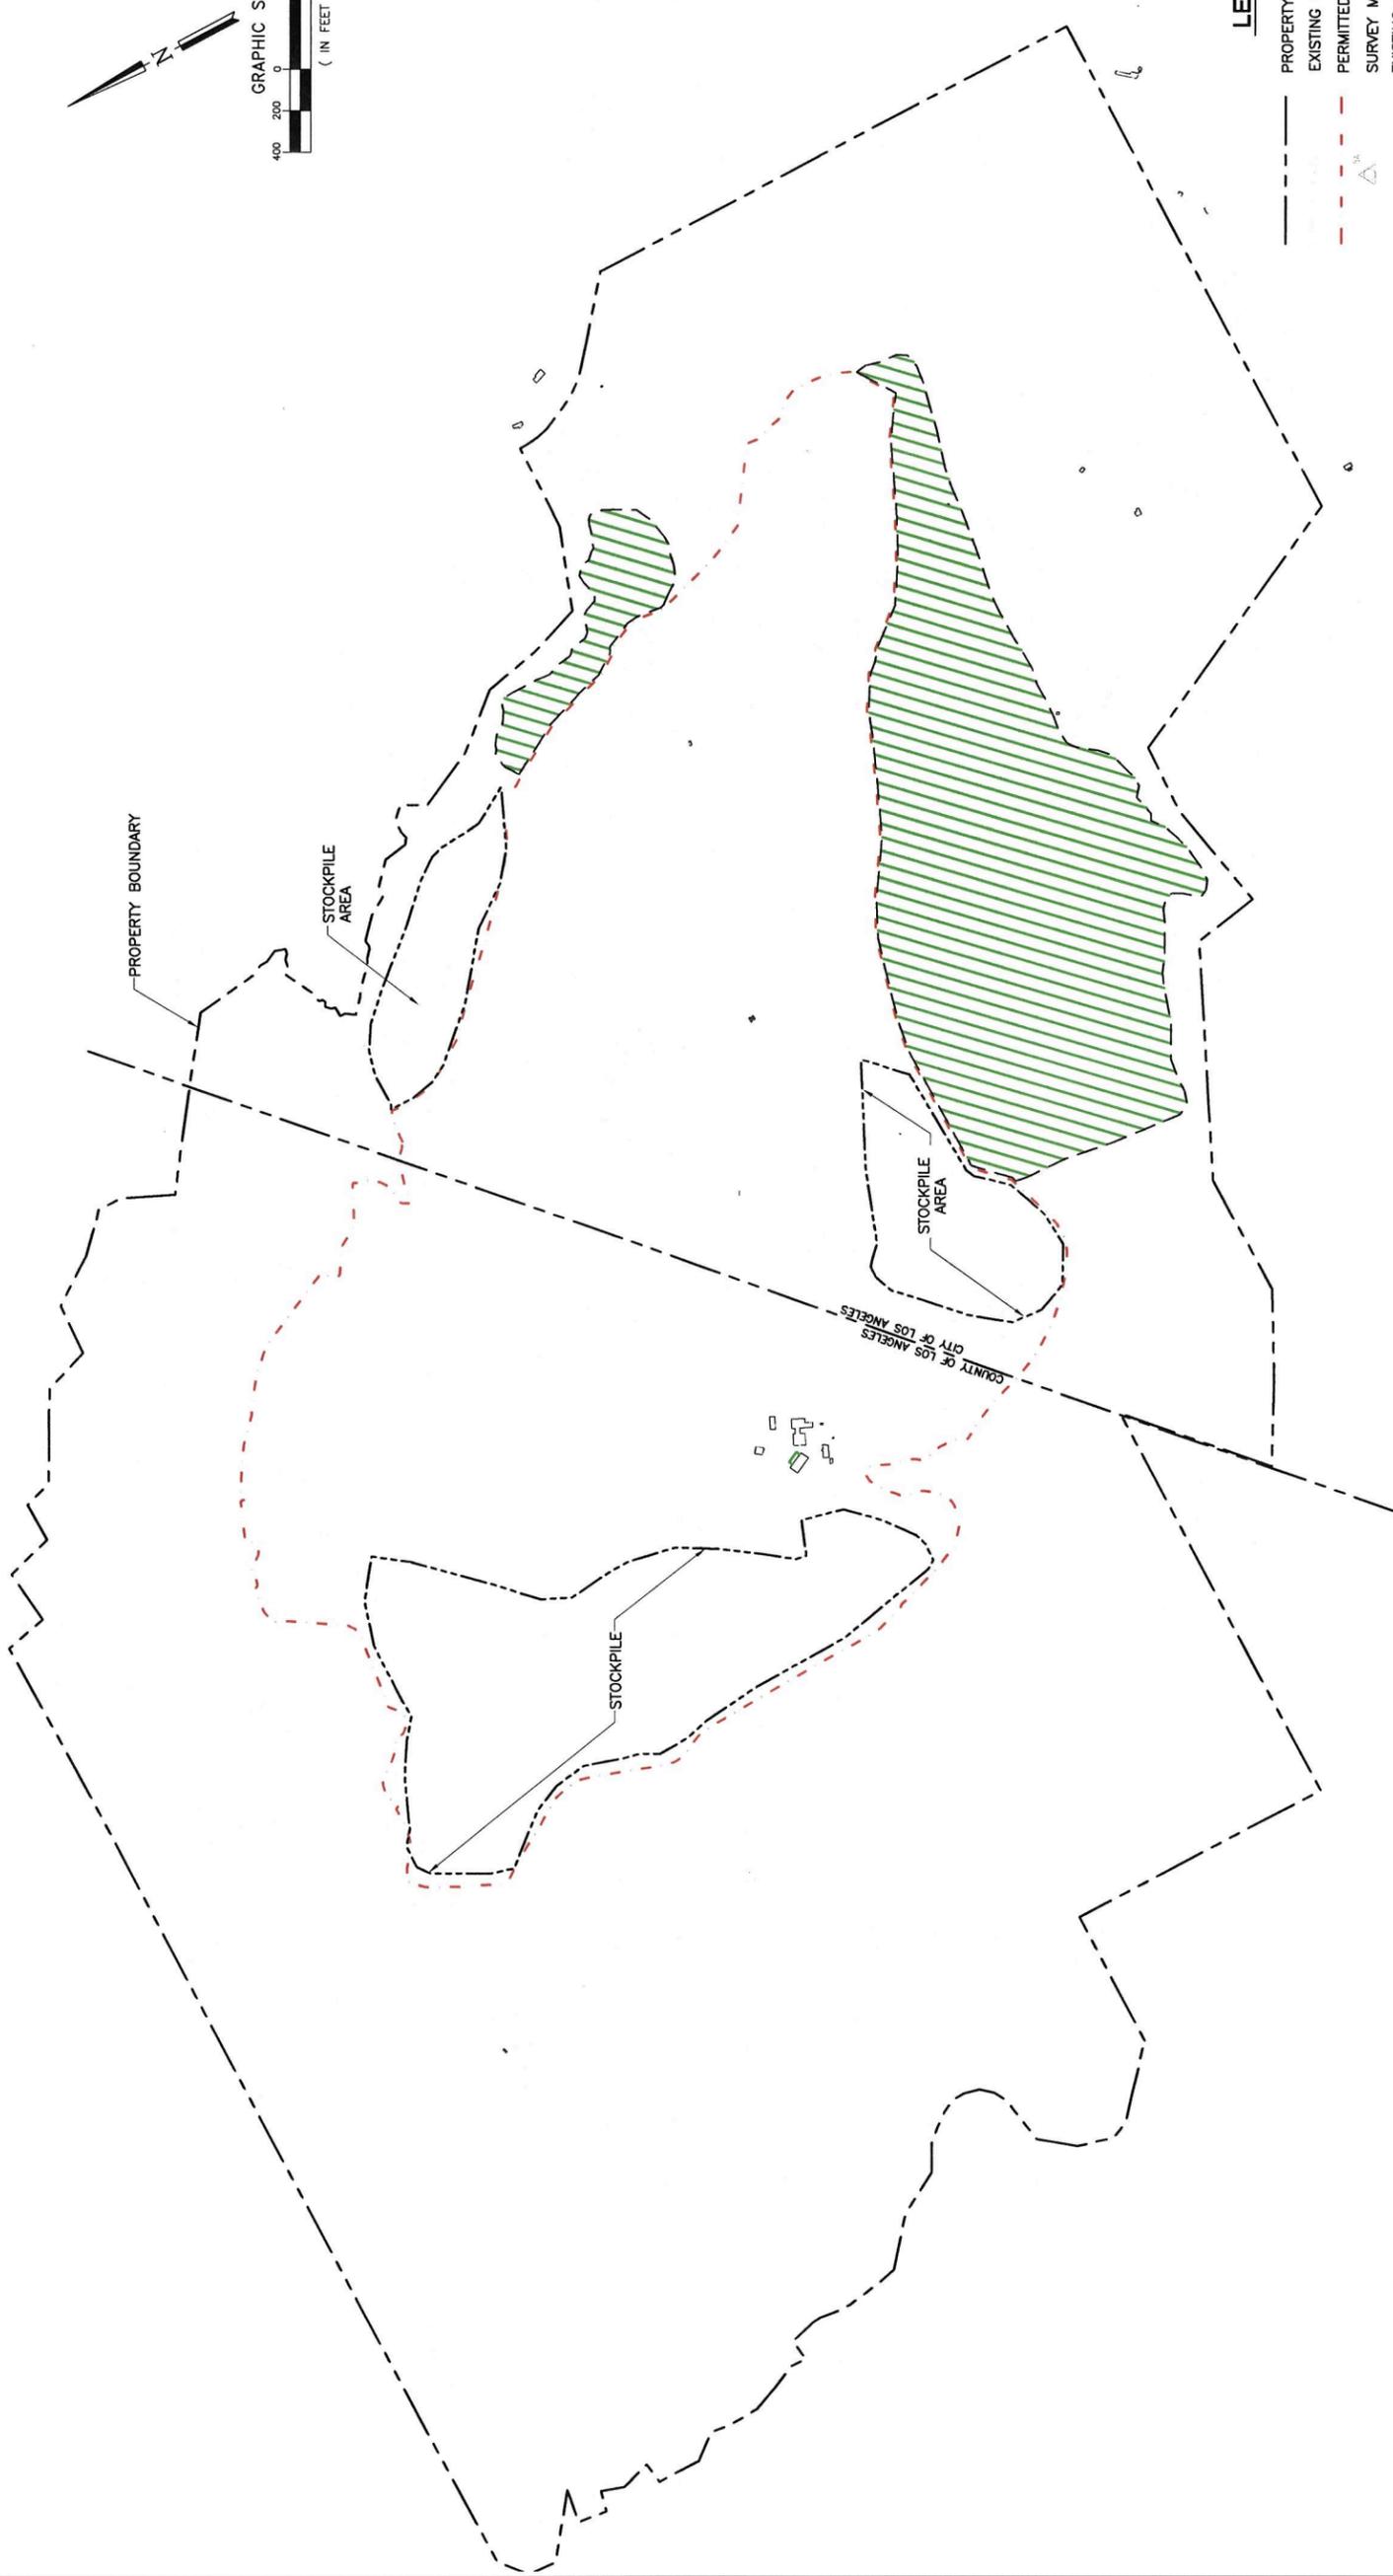
ATTACHMENT G

Placement and subsequent removal of stockpile material is an operational activity that occurs over the life of the landfill. The December 2013 TAC report provided a figure showing three stockpile areas on site. This figure is provided again in Attachment G for reference. Currently, the stockpile area on City South is being used to provide material for the daily soil cover requirements. The other stockpile areas will be used as deemed appropriate by site operations personnel. It should be noted that although there is stockpiled soil on the County portion of the site, the presence of the aboveground piping for the gas collection system makes it prohibitive for these stockpiled soils to be accessed at this time.

PERMITTED REFUSE LIMIT= 363 ACRES
 PERMITTED AREA= 1,036 ACRES
