RECOMMENDATION REPORT

CASE NO.: CHC-2015-3306-MAEX

PROJECT: 1830 N. Taft Avenue
Historic-Cultural Monument (HCM) No. 1070

The Polynesian
1830 N. Taft Avenue - Hollywood
Historic Structure Report

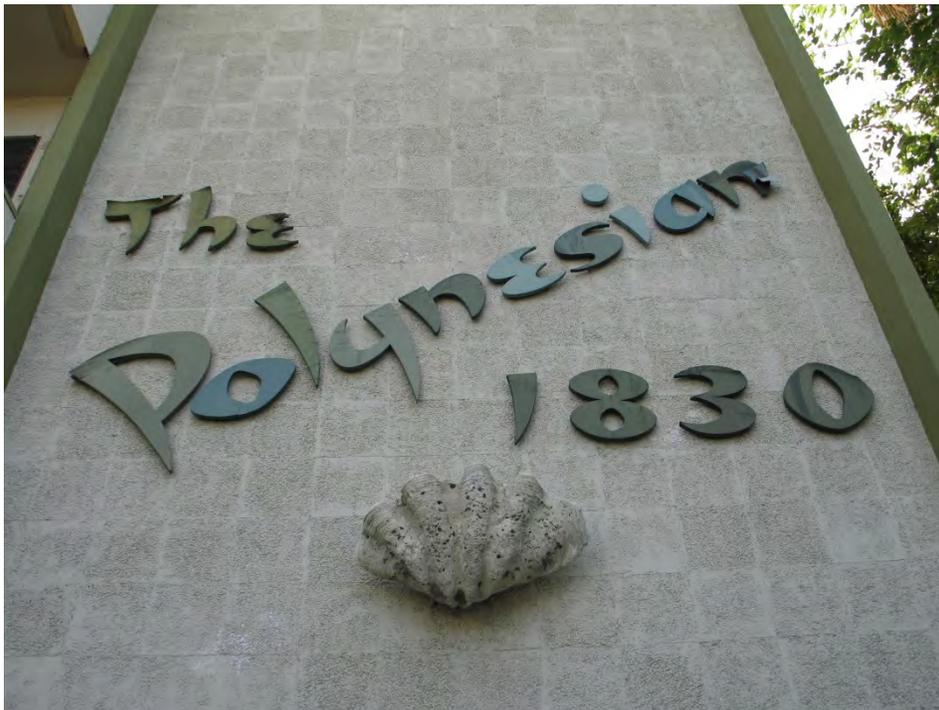
Fig. 2-4 Iconic Street signage and giant clam shell lighting sconce

Directly over the entrance to the garage is the iconic, original and largely intact painted plywood building sign with “The Polynesian 1830” up-lite with a giant clam shell sconce. (Fig. 2-4) The overall sign is quite large (approx. 8ft x 16ft) and is surface mounted to the now painted 8x8 tile finished “bookend” described earlier in this passage. It appears that the original “Tiki” font, letter sizes and spacing is substantially intact, such that a careful and thorough reconstruction of the historic signage is possible by a qualified signage fabricator. The signage material itself is individual plywood letters, cut with a scroll saw and individually mounted to the wall. The plywood letters are rotting and delaminating and may have been replaced at different times, judging by the different colors of faded paint. It is recommended that the plywood sign and letters be carefully documented and reconstructed out of the same materials and the same paint color and reinstalled in their original location.

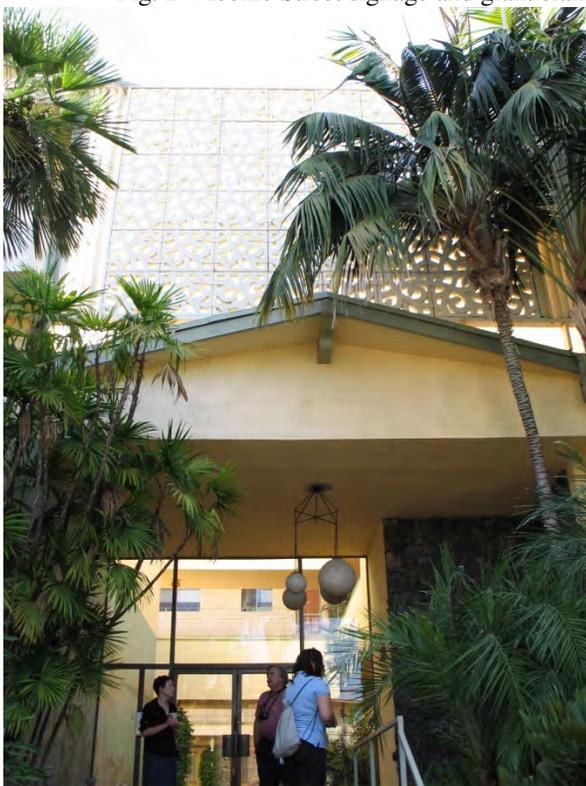
Fig. 2-5 Architectural screen - street view

High above the courtyard entry is a backlit architectural screen that helps define the courtyard entry. The screen has an organic scroll motif and is made up of individual, repeating 18x18inch coated high density foam panels sandwiched between 1/8” thick plastic boards. The individual panels are screw fastened to a painted 2x wood structure. (Fig. 2-5 thru 2-7) The repeating panels appear to be in satisfactory condition however one panel recently blew down in a windstorm, indicating that all fasteners and wood framing members should be checked for rot. The 2x wood framing system is exhibiting signs of wear, and possible rot. It is recommended that a conservator of exterior finishes inspects the screen – the top side of the foam screen panels is showing signs of degrading from the elements and should be recoated to prevent further degradation.

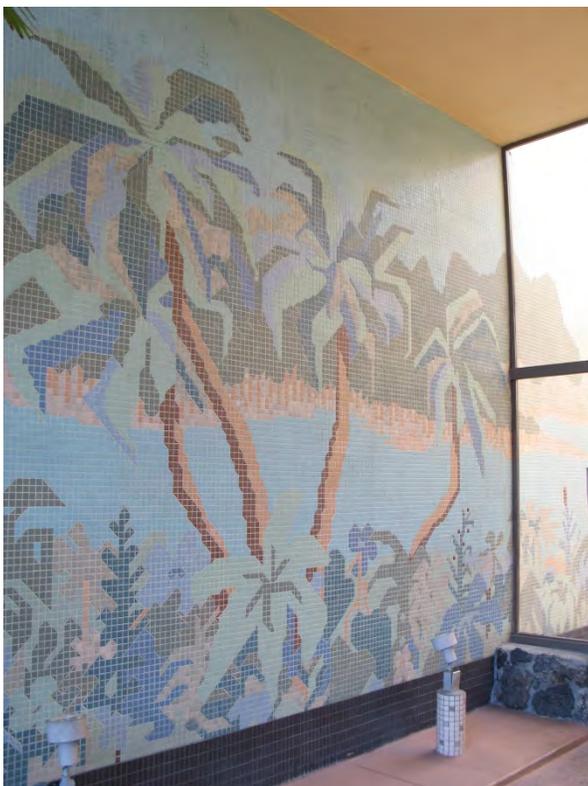
Gracing the courtyard entry of the Polynesian is a quite remarkable, original 12 foot high x 40 foot long mosaic tile artwork, featuring Polynesian themes of palm trees, ocean scenes, beaches and indigenous sailing vessels. (Fig. 2-8) The pastel colored 3/4” square mosaic tile and grout is intact and is in excellent condition with the exception of a small crack in the upper left corner next to entry doors (Fig. 2-9). Existing up lights are intact and are mounted to knee high mosaic tile covered pedestals, running the length of a slightly raised floor area in front of the wall mosaic. It is unclear whether the lights are original, however they are certainly older. It is recommended that the owner hires a professional conservator to suggest a maintenance program and to inspect the mosaic and suggest methods of treating the crack, cleaning the mosaic and possible sealing to protect it.

Fig. 2-8 Mosaic tile mural at courtyard entry.
Note pedestal uplight.

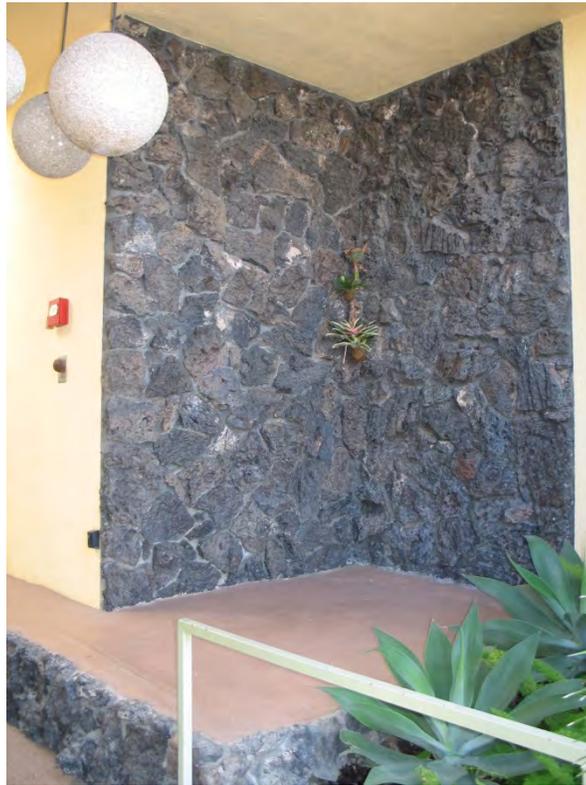
Fig. 2-10 Lava rock niche at courtyard entry

Opposite the mosaic is a lava rock wall niche with a 10x10 concrete slab at its base. (Fig. 2-10) It appears that there may have been something in this niche based on its prominent location but it's unclear. The building manager and historian have not yet unearthed archival documentation of what may have been in that location. The Secretary of the Interior guides against reconstruction of historic details without archival basis and does not condone reconstruction based on conjecture. Acknowledging that the lava rock niche is a bit odd, the preservation recommendation is, however, to leave the niche as is until archival information can be produced.

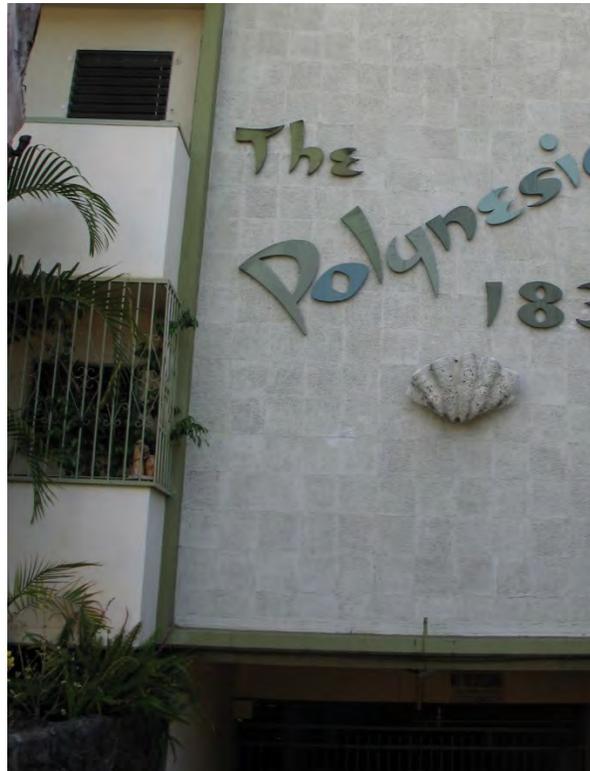
The security bars present on lower level apartment balconies facing the street are more recent additions and distract from the architectural qualities of the building are not appropriately designed. (Fig. 2-14) There is also some concern about meeting life safety code with the security bars preventing adequate egress from bedrooms. It is recommended that other security measures be explored that will meet life safety regulations and do not detract from the architecture. On the top balconies facing the street there is a more recent metal canopy with supports mounted to the original stucco guardrail. Similar canopies have been mounted on the rear property line balconies. The metal canopies do detract from the architecture of the wood outriggers but are not too objectionable and clearly they help with sun and rain control, which in turn prolongs the life of the building. The awnings can also be easily removed at a future date, should someone want to return to the original partially roofed balconies to their original state.

Fig. 2-14 Security grills on balconies (on left)

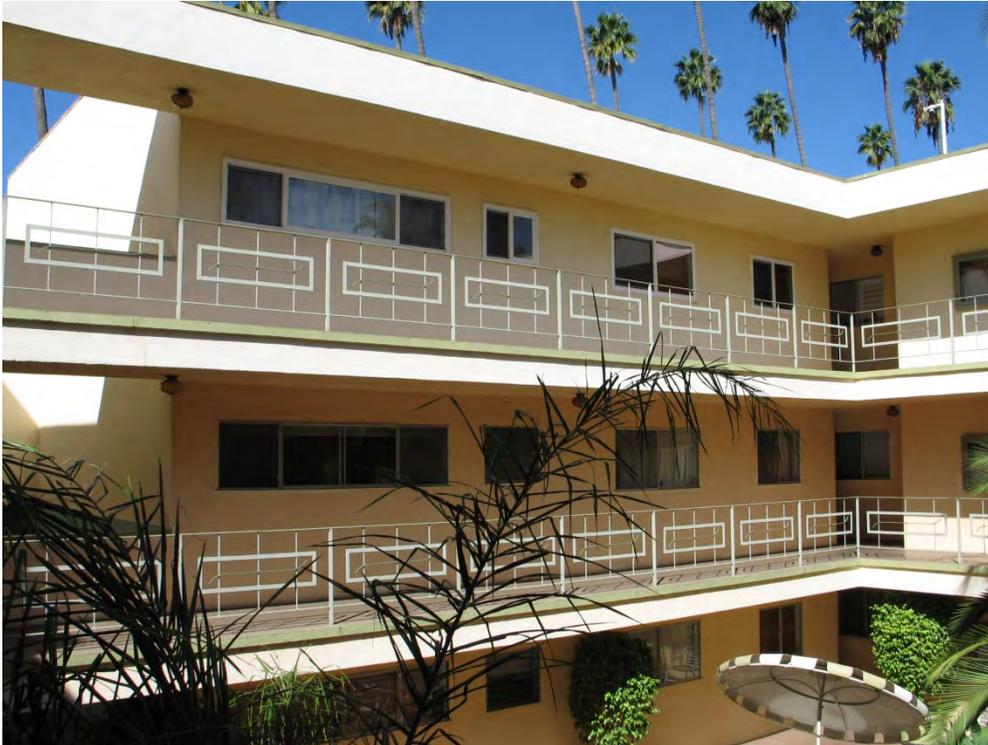
Fig. 2-15 Cantilevered walkways with guardrails. Note upper apartment with newer vinyl slider windows

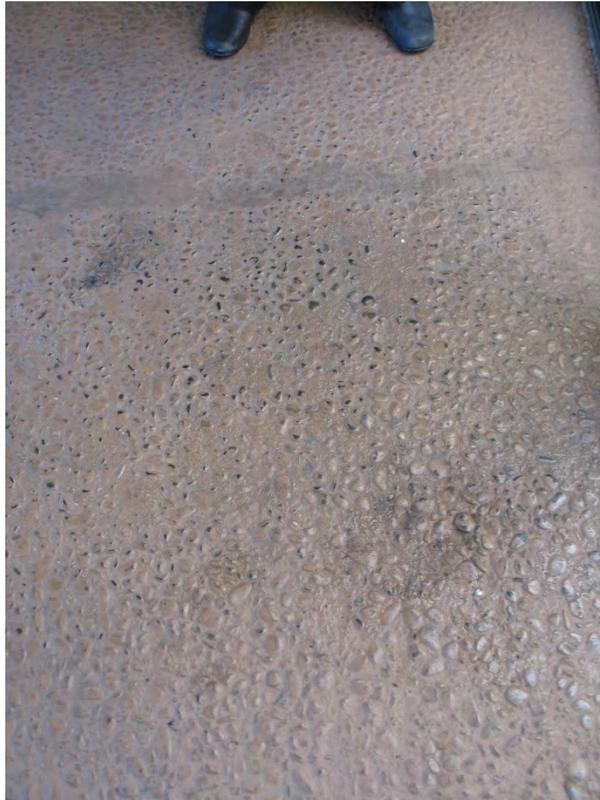
Fig. 2-17 Paving (street side of entry doors)

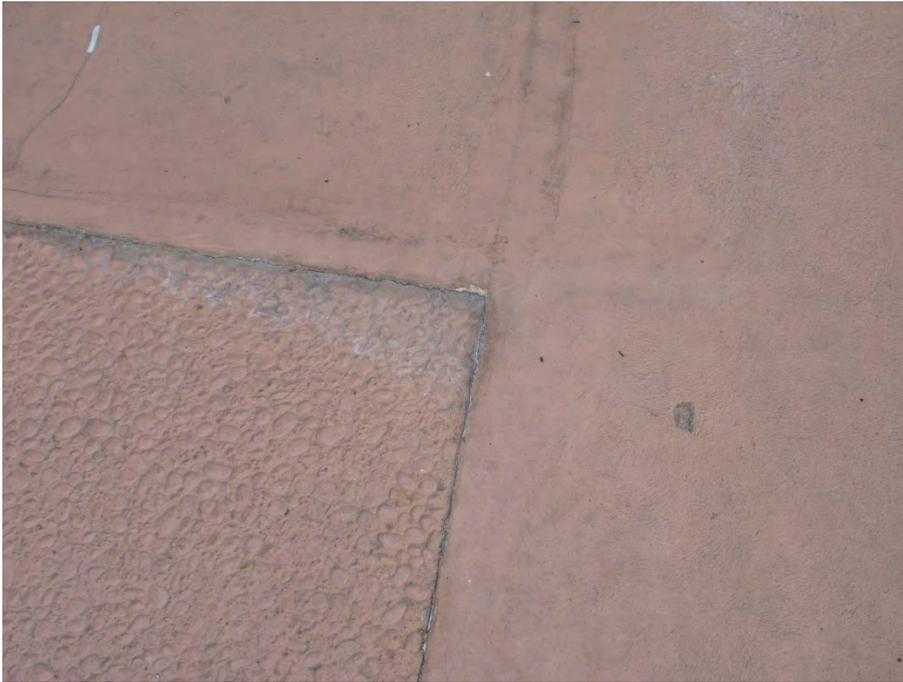
Fig. 2-19 Paving on courtyard podium deck (parking garage below)

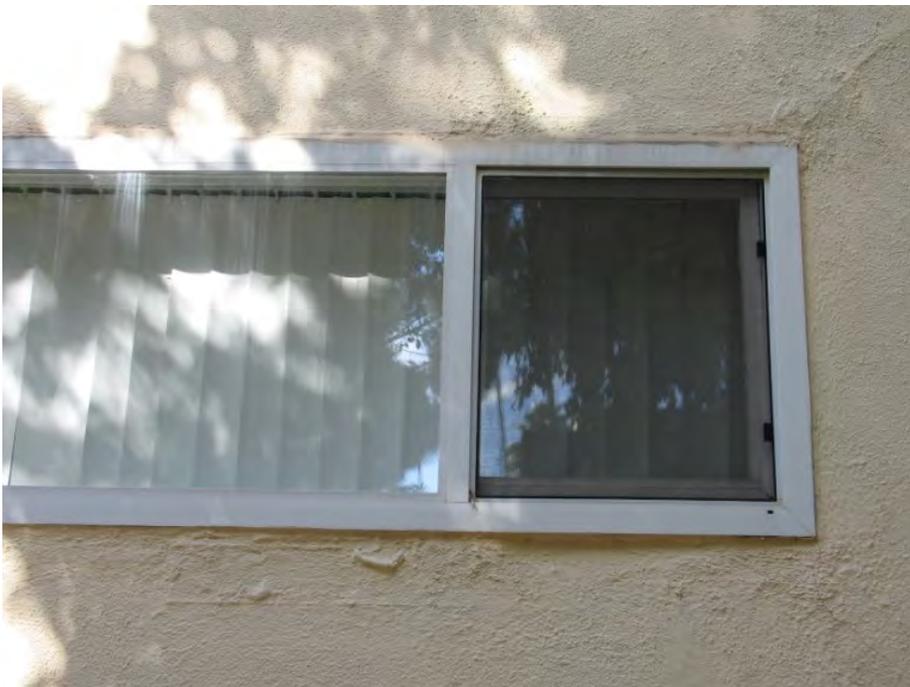
Fig. 2-26 Newer vinyl slider window on North facade

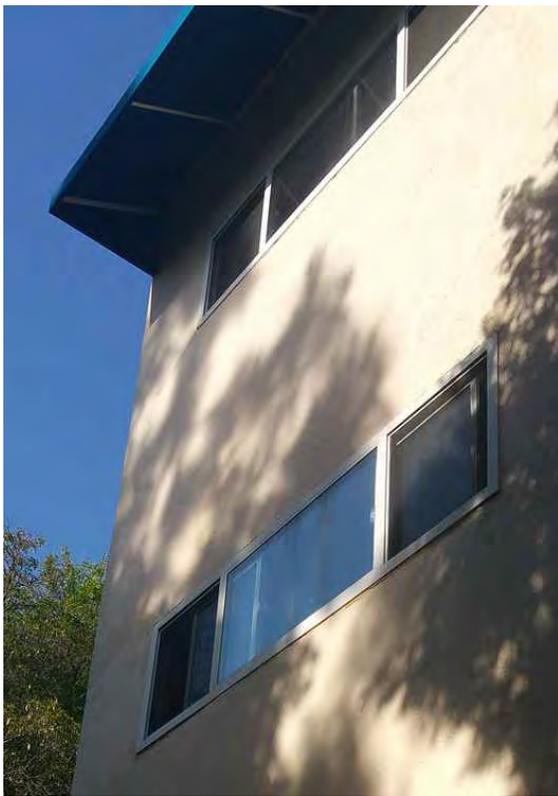
Fig. 2-27 Newer vinyl windows on East façade

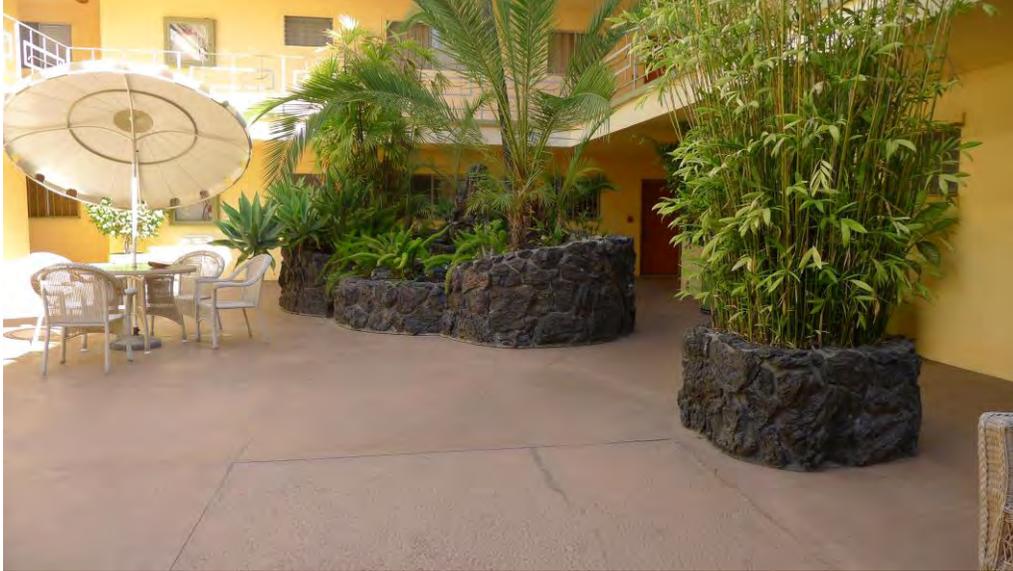
Figure 13: Courtyard

At the entry courtyard, planters were spread out throughout the area on top of the podium slab (Fig 13). Cracks were observed at the planter wall (Fig 14, 15, & 16). The planter wall does not appear to be reinforced and the pressure from the soil and roots are pushing through the cracks. Invasive plants can cause structural damage not only to the planter wall but to the podium slab as well. Proper maintenance to ensure drainage flow is critical to not overload the existing podium slab. The podium slab may not be able to sustain the additional stagnant water pressure from the planter. Proper waterproof and maintenance should be provided for the structural slab/podium. It
