APPENDIX I

GEOTECHNICAL REPORTS

December 31, 1998

Subject: **Geotechnical Considerations
Proposed Property Purchase
Ocean Woods Terraces Apartment Complex
17331-17333 Tramonto Drive
Pacific Palisades, California
Law/Crandall Project Number 70131-8-0618**

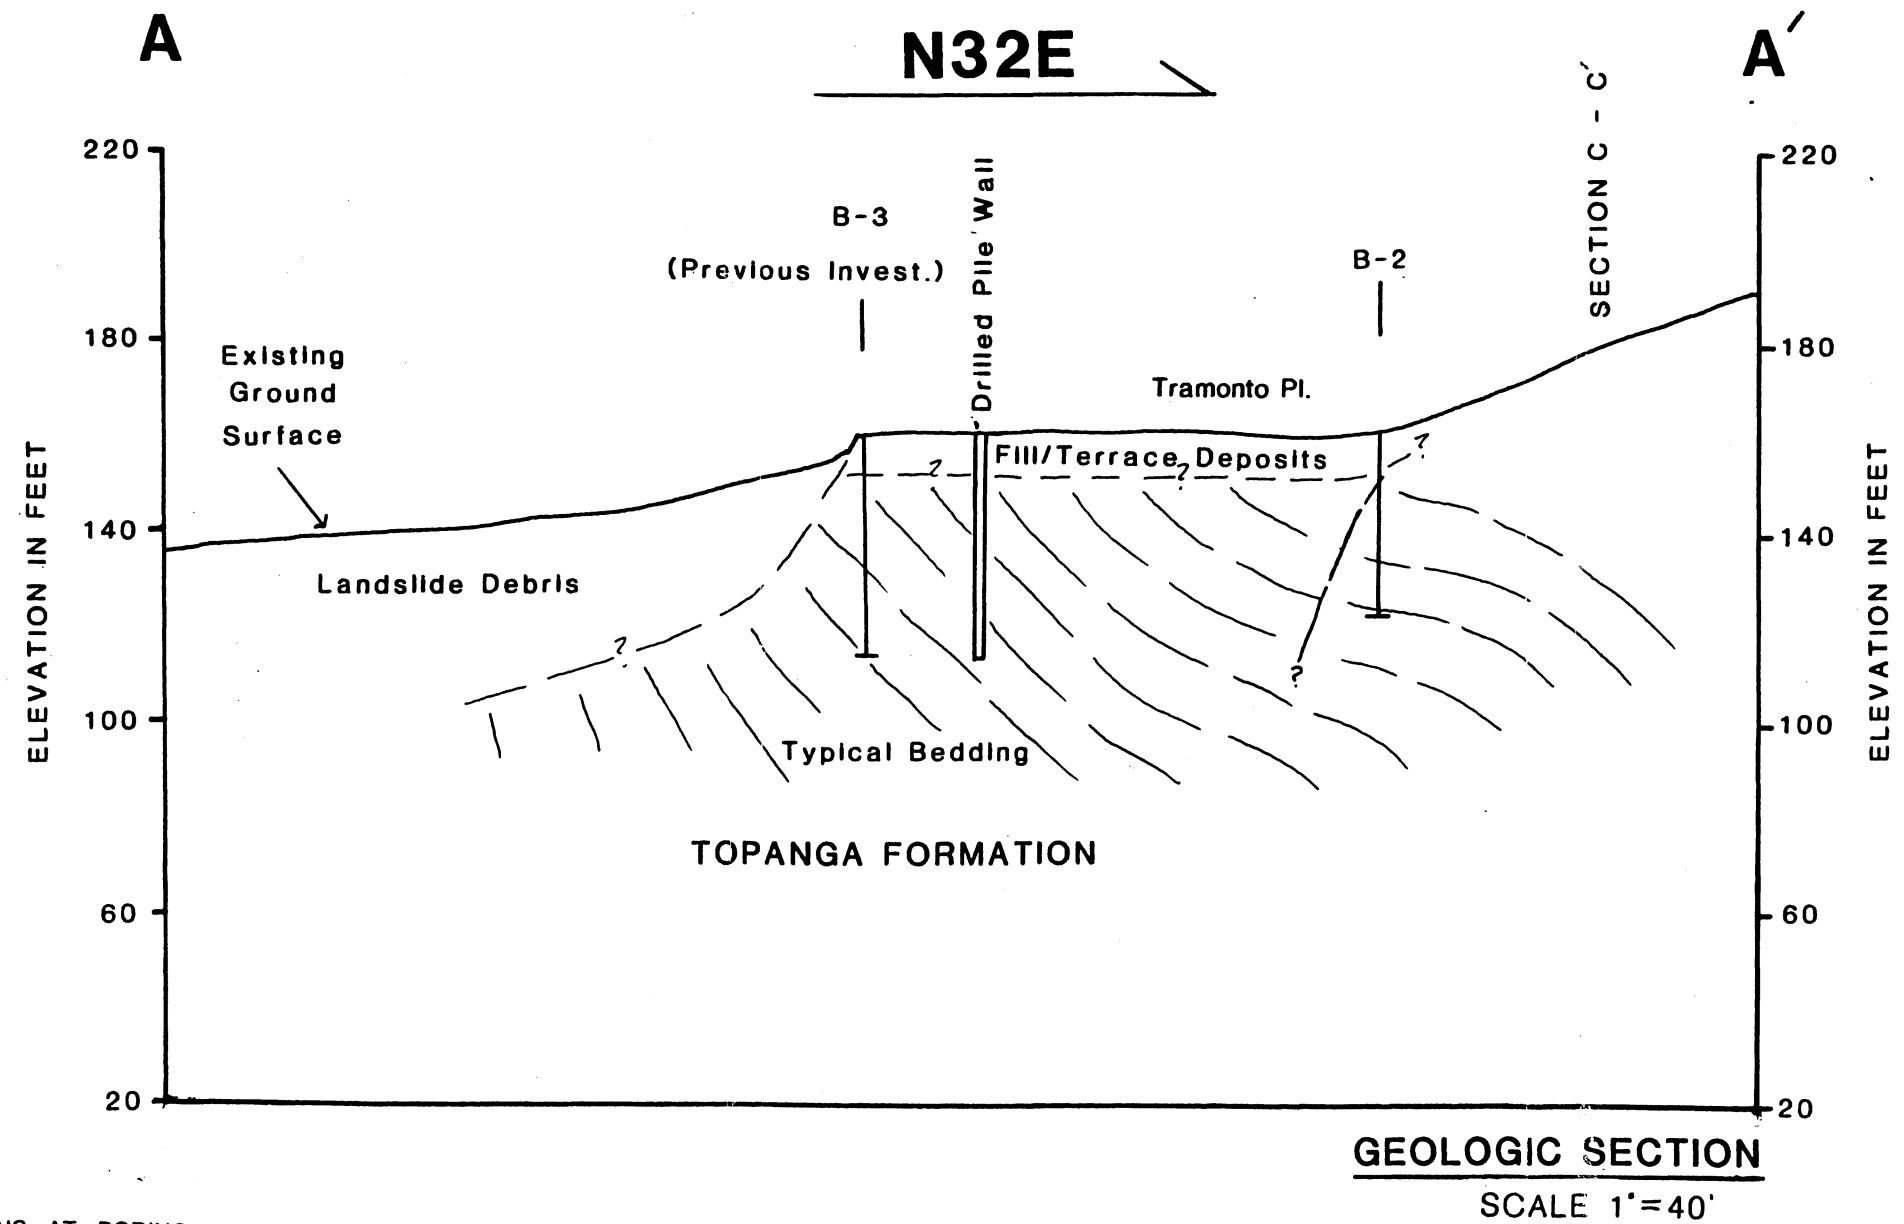
Geologic structure is characterized by moderately steep, northeasterly dipping bedding planes in the sedimentary units that are generally neutral to, or dip into the slope in this area. Minor folding and drag folding along faults result in minor departures from this preferred bedding plane orientation. Interpreted subsurface geologic conditions including geologic structure within the bedrock units and the relationship of various geologic units at the site are illustrated on Figures 3.1 to 3.3. Geologic Sections.

1. SECTIONS ARE BASED ON GEOLOGIC CONDITIONS AT BORING LOCATIONS AND AT SURFACE EXPOSURES MAPPED DURING THE INVESTIGATION. GEOLOGIC CONDITIONS BETWEEN AND BEYOND SUCH LOCATIONS HAVE BEEN INTERPOLATED OR EXTRAPOLATED. LOCALIZED VARIATIONS FROM CONDITIONS ENCOUNTERED MAY OCCUR. SECTIONS ARE INTENDED FOR DESCRIPTIVE PURPOSES ONLY.
2. SEE FIGURE 2 FOR LOCATIONS OF SECTIONS.
