**2640-2656 NORTH ABERDEEN AVENUE**  
Aberdeen House, Historic-Cultural Monument (HCM) #1171  
CHC-2019-1328-MAEX

**STAFF RECOMMENDATION REPORT**

CASE NO.: CHC-2019-1328-MAEX

**PROJECT:** 2640-2656 North Aberdeen Avenue  
Aberdeen House, Historic-Cultural Monument (HCM) #1171

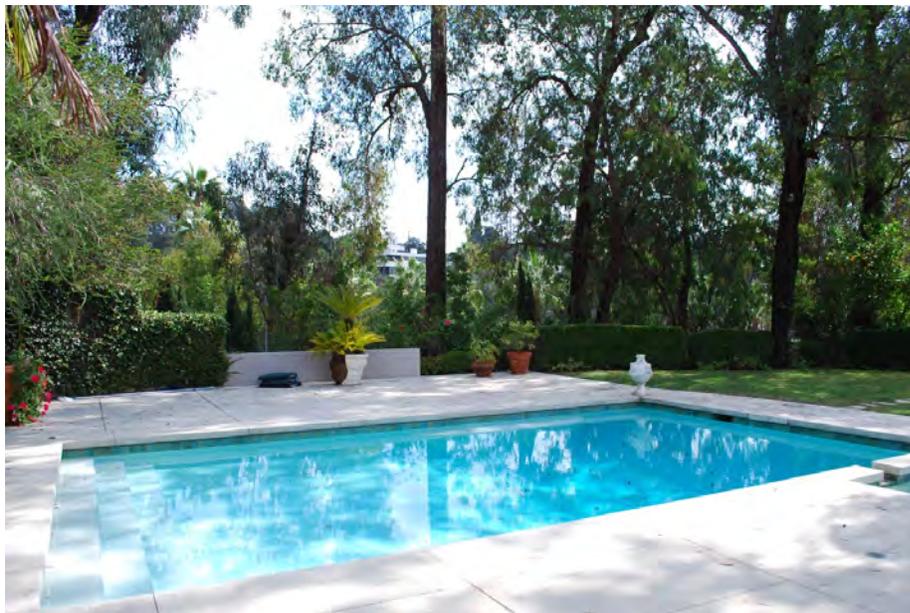
*Pool:* The rear yard pool is elevated above the main house to the northwest on a plateau accessed by a steep staircase. The pool and associated features are not original and do not have primary historic significance. The pool appears to be in fair condition and does not receive intense focus for the purposes of this study.

Figure 4 Pool and adjacent pool deck area, 2017. Photo credit: V.Withers

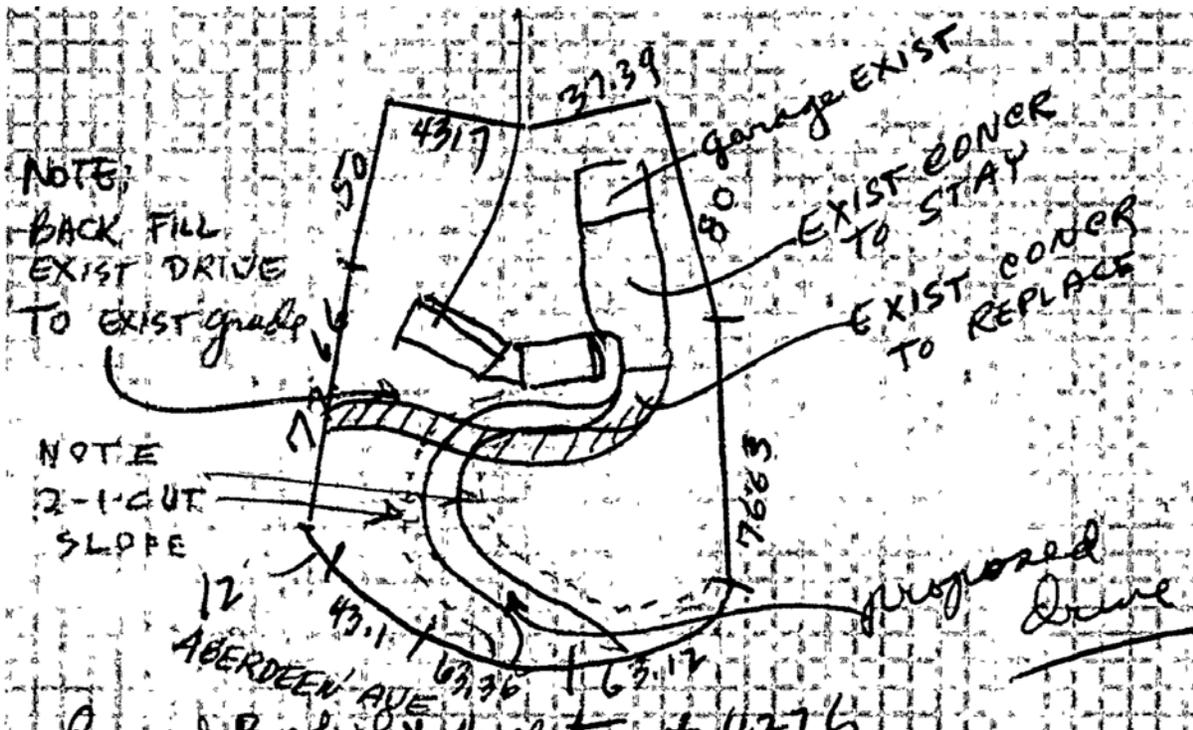
*Driveway:* The existing driveway was constructed in 1964 and winds up the hill in front of the main house. The driveway is in fair condition with portions of the driveway cracked and slabs uplifted. The driveway and its placement are not original.

Figure 6 Excerpt from 1964 permit showing re-routing of driveway

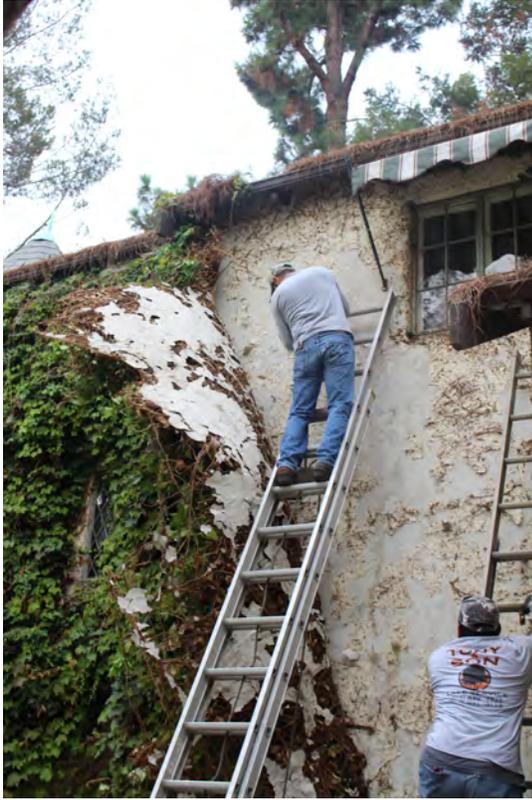
Figure 19 Beginnings of removal of ivy off rear elevation, 2017. Photo credit: Stuart Gulland

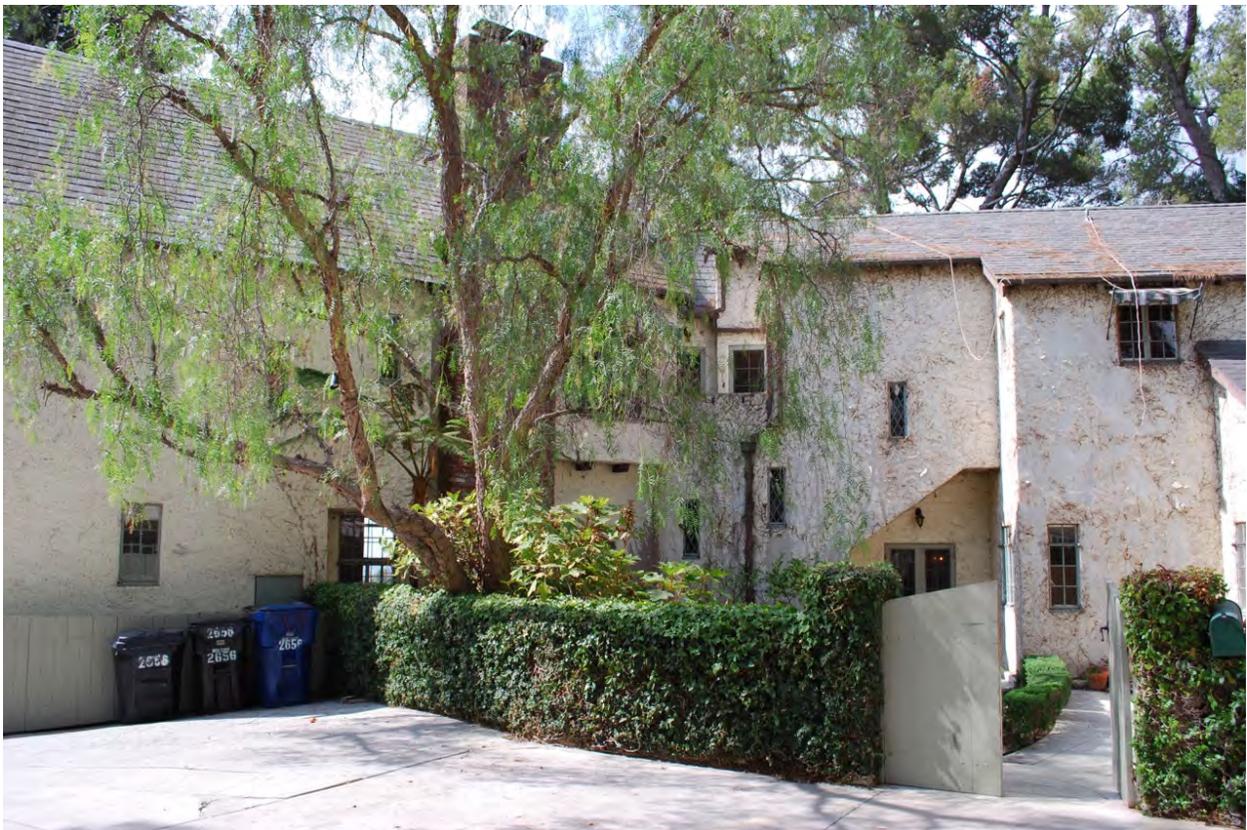
Figure 20 Rear elevation soon after ivy was removed, 2017. Photo credit: V. Withers

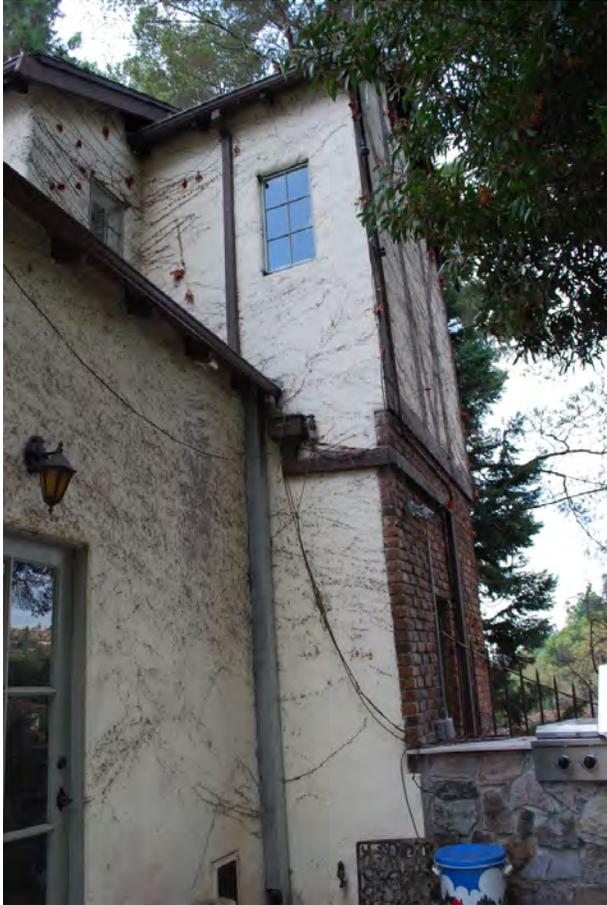
*West Elevation:* The west side of the residence sits close to the property boundary and does not have as much detail or articulation as the other elevations. This elevation appears to be in fair condition, facing the same issues with brick and stucco and wood elements that follow on other elevations.

Figure 23 The west elevation has a gable end with decorative half-timbering and also an attached BBQ area. The electrical panel is also located on this elevation. 2017. Photo credit: V. Withers

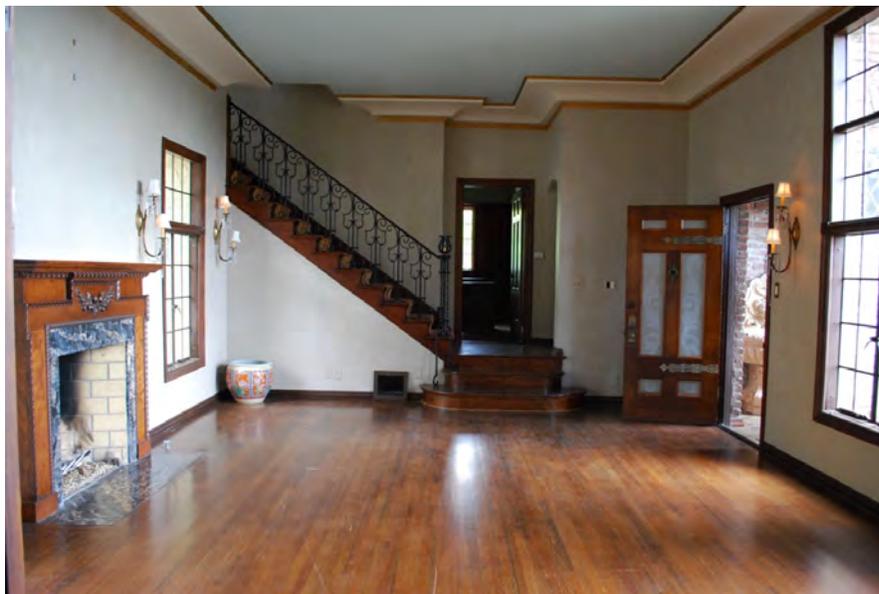
The Living Room is in the east wing of the house and retains original character-defining materials, such as oak hardwood floors, steel casement windows, and wood moldings. The room is in fair condition.

**Figure 27** Living Room (view East), 2017. Photo credit: V.Withers

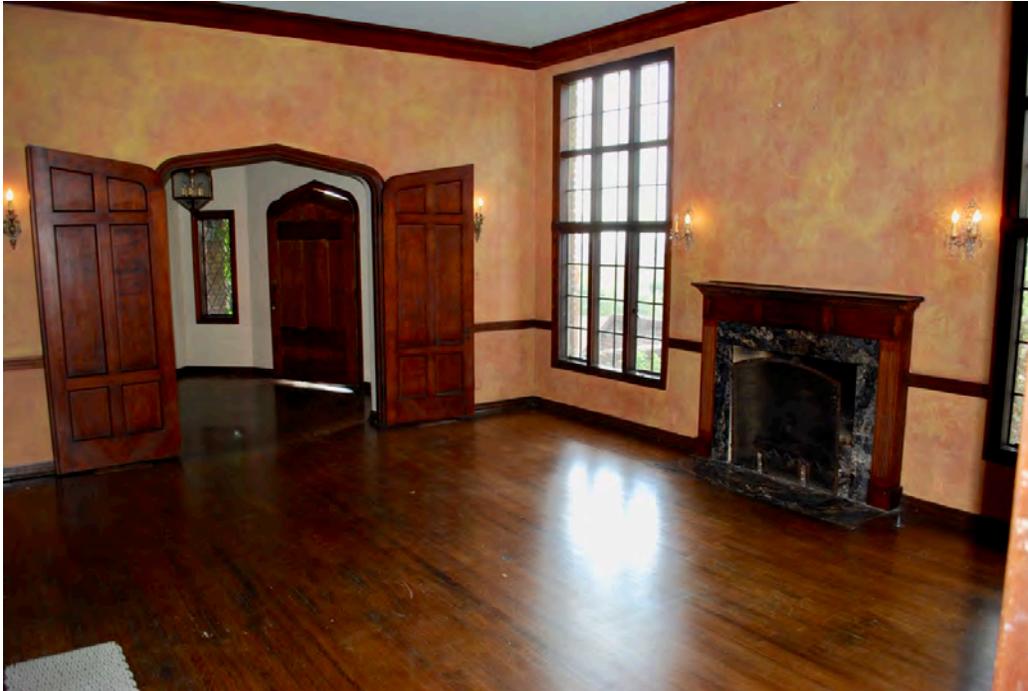
The Family / Formal Dining Room retains original character-defining features similar to those of the Living Room and is in fair condition.

Figure 28 Family Room (possibly originally Formal Dining Room), view towards Entry

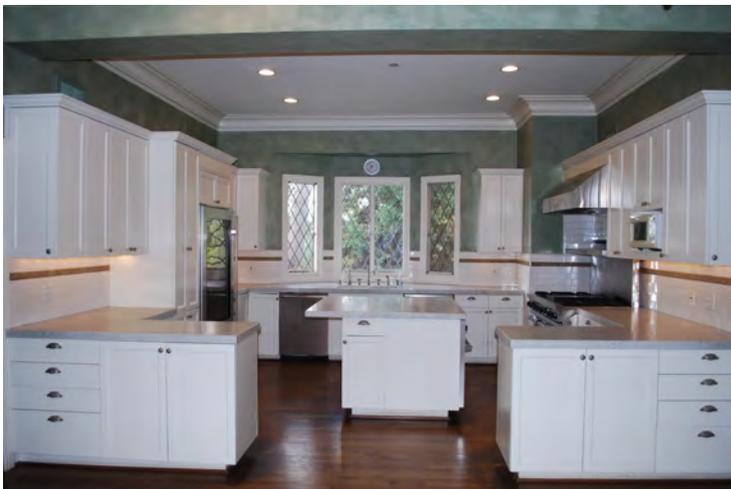
The Kitchen and attached Dining Room was expanded and remodeled in 1996. There is very little historic material in these areas. They are in functional condition.

Figure 29 Kitchen (view SW), 2017. Photo credit: V.Withers

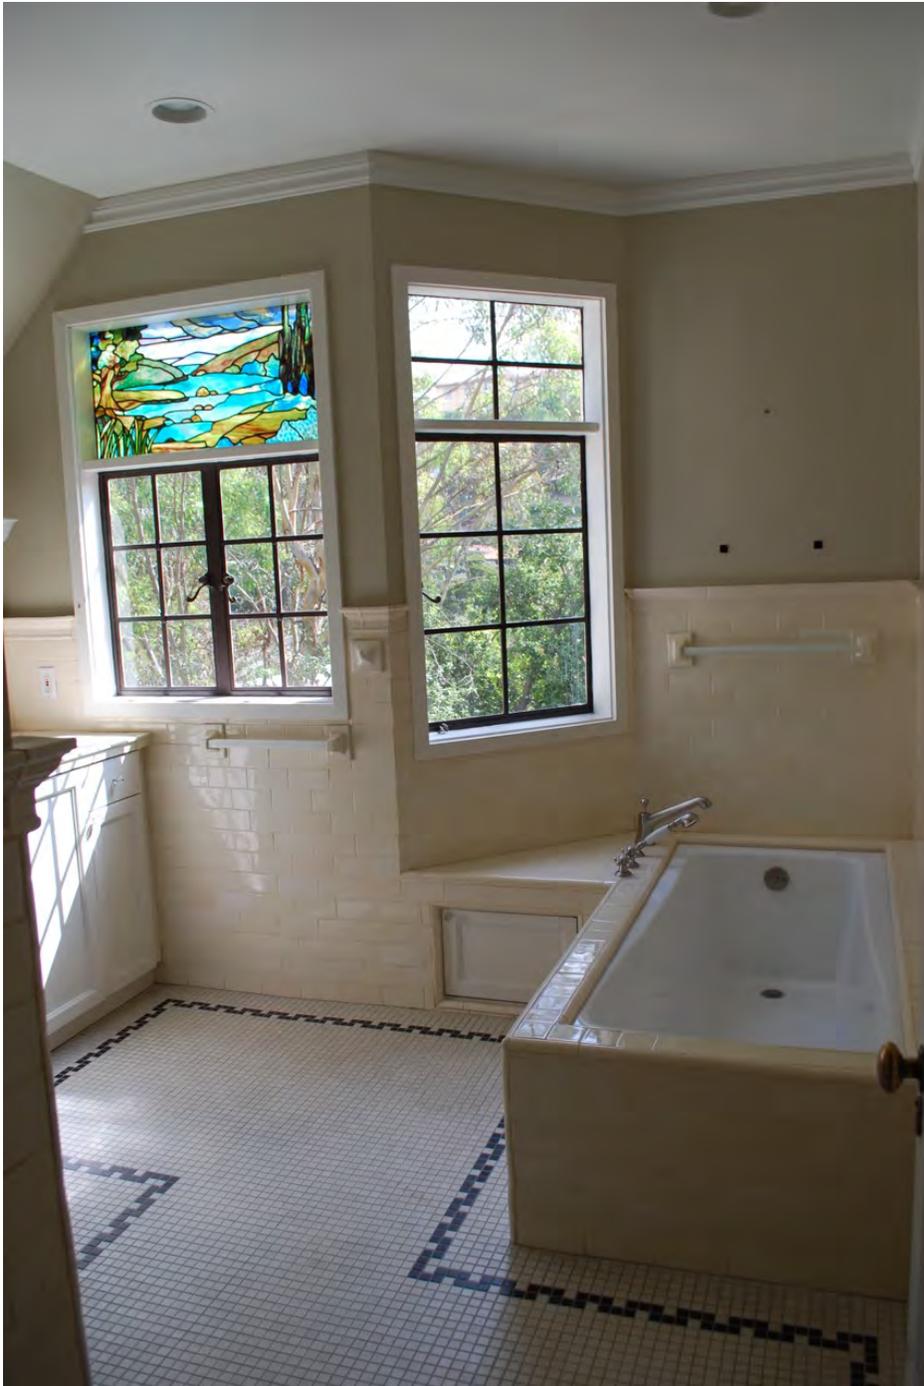
Figure 32 Upstairs Bath previously remodeled, 2017. Photo credit: V. Withers

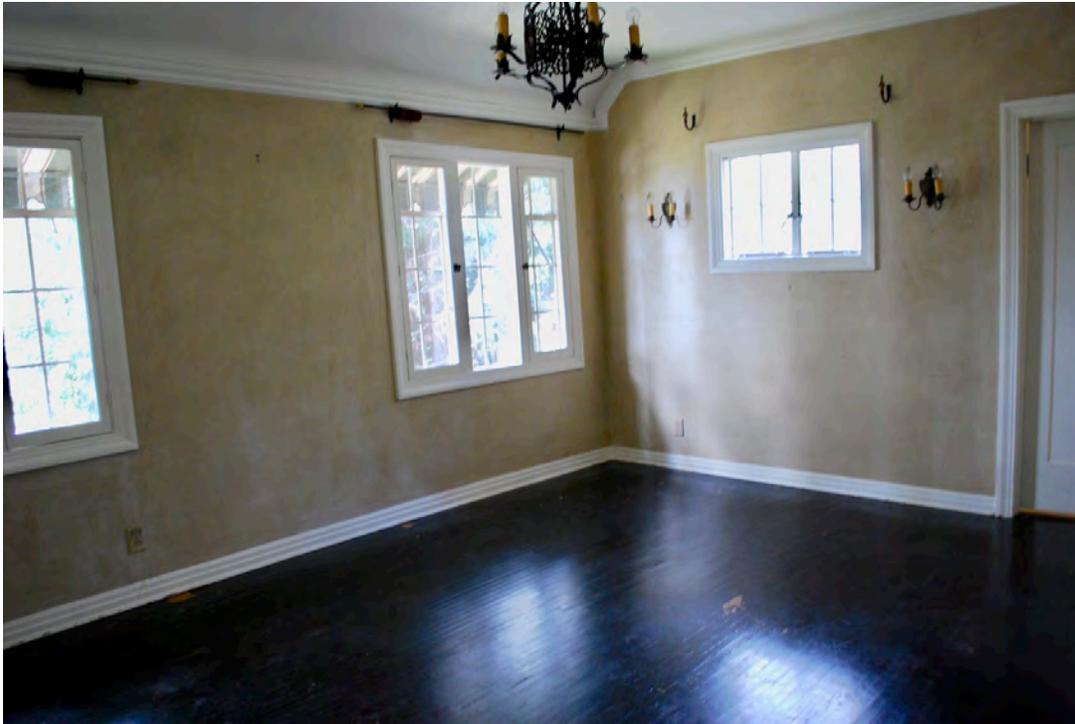
**Figure 33** Representative second floor bedroom in fair condition, 2017. Photo credit: V.Withers

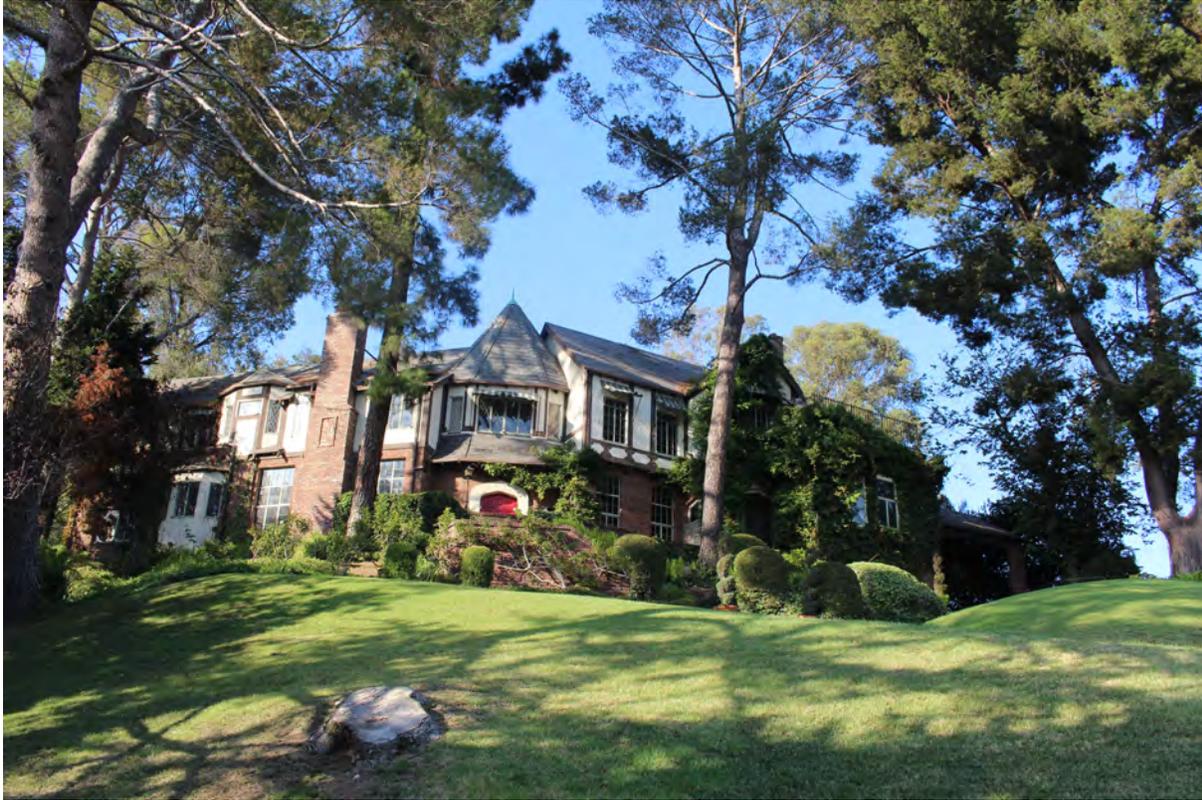
**Figure 36. Aberdeen before Ivy was removed, 2017. Photo credit: Stuart Gulland**

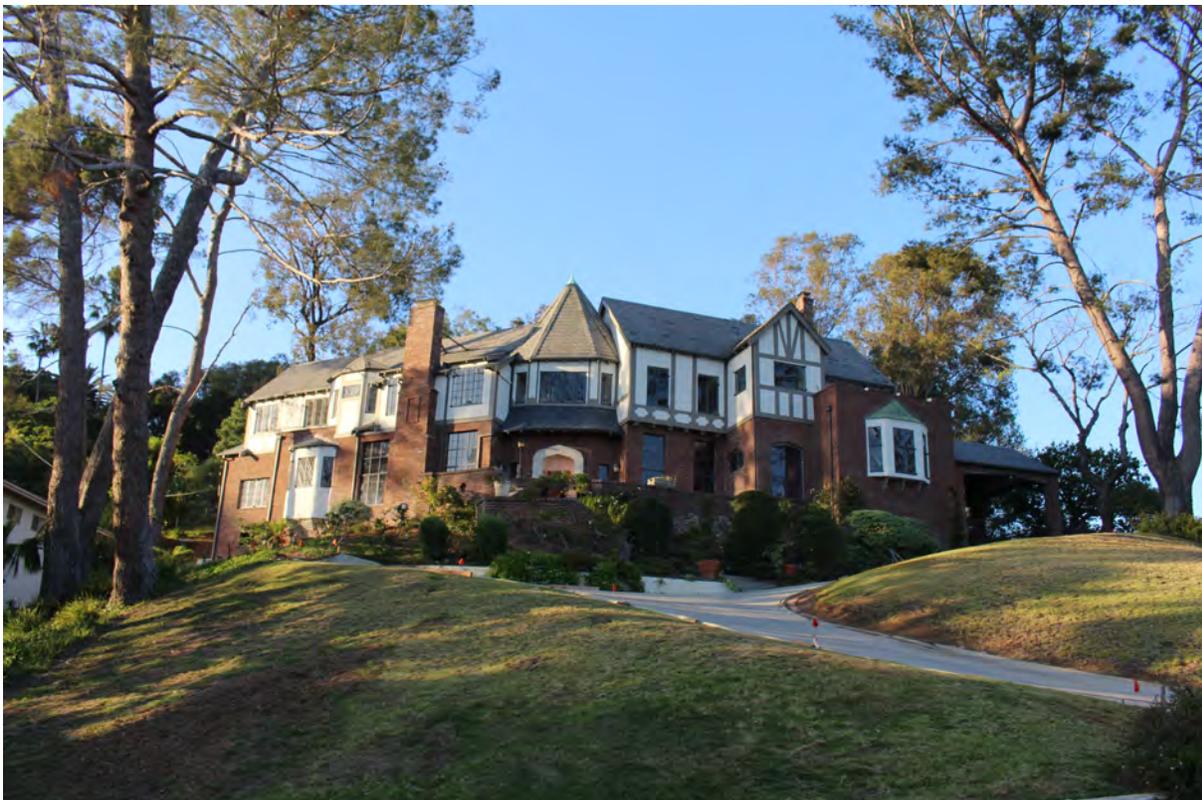
**Figure 37. Aberdeen House 2019 (after rehabilitation of the exterior elevations)**

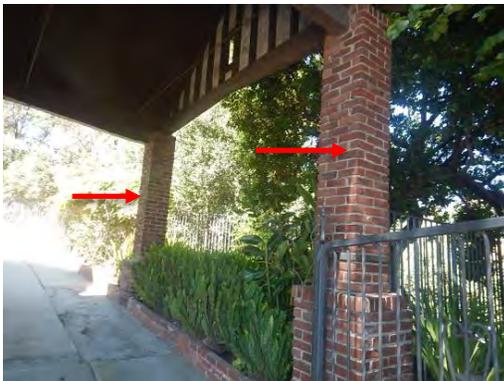
The slender brick columns that support the east side of the portico appeared as if they may be constructed with unreinforced brick or a brick veneer attached to wood posts. X-ray testing or invasive testing could be performed to verify this. **If it is determined the columns do not contain reinforcing steel or structural steel columns, it is our opinion that the columns have an elevated risk of potential seismic damage, and we recommend replacing the brick columns with structural steel columns or reinforced concrete that could then be clad in brick. See photo below.**

This photo shows the slender brick columns supporting the east side of the portico.

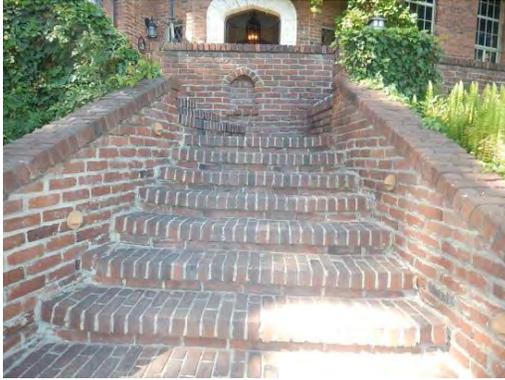
The front entry steps and entry porch are constructed with what appeared to be unreinforced brick retaining walls and brick paving materials. The brick retaining walls have experienced lateral rotation and we observed numerous cracks in the walls and separations between the walls and the paved surfaces. For example, the brick retaining wall at the south side of the entry porch was measured to be leaning/rotated approximately 2 inches. The entry porch surface has settled more than 6 inches, creating tripping hazards and a lack of slope for drainage. The severe settlement the entry porch paving has experienced appeared related to the lateral movement in the surrounding retaining walls and a lack of compaction of the underlying soil. Ponding water on the entry porch surfaces will cause saturated soil conditions, which will exacerbate the settlement and lateral movement of the retaining walls. **At a minimum, we recommend removing the settled portions of the entry porch and steps, recompacting the soil, and resetting the bricks with proper slope for drainage. However, additional movement of the brick retaining walls that surround the entry porch and steps will likely cause ongoing cracking and settlement. Ideally, this entire porch/stair structure should be reconstructed with properly engineered retaining walls. See photos below.**

View of the brick entry steps and entry porch.

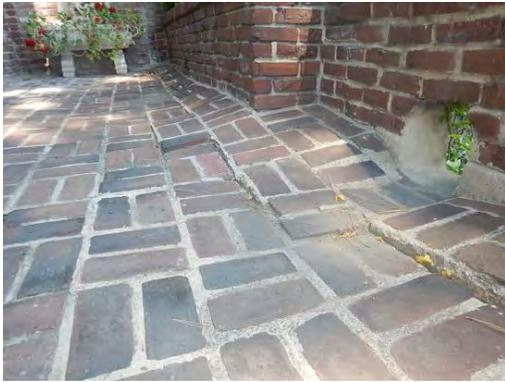
Portions of the brick paving at the front entry porch have settled more than 6 inches.

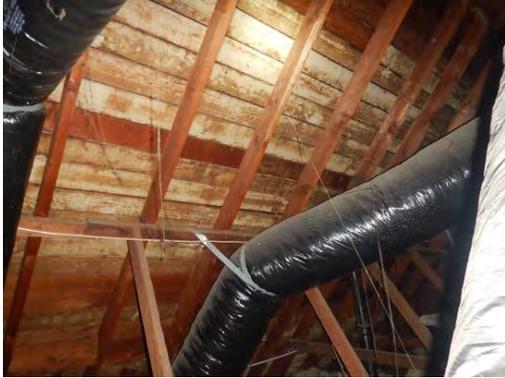
1 x 6 ridge boards, 2 x 8 valley members, 2 x 4 purlin braces, and 1 x 6 roof sheathing. We were unable to visually evaluate portions of the roof/attic framing due to tight clearances. The visible portions of the roof framing appeared to be performing adequately. See photo below.

This photo shows an example of some of the typical roof/attic framing.

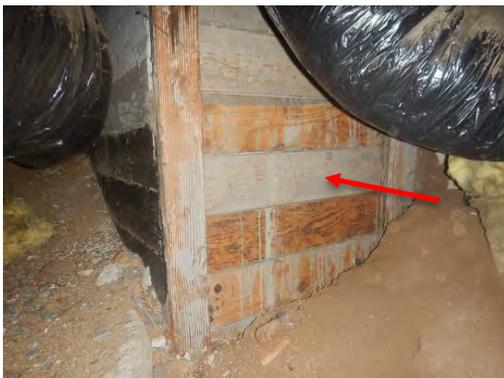
7. The temporary form lumber has yet to be removed at one of the foundations below the western portion of the home. This is located near the stairwell down to the laundry basement. The form lumber contacting the concrete and the soil in a crawlspace environment can promote pest damage and decay. **The form lumber should be removed. See photo below.**

This temporary form lumber has yet to be removed near the stairwell down to the laundry basement.

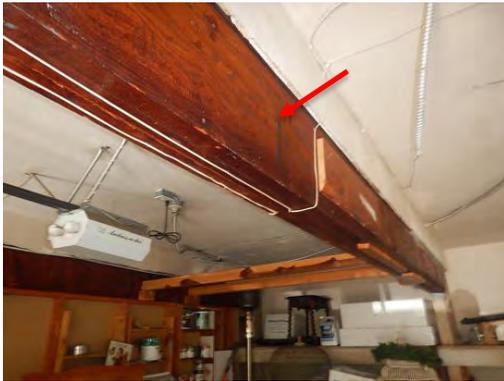
This is the triple 2 x 12 beam that was installed to address the removal of a support posts for the original beam above.

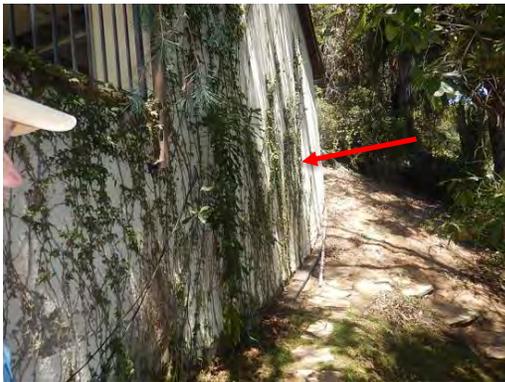
This is the retaining wall that supports the east side of the garage.

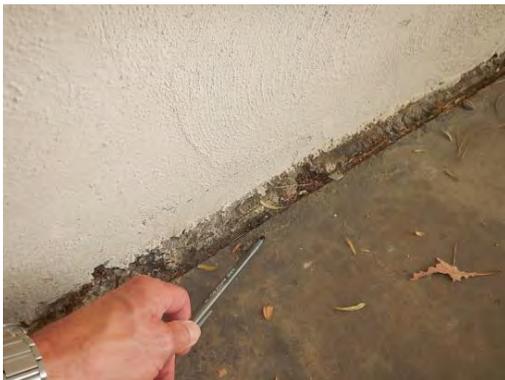
We observed several small cracks in the garage floor slab. The largest cracks we observed are approximately 1/8 inch in width and did not appear structurally significant. Our laser measuring device indicated the garage floor slopes downward approximately 1 inch toward the east. There are gaps/separations up to approximately 1 1/2 inches wide between the easterly edge of the garage floor slab and the east foundation of the garage. The east wall of the garage is supported on an approximate 7 to 8 foot tall concrete retaining wall. Our laser measuring device indicated this retaining wall is leaning/rotated approximately 1 inch toward the east along the portion of the wall that is supporting the garage. The movement of the retaining wall appeared to be the cause of the separations between the slab and the top of the wall and is likely the cause of the downward sloping of the garage floor slab and the floor of the guest unit above. It is our opinion that the approximately 1 inch of rotation associated with this 7 to 8 feet tall wall has not significantly compromised structural integrity of the retaining wall or the garage structure. However, additional movement/rotation of the retaining wall may occur in the future, particularly if the wall is subjected to strong earthquake ground shaking or saturated soil conditions in the retained earth behind the wall. **We recommend periodically monitoring this condition. See photos below.**

Gaps between the east edge of the garage floor slab and the top of the retaining wall that supports the east side of the garage.

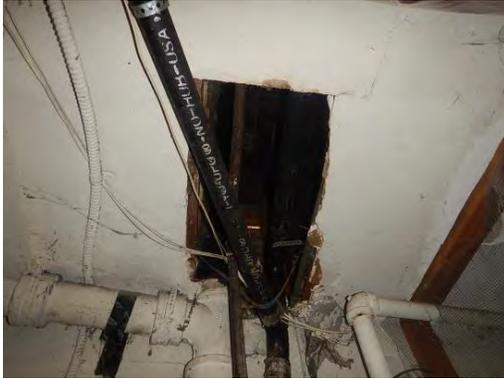
There are holes in the plaster ceiling in the garage that may be compromising the required fire separation between the garage and the habitable areas above. **This is a nonstructural**

Hole in the garage ceiling.

**issue that should be addressed by the general home inspector or other qualified professionals. See photos below.**

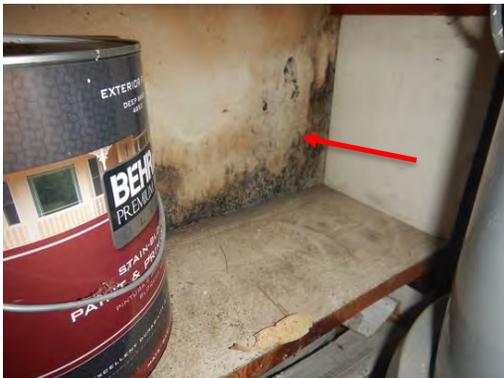
A wood framed partition wall has been installed between the westerly of the garage and the two the easterly garage bays. We could see water damage and what appeared to be bio growth (mold?) on the drywall associated with this wall. **The source of the moisture should be identified and eliminated and we recommend having the structures on the property evaluated by an environmental/mold consultant. See photo below.**

Water damage and bio growth on the partition wall between the west garage bay and the easterly garage bays.

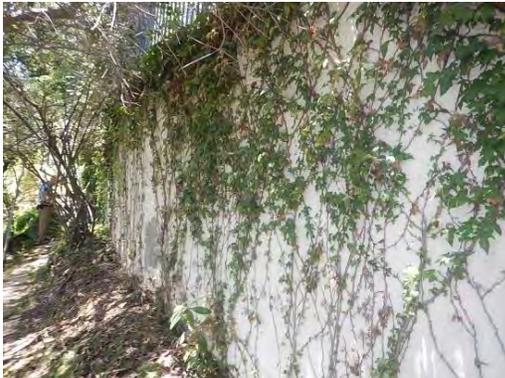
A stucco finished retaining wall that is up to 7 or 8 feet tall extends along the east side of the driveway and portico area, and the northern portion of the wall serves as the foundation for the east side of the garage/guesthouse. This wall retains the higher grade associated with the driveway and garage relative to a descending slope at the east side of the wall. As we noted above, a portion of the retaining wall that is supporting the garage was measured to be leaning/rotated approximately 1 inch toward the east. We placed our laser measuring device on the wall at various locations. The maximum amount of rotation we measured along the length of the wall was on the order of approximately 2 inches. It is our opinion that this retaining wall is still in serviceable condition. However, additional movement/rotation of the retaining wall may occur in the future, particularly if the wall is subjected to strong earthquake ground shaking or saturated soil conditions in the retained earth behind the wall. Elevated moisture levels in the retained earth could be caused by various factors, including adverse drainage and overwatering, a leaking plumbing line, etc. **We recommend periodically monitoring the condition of the wall. See photo below.**

This is the retaining wall at the east side of the driveway area.

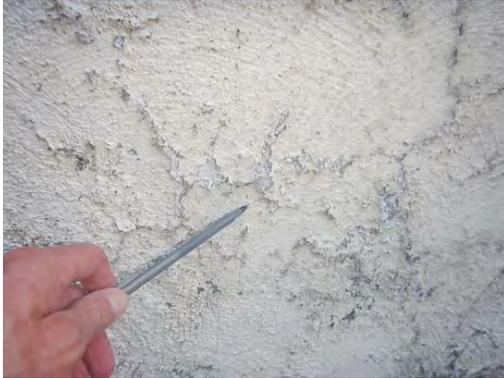
We observed efflorescence and moisture seepage on portions of the retaining wall that extends around the east and southeast portions of the property.
