**PRELIMINARY GEOTECHNICAL
ENGINEERING INVESTIGATION**

**Proposed 13-Story Hotel Expansion
Over Partial One Level Subgrade Parking
&
22-Story Residential Building
Over 3-4 Levels Subgrade Parking**

**1246 S. Hope Street
&
427 W. Pico Boulevard
Los Angeles, California**

Project 5076

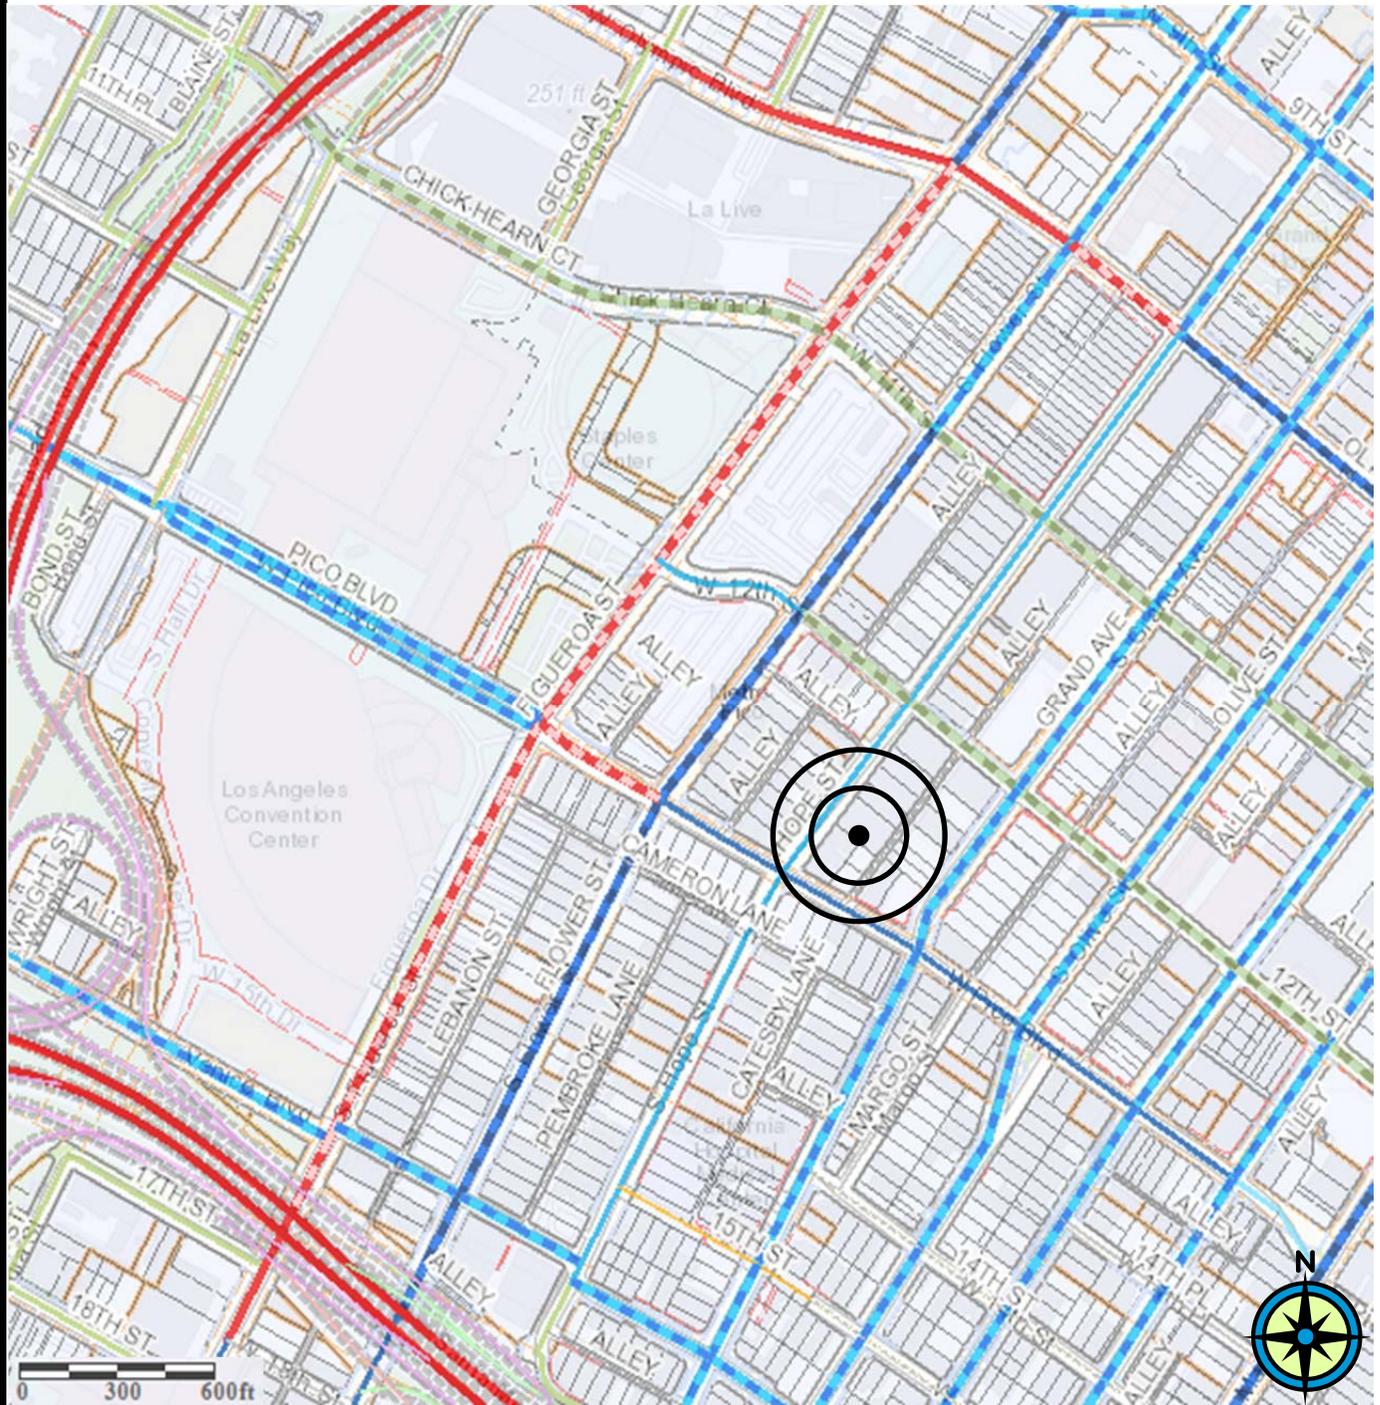
LOCATION MAP

Reference:

City of Los Angeles, Bureau of Engineering, NavigateLA

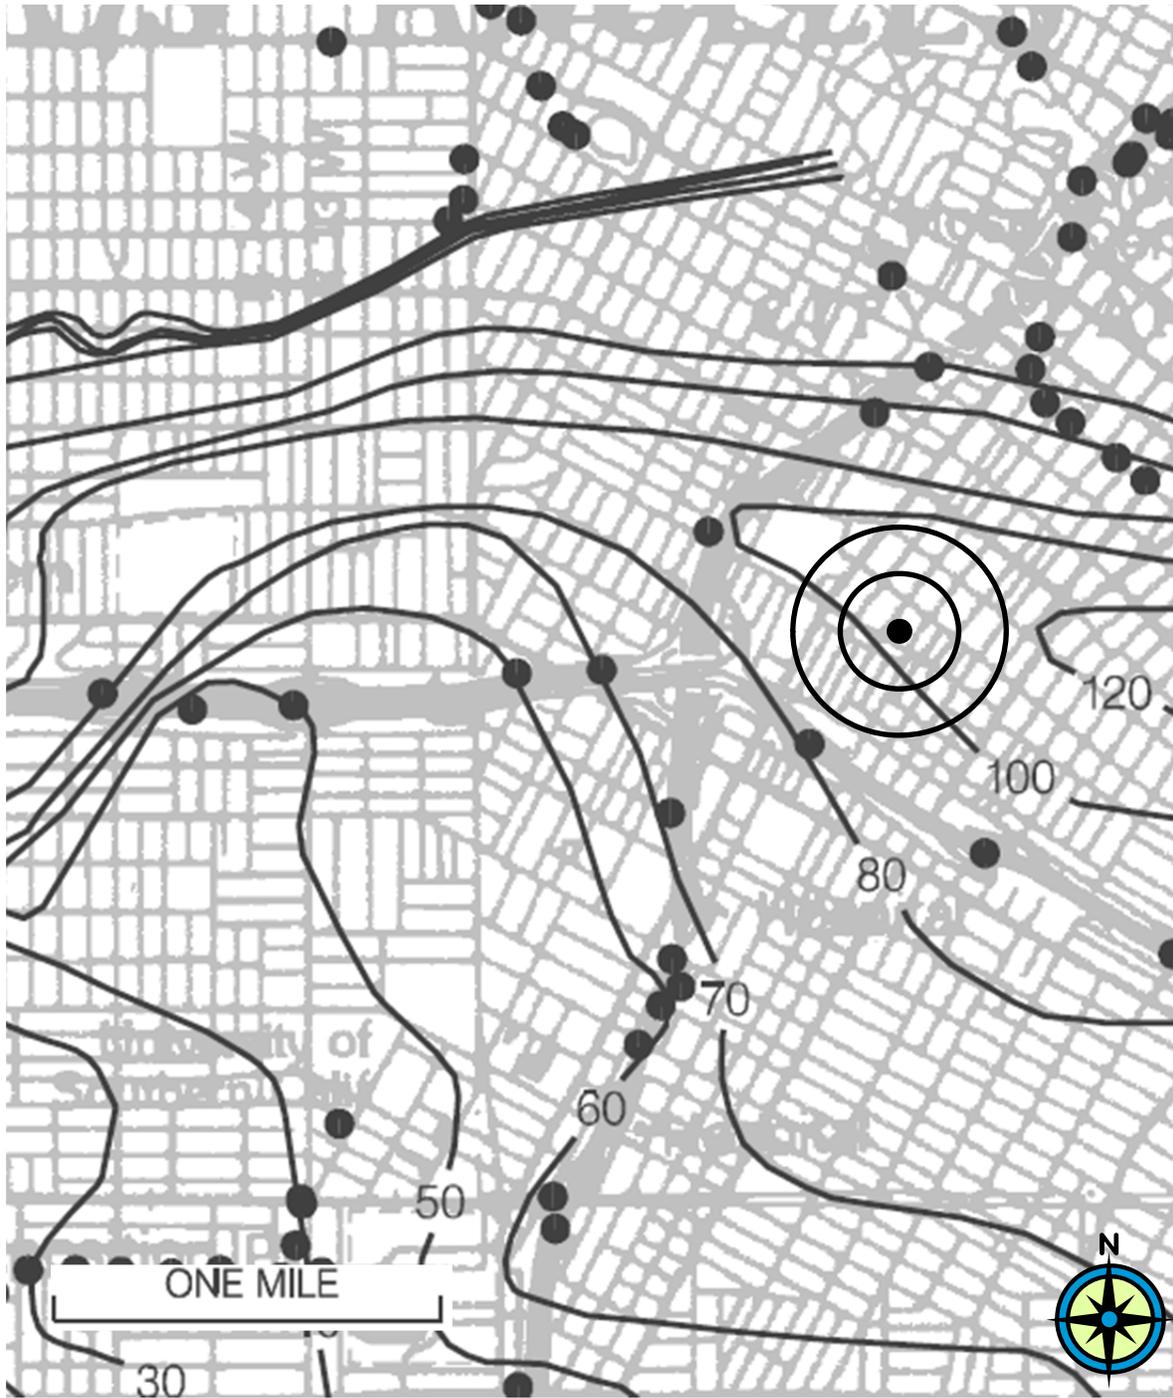
● Borehole Site

— 30 — Depth to ground water in feet

Reference:

State of California Seismic Hazard Report, Hollywood Quadrangle

No active surface groundwater seeps or springs were observed on the subject site. The subsurface exploration did encounter groundwater seepage at a depth of 157.5 & 187.5 feet. The depth to seeps/perched water groundwater, when encountered in the explorations, is only valid for the date of exploration. Based on the Seismic Hazard Zone Report by the California Geological Survey (formerly Division of Mines and Geology), the depth to historical high groundwater level is greater than 100 feet below the surface. Seasonal fluctuations of groundwater levels may occur by varying amounts of rainfall, irrigation and recharge.

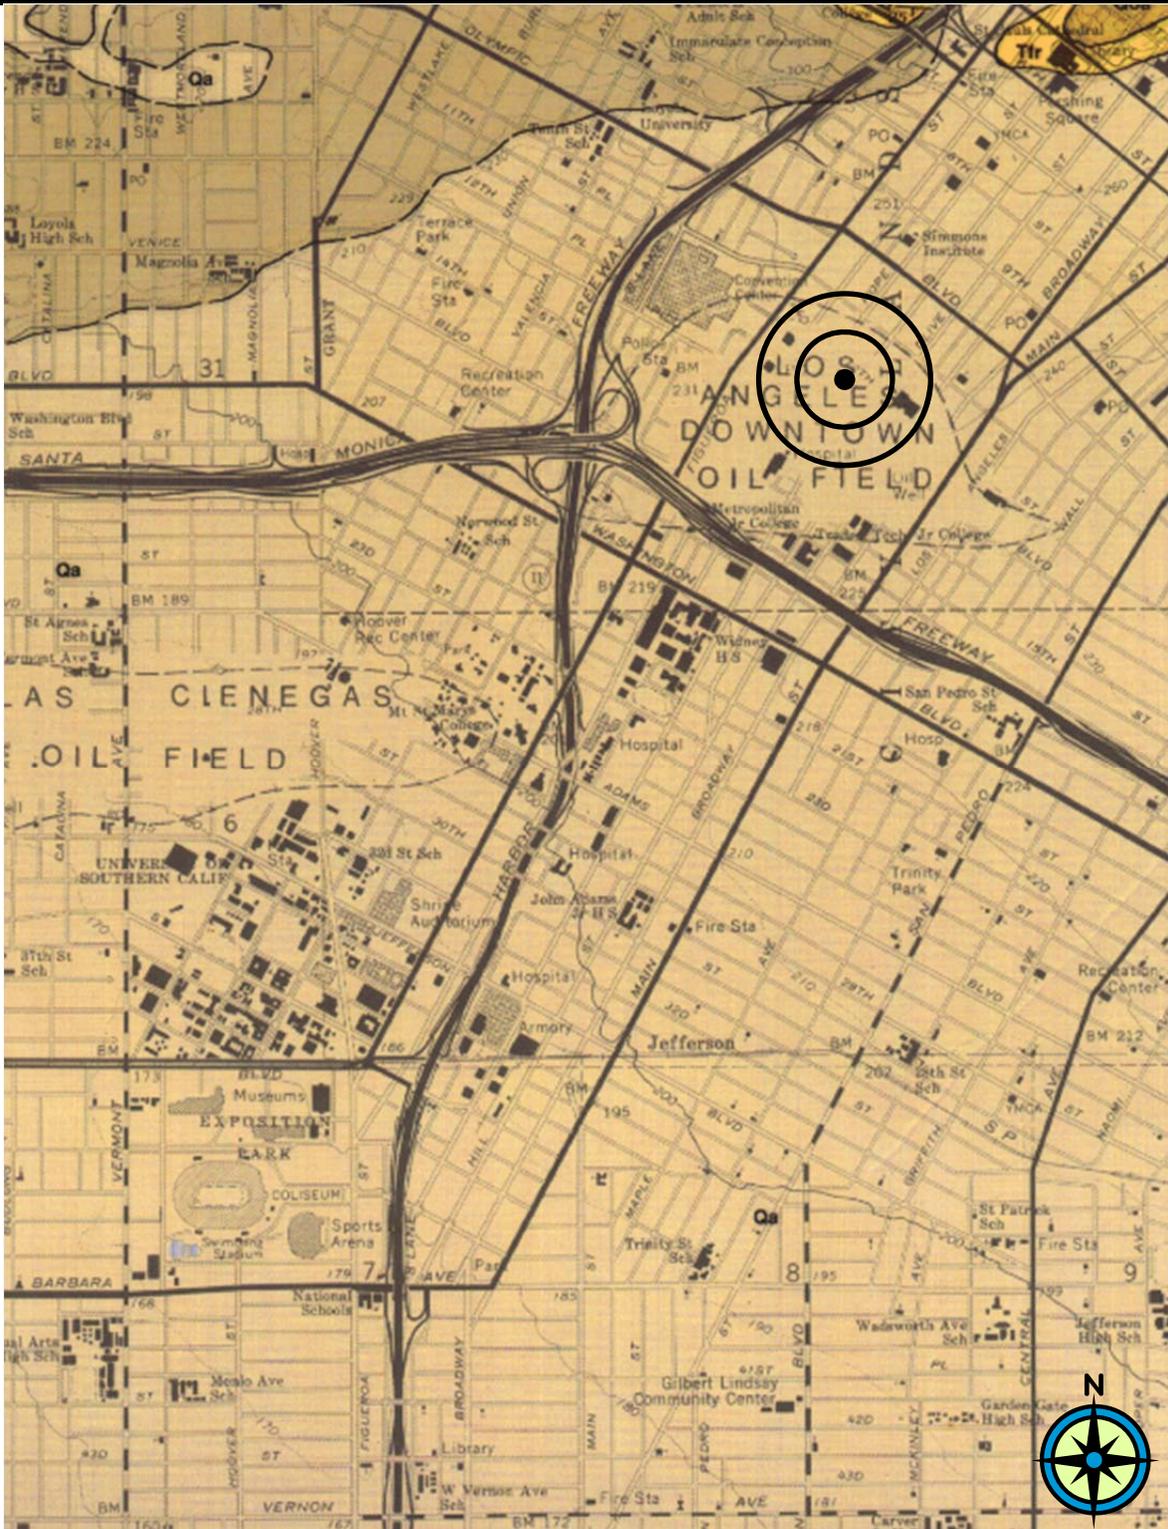
REGIONAL GEOLOGIC MAP

Reference: Dibble Geologic Map, Hollywood Quadrangle

Scale: 1" = 5280'

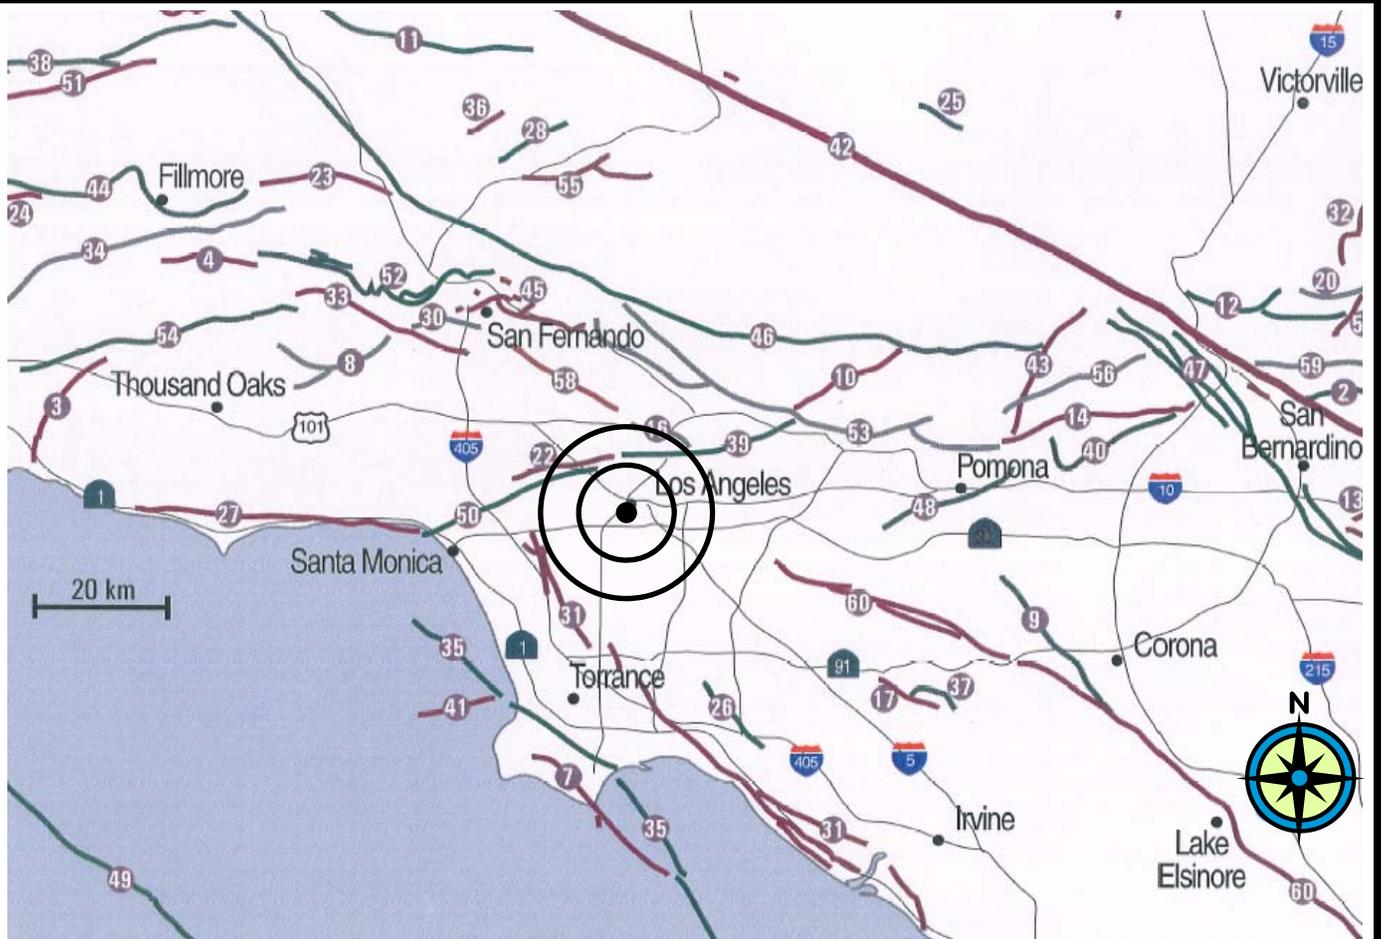
USGS FAULT MAP

Lisa Wald, U.S. Geologic Survey (modified from SCEC).

The Alquist-Priolo Earthquake Fault Zoning (AP) Act was passed into law following the destructive February 9, 1971 San Fernando earthquake. The intent of the Act is to increase public safety by reducing the siting of most structures for human occupancy across an active fault. The Act only addresses the hazard of surface fault rupture and is not directed toward other earthquake hazards. The property is not located within an Alquist-Priolo Earthquake Fault Zone. The general locations of major faults within Southern California are depicted on a fault map provided by the USGS in Appendix I.

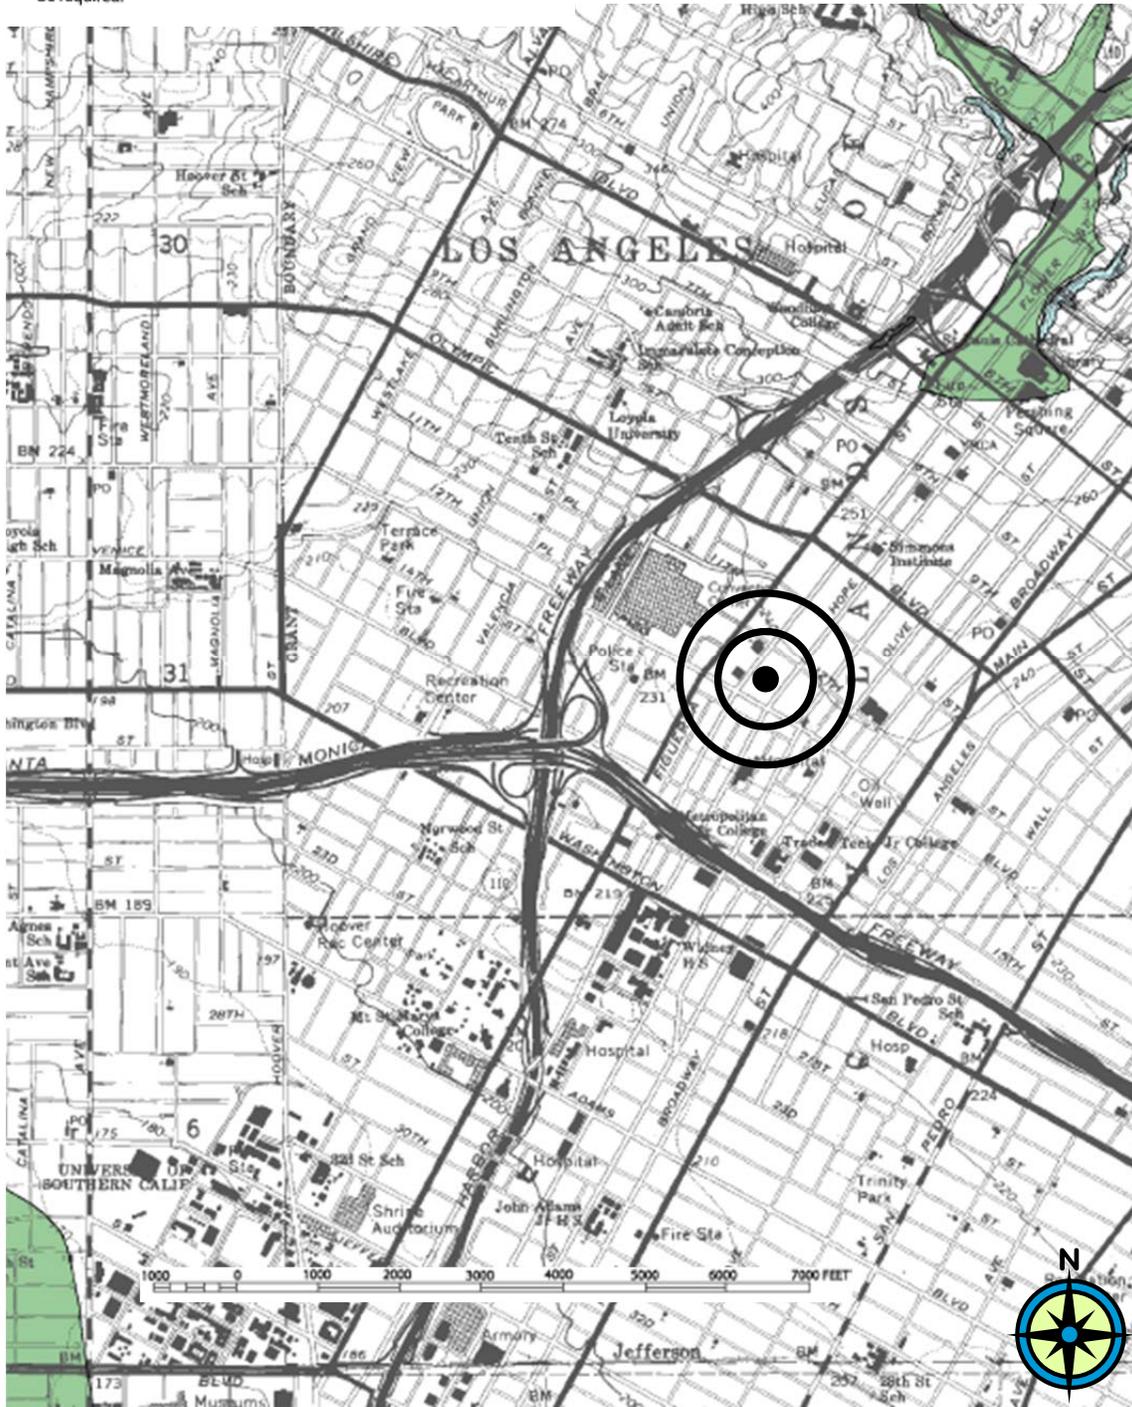
Liquefaction

Areas where historic occurrence of liquefaction, or local geological, geotechnical and groundwater conditions indicate a potential for permanent ground displacements such that mitigation as defined in Public Resources Code Section 2693(c) would be required.

Reference: State of California, Seismic Hazard Map of the Hollywood Quadrangle

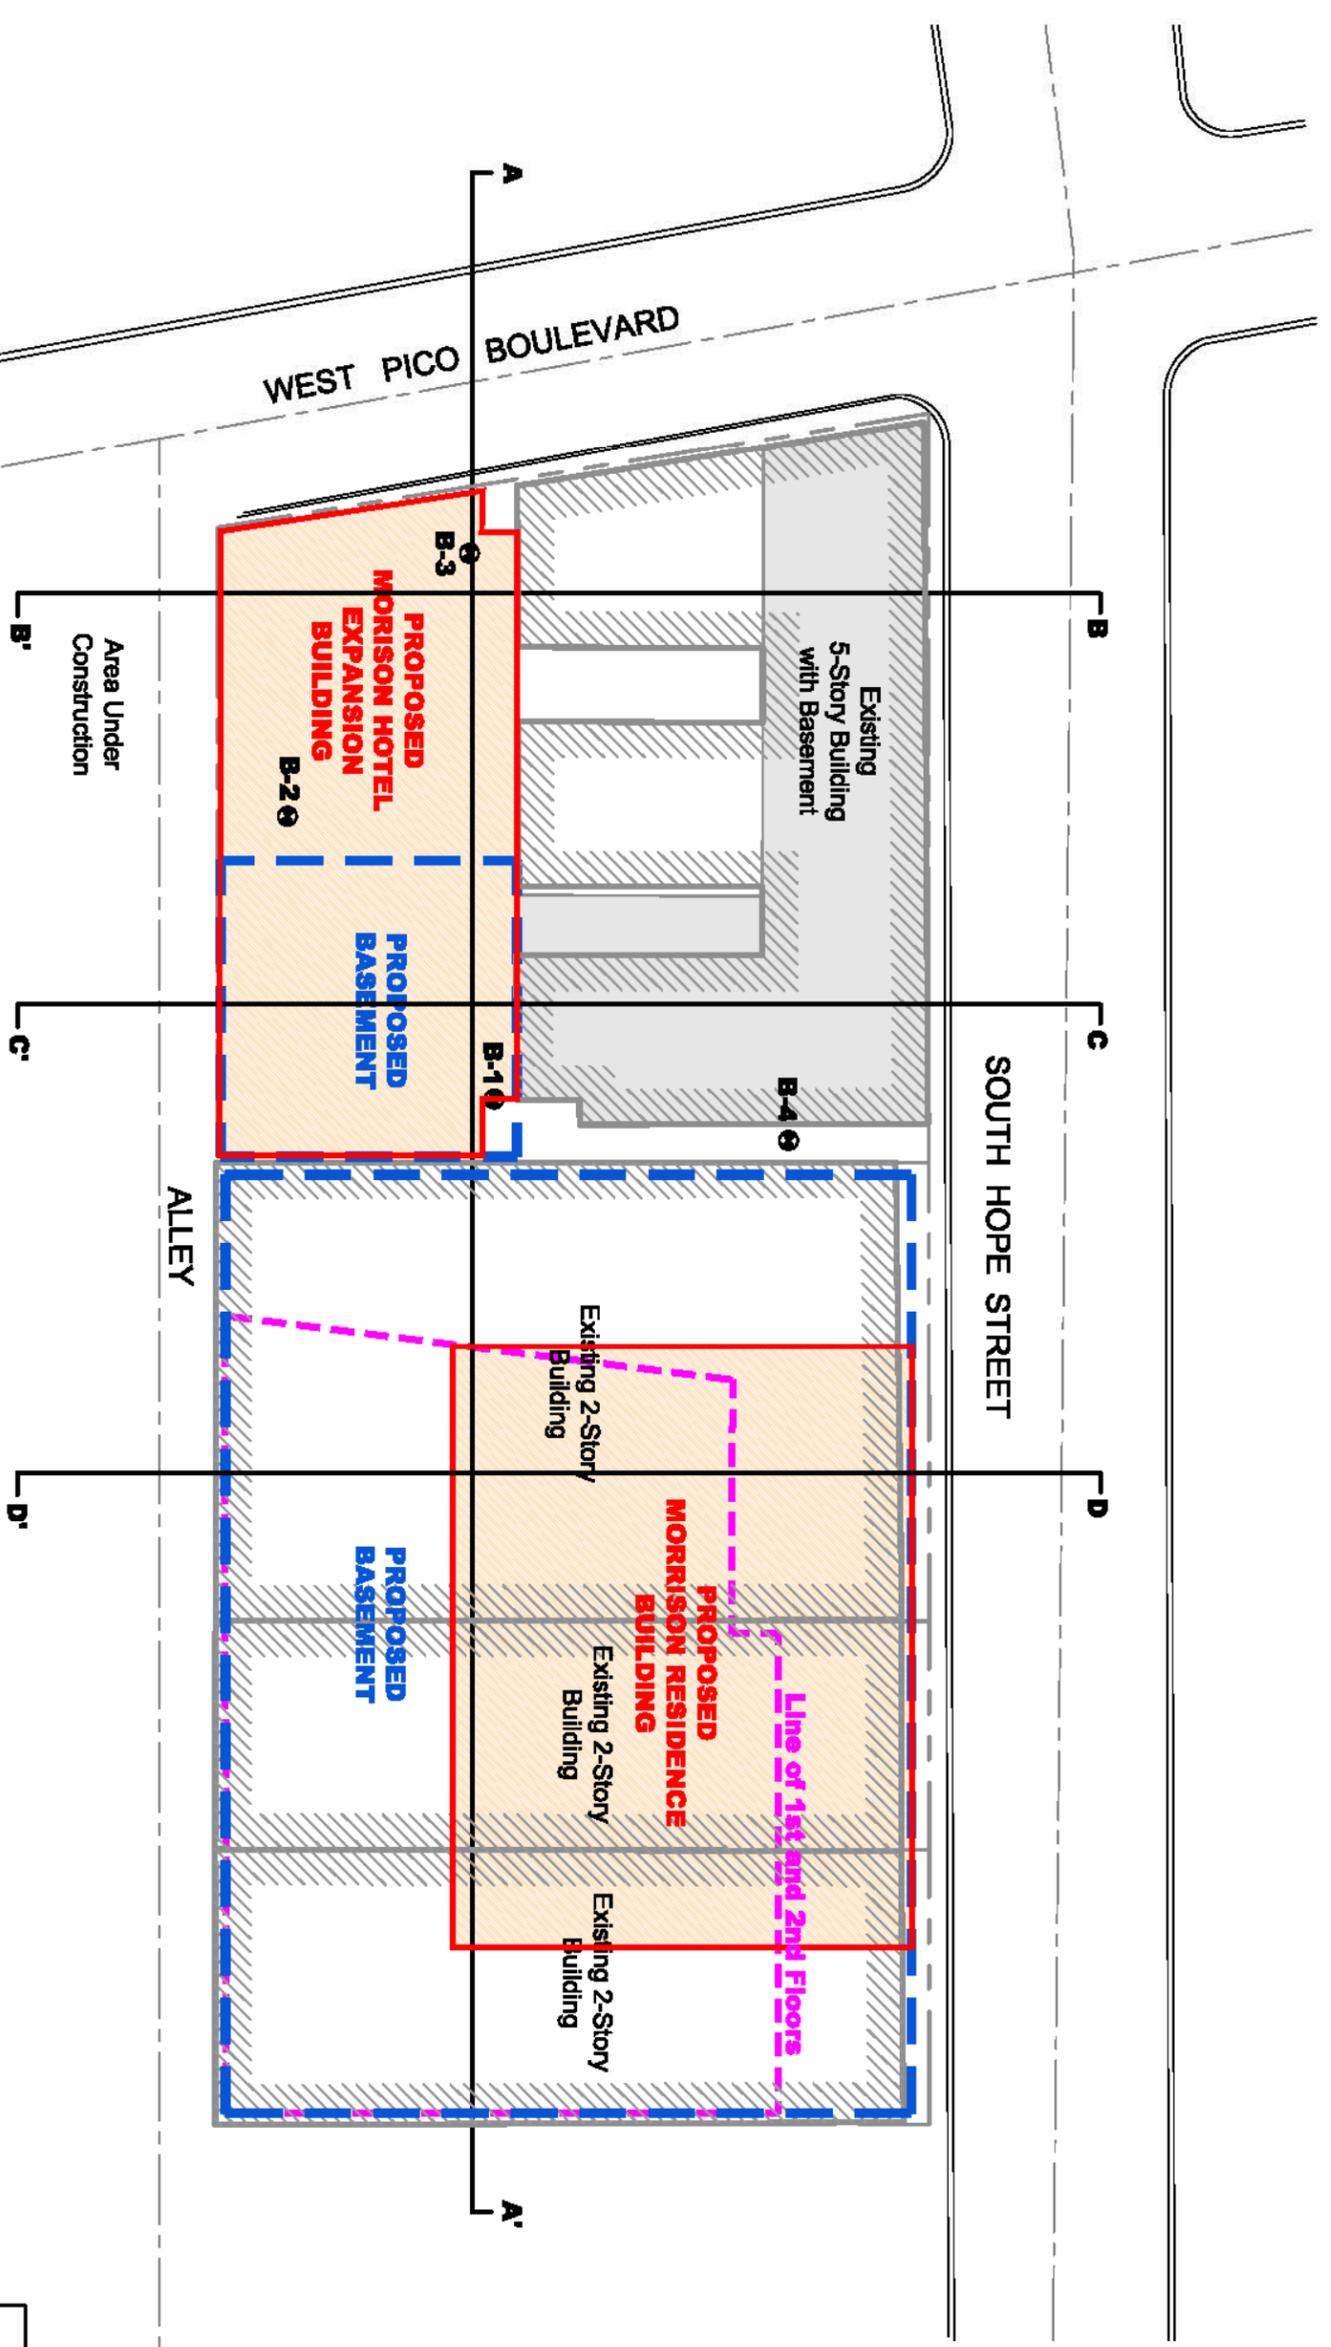
Explanation	
B-4	Location of Borings
D-D'	Line of Cross Section

The scope of this investigation is limited to the project area explored as depicted on the Plot Map. This report has not been prepared for use by other parties or for purposes other than the proposed project. GeoConcepts, Inc. should be consulted to determine if additional work is required when our work is used by others or if the scope of the project has changed. If the project is delayed for more than one year, this office should be contacted to verify the current site conditions and to prepare an update report.

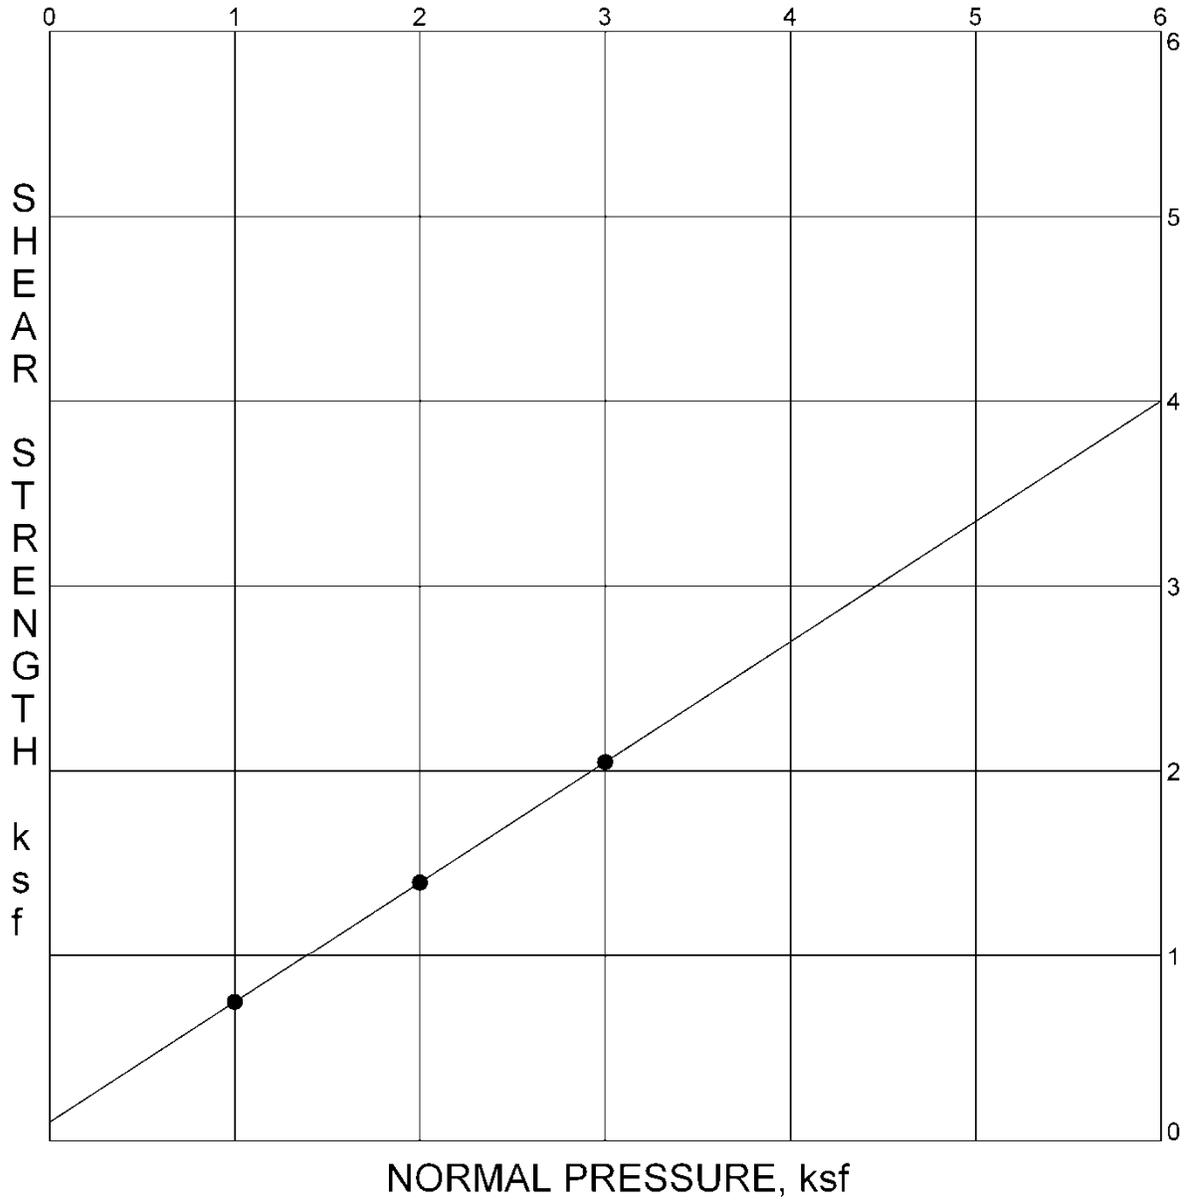
SAMPLE LOCATION: B-1 @ 10.0

DESCRIPTION: Qa

Test Results

Moisture Content (%)	Density (pcf)	Ultimate Strength
Insitu: 1.0	Dry Density: 119.9	Phi (deg): 33.0
Saturated: 15.0		Cohesion (ksf): 0.100

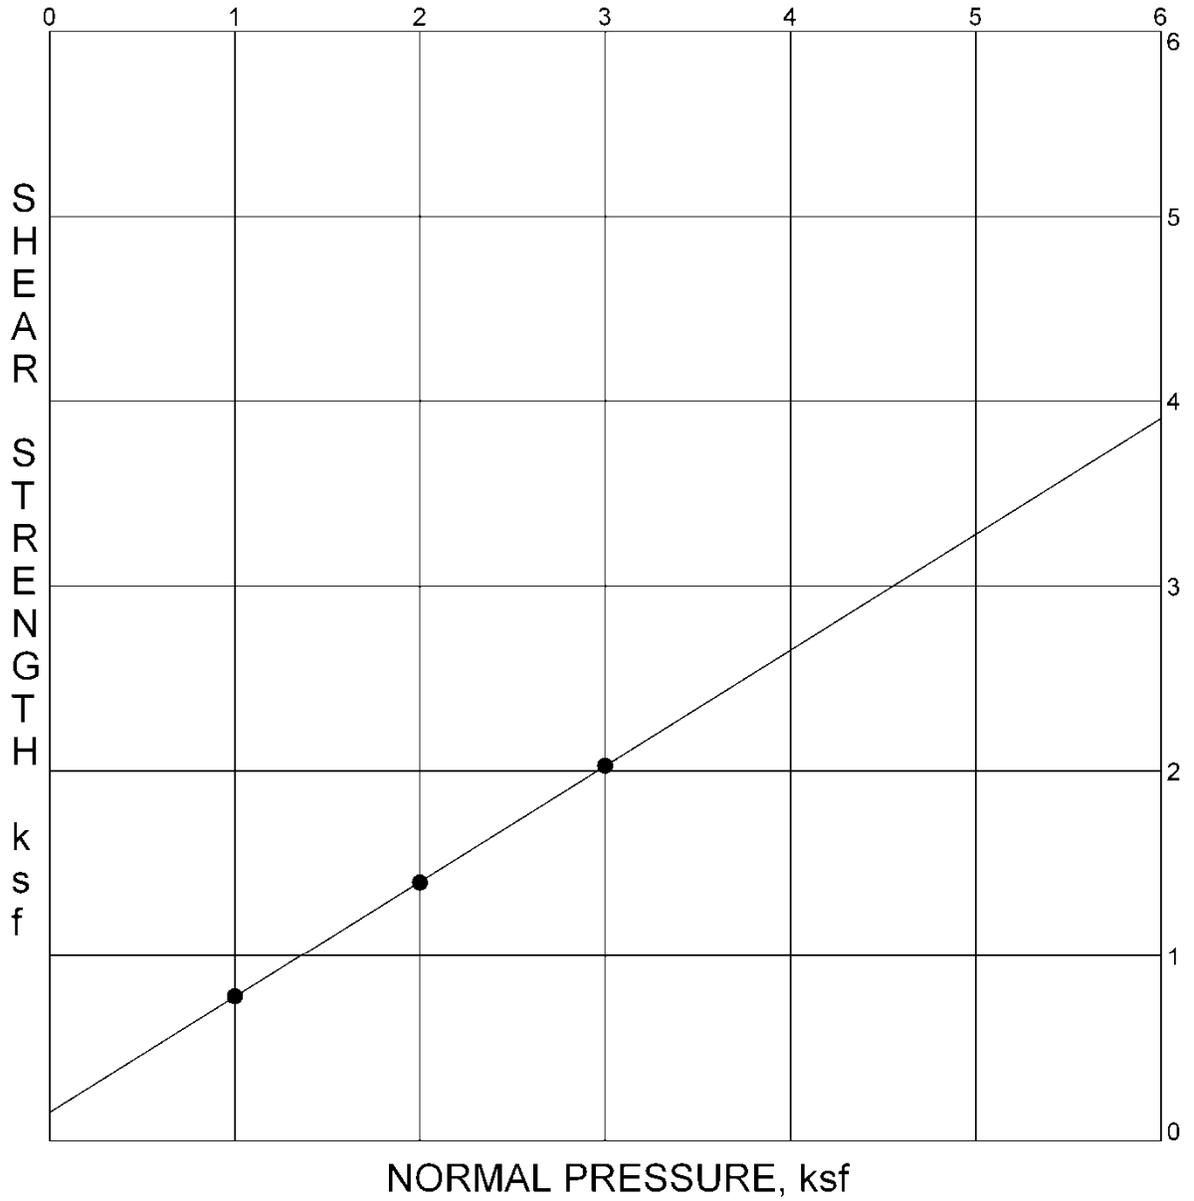
SAMPLE LOCATION: B-1 @ 20.0

DESCRIPTION: Qa

Test Results

Moisture Content (%)	Density (pcf)	Ultimate Strength
Insitu: 7.3	Dry Density: 112.1	Phi (deg): 32.0
Saturated: 18.6		Cohesion (ksf): 0.150

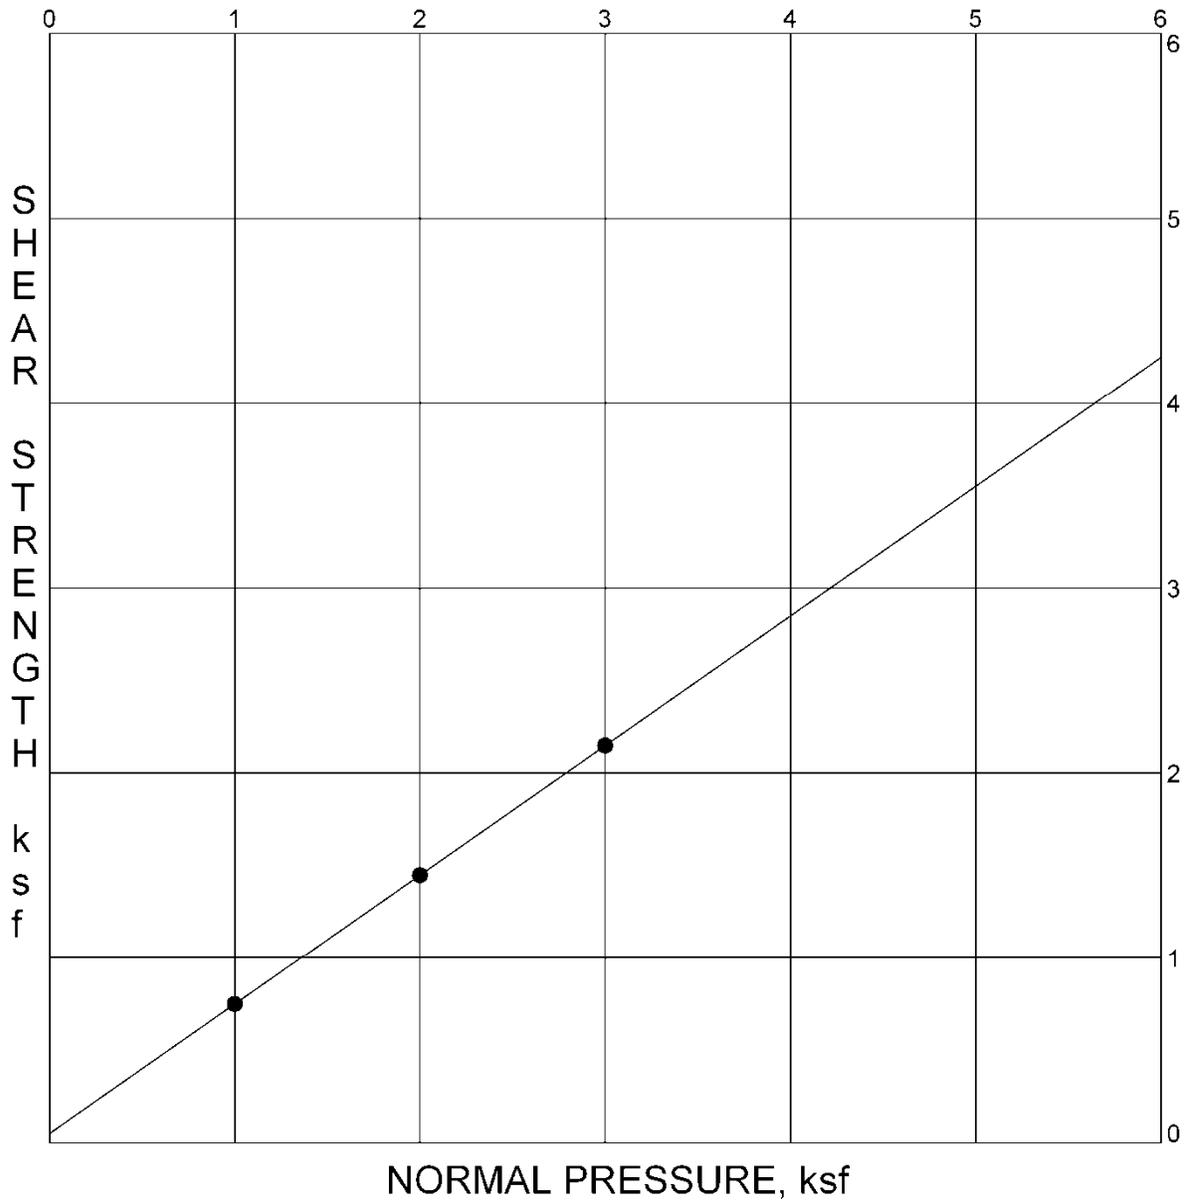
SAMPLE LOCATION: B-1 @ 40.0

DESCRIPTION: Qa

Test Results

Moisture Content (%)	Density (pcf)	Ultimate Strength
Insitu: 9.2	Dry Density: 110.9	Phi (deg): 35.0
Saturated: 19.2		Cohesion (ksf): 0.050

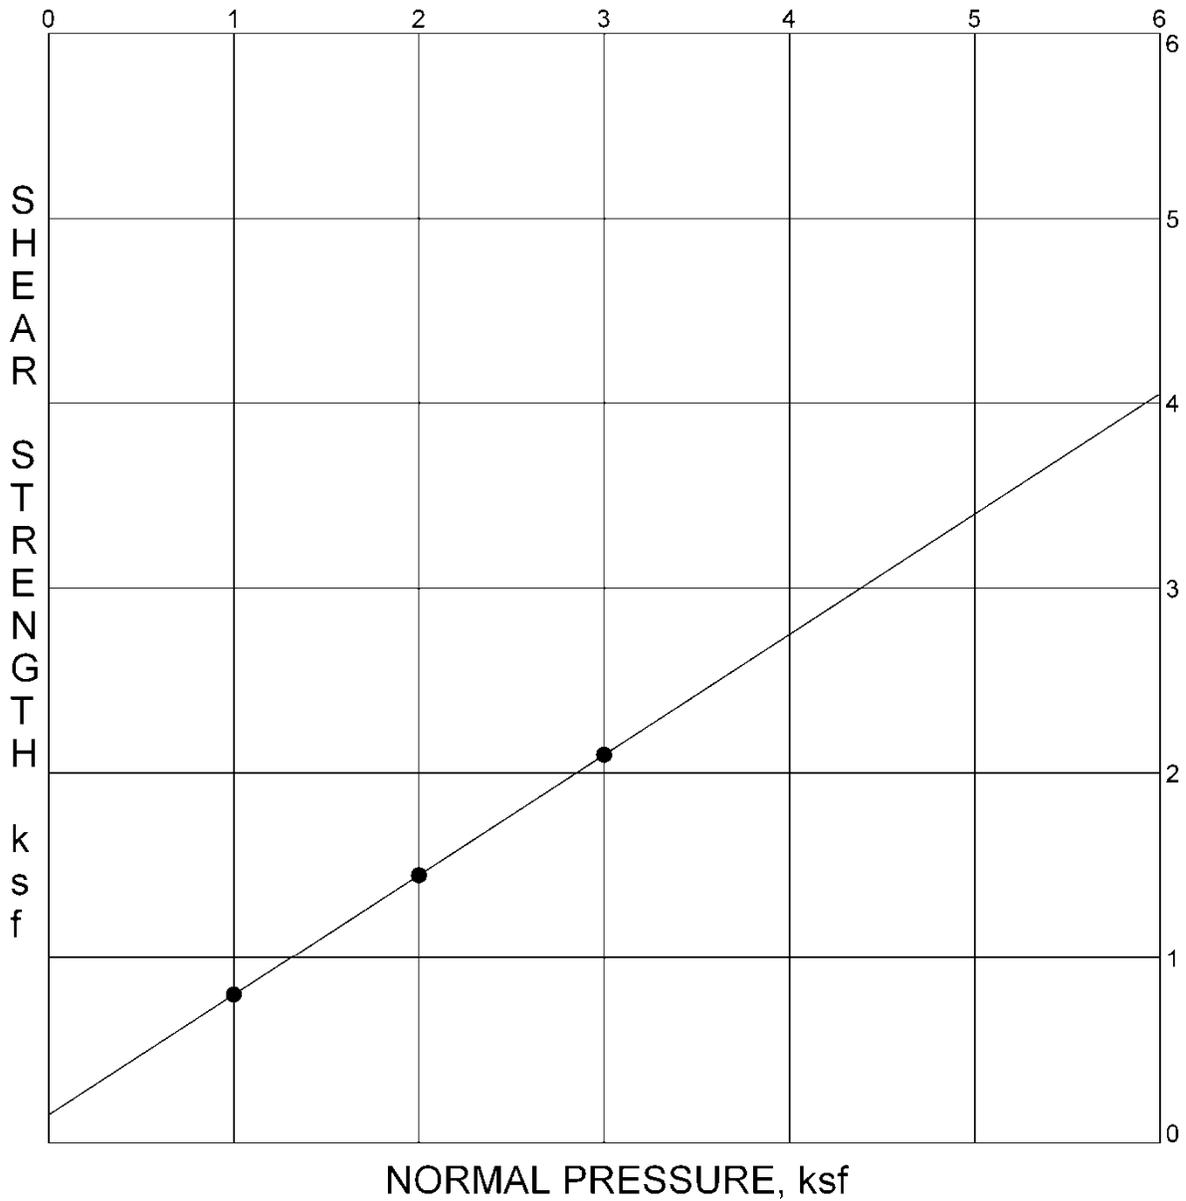
SAMPLE LOCATION: B-1 @ 50.0

DESCRIPTION: Qa

Test Results

Moisture Content (%)	Density (pcf)	Ultimate Strength
Insitu: 7.3	Dry Density: 103.5	Phi (deg): 33.0
Saturated: 23.2		Cohesion (ksf): 0.175

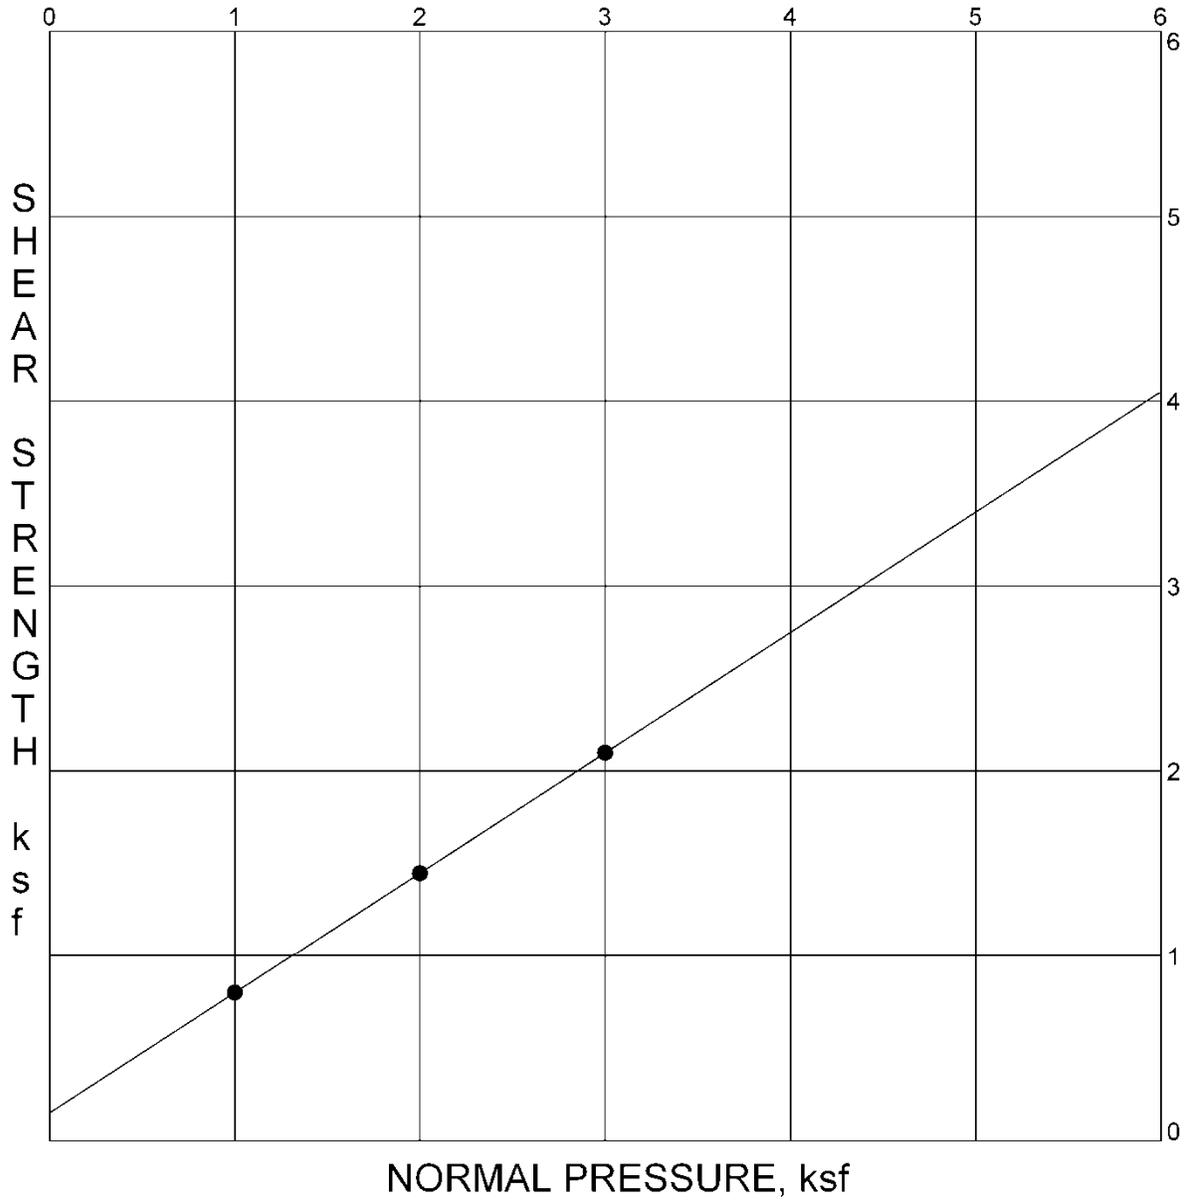
SAMPLE LOCATION: B-1 @ 65.0

DESCRIPTION: Qa

Test Results

Moisture Content (%)	Density (pcf)	Ultimate Strength
Insitu: 12.8	Dry Density: 111.8	Phi (deg): 33.0
Saturated: 18.7		Cohesion (ksf): 0.150

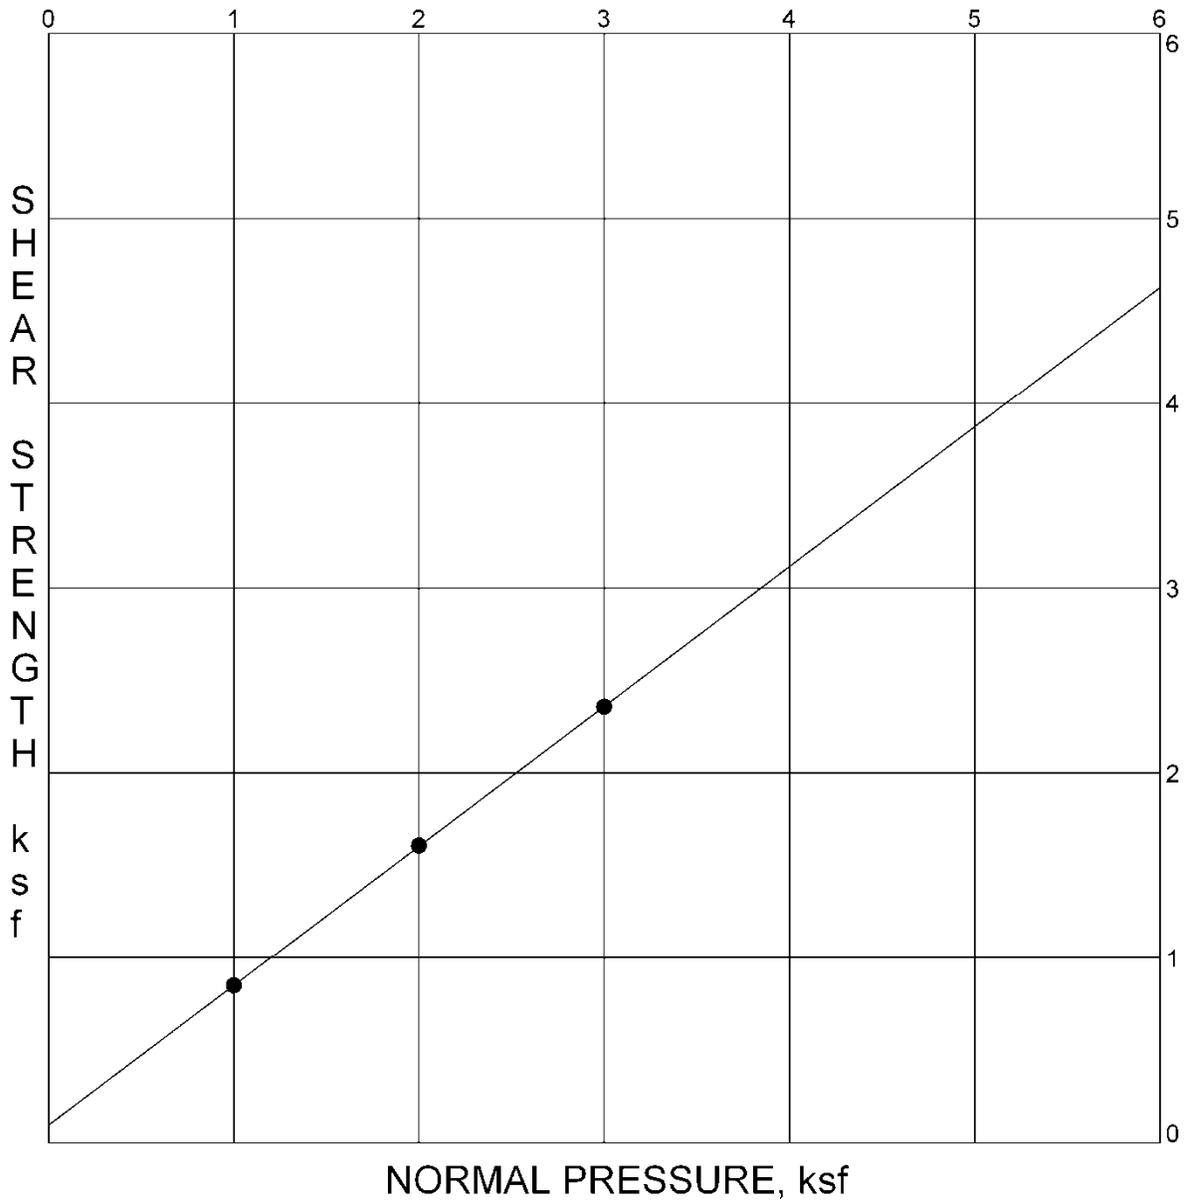
SAMPLE LOCATION: B-1 @ 80.0

DESCRIPTION: Qa

Test Results

Moisture Content (%)	Density (pcf)	Ultimate Strength
Insitu: 1.4	Dry Density: 117.5	Phi (deg): 37.0
Saturated: 16.0		Cohesion (ksf): 0.100

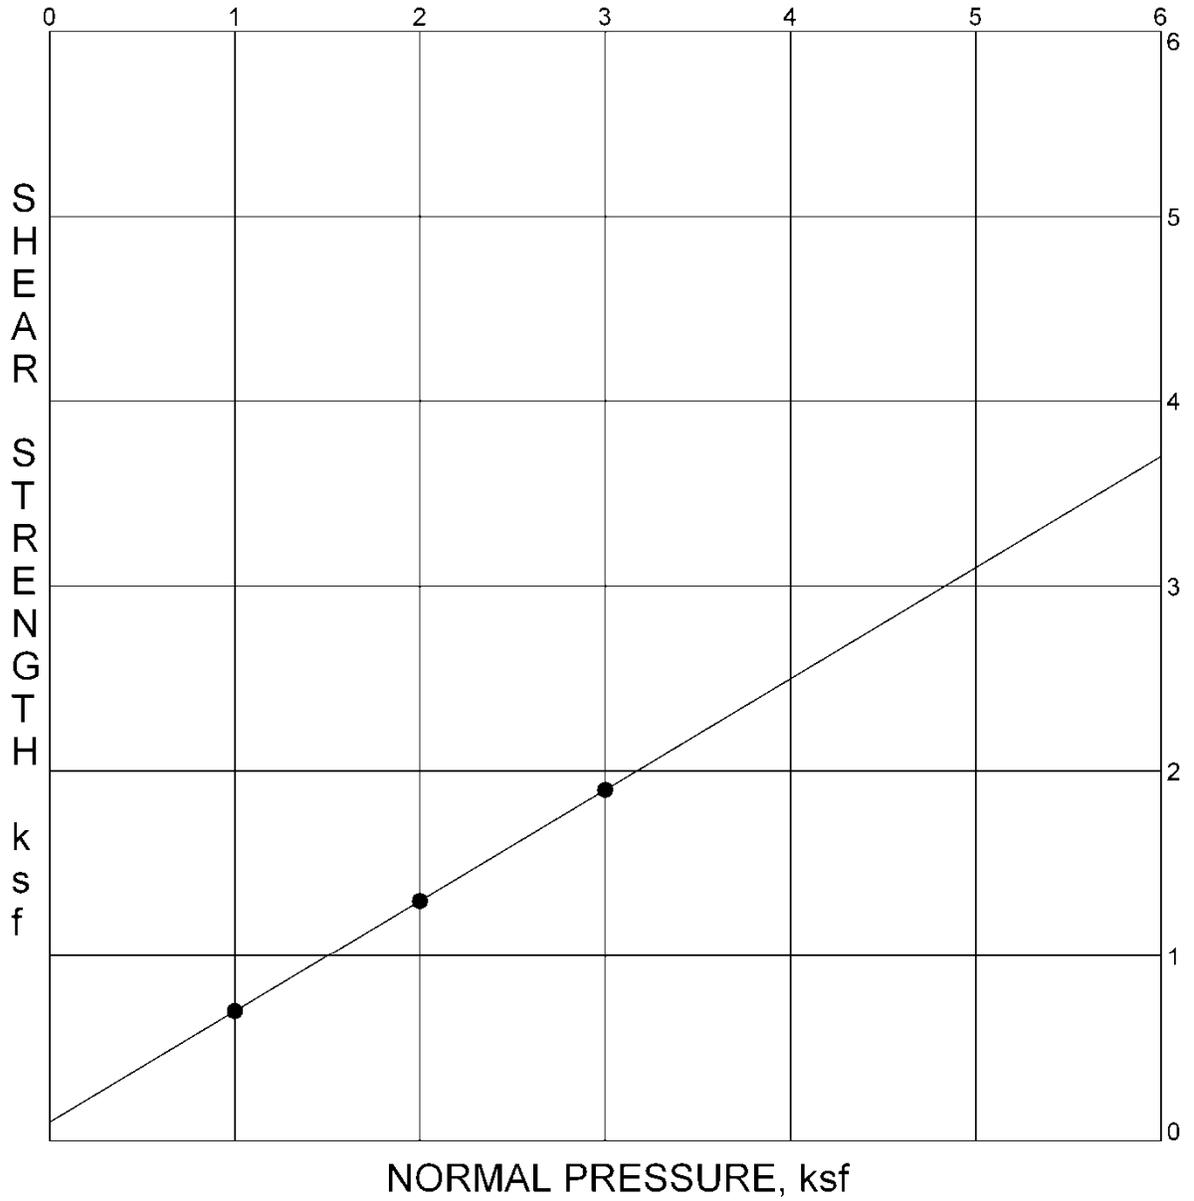
SAMPLE LOCATION: B-2 @ 5.0

DESCRIPTION: Qa

Test Results

Moisture Content (%)	Density (pcf)	Ultimate Strength
Insitu: 5.6	Dry Density: 113.1	Phi (deg): 31.0
Saturated: 18.1		Cohesion (ksf): 0.100
