**PRELIMINARY GEOTECHNICAL
ENGINEERING INVESTIGATION**

**Proposed 13-Story Hotel Expansion
Over Partial One Level Subgrade Parking
&
22-Story Residential Building
Over 3-4 Levels Subgrade Parking**

**1246 S. Hope Street
&
427 W. Pico Boulevard
Los Angeles, California**

Project 5076

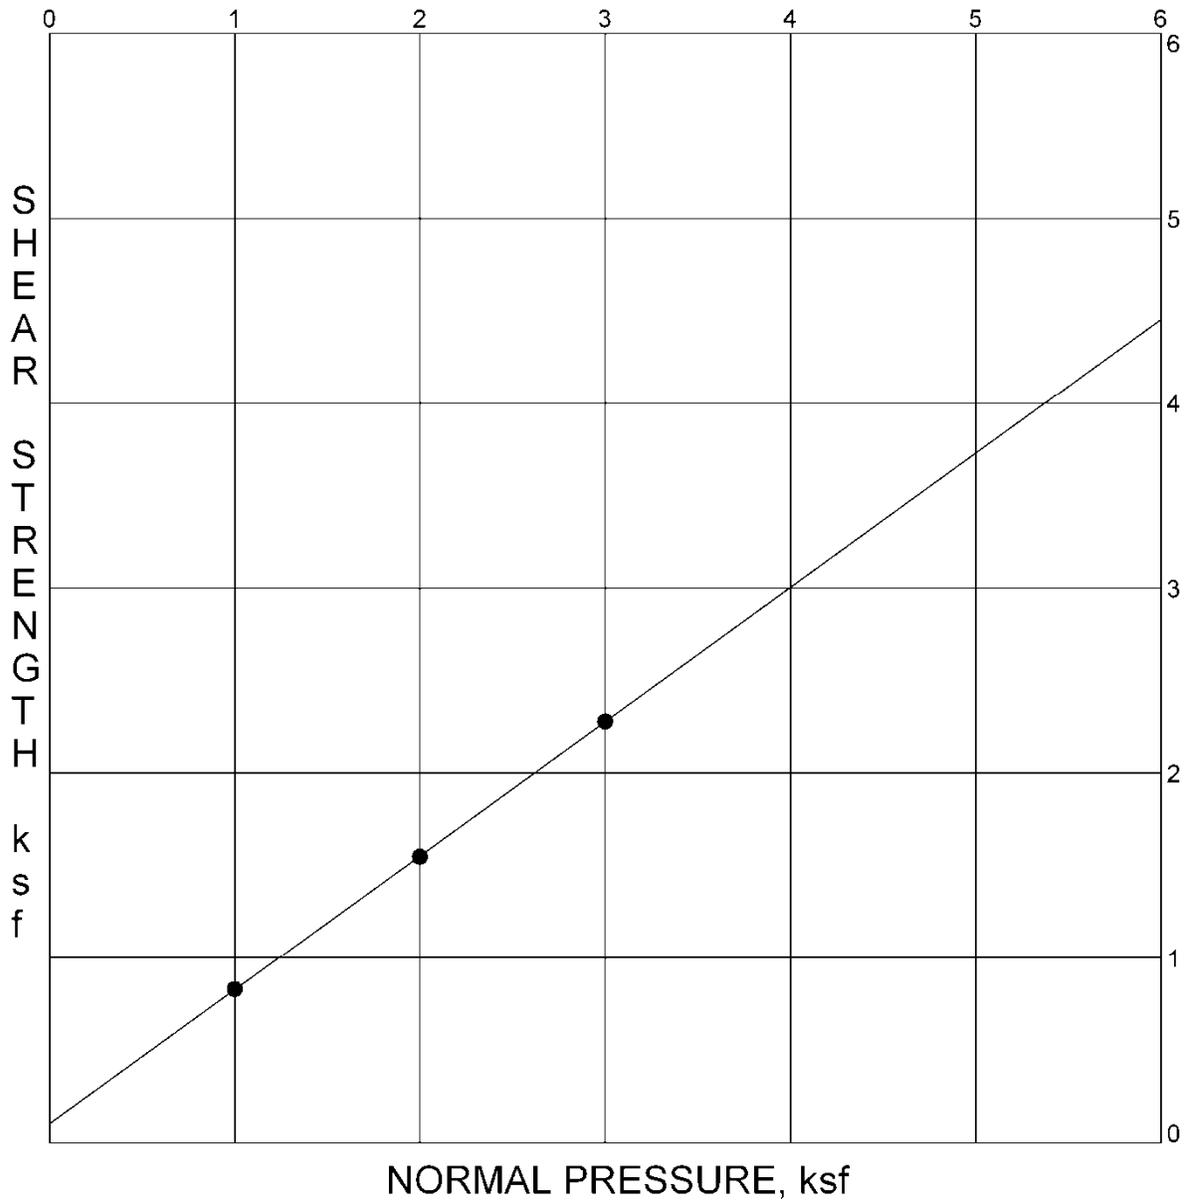
SAMPLE LOCATION: B-2 @ 25.0

DESCRIPTION: Qa

Test Results

Moisture Content (%)	Density (pcf)	Ultimate Strength
Insitu: 8.7	Dry Density: 112.9	Phi (deg): 36.0
Saturated: 18.2		Cohesion (ksf): 0.100

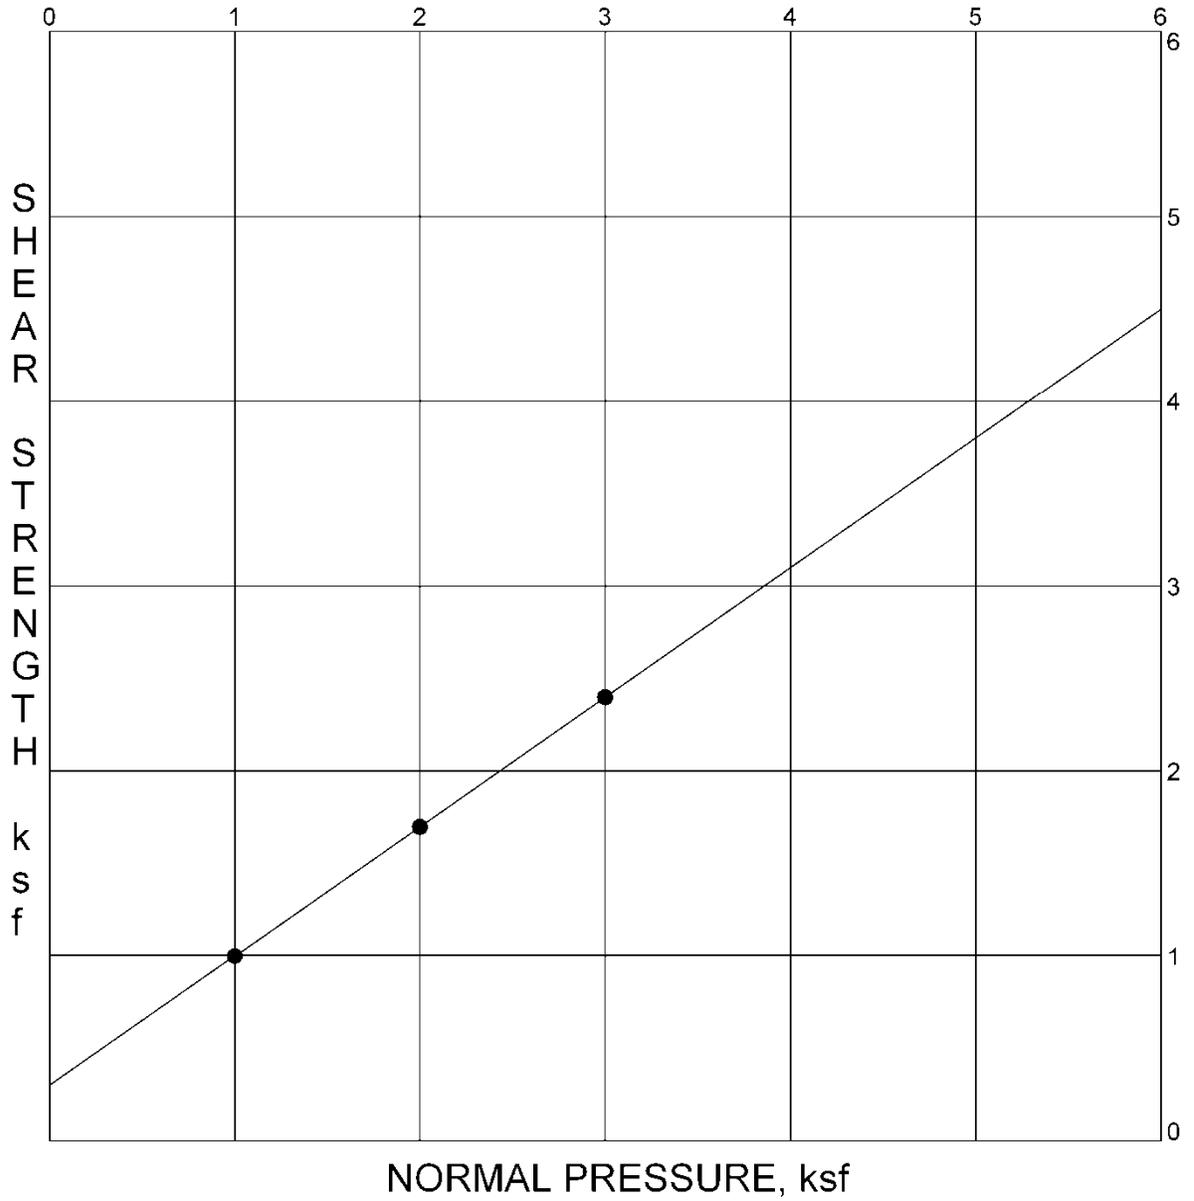
SAMPLE LOCATION: B-2 @ 30.0

DESCRIPTION: Qa

Test Results

Moisture Content (%)	Density (pcf)	Ultimate Strength
Insitu: 11.5	Dry Density: 113.9	Phi (deg): 35.0
Saturated: 17.7		Cohesion (ksf): 0.300

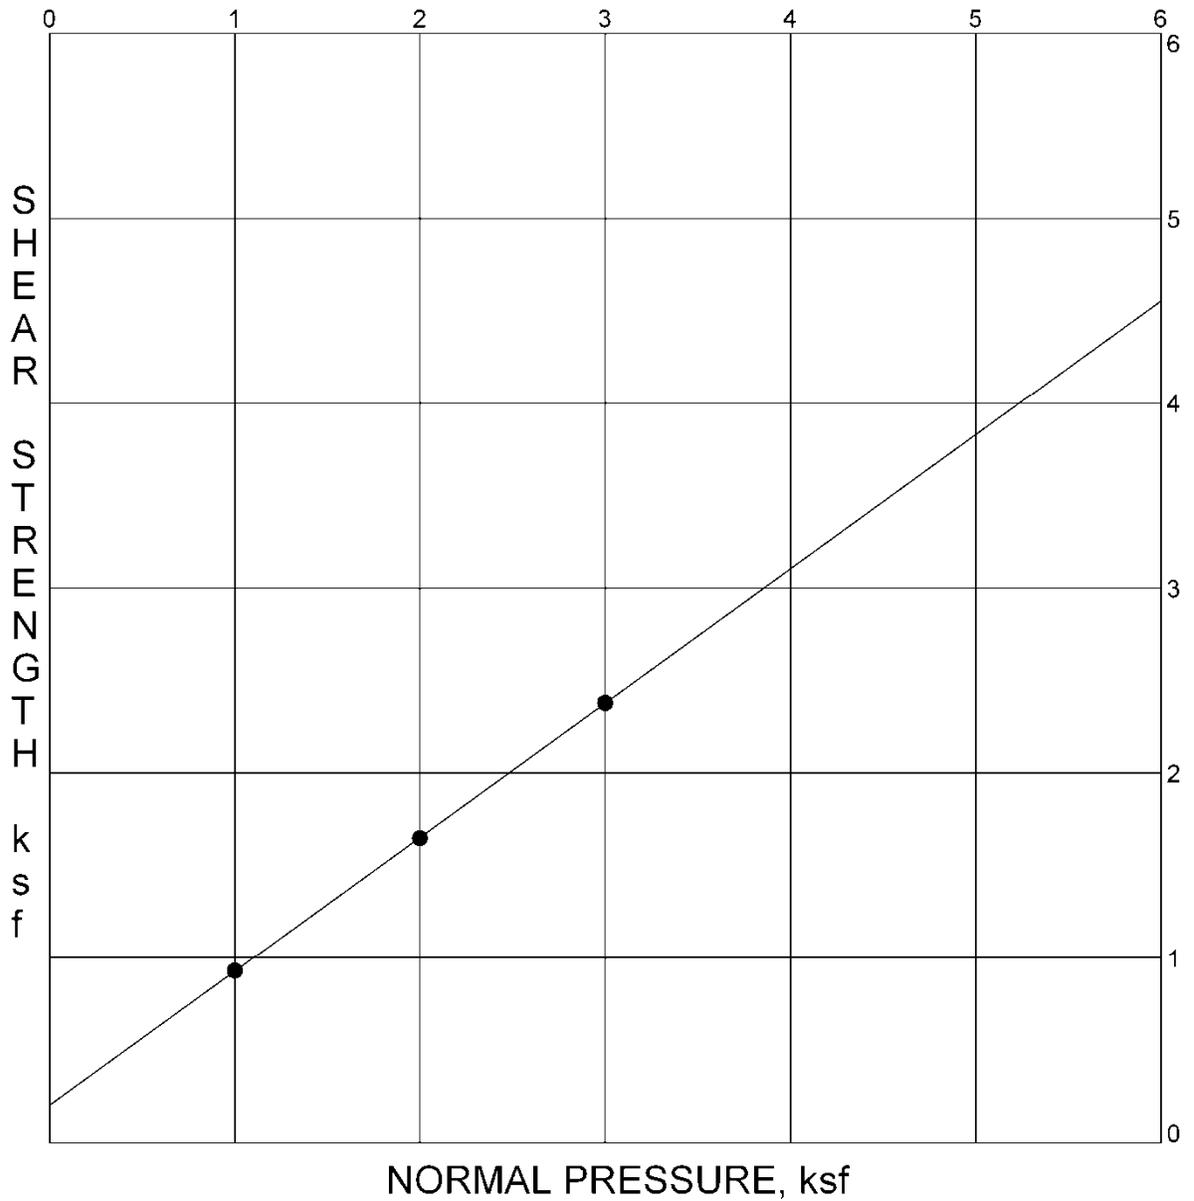
SAMPLE LOCATION: B-2 @ 35.0

DESCRIPTION: Qa

Test Results

Moisture Content (%)	Density (pcf)	Ultimate Strength
Insitu: 10.7	Dry Density: 115.1	Phi (deg): 36.0
Saturated: 17.1		Cohesion (ksf): 0.200

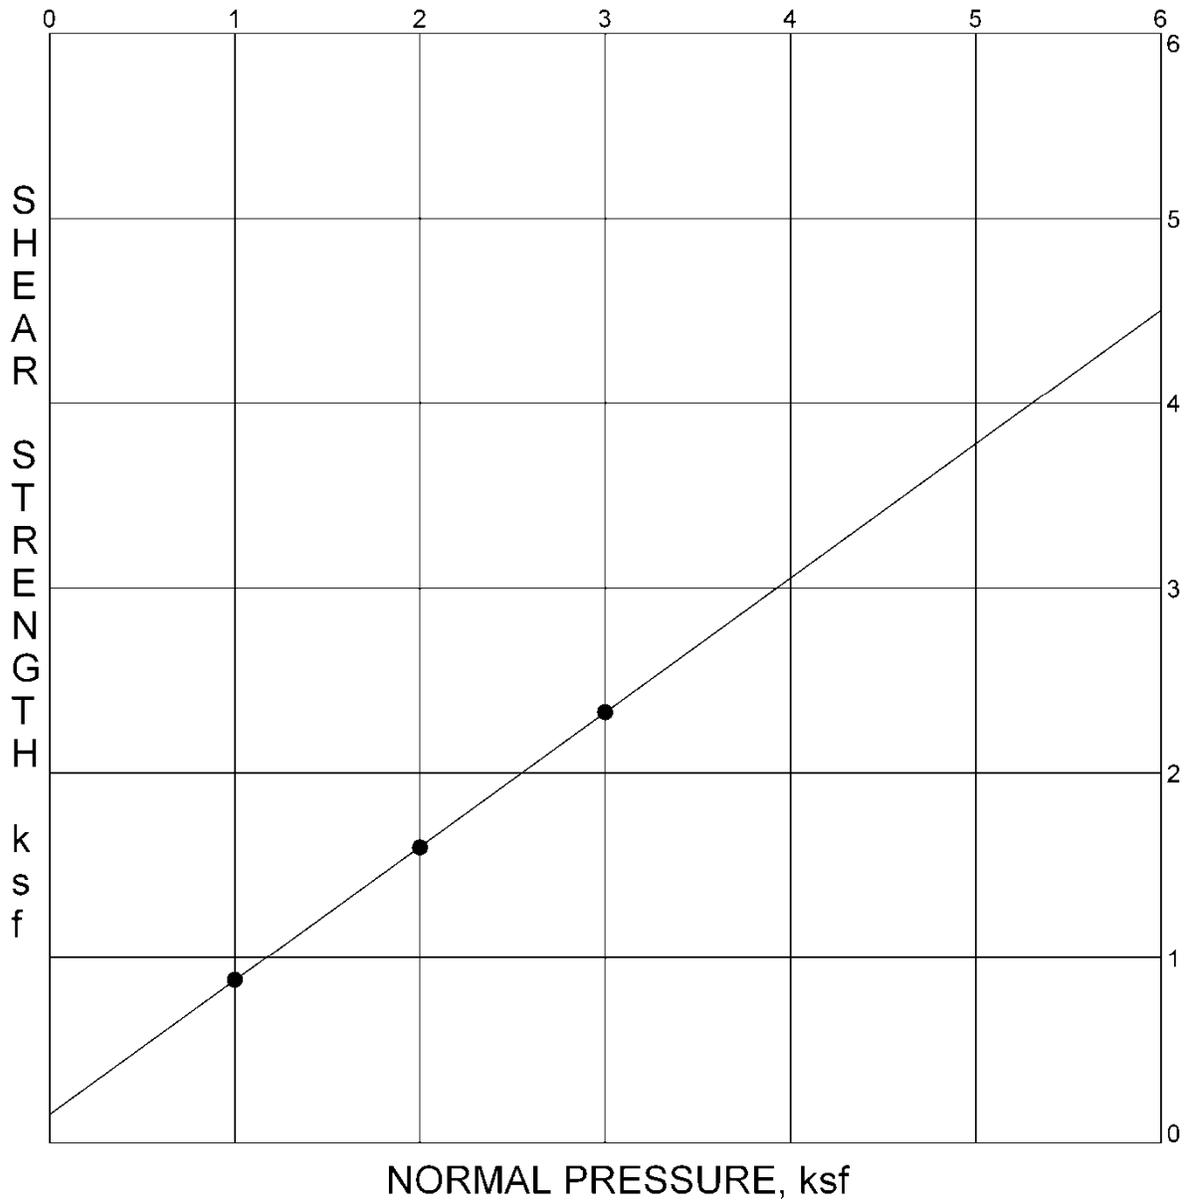
SAMPLE LOCATION: B-2 @ 80.0

DESCRIPTION: Qa

Test Results

Moisture Content (%)	Density (pcf)	Ultimate Strength
Insitu: 2.5	Dry Density: 118.9	Phi (deg): 36.0
Saturated: 15.4		Cohesion (ksf): 0.150

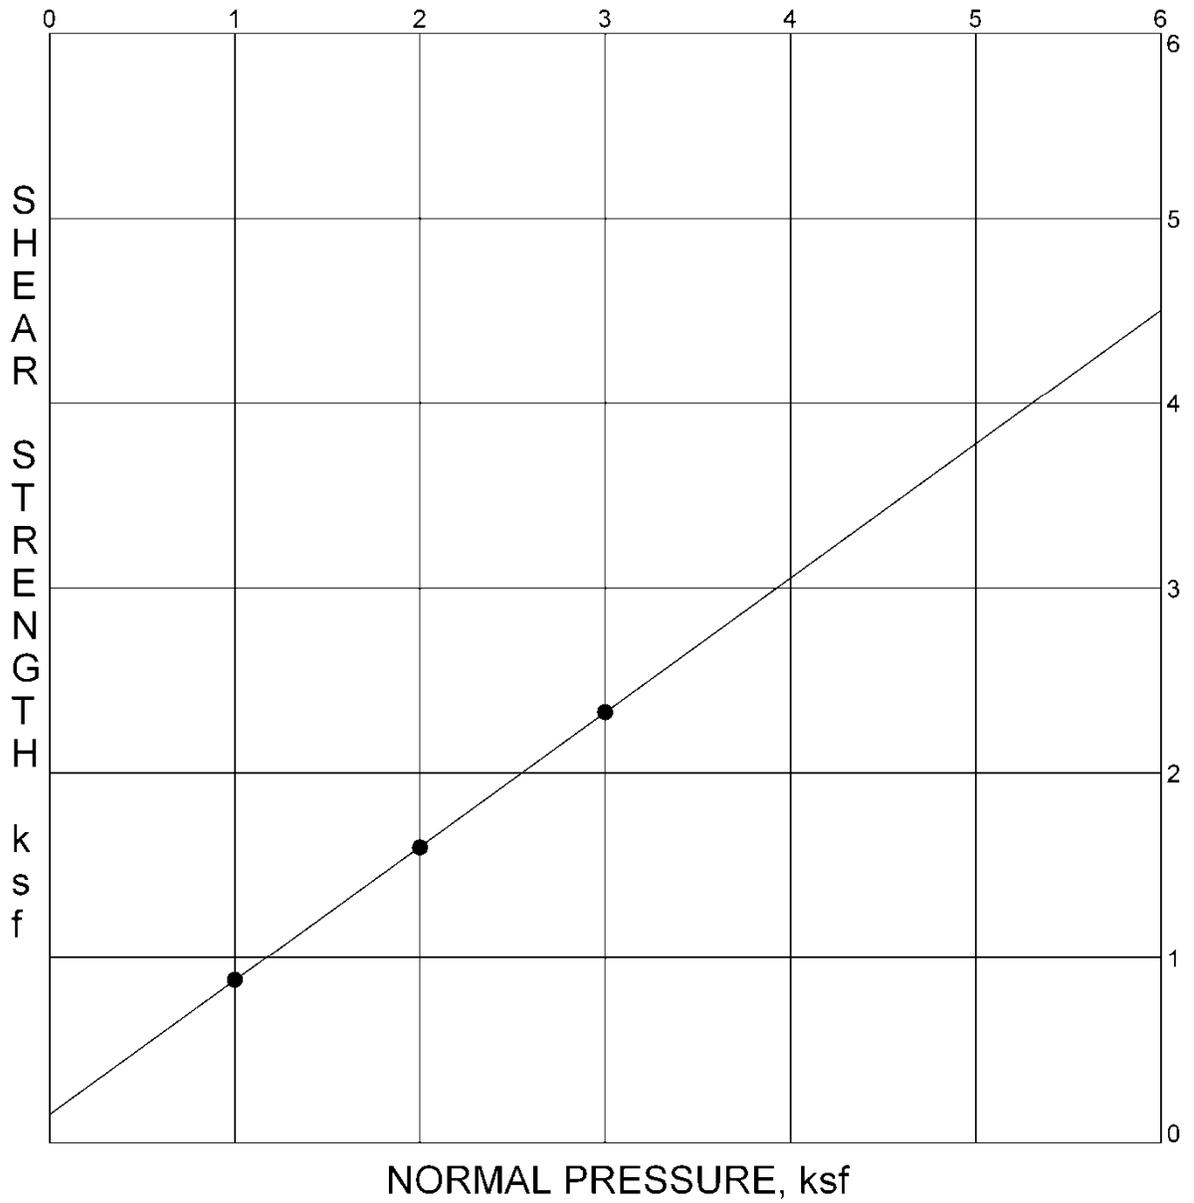
SAMPLE LOCATION: B-3 @ 5.0

DESCRIPTION: Qa

Test Results

Moisture Content (%)	Density (pcf)	Ultimate Strength
Insitu: 3.8	Dry Density: 117.4	Phi (deg): 36.0
Saturated: 16.1		Cohesion (ksf): 0.150

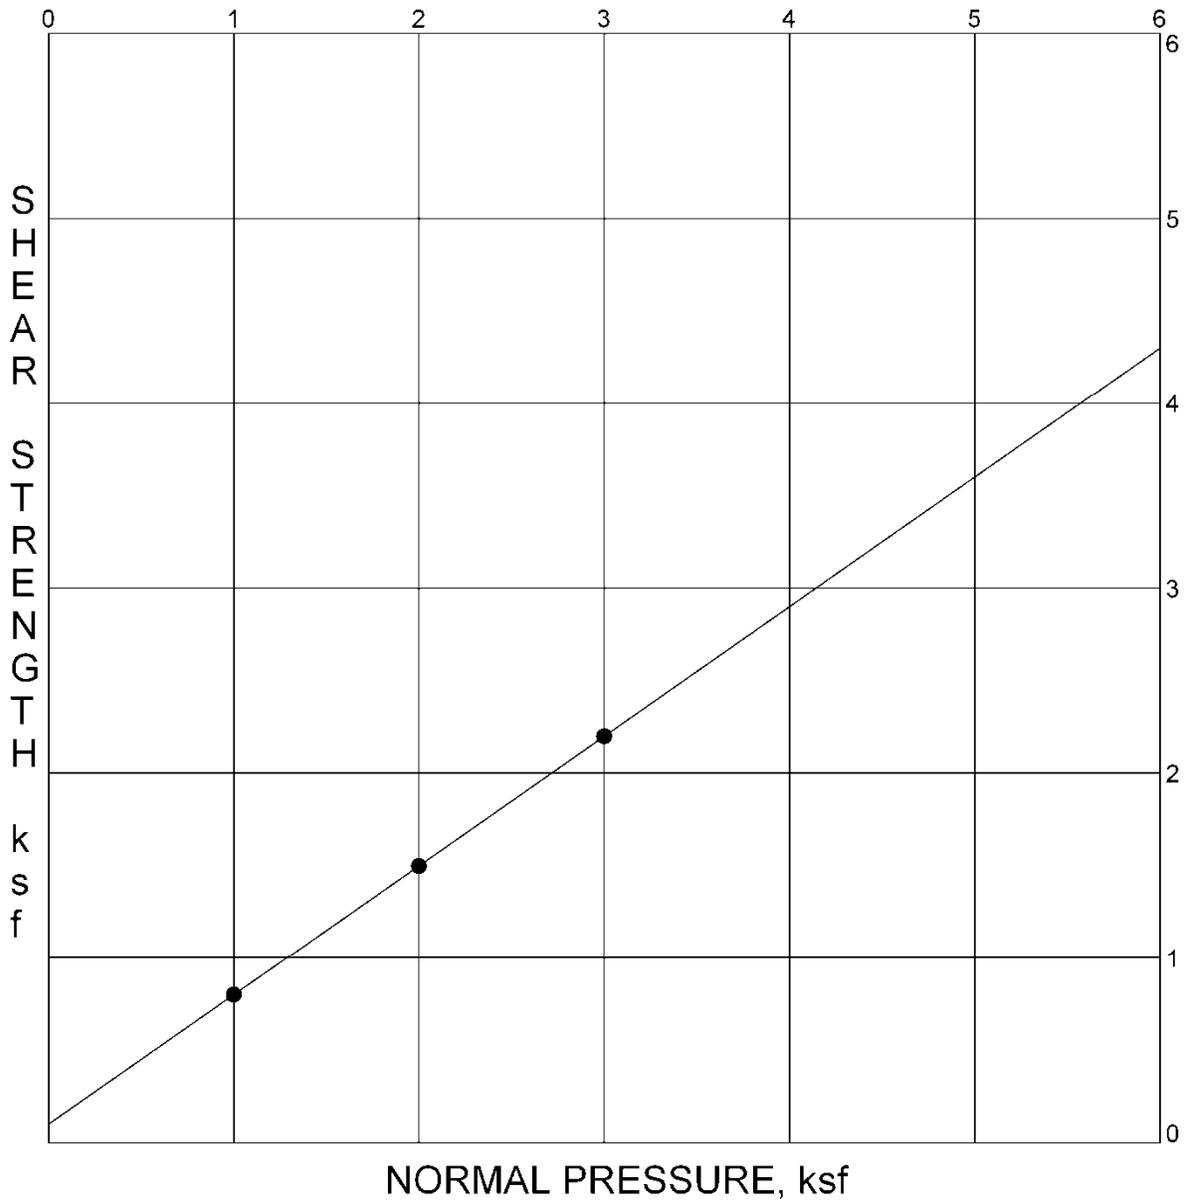
SAMPLE LOCATION: B-3 @ 15.0

DESCRIPTION: Qa

Test Results

Moisture Content (%)	Density (pcf)	Ultimate Strength
Insitu: 2.4	Dry Density: 110.2	Phi (deg): 35.0
Saturated: 19.5		Cohesion (ksf): 0.100

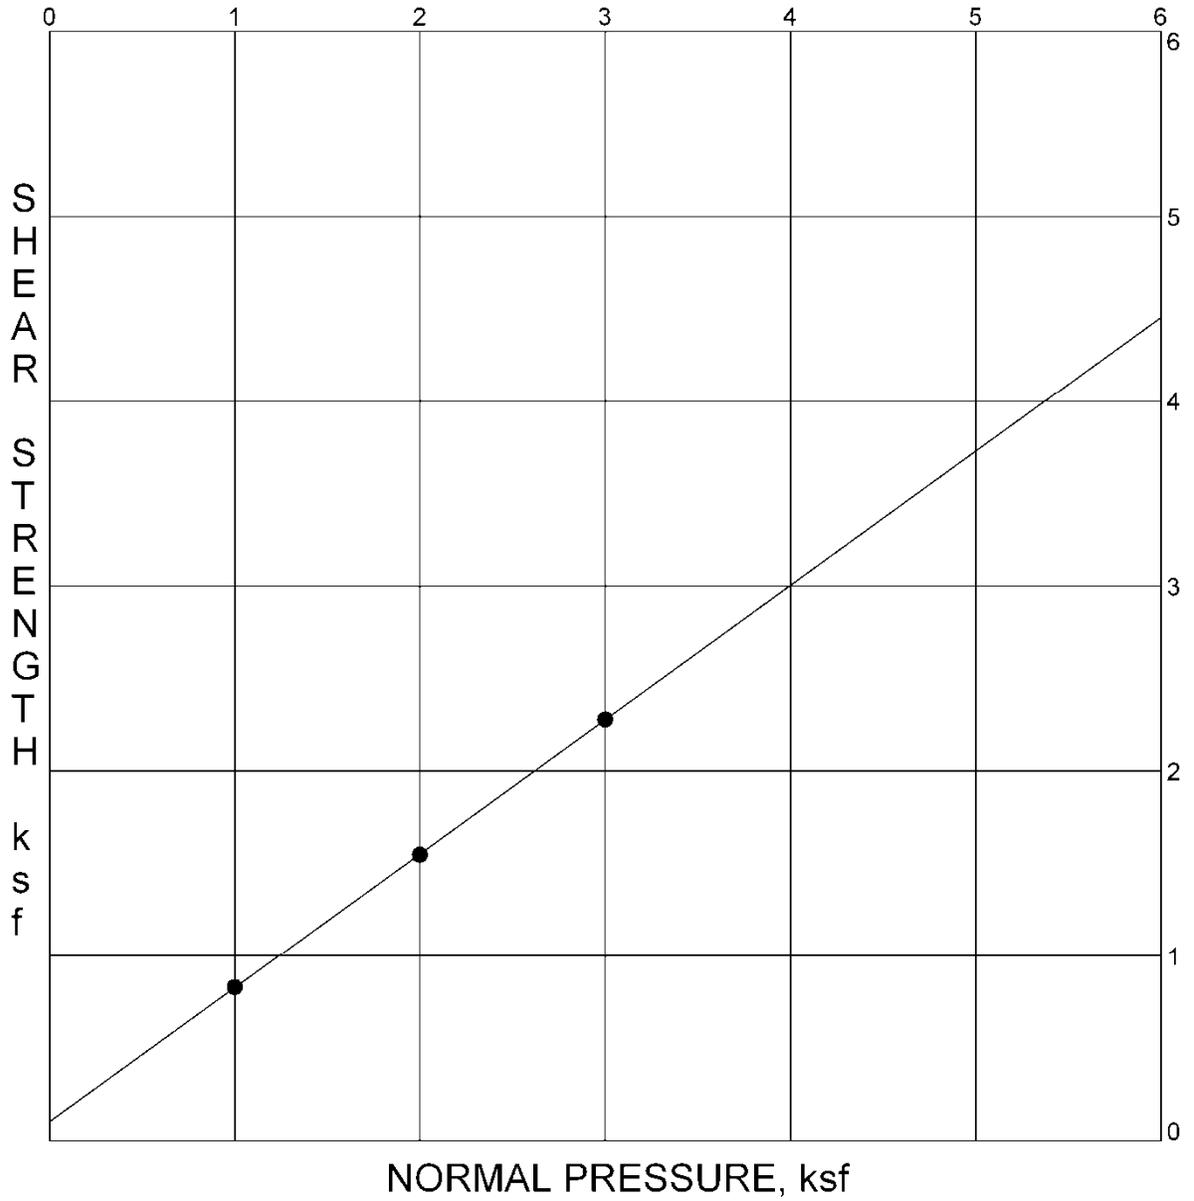
SAMPLE LOCATION: B-3 @ 25.0

DESCRIPTION: Qa

Test Results

Moisture Content (%)	Density (pcf)	Ultimate Strength
Insitu: 4.8	Dry Density: 118.0	Phi (deg): 36.0
Saturated: 15.8		Cohesion (ksf): 0.100

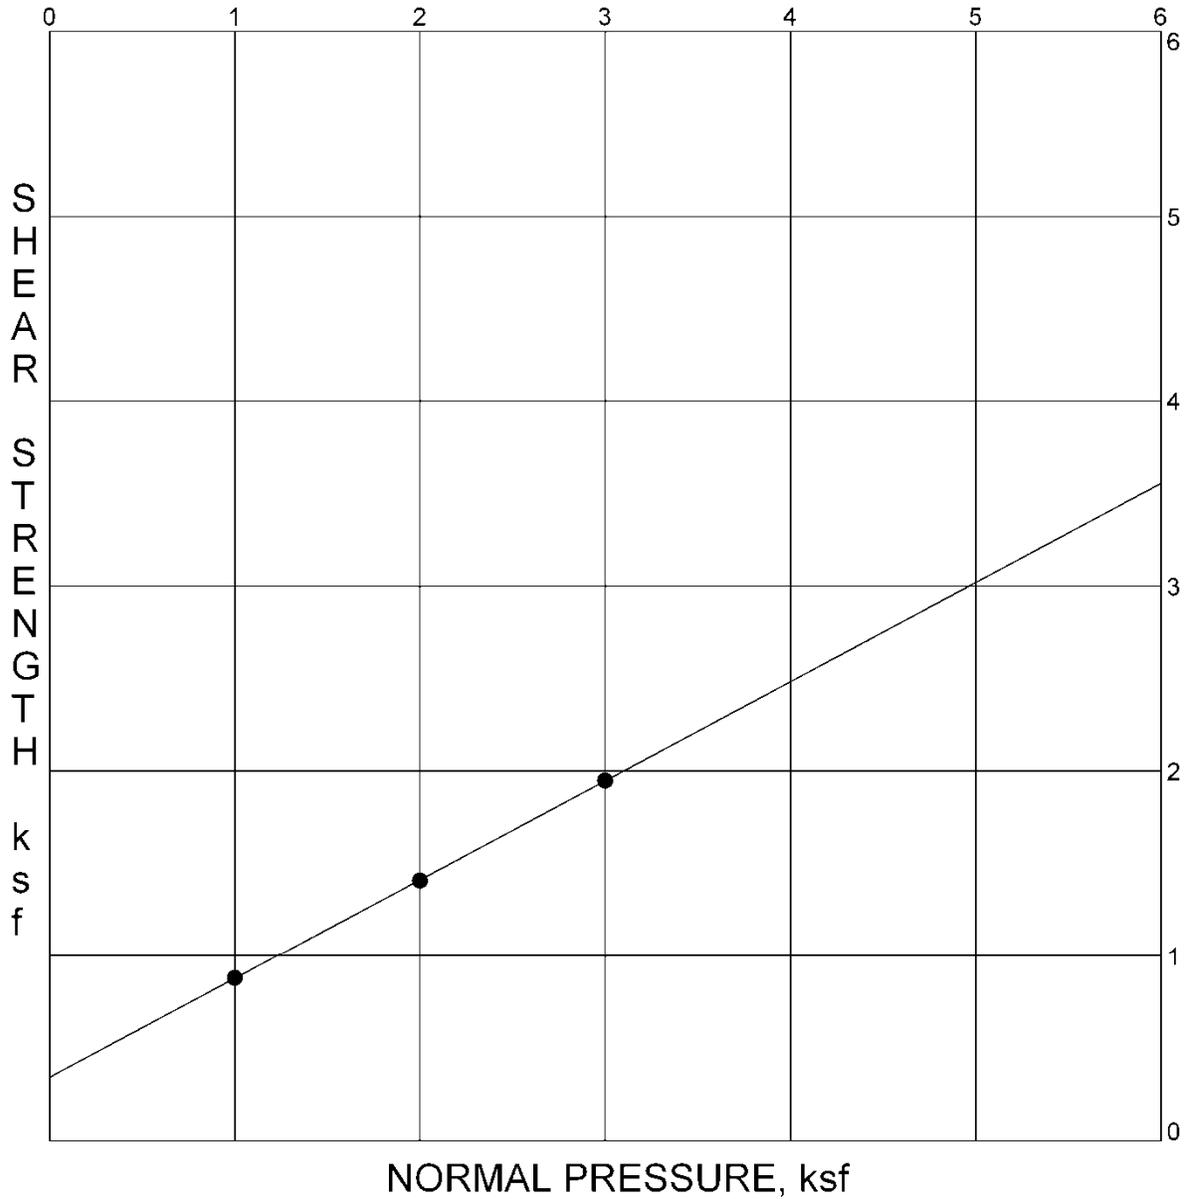
SAMPLE LOCATION: B-3 @ 50.0

DESCRIPTION: Qa

Test Results

Moisture Content (%)	Density (pcf)	Ultimate Strength
Insitu: 13.3	Dry Density: 100.3	Phi (deg): 28.0
Saturated: 25.1		Cohesion (ksf): 0.350

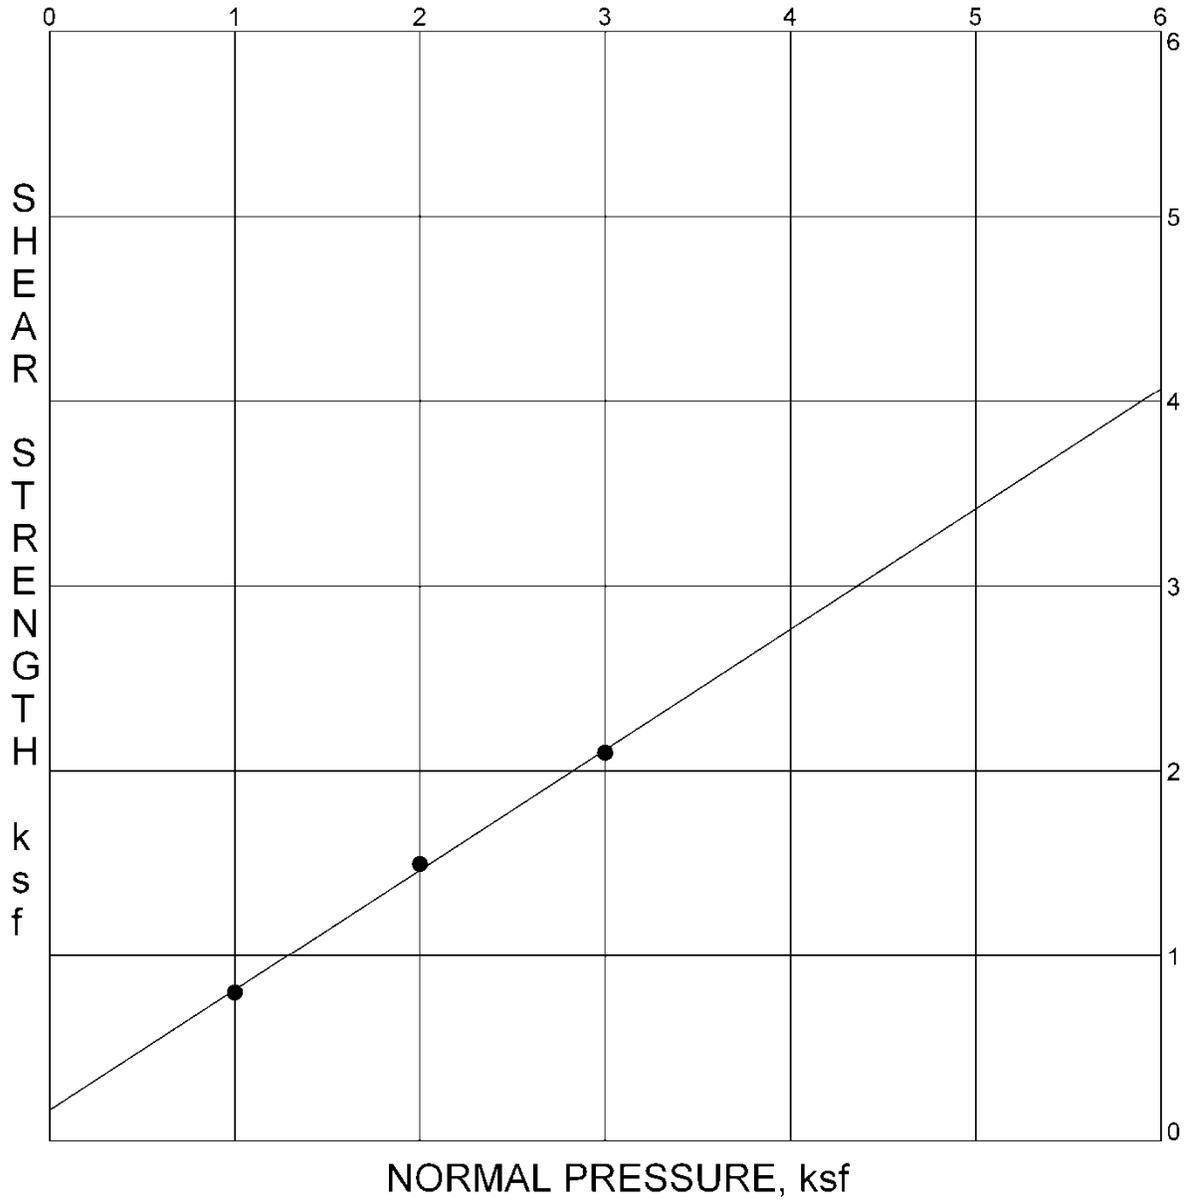
SAMPLE LOCATION: B-4 @ 10.0

DESCRIPTION: Qal

Test Results

Moisture Content (%)	Density (pcf)	Ultimate Strength
Insitu: 4.2	Dry Density: 116.8	Phi (deg): 33.0
Saturated: 16.4		Cohesion (ksf): 0.150

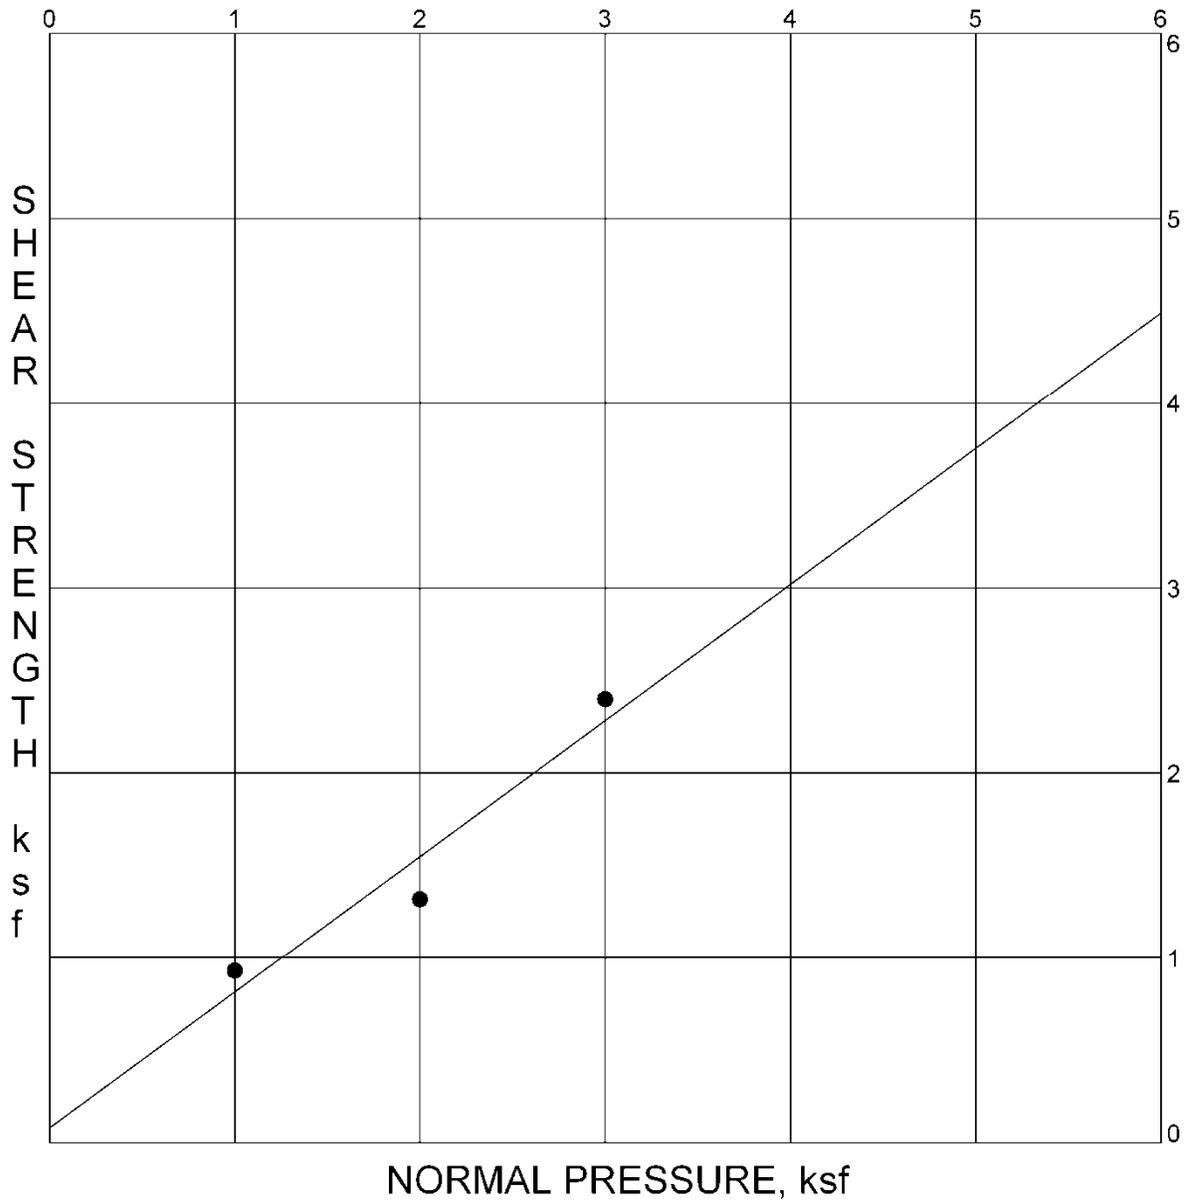
SAMPLE LOCATION: B-4 @ 35.0

Test Results

Moisture Content (%)	Density (pcf)	Ultimate Strength
Insitu: 4.1	Dry Density: 116.5	Phi (deg): 36.0
Saturated: 16.5		Cohesion (ksf): 0.075

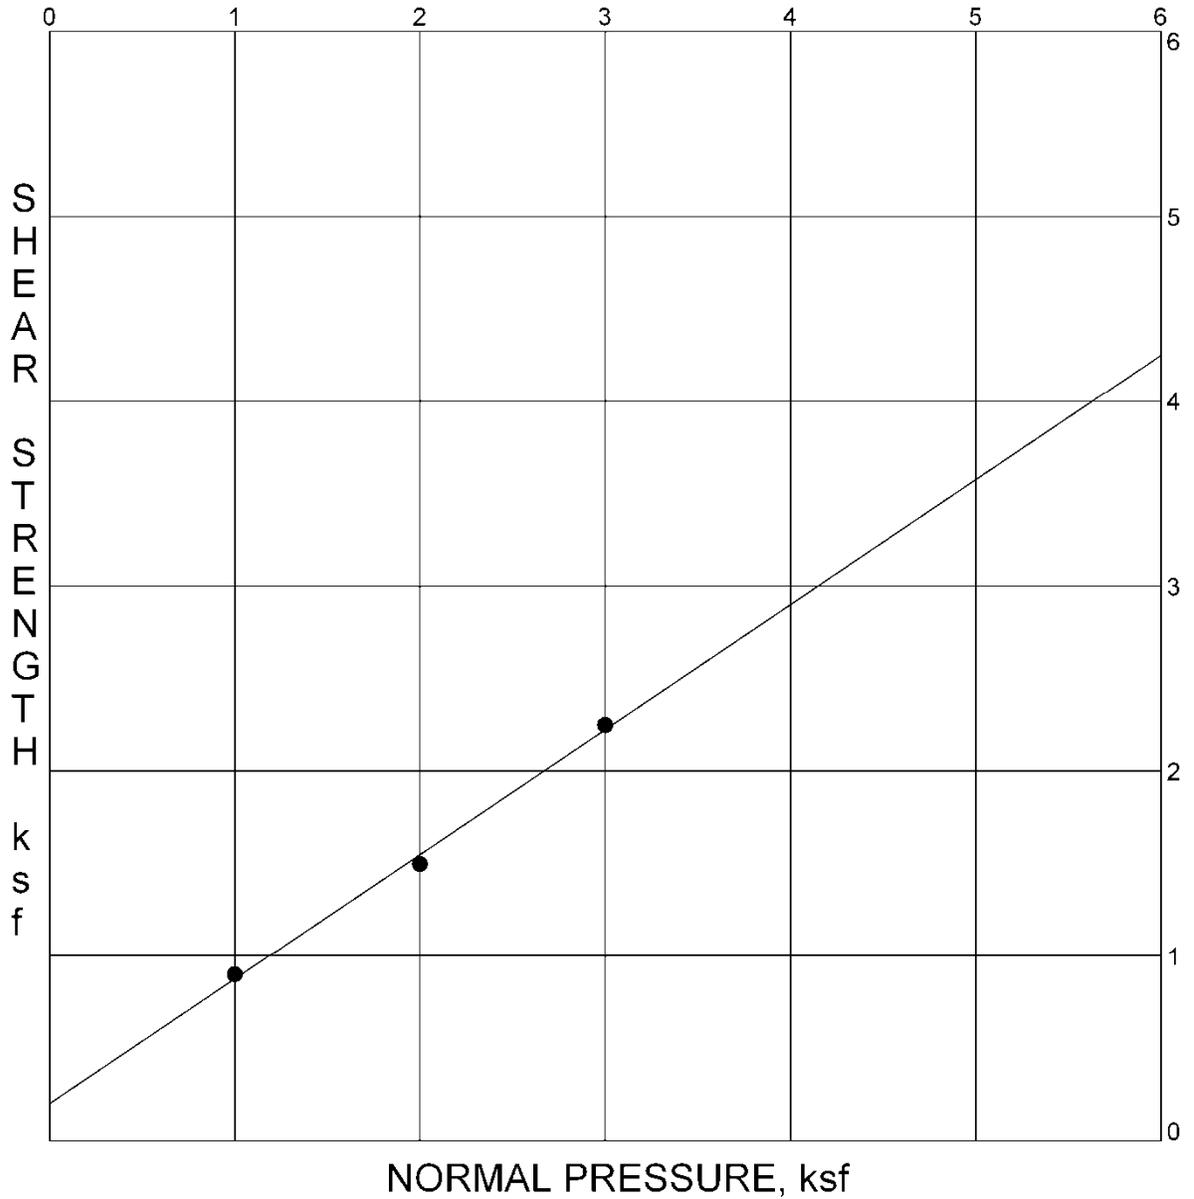
SAMPLE LOCATION: B-4 @ 45.0

Test Results

Moisture Content (%)	Density (pcf)	Ultimate Strength
Insitu: 5.7	Dry Density: 117.3	Phi (deg): 34.0
Saturated: 16.1		Cohesion (ksf): 0.200

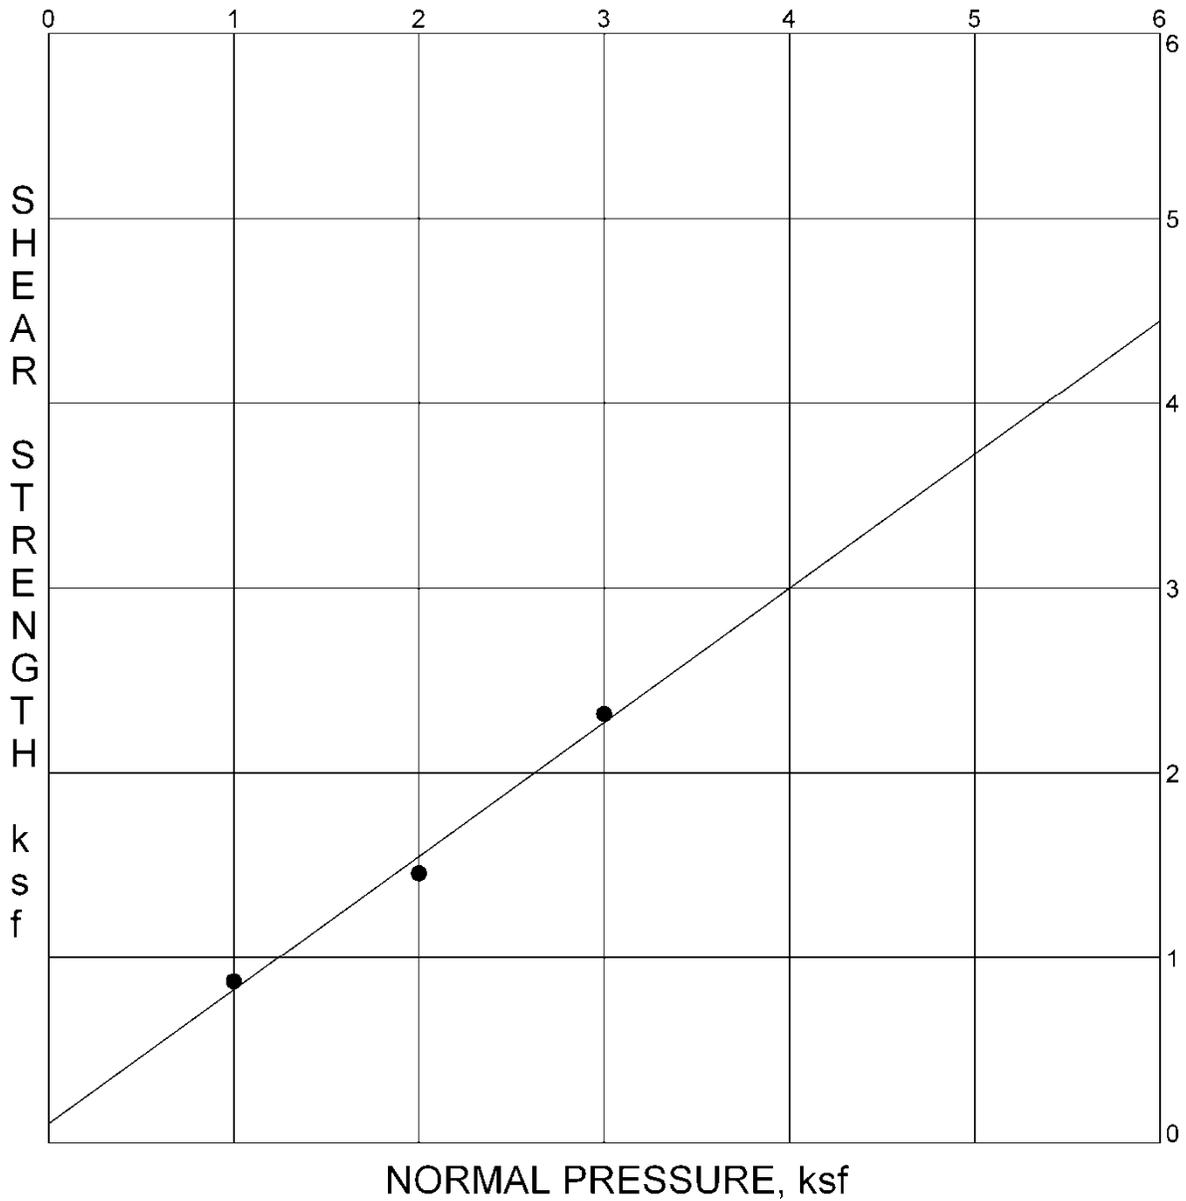
SAMPLE LOCATION: B-4 @ 55.0

Test Results

Moisture Content (%)	Density (pcf)	Ultimate Strength
Insitu: 12.3	Dry Density: 107.1	Phi (deg): 36.0
Saturated: 21.2		Cohesion (ksf): 0.100

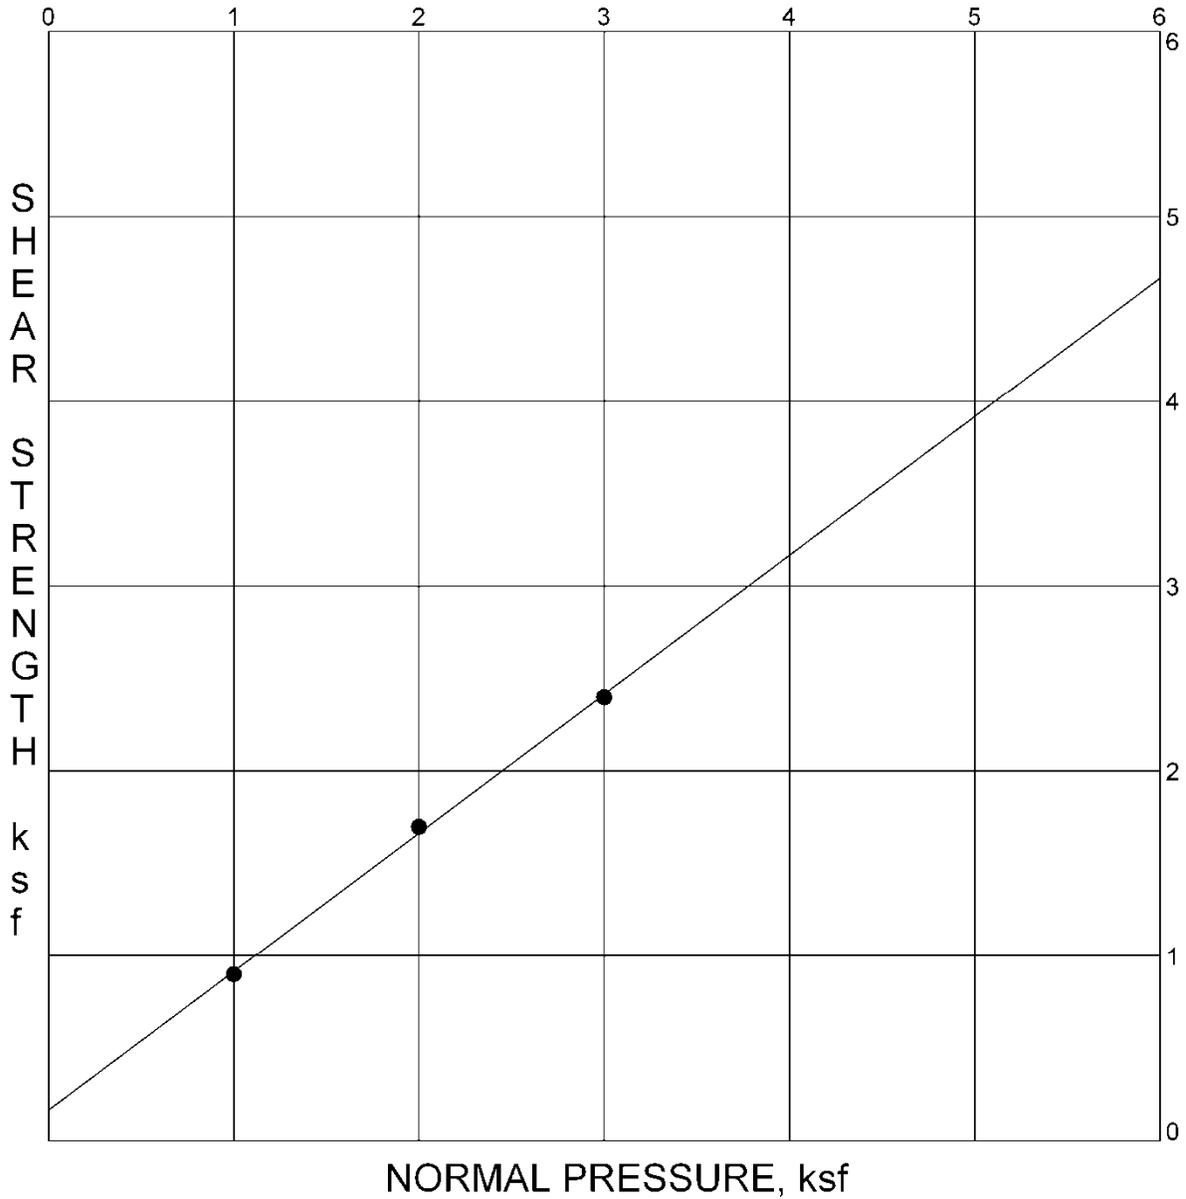
SAMPLE LOCATION: B-4 @ 65.0

Test Results

Moisture Content (%)	Density (pcf)	Ultimate Strength
Insitu: 14.4	Dry Density: 113.7	Phi (deg): 37.0
Saturated: 17.8		Cohesion (ksf): 0.150

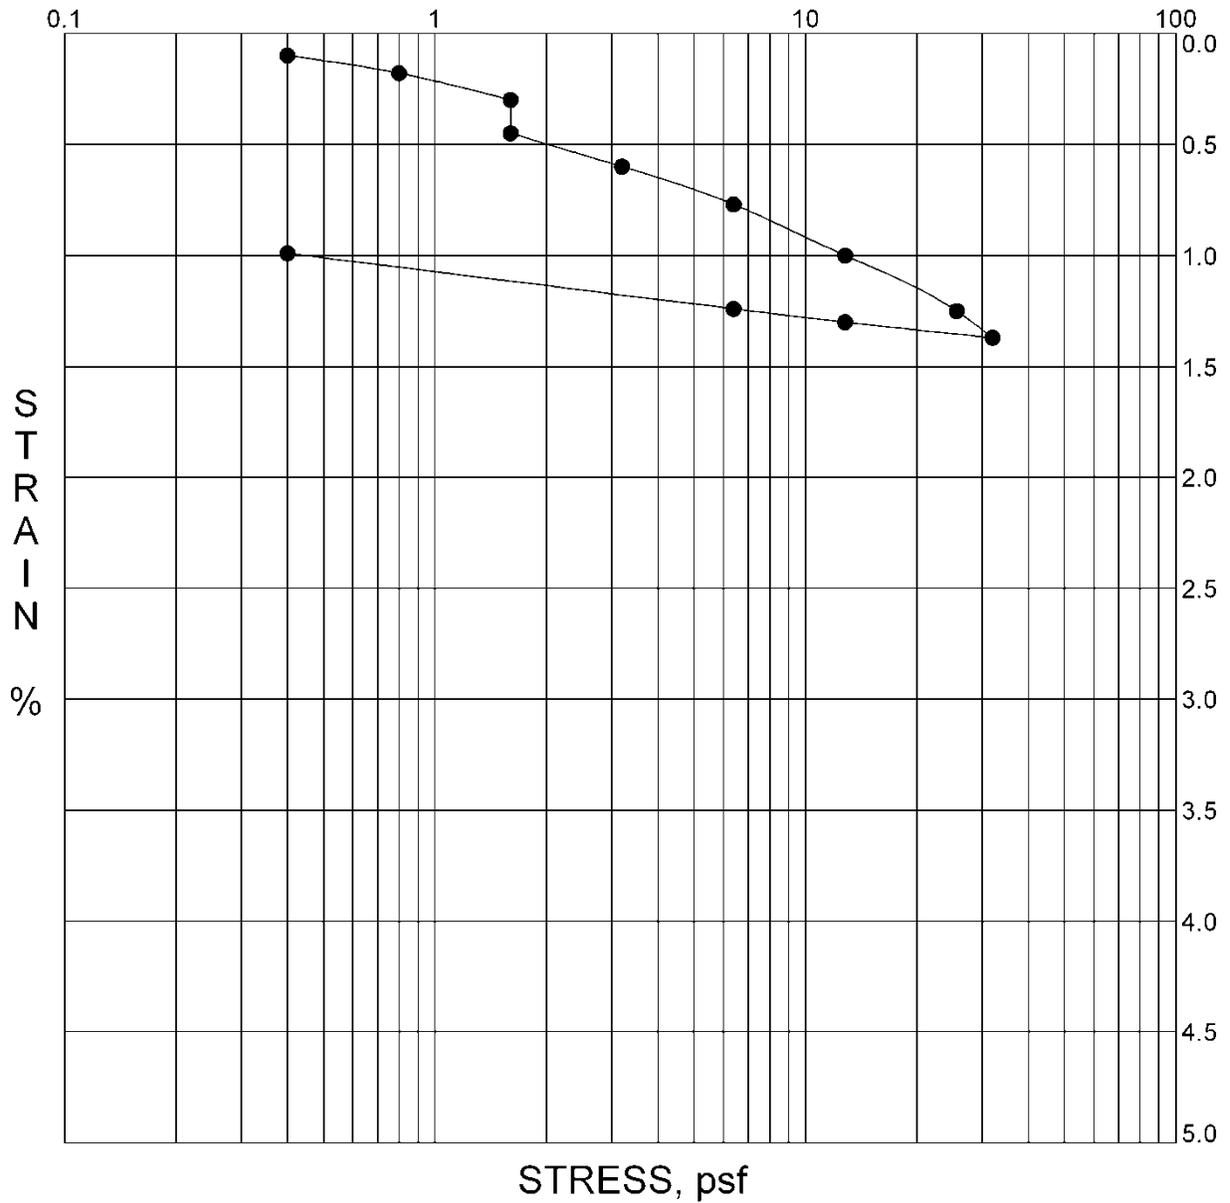
SAMPLE LOCATION: B-1 @ 40.0

DESCRIPTION: Qa

Test Results

Moisture Content (%)	Density (pcf)	Water Added At
Insitu: 9.2	Dry Density: 110.9	1600 lbs.

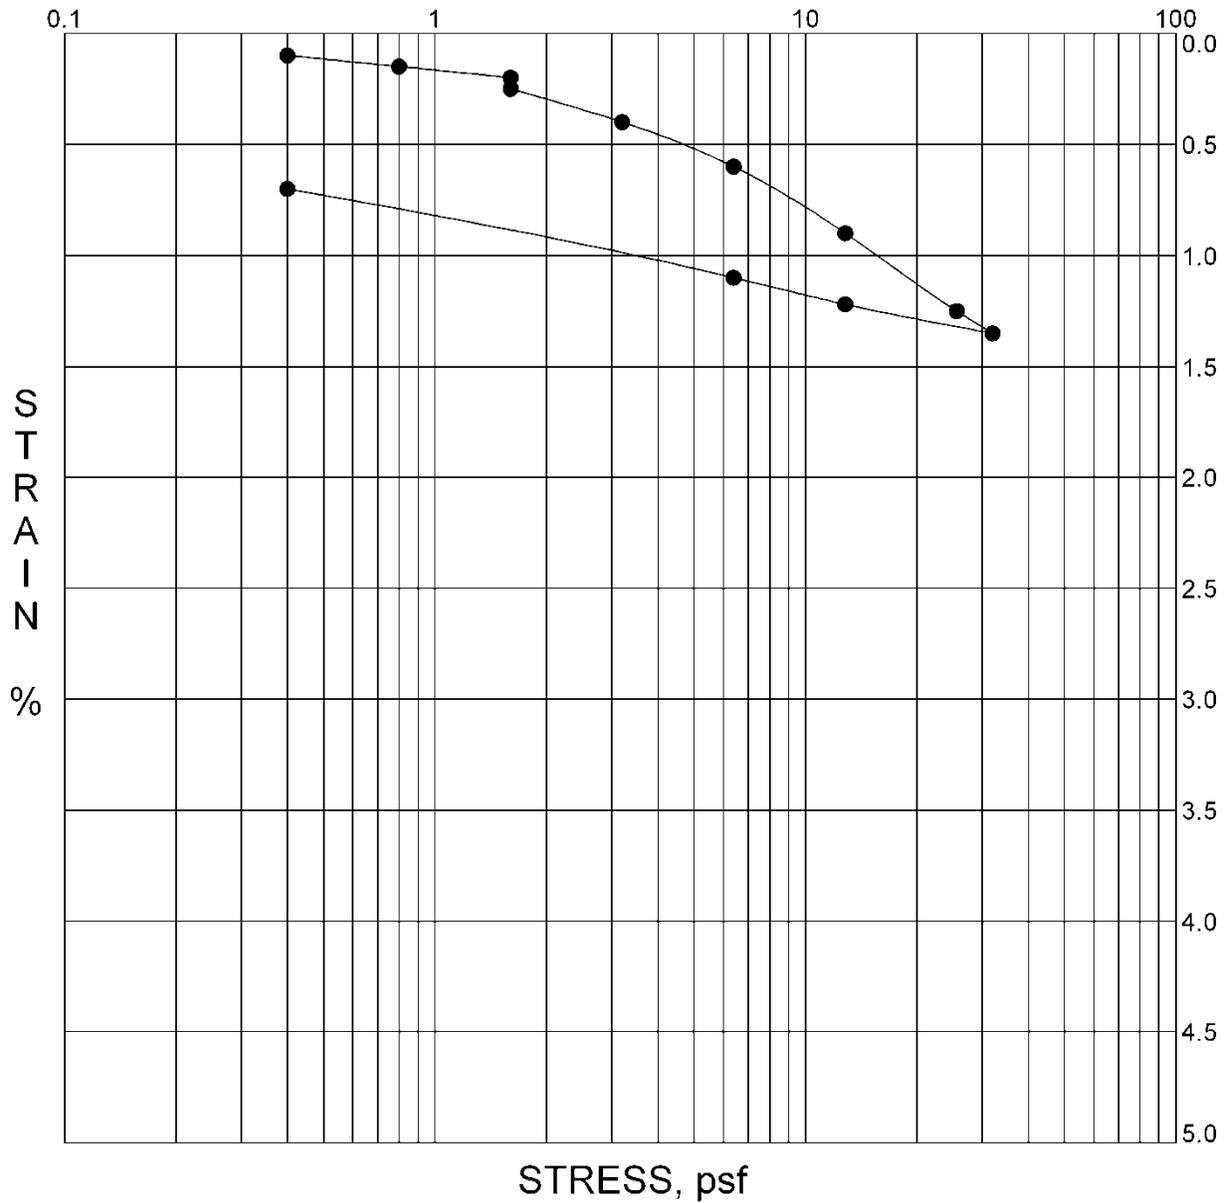
SAMPLE LOCATION: B-1 @ 45.0

DESCRIPTION: Qa

Test Results

Moisture Content (%)	Density (pcf)	Water Added At
In situ: 11.0	Dry Density: 107.3	1600 lbs.
