**PRELIMINARY GEOTECHNICAL
ENGINEERING INVESTIGATION**

**Proposed 13-Story Hotel Expansion
Over Partial One Level Subgrade Parking
&
22-Story Residential Building
Over 3-4 Levels Subgrade Parking**

**1246 S. Hope Street
&
427 W. Pico Boulevard
Los Angeles, California**

Project 5076

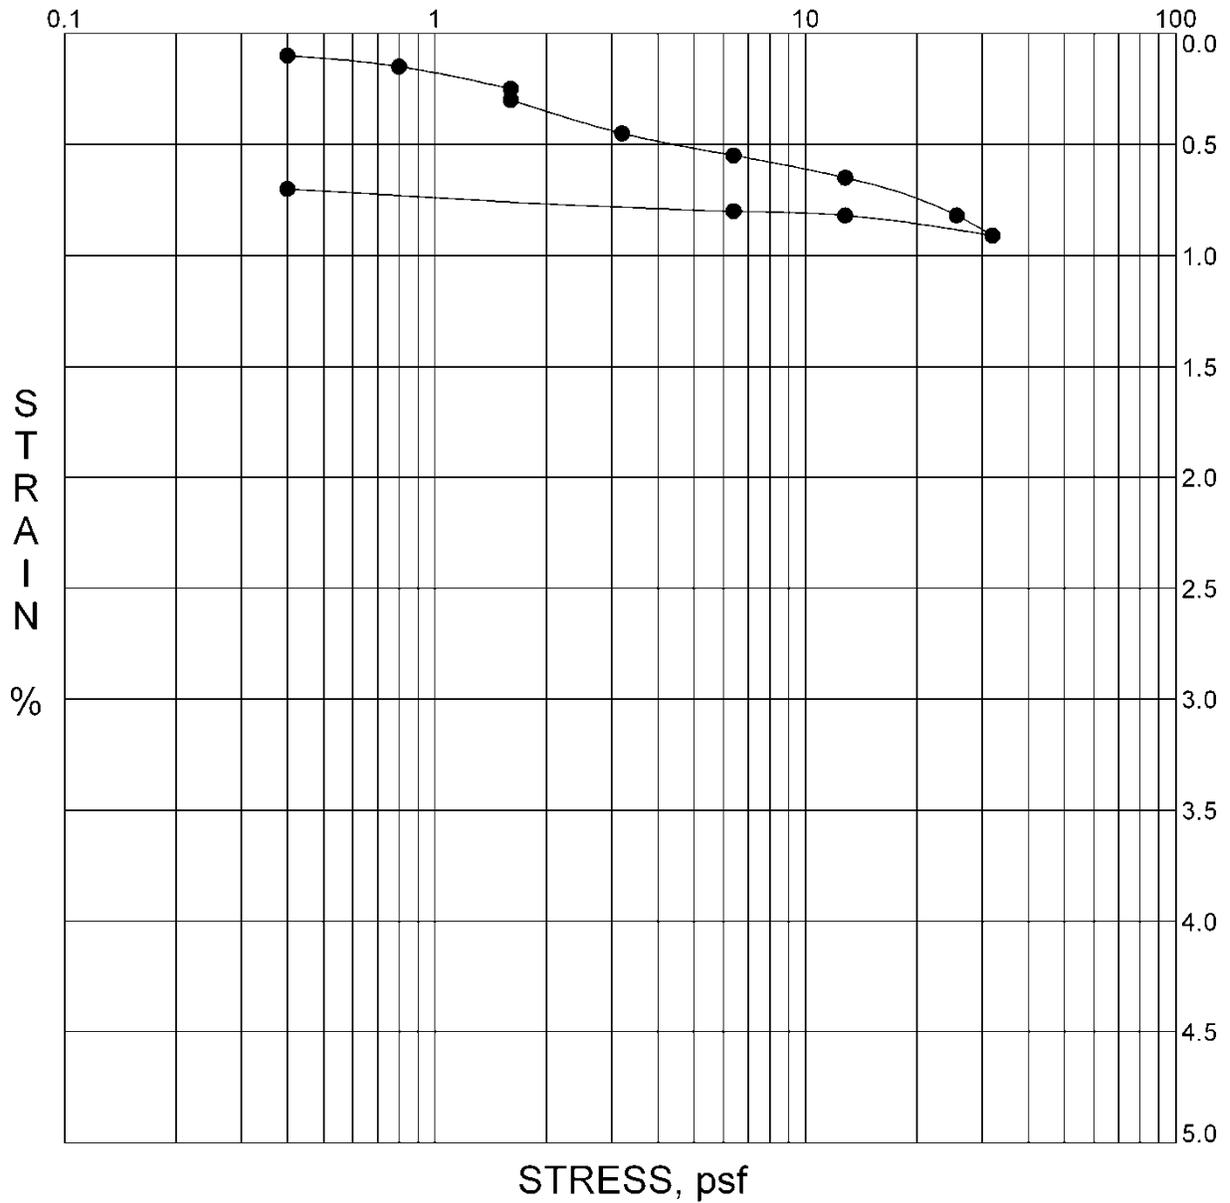
SAMPLE LOCATION: B-1 @ 60.0

DESCRIPTION: Qa

Test Results

Moisture Content (%)	Density (pcf)	Water Added At
In situ: 10.2	Dry Density: 105.3	1600 lbs.

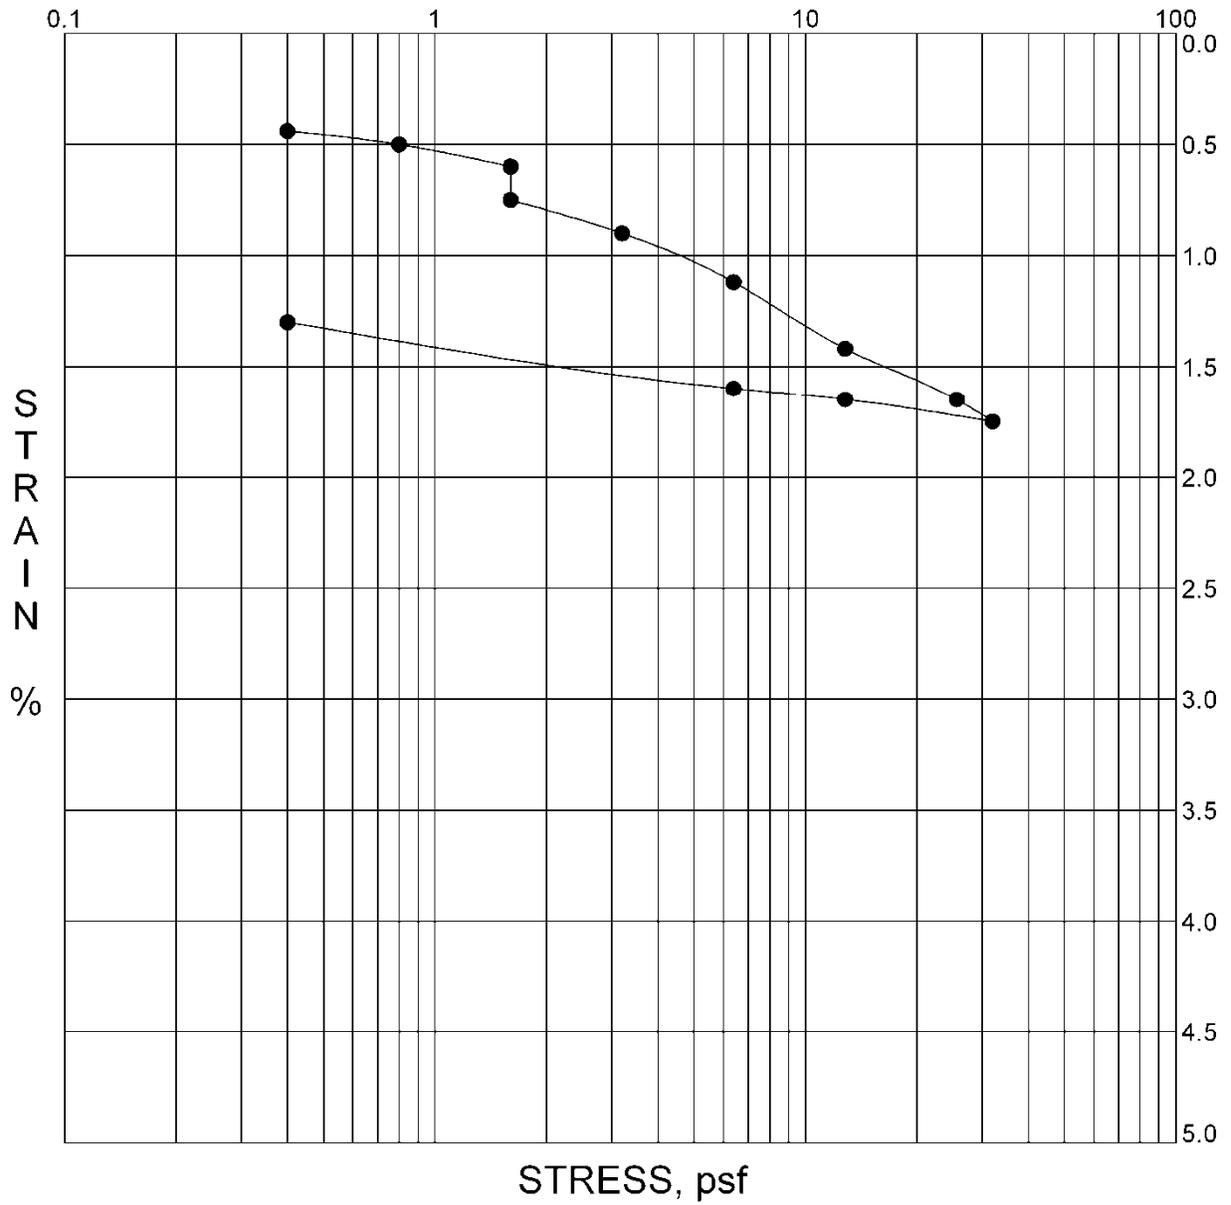
SAMPLE LOCATION: B-1 @ 75.0

DESCRIPTION: Qa

Test Results

Moisture Content (%)	Density (pcf)	Water Added At
In situ: 8.0	Dry Density: 111.4	1600 lbs.

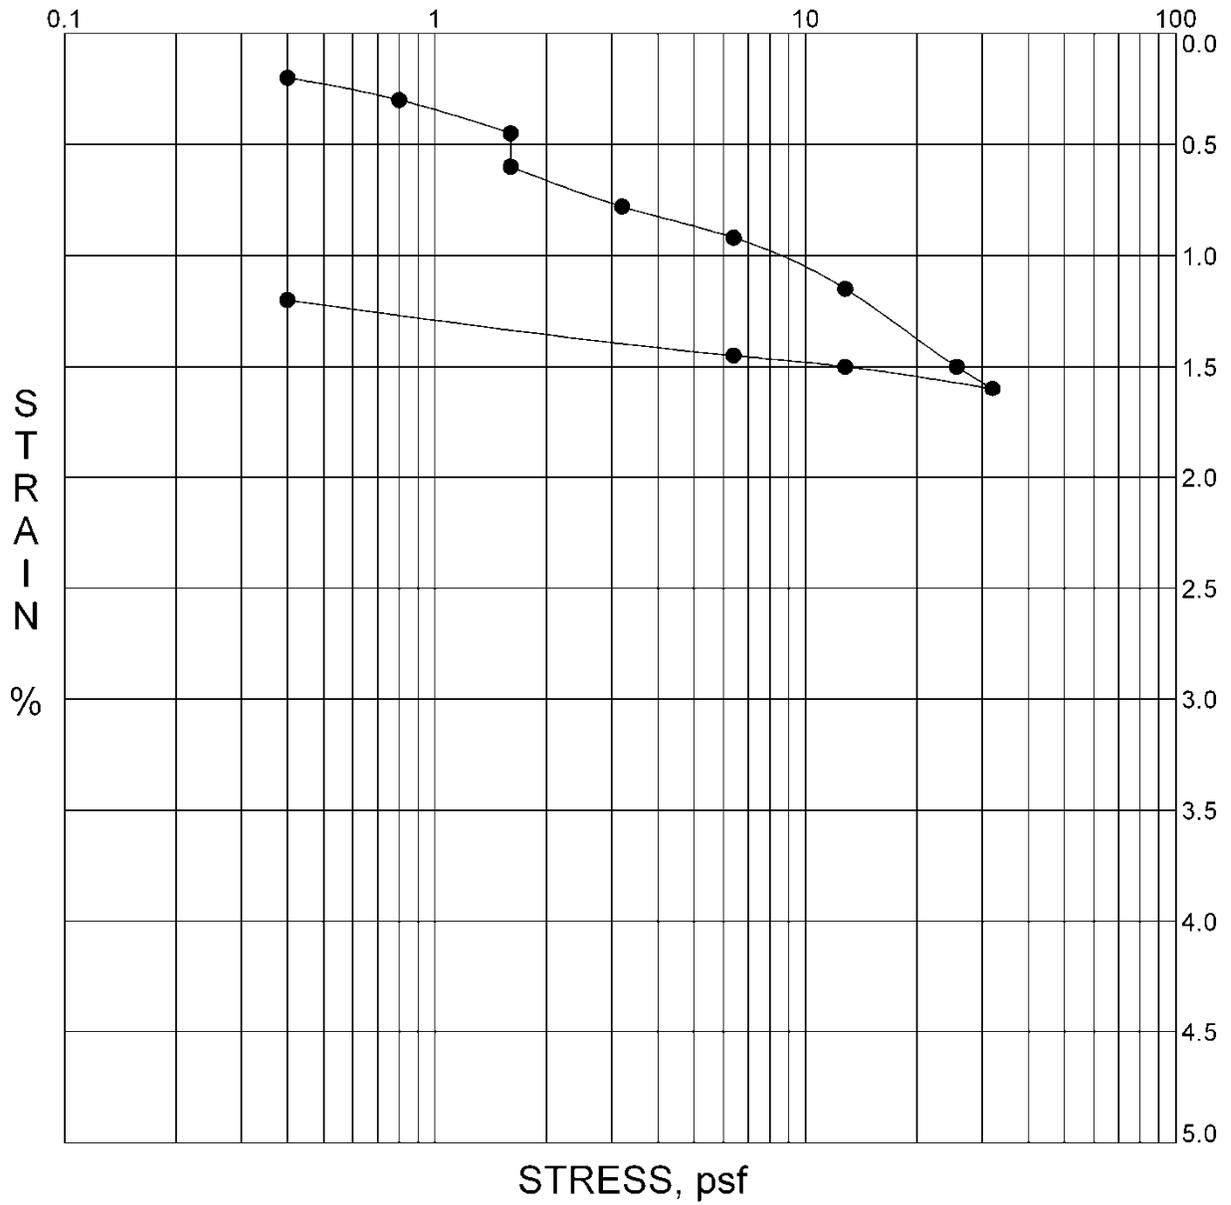
SAMPLE LOCATION: B-1 @ 90.0

DESCRIPTION: Qa

Test Results

Moisture Content (%)	Density (pcf)	Water Added At
Insitu: 5.2	Dry Density: 111.2	1600 lbs.

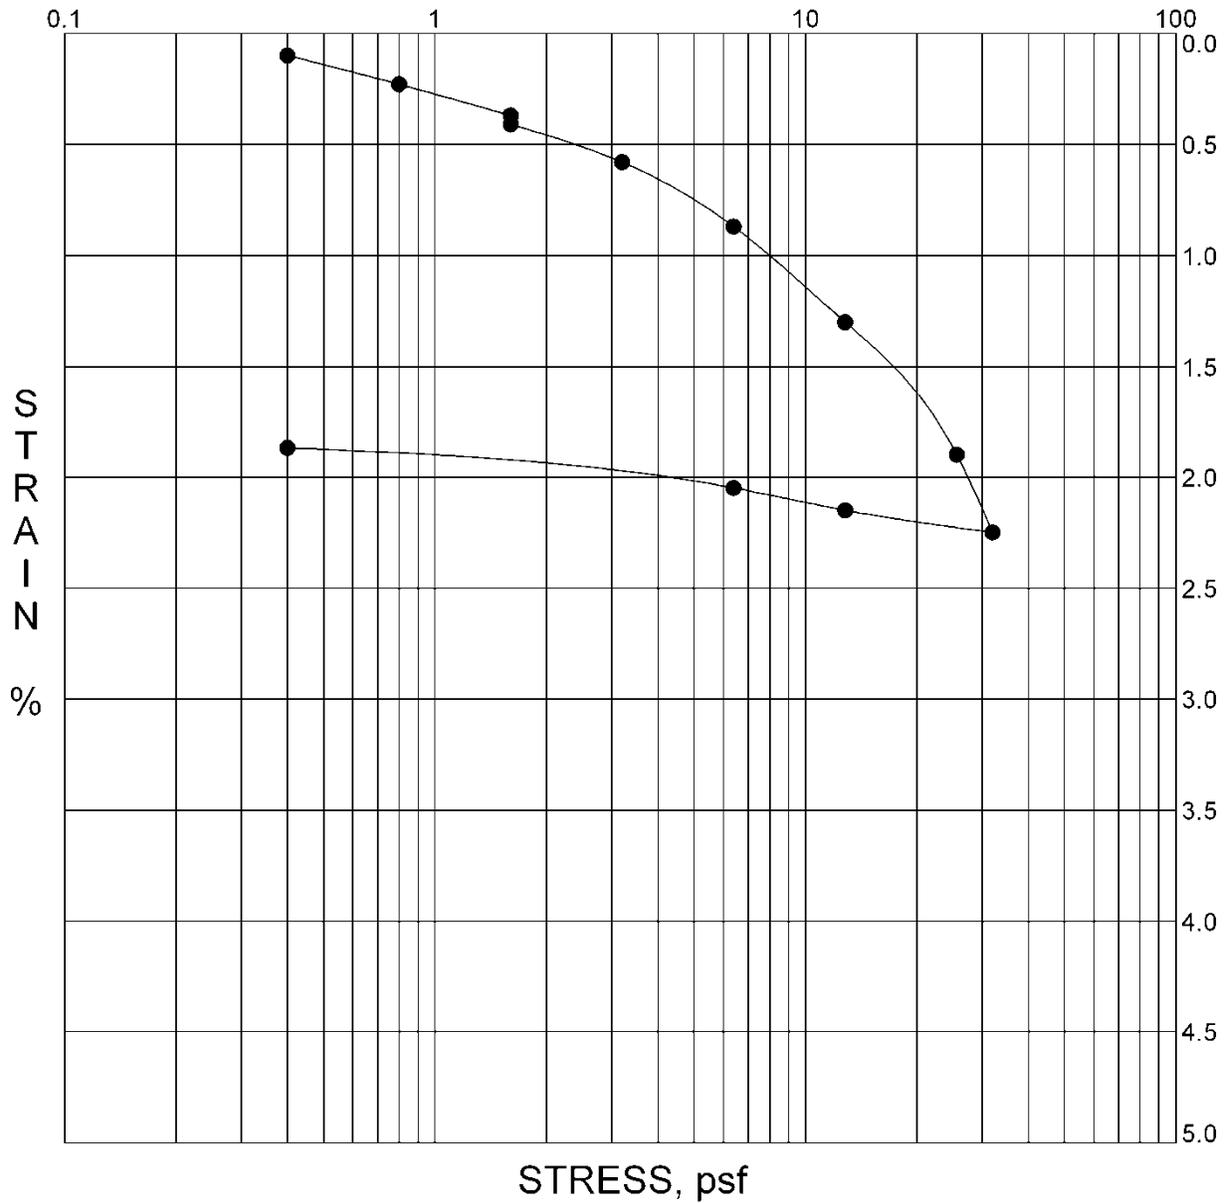
SAMPLE LOCATION: B-1 @ 100.0

DESCRIPTION: Qa

Test Results

Moisture Content (%)	Density (pcf)	Water Added At
Insitu: 15.2	Dry Density: 95.7	1600 lbs.

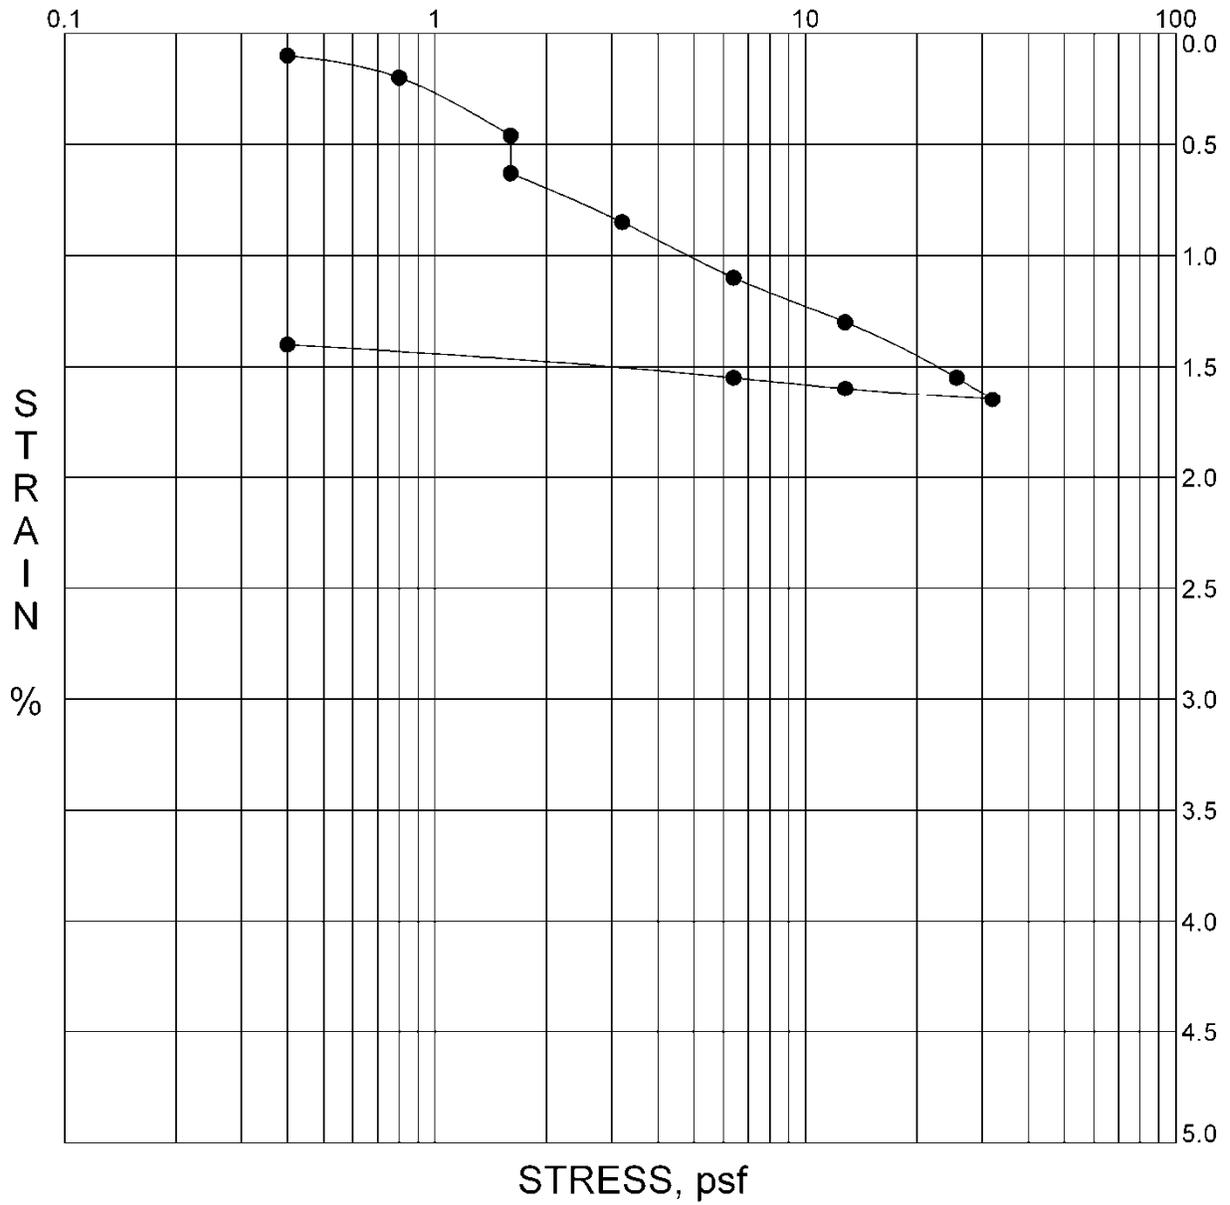
SAMPLE LOCATION: B-1 @ 105.0

DESCRIPTION: Qa

Test Results

Moisture Content (%)	Density (pcf)	Water Added At
In situ: 1.5	Dry Density: 115.2	1600 lbs.

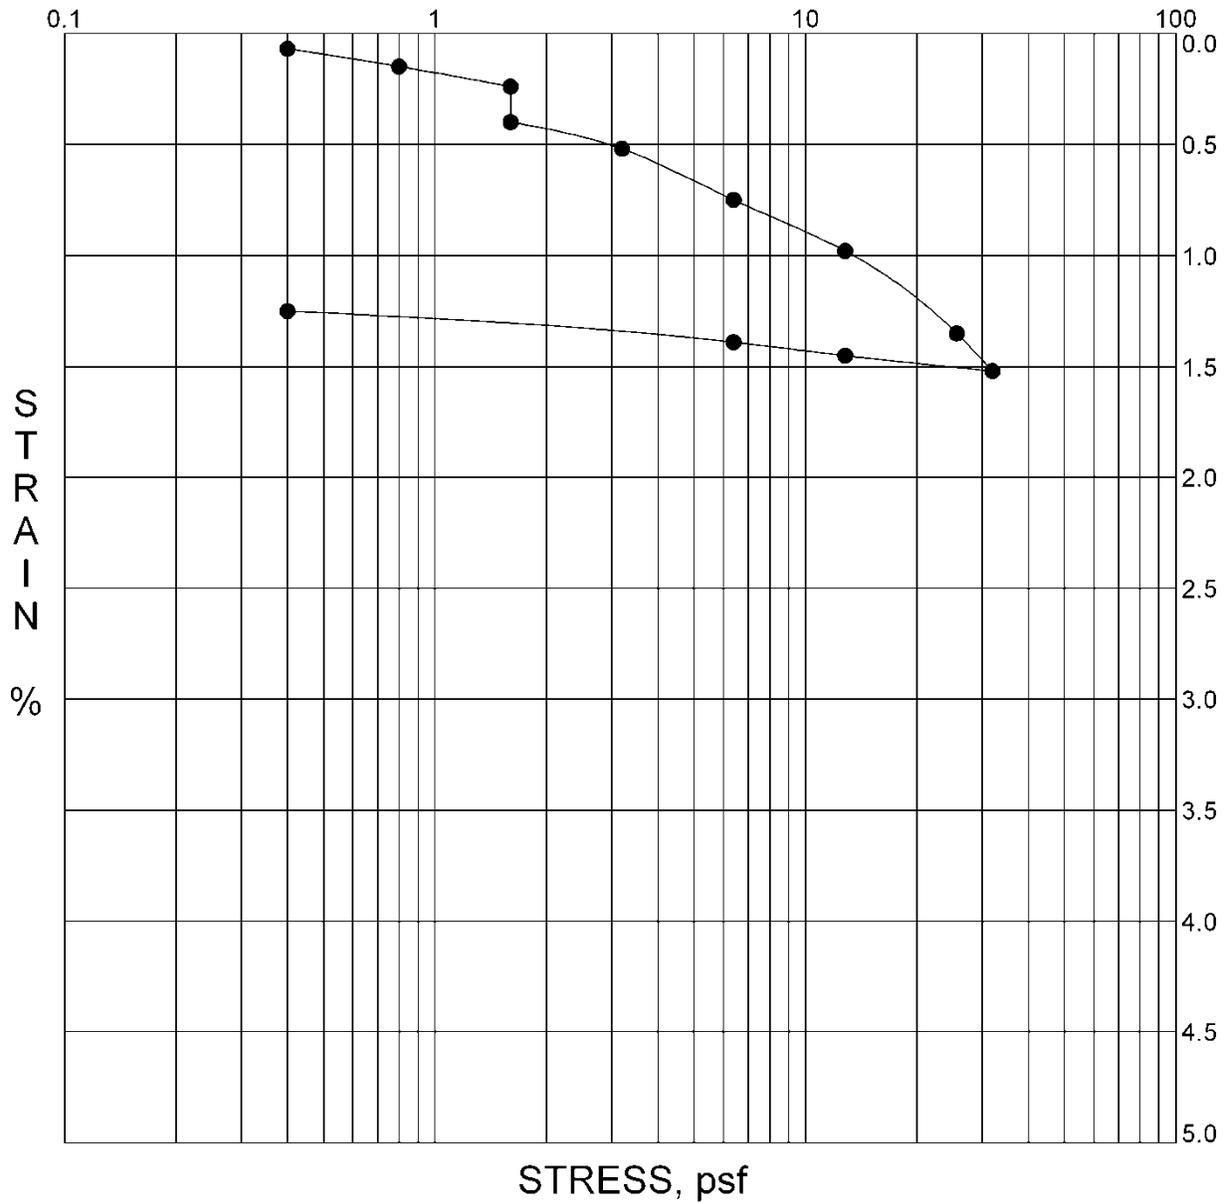
SAMPLE LOCATION: B-1 @ 115.0

DESCRIPTION: Qa

Test Results

Moisture Content (%)	Density (pcf)	Water Added At
In situ: 7.0	Dry Density: 117.9	1600 lbs.

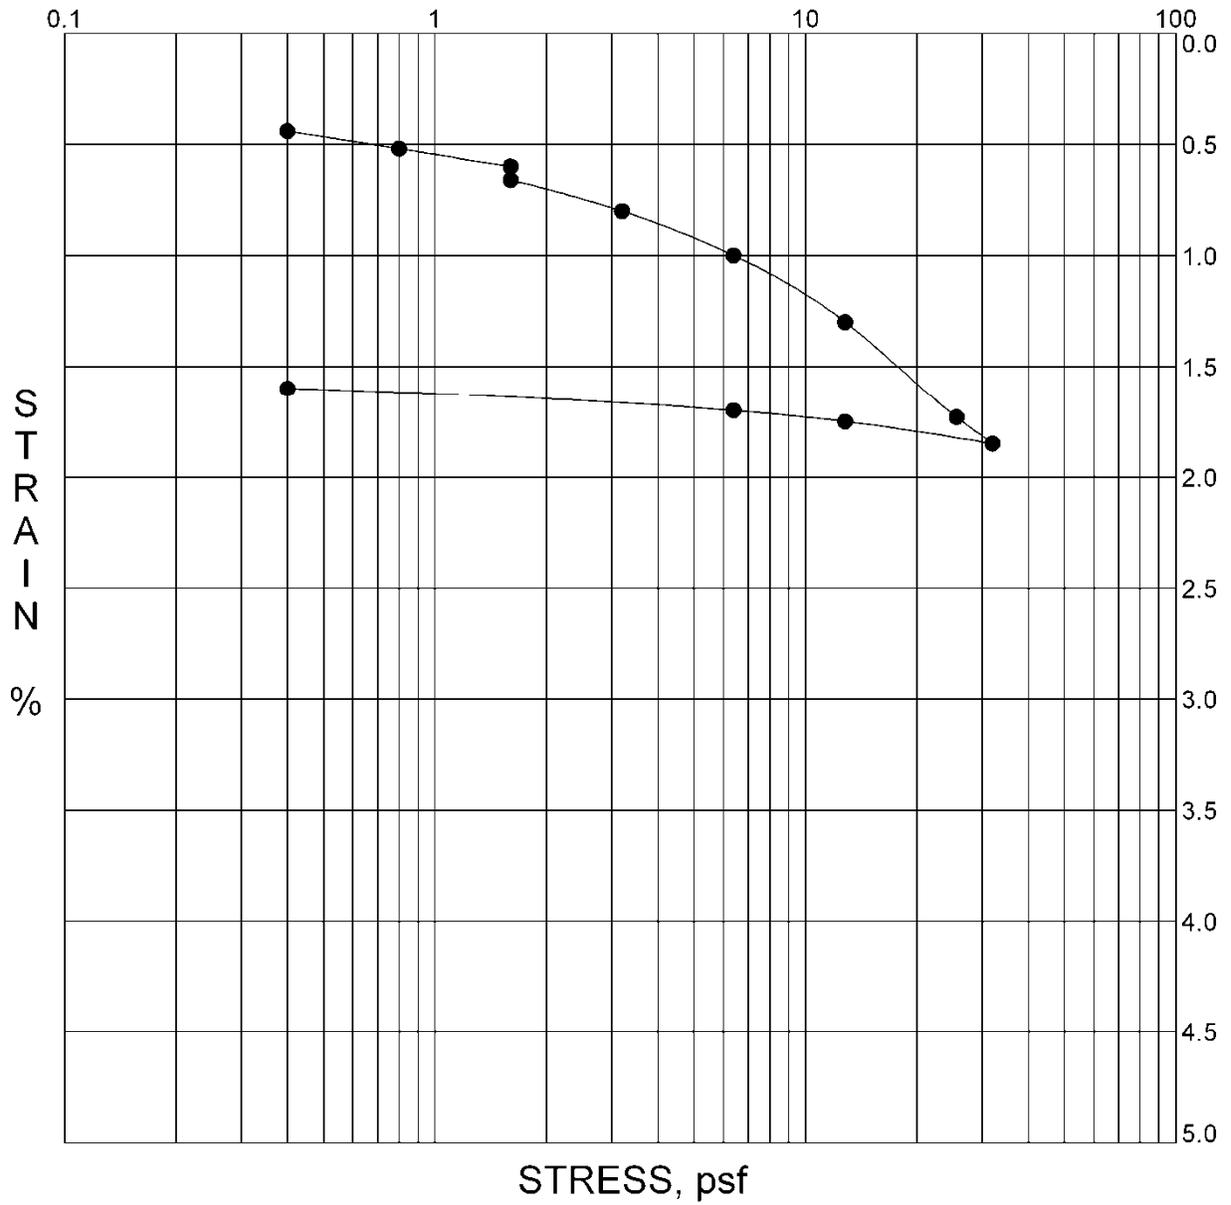
SAMPLE LOCATION: B-1 @ 135.0

DESCRIPTION: Qa

Test Results

Moisture Content (%)	Density (pcf)	Water Added At
In situ: 3.7	Dry Density: 111.1	1600 lbs.

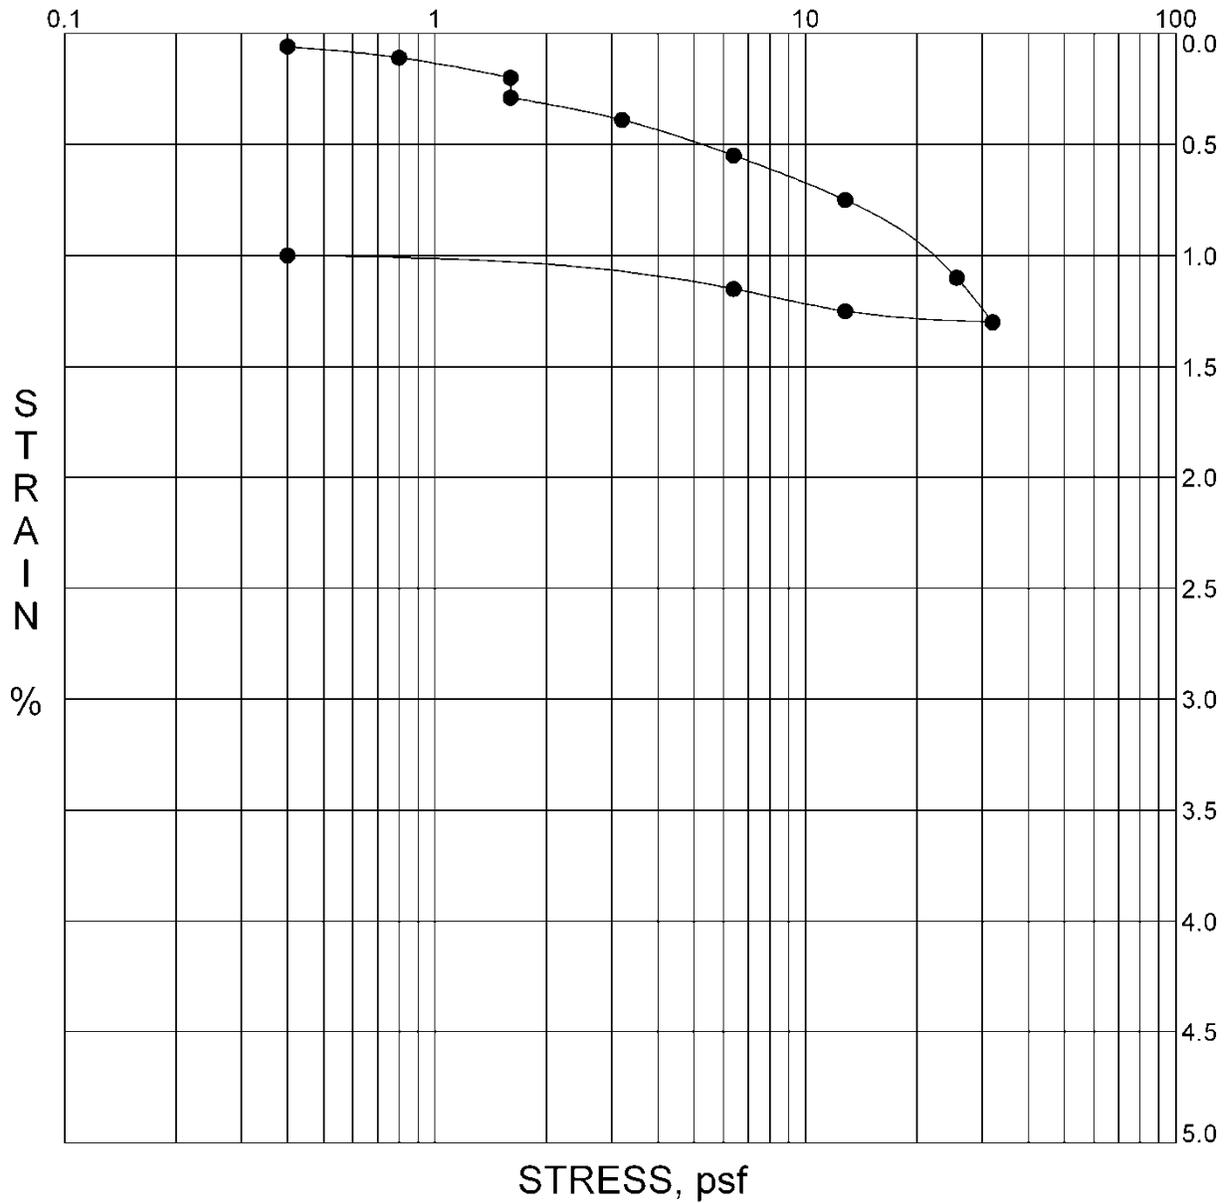
SAMPLE LOCATION: B-1 @ 145.0

DESCRIPTION: Qa

Test Results

Moisture Content (%)	Density (pcf)	Water Added At
In situ: 5.1	Dry Density: 115.3	1600 lbs.

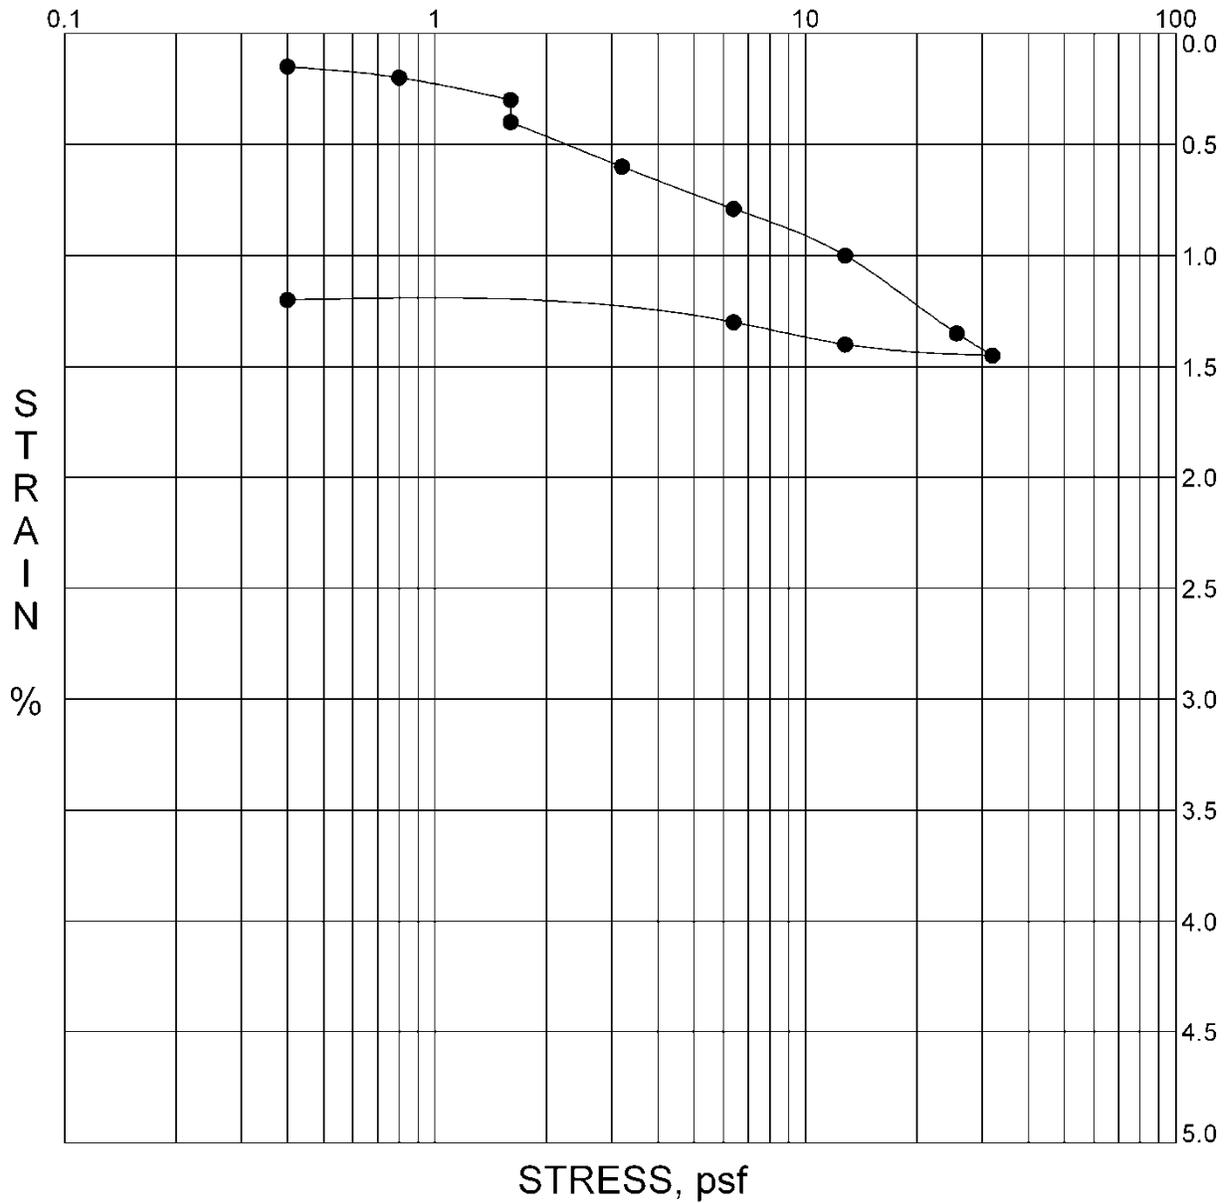
SAMPLE LOCATION: B-1 @ 160.0

DESCRIPTION: Qa

Test Results

Moisture Content (%)	Density (pcf)	Water Added At
Insitu: 14.9	Dry Density: 103.2	1600 lbs.

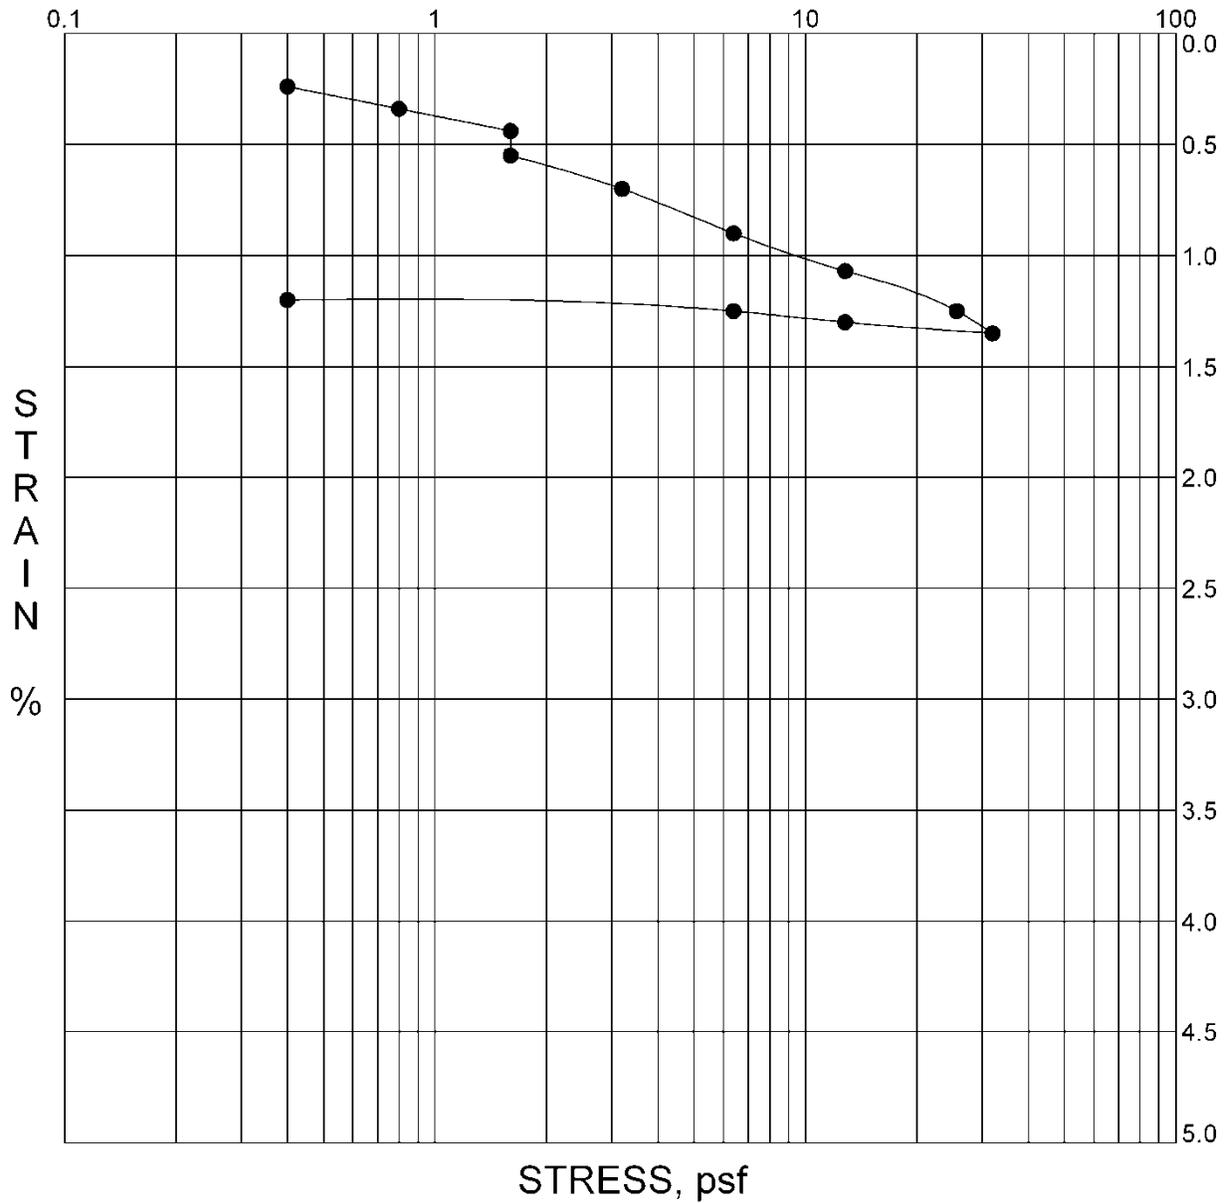
SAMPLE LOCATION: B-1 @ 170.0

DESCRIPTION: Qa

Test Results

Moisture Content (%)	Density (pcf)	Water Added At
In situ: 10.2	Dry Density: 111.4	1600 lbs.

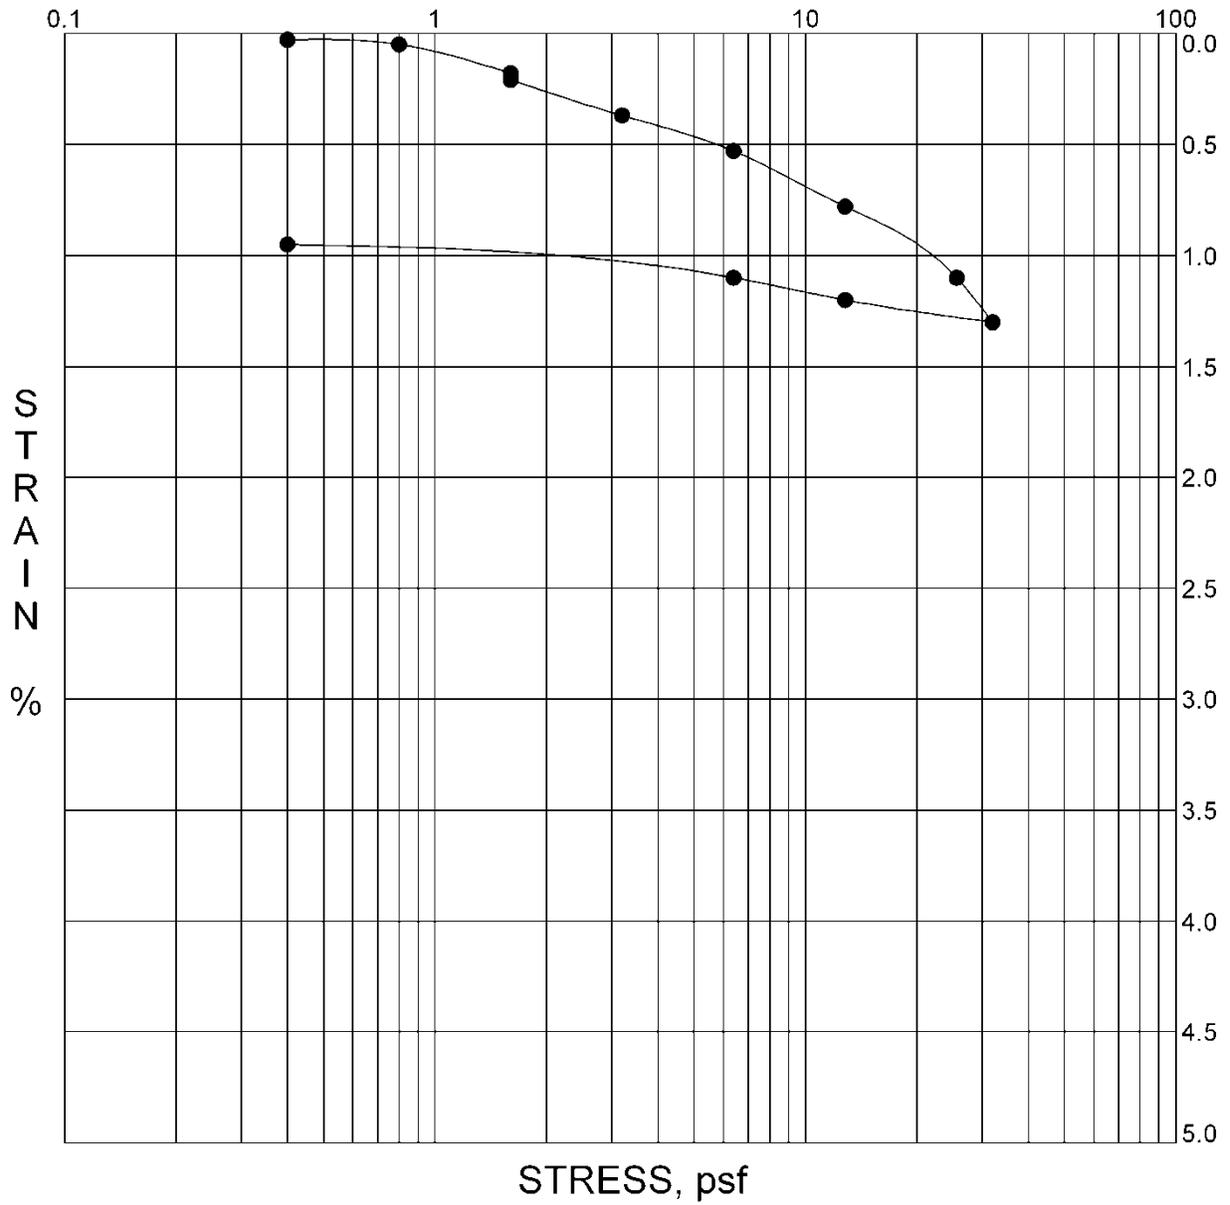
SAMPLE LOCATION: B-1 @ 180.0

DESCRIPTION: Qa

Test Results

Moisture Content (%)	Density (pcf)	Water Added At
Insitu: 9.0	Dry Density: 114.9	1600 lbs.

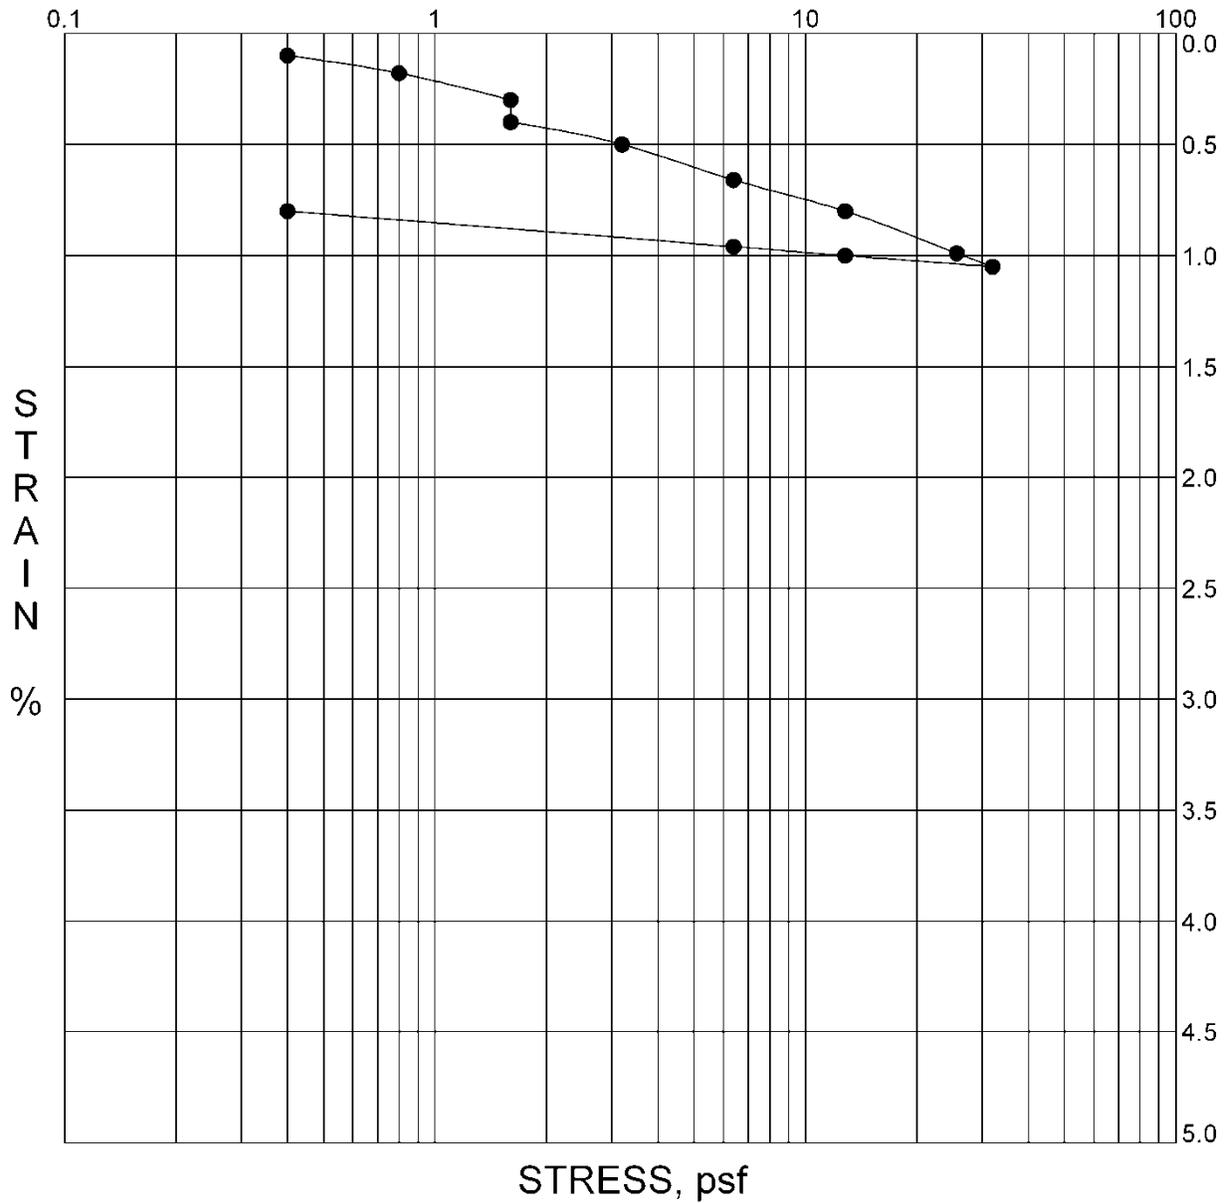
SAMPLE LOCATION: B-1 @ 190.0

DESCRIPTION: Qa

Test Results

Moisture Content (%)	Density (pcf)	Water Added At
Insitu: 6.6	Dry Density: 116.8	1600 lbs.

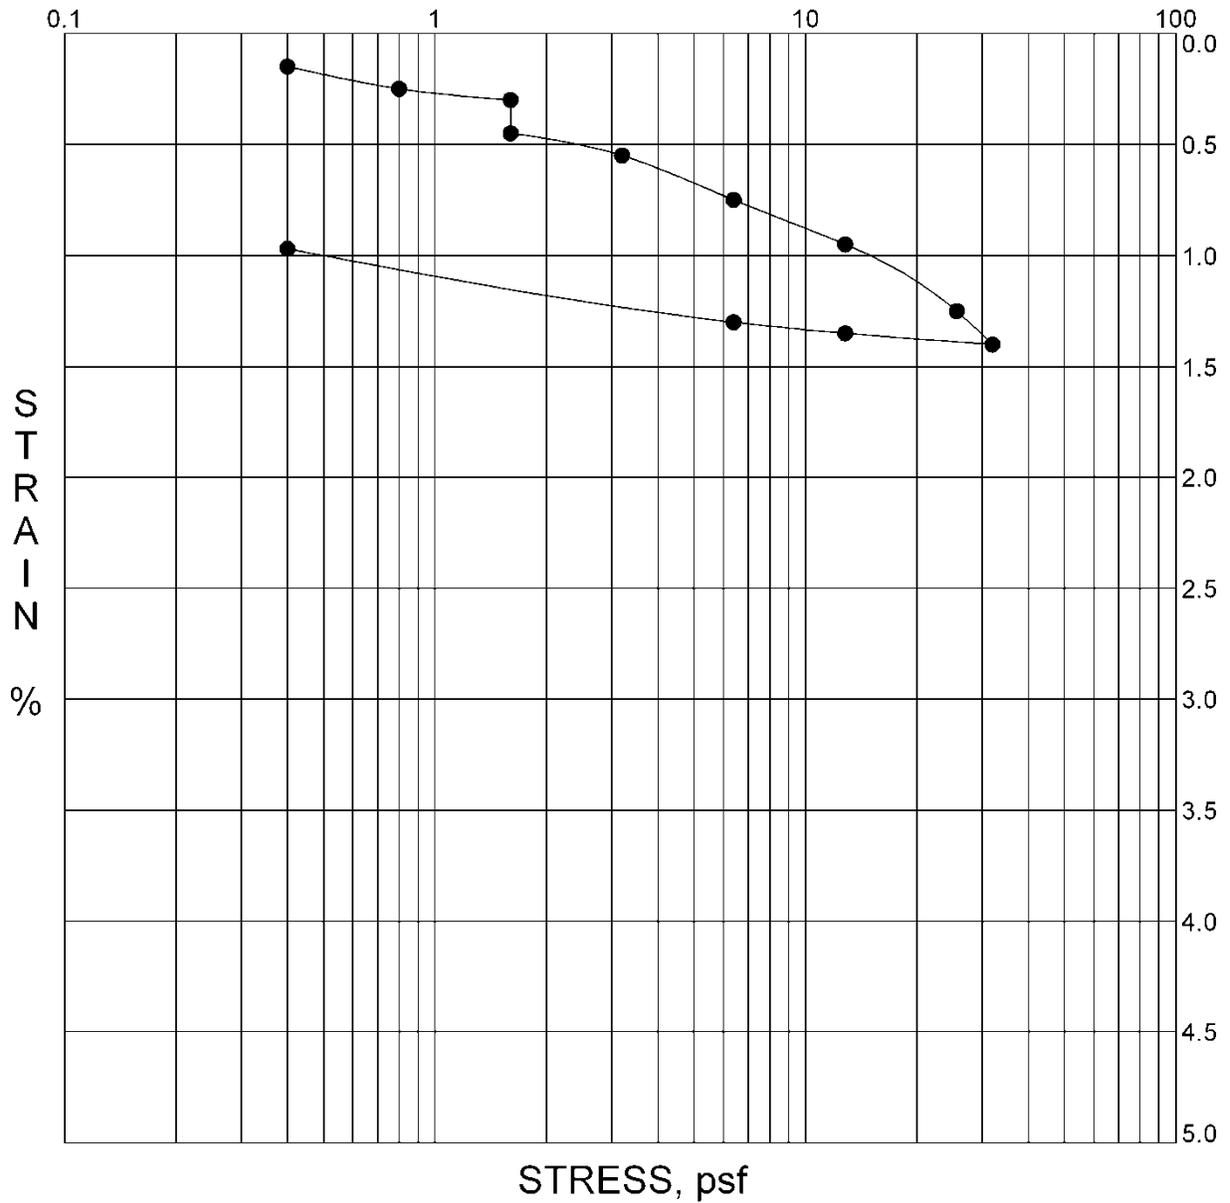
SAMPLE LOCATION: B-2 @ 45.0

DESCRIPTION: Qa

Test Results

Moisture Content (%)	Density (pcf)	Water Added At
In situ: 12.1	Dry Density: 111.8	1600 lbs.

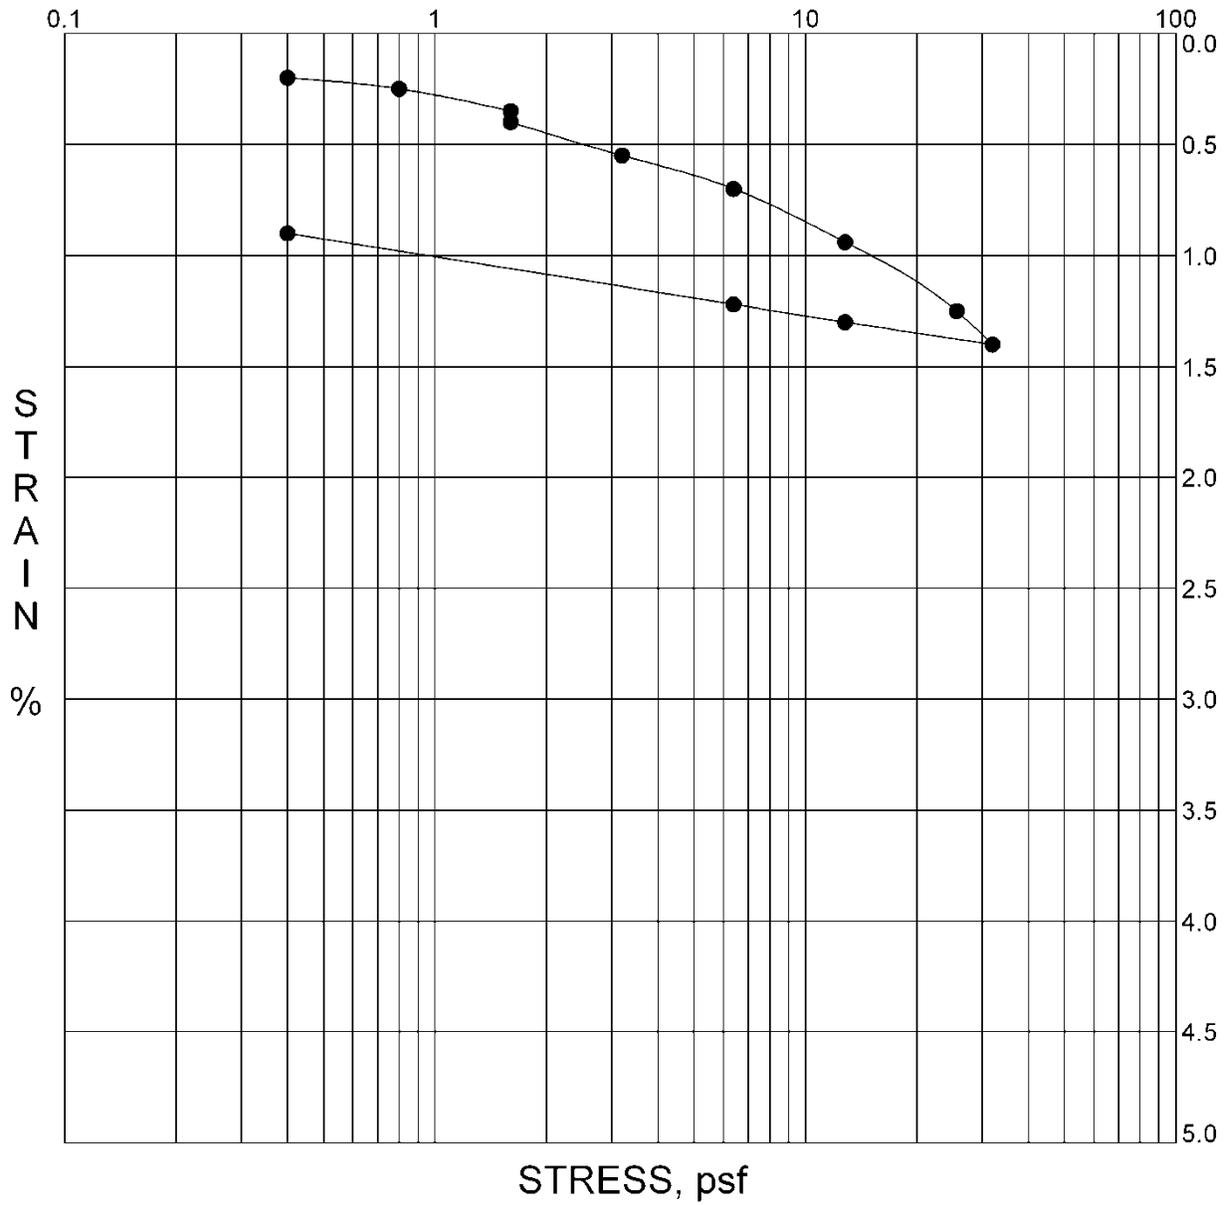
SAMPLE LOCATION: B-2 @ 60.0

DESCRIPTION: Qa

Test Results

Moisture Content (%)	Density (pcf)	Water Added At
Insitu: 10.0	Dry Density: 116.2	1600 lbs.

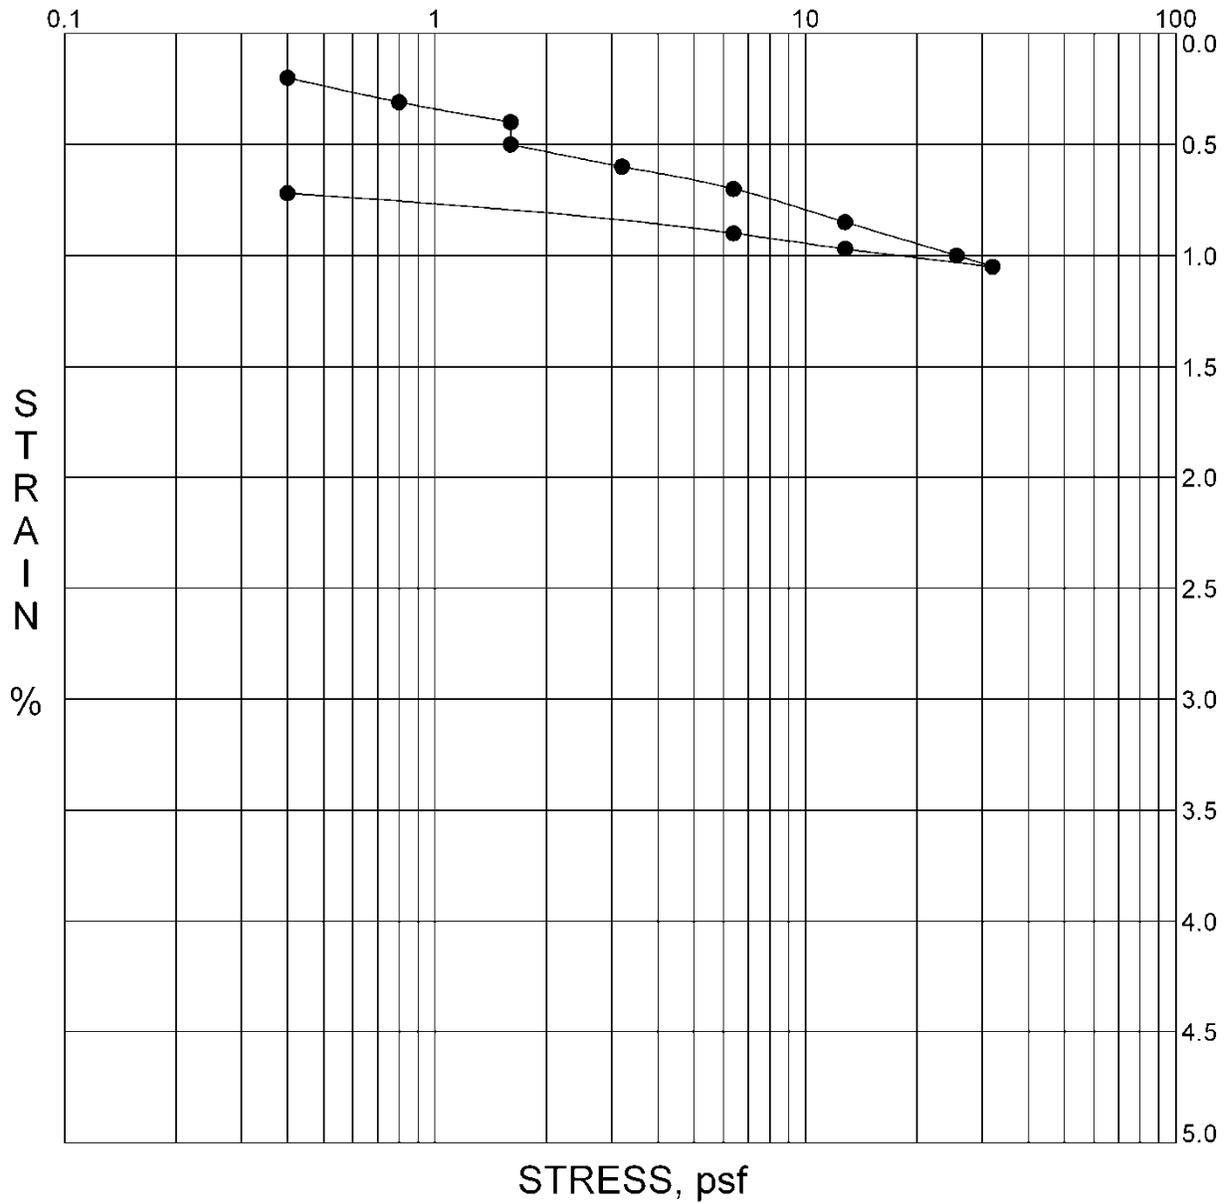
SAMPLE LOCATION: B-2 @ 65.0

DESCRIPTION: Qa

Test Results

Moisture Content (%)	Density (pcf)	Water Added At
In situ: 10.1	Dry Density: 119.5	1600 lbs.
