**PRELIMINARY GEOTECHNICAL
ENGINEERING INVESTIGATION**

**Proposed 13-Story Hotel Expansion
Over Partial One Level Subgrade Parking
&
22-Story Residential Building
Over 3-4 Levels Subgrade Parking**

**1246 S. Hope Street
&
427 W. Pico Boulevard
Los Angeles, California**

Project 5076

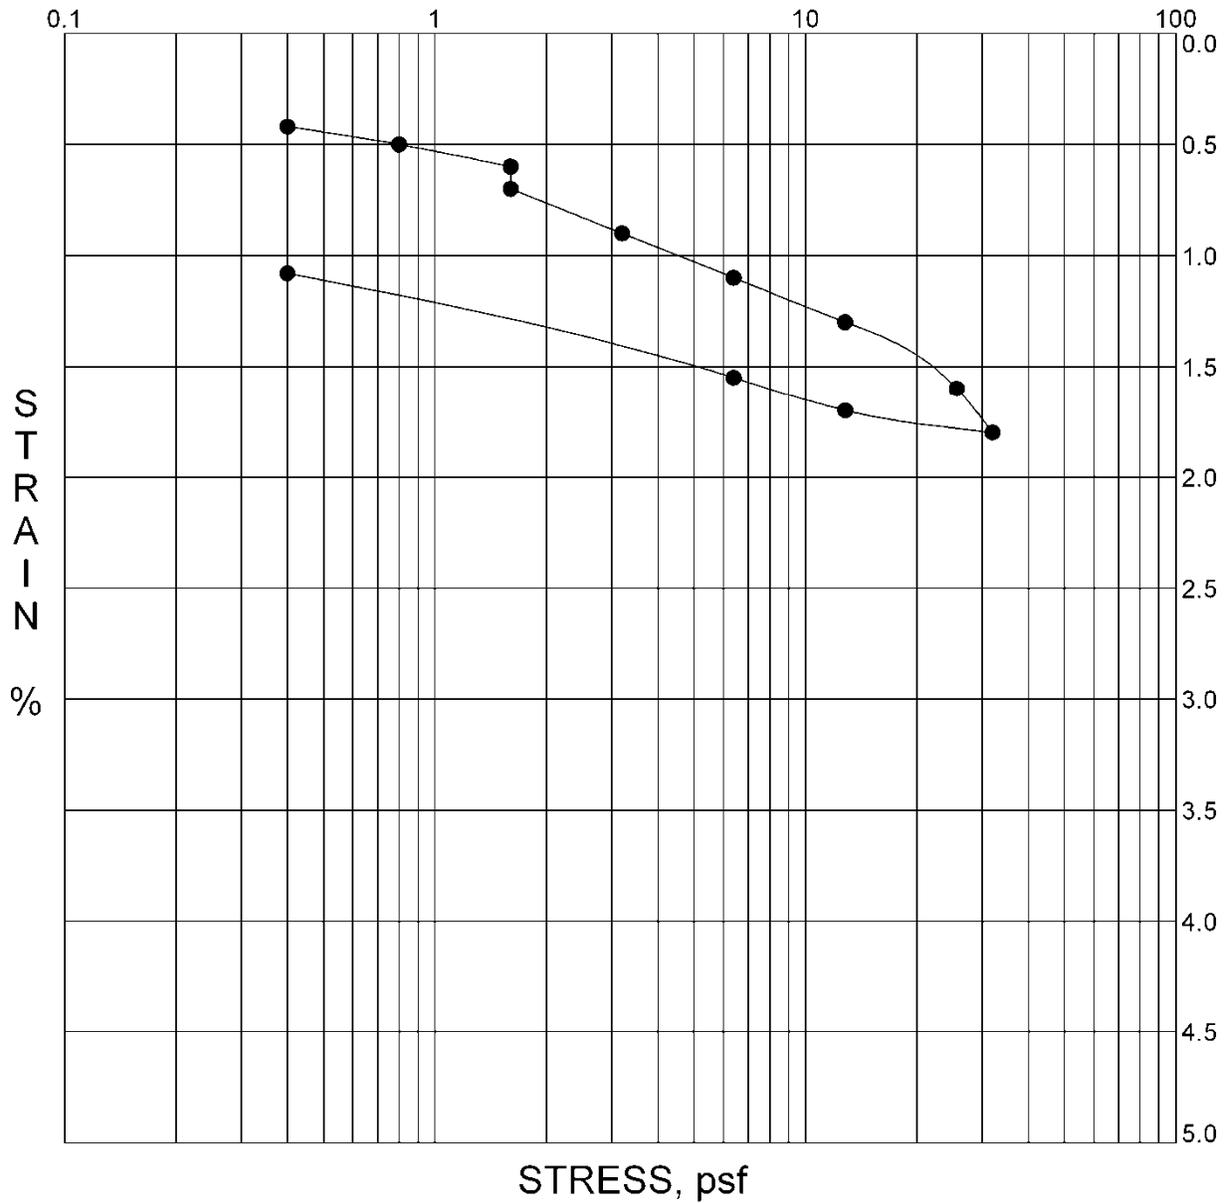
SAMPLE LOCATION: B-2 @ 75.0

DESCRIPTION: Qa

Test Results

Moisture Content (%)	Density (pcf)	Water Added At
Insitu: 3.0	Dry Density: 118.5	1600 lbs.

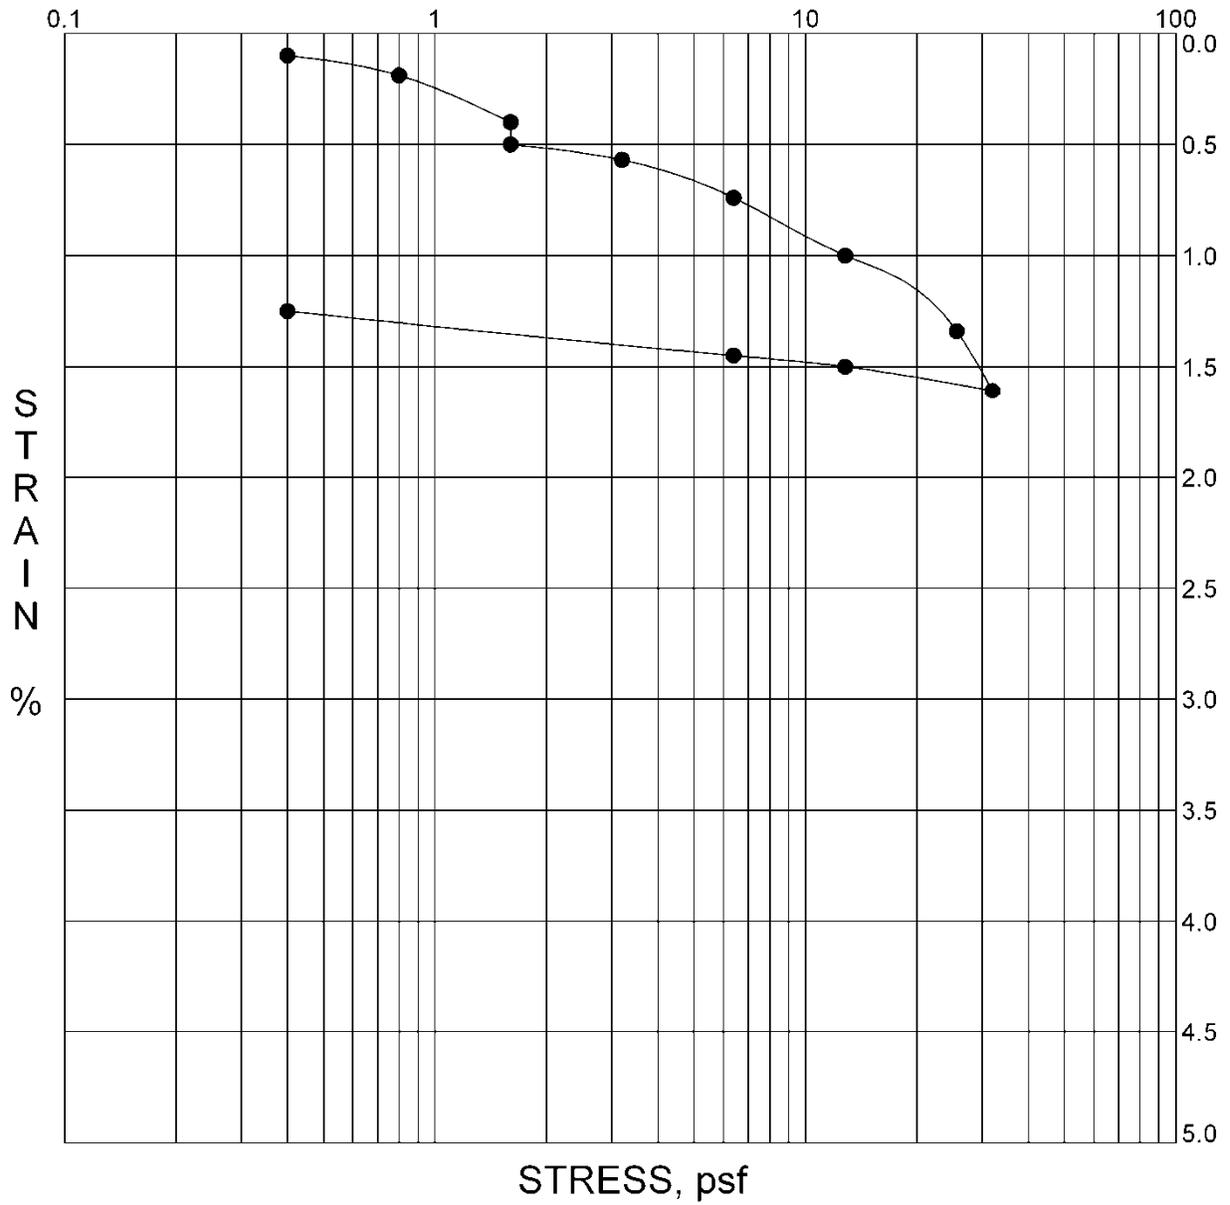
SAMPLE LOCATION: B-3 @ 45.0

DESCRIPTION: Qa

Test Results

Moisture Content (%)	Density (pcf)	Water Added At
Insitu: 15.0	Dry Density: 103.9	1600 lbs.

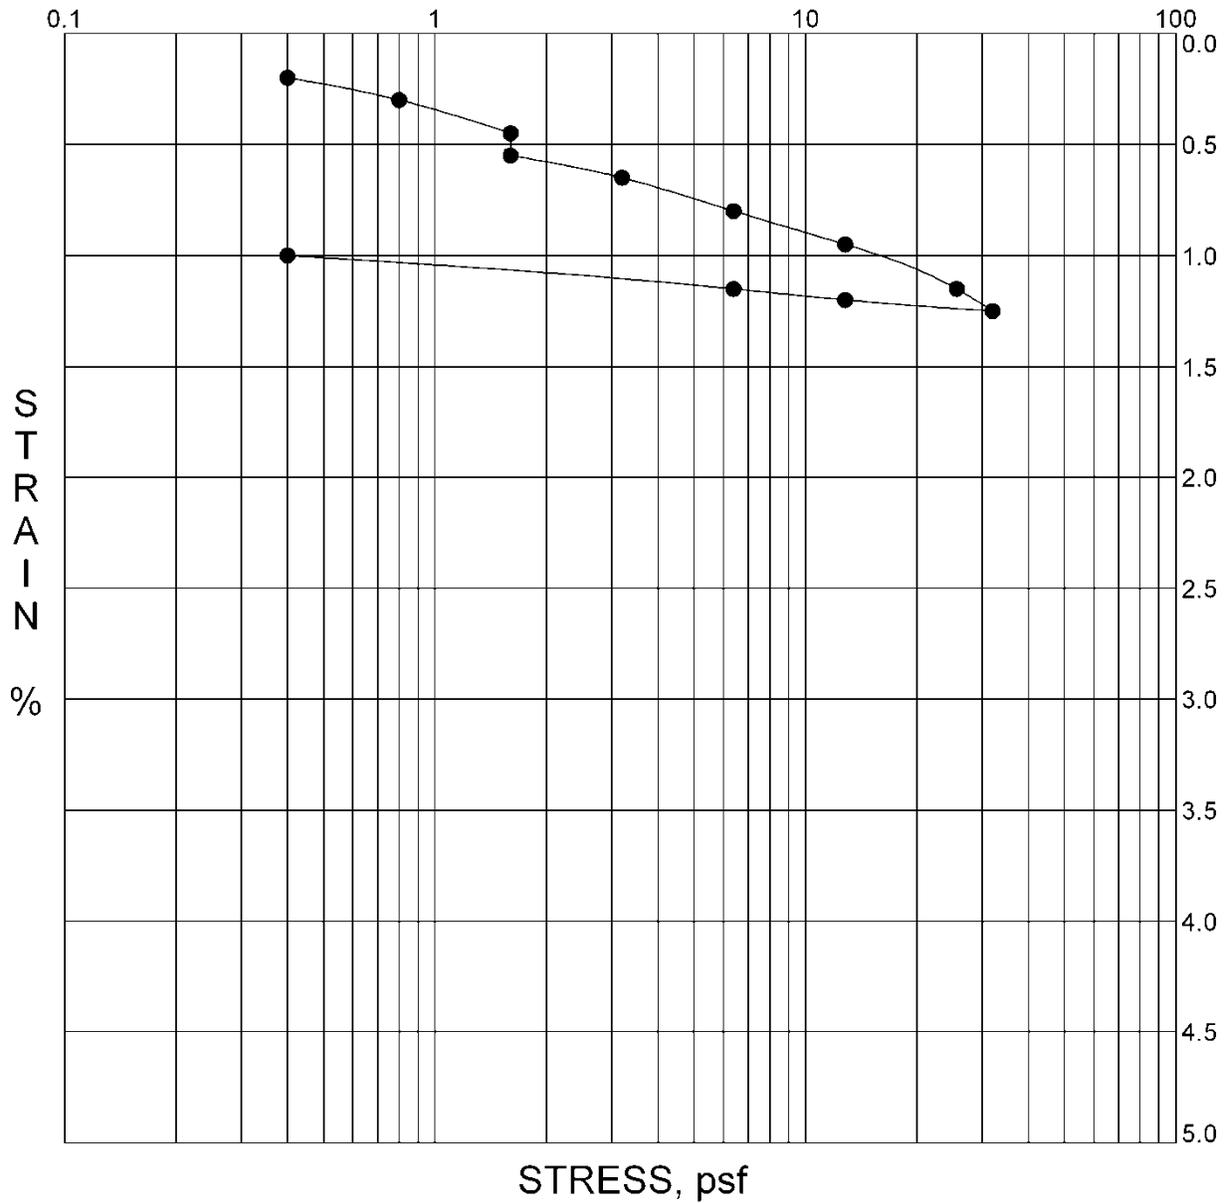
SAMPLE LOCATION: B-3 @ 55.0

DESCRIPTION: Qa

Test Results

Moisture Content (%)	Density (pcf)	Water Added At
In situ: 11.6	Dry Density: 113.0	1600 lbs.

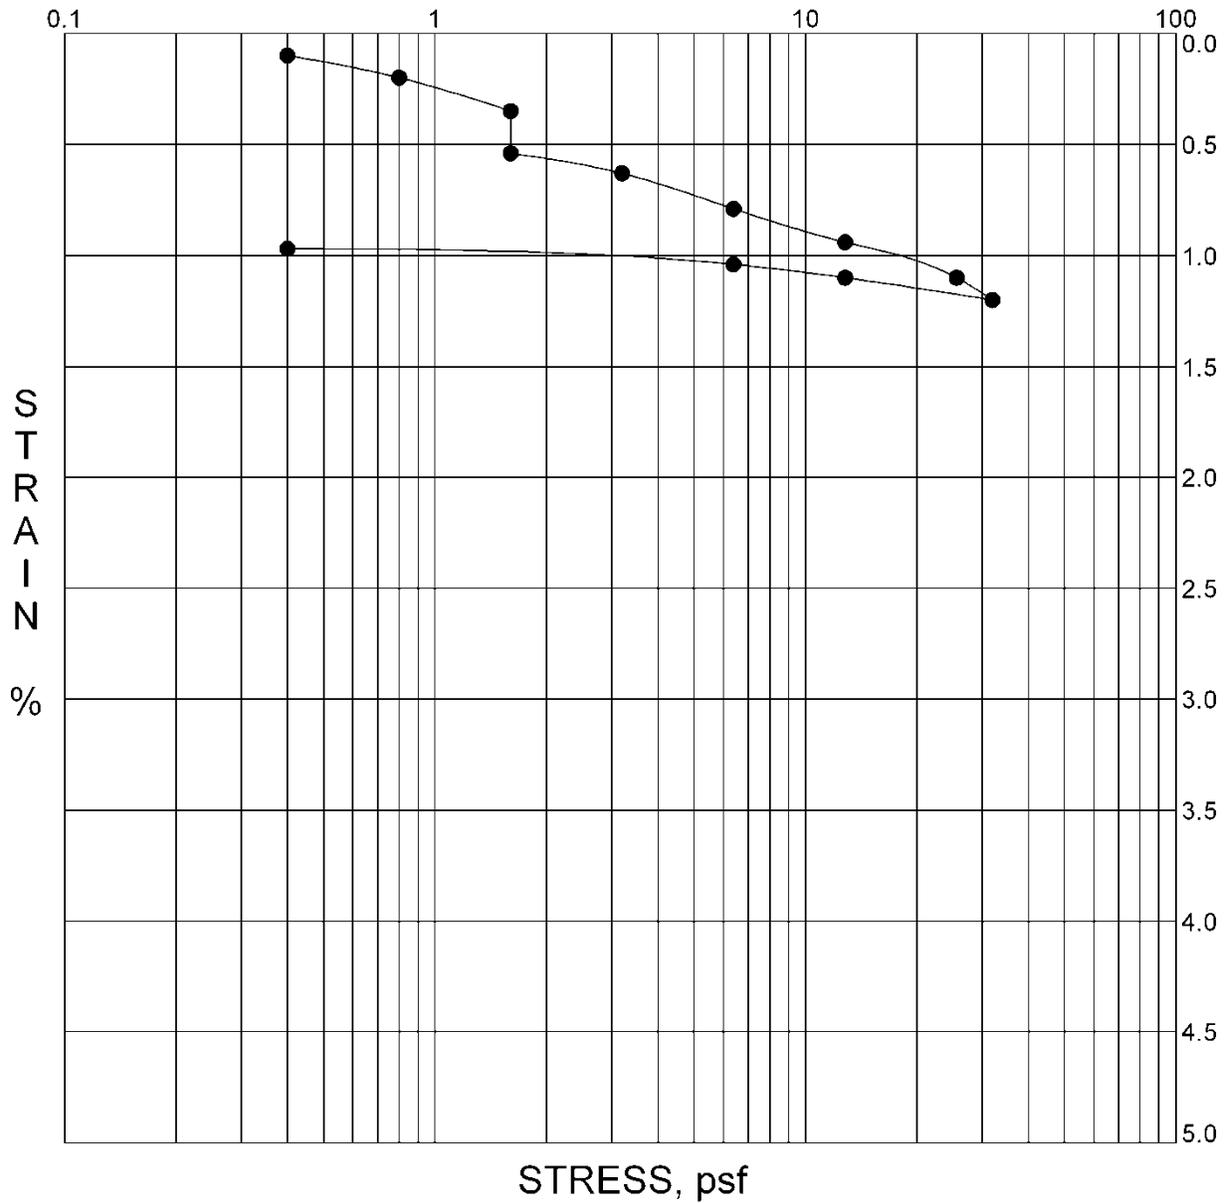
SAMPLE LOCATION: B-3 @ 70.0

DESCRIPTION: Qa

Test Results

Moisture Content (%)	Density (pcf)	Water Added At
Insitu: 4.9	Dry Density: 122.6	1600 lbs.

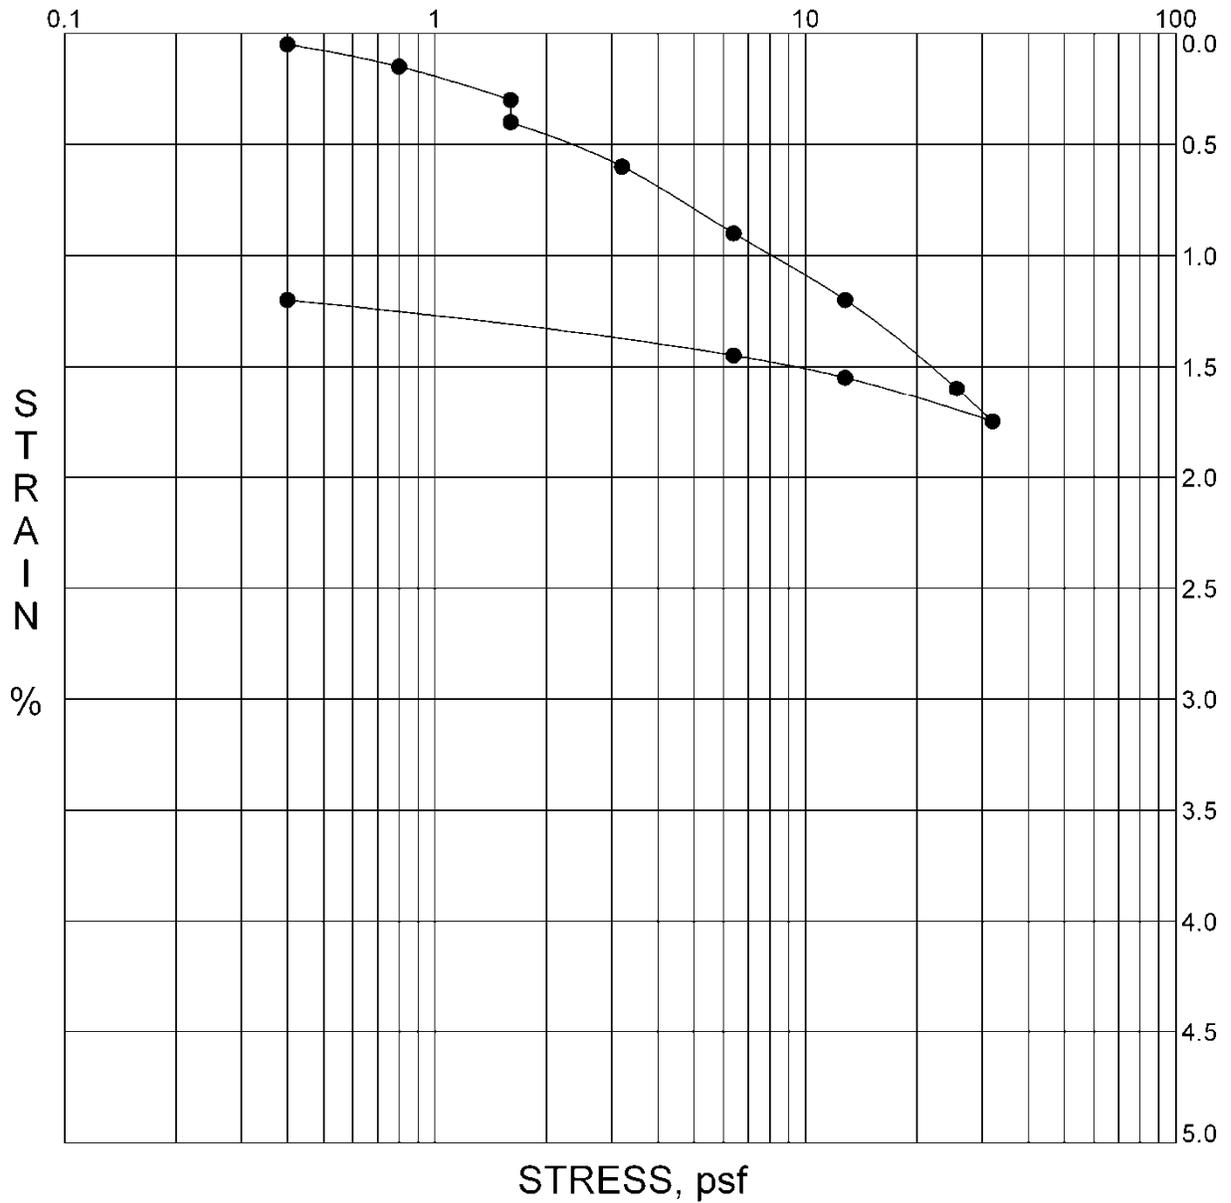
SAMPLE LOCATION: B-3 @ 75.0

DESCRIPTION: Qa

Test Results

Moisture Content (%)	Density (pcf)	Water Added At
In situ: 2.4	Dry Density: 124.0	1600 lbs.

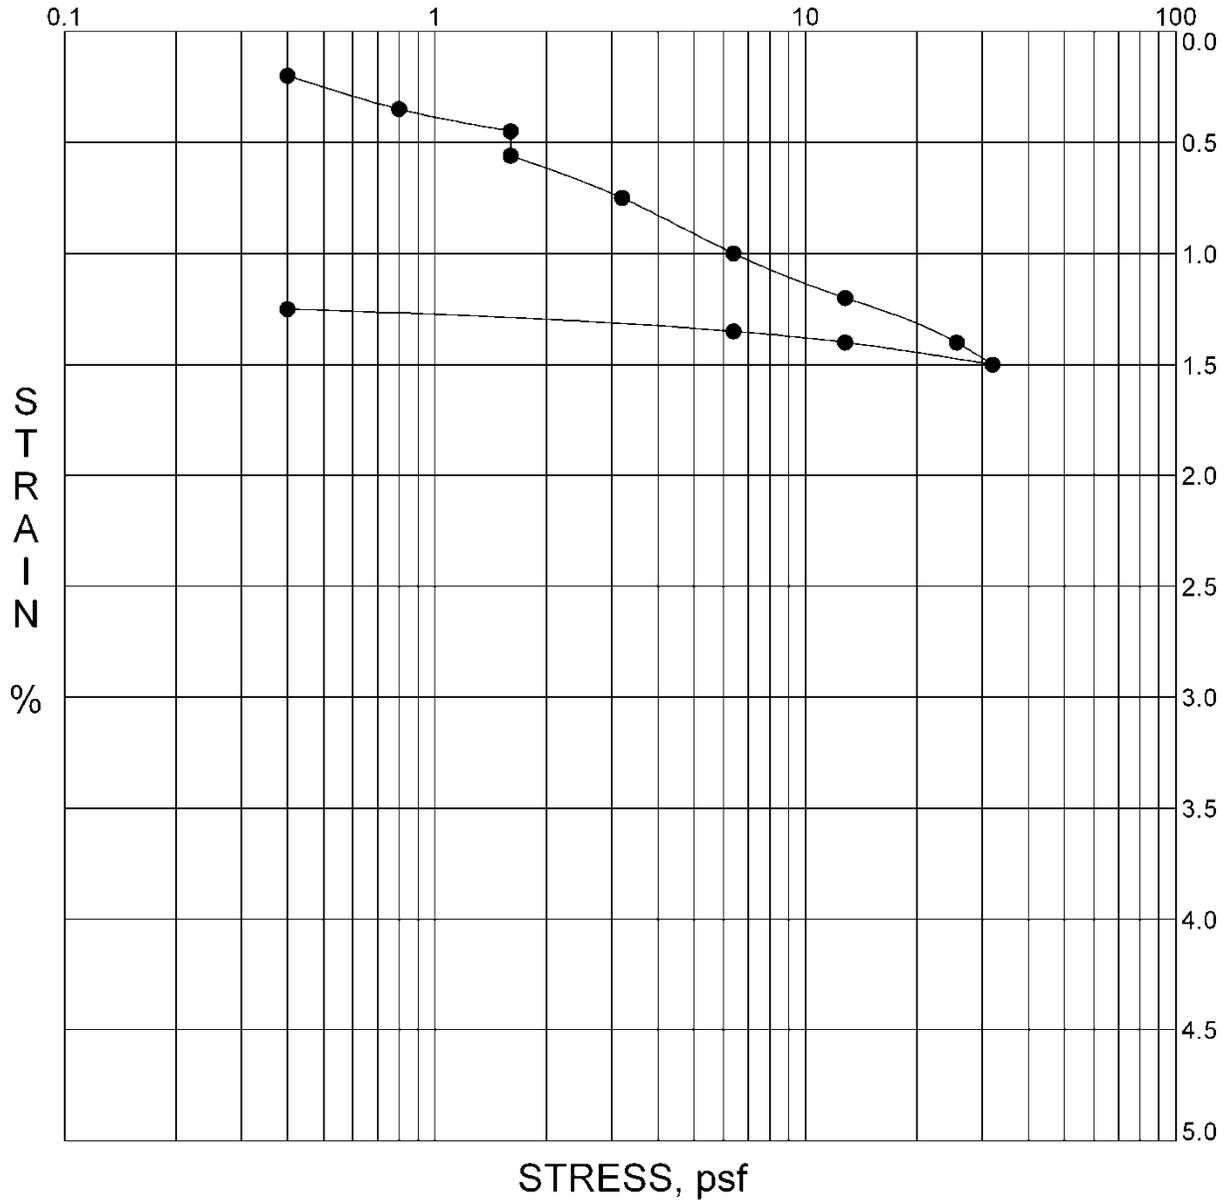
SAMPLE LOCATION: B-4 @ 10.0

DESCRIPTION: Qa1

Test Results

Moisture Content (%)	Density (pcf)	Water Added At
Insitu: 4.2	Dry Density: 116.8	1600 lbs.

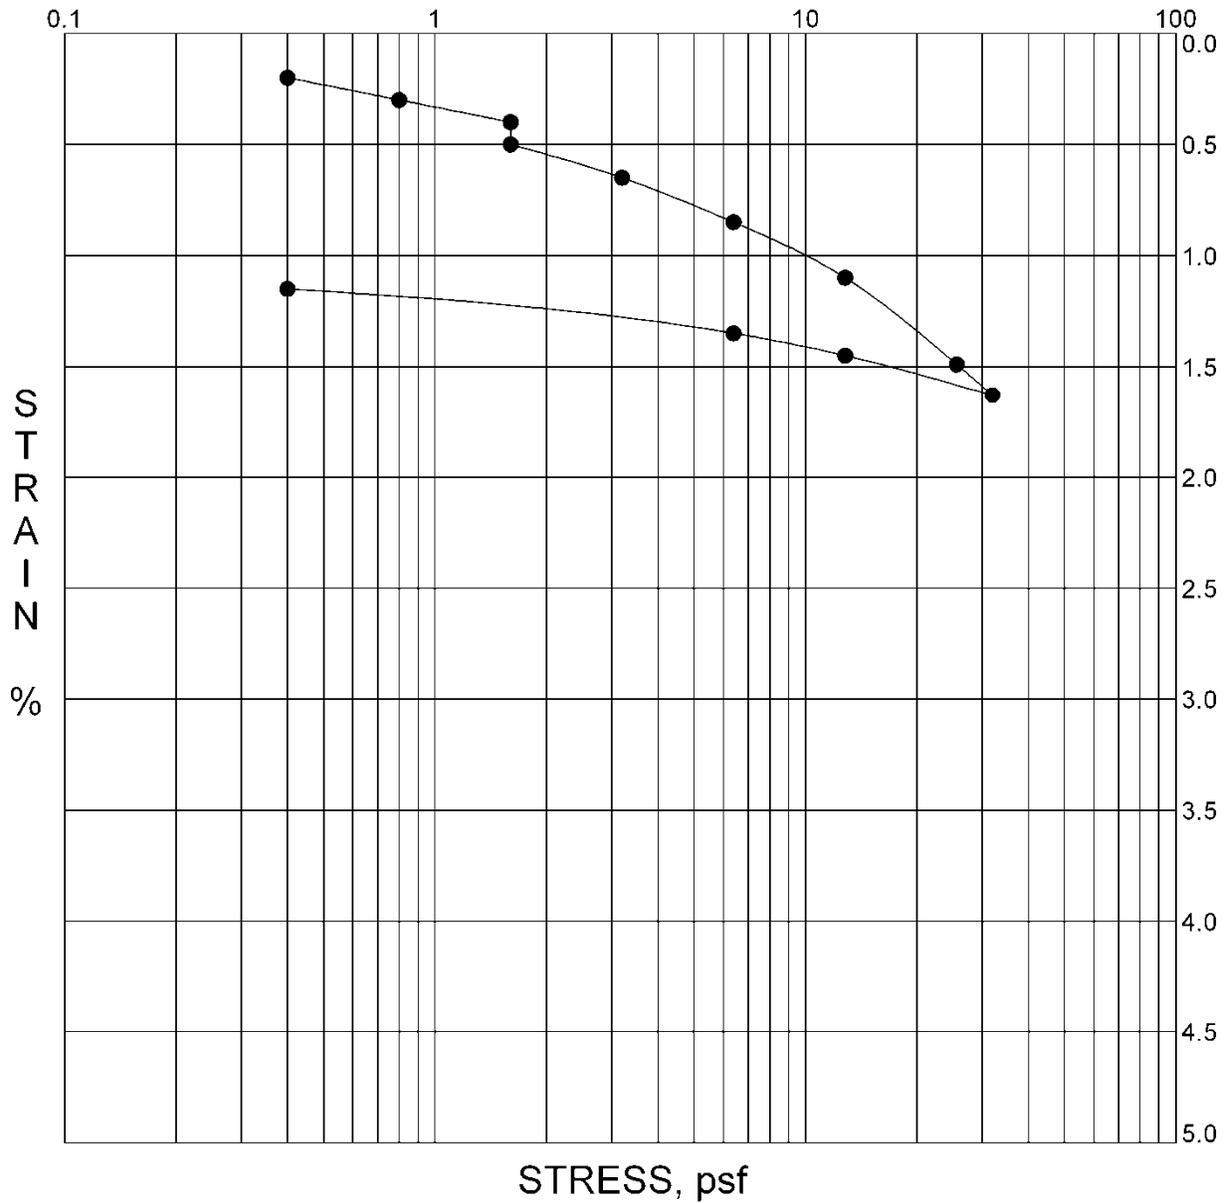
SAMPLE LOCATION: B-4 @ 20.0

Test Results

Moisture Content (%)	Density (pcf)	Water Added At
In situ: 8.7	Dry Density: 115.2	1600 lbs.

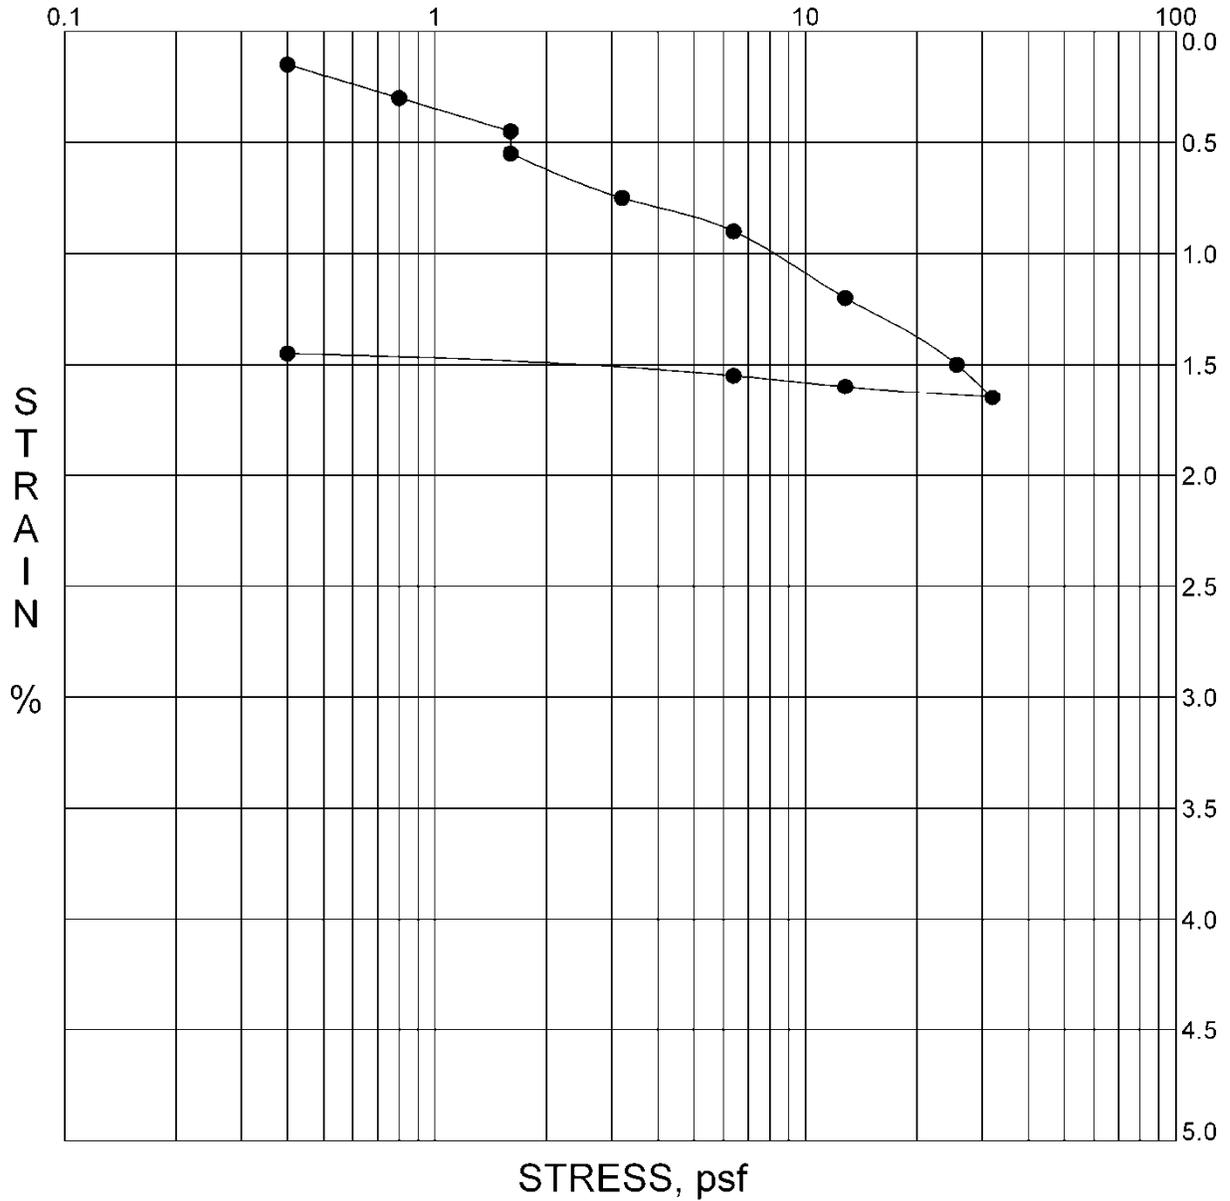
SAMPLE LOCATION: B-4 @ 25.0

DESCRIPTION: Qal

Test Results

Moisture Content (%)	Density (pcf)	Water Added At
Insitu: 4.7	Dry Density: 114.9	1600 lbs.

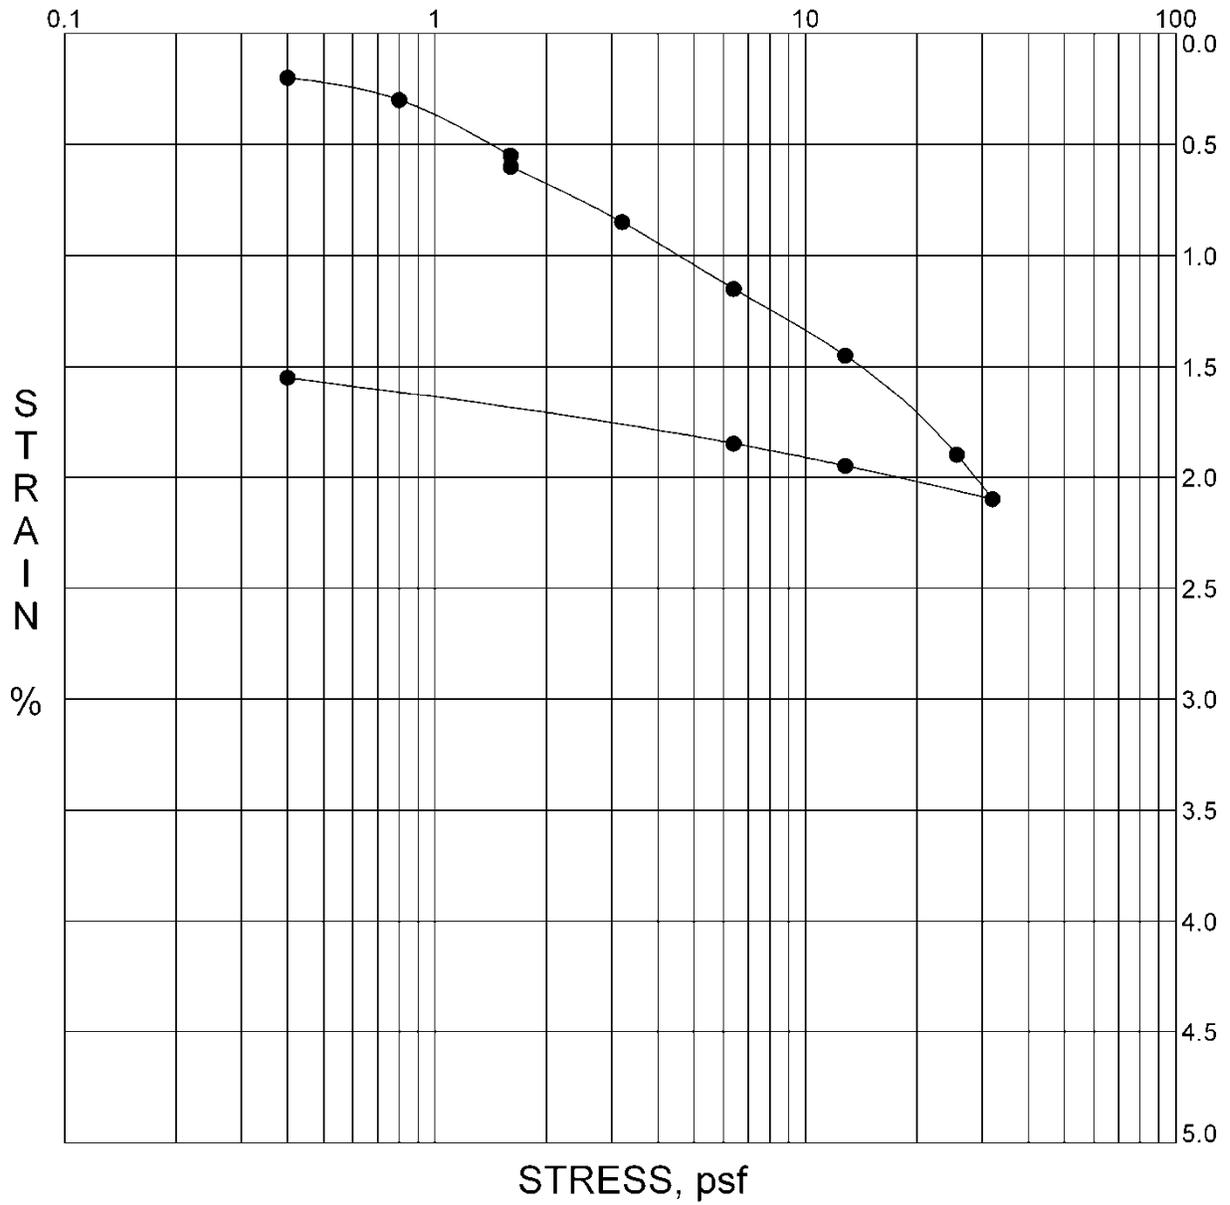
SAMPLE LOCATION: B-4 @ 30.0

Test Results

Moisture Content (%)	Density (pcf)	Water Added At
In situ: 5.9	Dry Density: 112.8	1600 lbs.

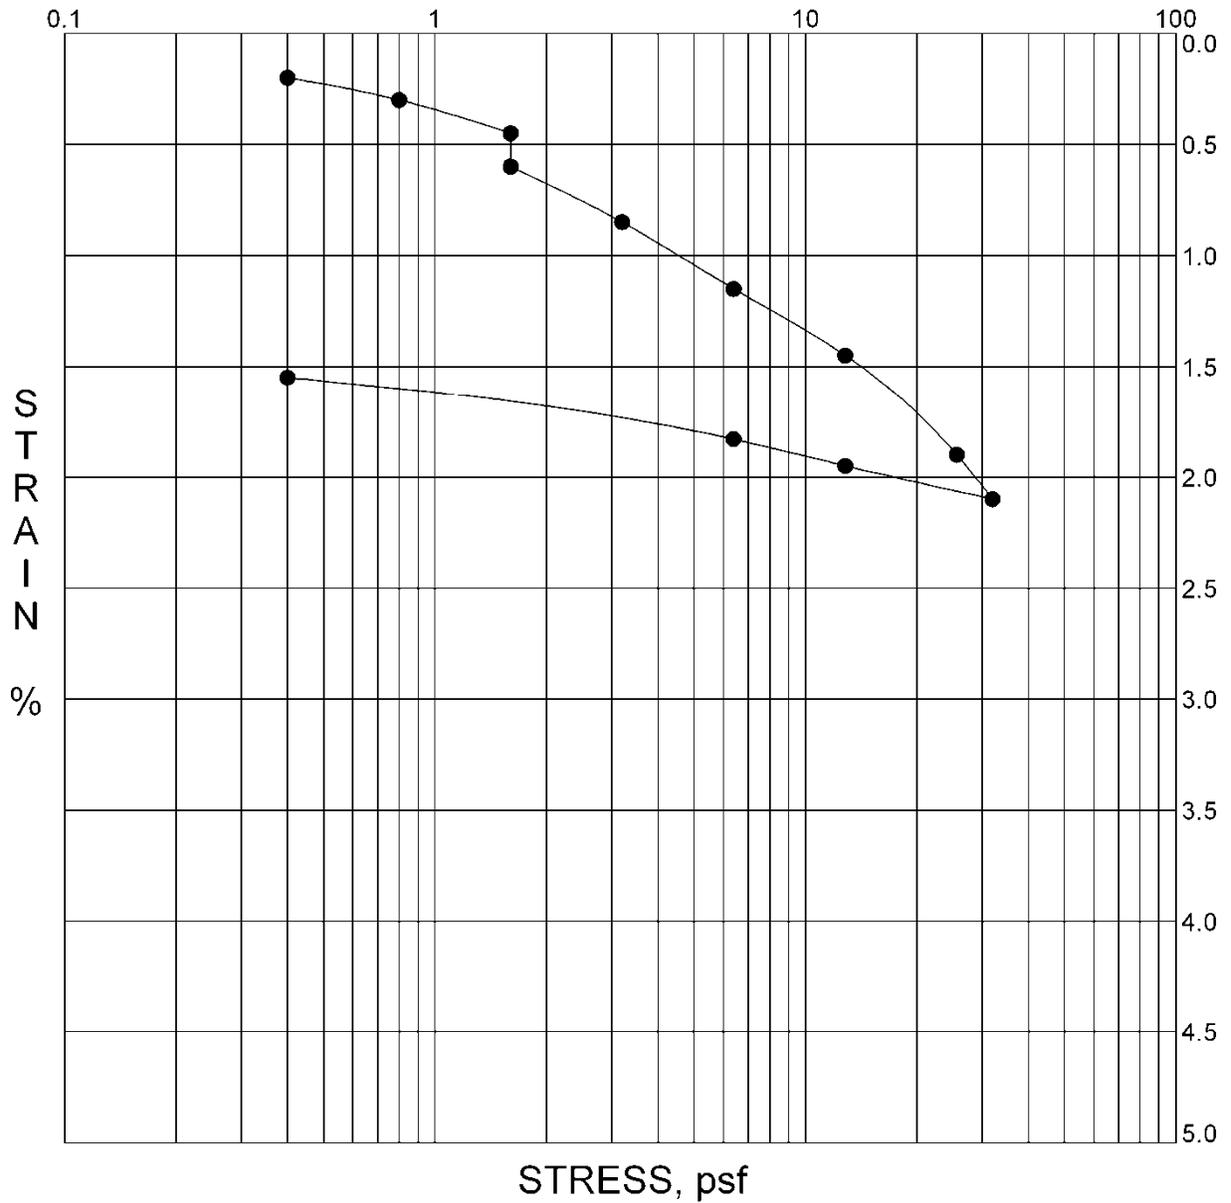
SAMPLE LOCATION: B-4 @ 35.0

Test Results

Moisture Content (%)	Density (pcf)	Water Added At
Insitu: 4.1	Dry Density: 116.5	1600 lbs.

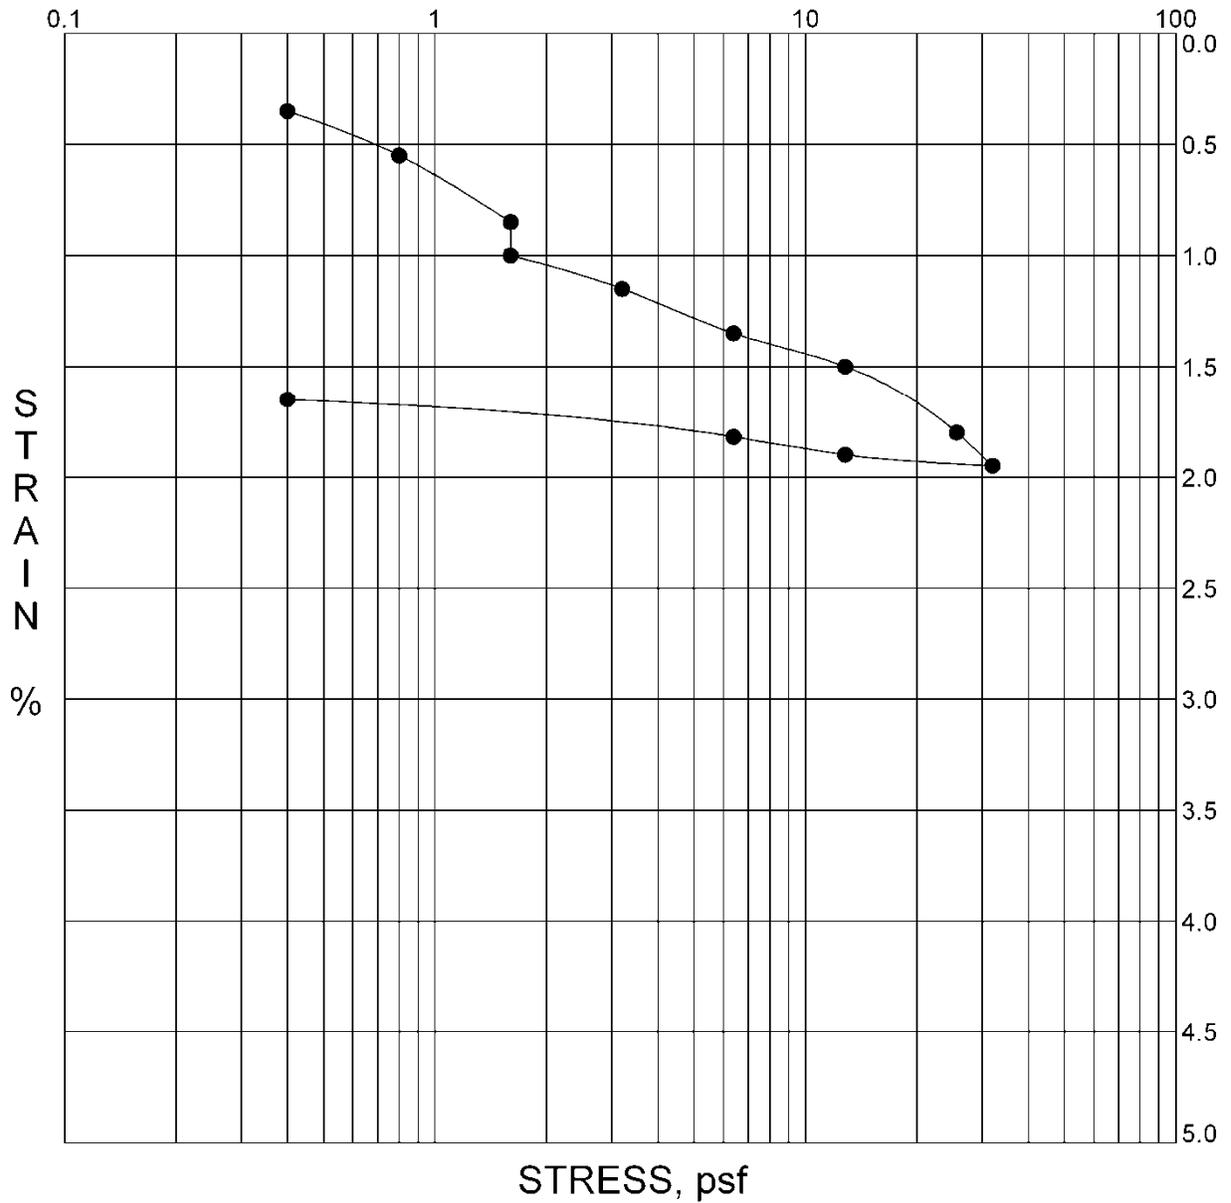
SAMPLE LOCATION: B-4 @ 45.0

Test Results

Moisture Content (%)	Density (pcf)	Water Added At
In situ: 5.7	Dry Density: 117.3	1600 lbs.

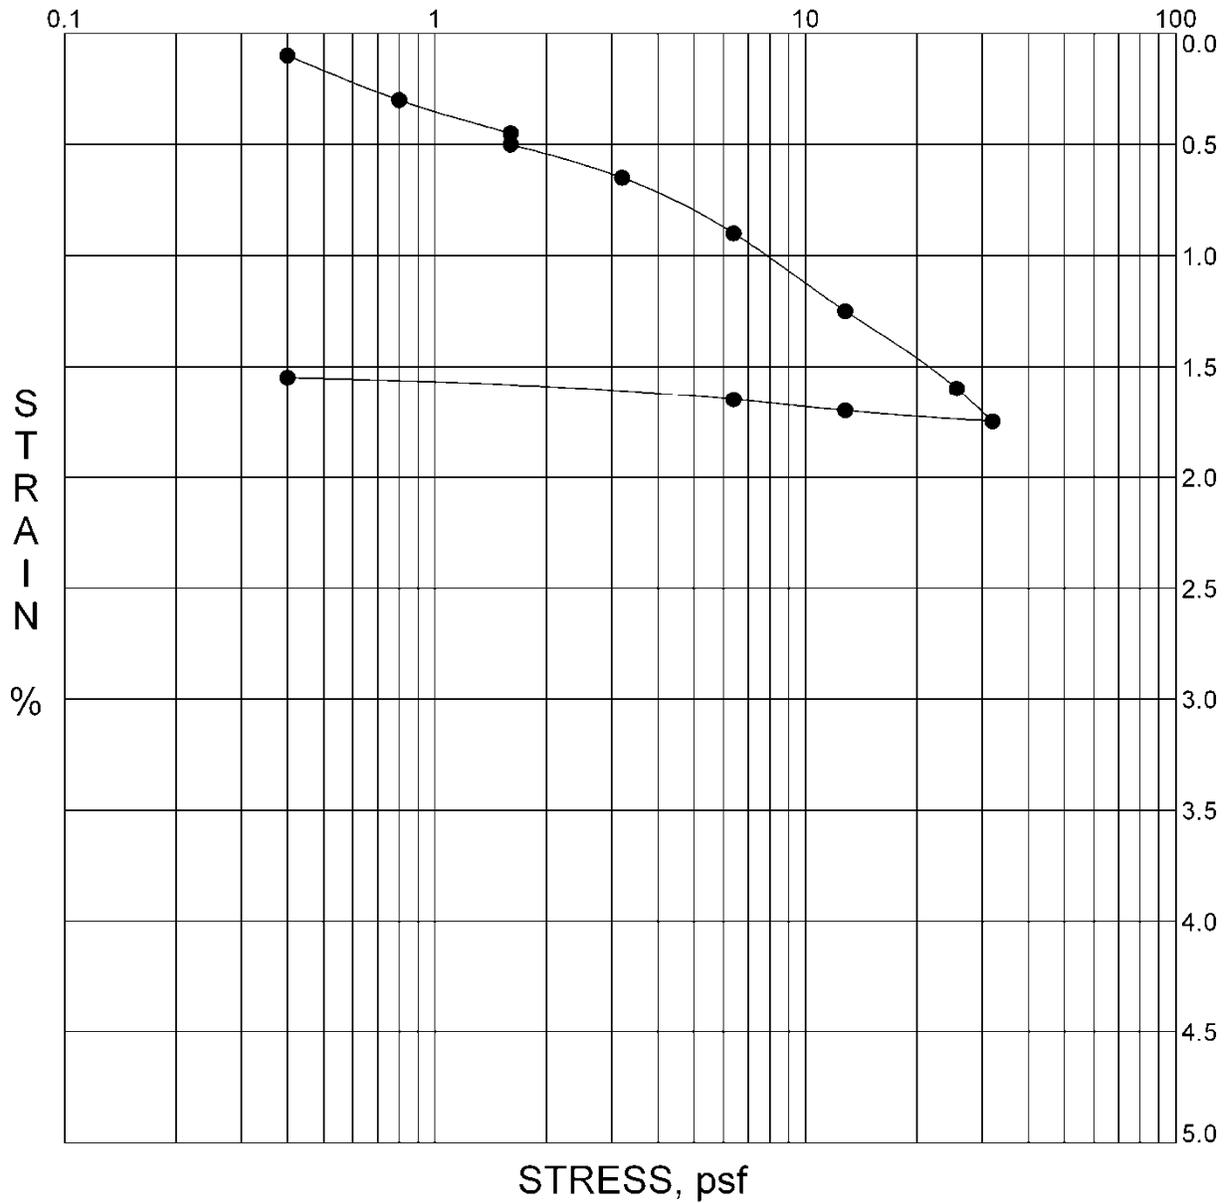
SAMPLE LOCATION: B-4 @ 55.0

Test Results

Moisture Content (%)	Density (pcf)	Water Added At
In situ: 12.3	Dry Density: 107.1	1600 lbs.

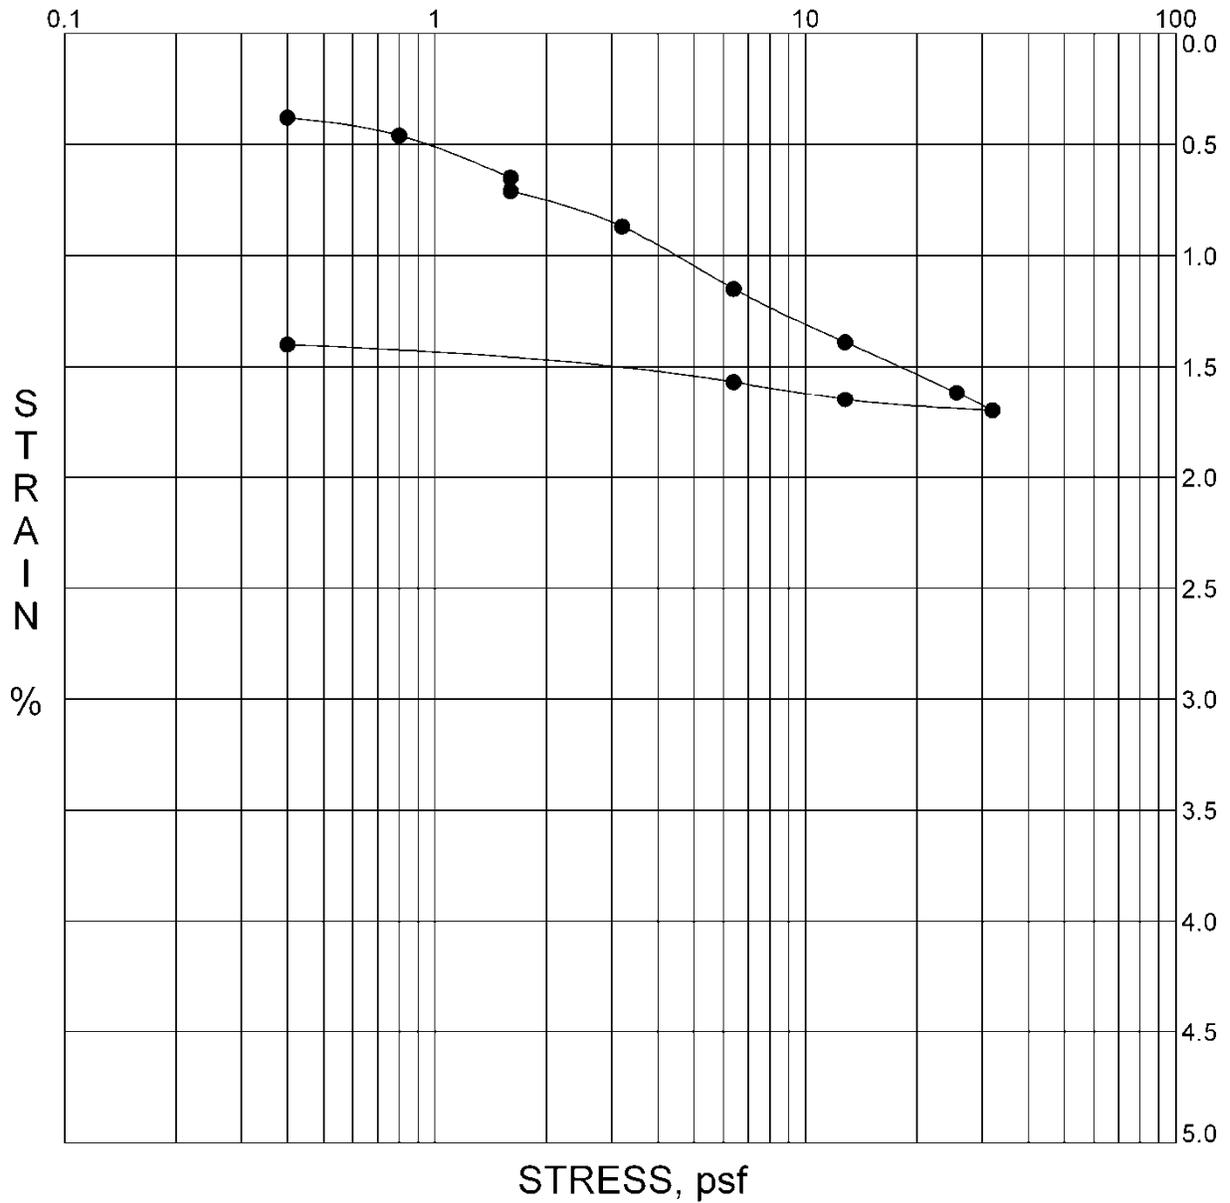
SAMPLE LOCATION: B-4 @ 65.0

Test Results

Moisture Content (%)	Density (pcf)	Water Added At
Insitu: 14.4	Dry Density: 113.7	1600 lbs.

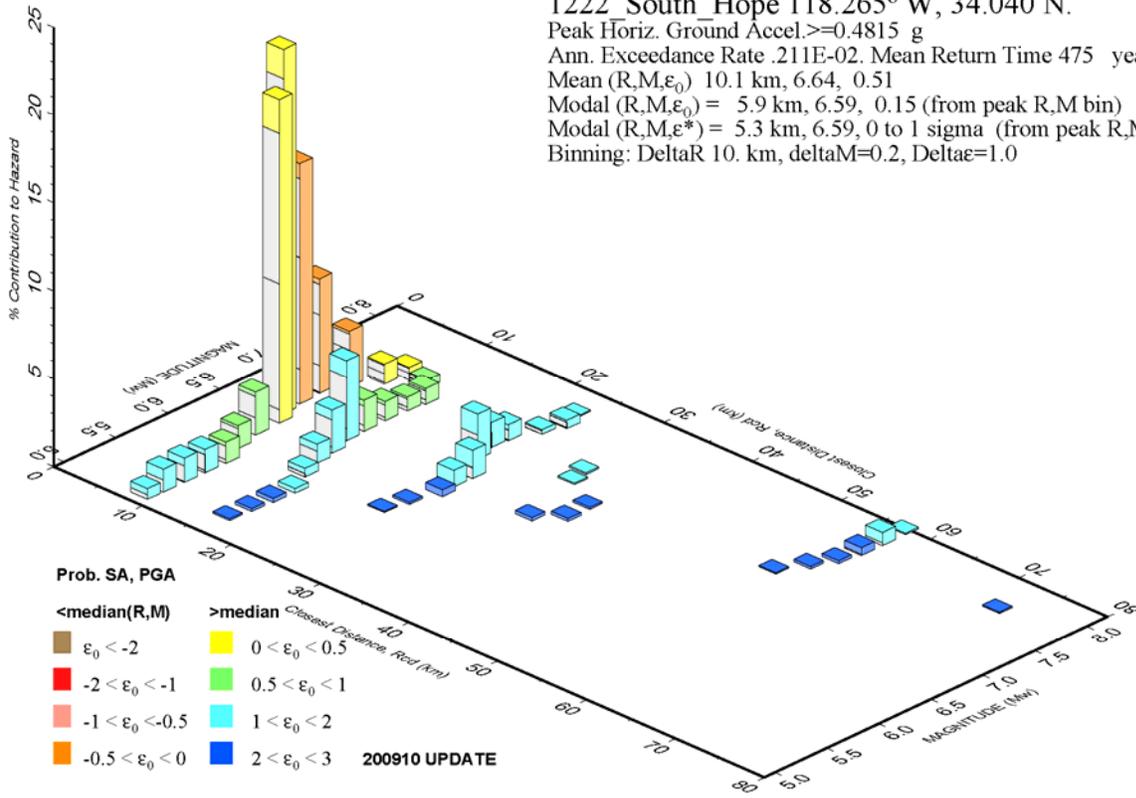
PSH Deaggregation on NEHRP C soil
 1222_South_Hope 118.265° W, 34.040 N.
 Peak Horiz. Ground Accel. ≥ 0.4815 g
 Ann. Exceedance Rate .211E-02. Mean Return Time 475 years
 Mean (R,M, ϵ_0) 10.1 km, 6.64, 0.51
 Modal (R,M, ϵ_0) = 5.9 km, 6.59, 0.15 (from peak R,M bin)
 Modal (R,M, ϵ^*) = 5.3 km, 6.59, 0 to 1 sigma (from peak R,M, ϵ bin)
 Binning: DeltaR 10. km, deltaM=0.2, Delta ϵ =1.0

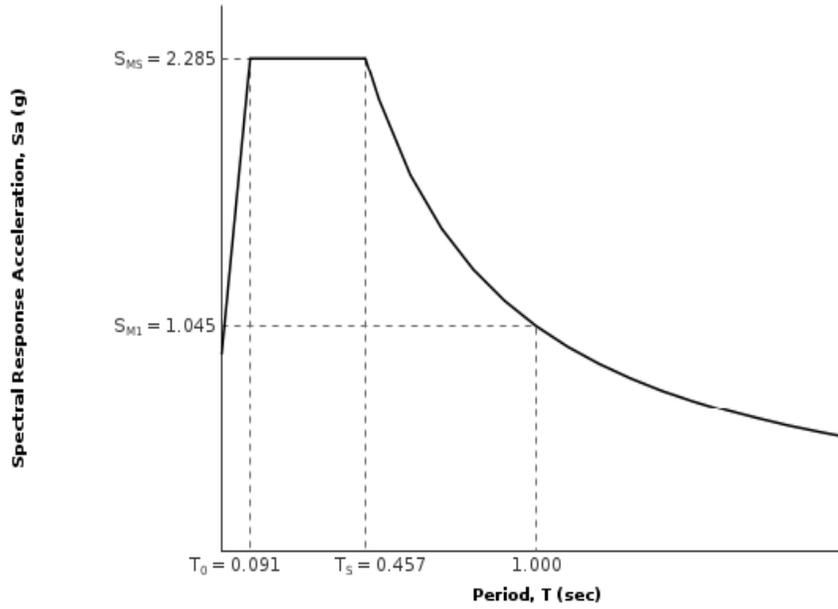
Section 11.4.6 — Risk-Targeted Maximum Considered Earthquake (MCE_R) Response Spectrum

The MCE_R Response Spectrum is determined by multiplying the design response spectrum above by 1.5.
